**ANNUAL PROGRAM  
FOR  
NRW REDUCTION**

**JAPANESE TECHNICAL COOPERATION  
FOR  
THE CAPACITY DEVELOPMENT PROJECT  
FOR NON REVENUE WATER REDUCTION  
IN COLOMBO CITY**

**May 2010**

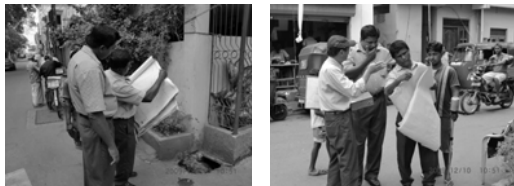
② Site survey by using existing pipe drawings

NRW Reduction Team and JICA experts have conducted site survey in Borella and Kotehana

Detecting buried valve by using metal locator and pipe locator

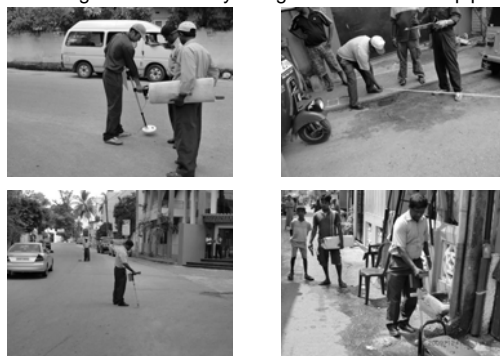
Water pressure survey in the sub zone

NRW Reduction team have checked water pressure condition in the sub zone by using water pressure gauge in the day time.

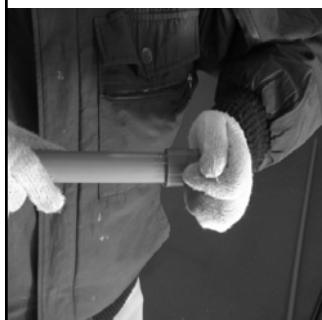
- The pipe is inserted in the fitting at a dash

- The state of inserting the pipe in the fitting has to be maintained for about 30 second
- In the case of no keeping the state, the pipe moves to out

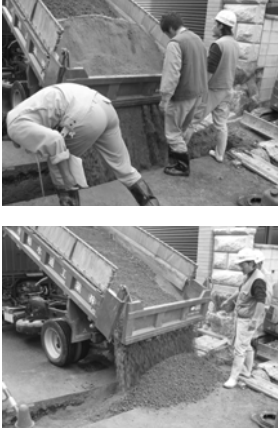
- It is necessary to survey the ground and the underground structure before excavation
- Because not to damage them
- depth of trench
  - On the road 60cm or more
  - Excluding the road 30cm or more

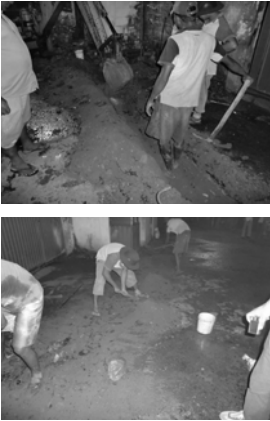
② Back-fill

- Use pit sand first
- (at least about 10cm from the pipe top)
- Afterwards, back-fill by gravel

- enough surface compaction

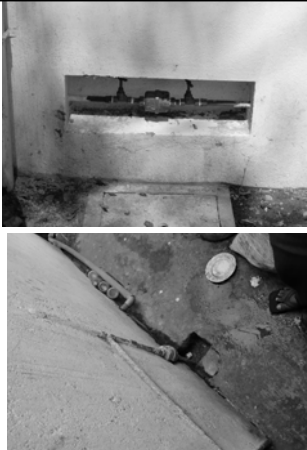
▪ Good example

- It is easy to read a meter and meter changing is also easy

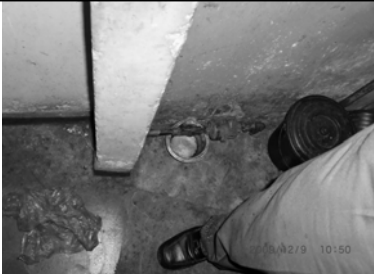
a) Meter is buried under the wall, and changing is difficult

b) The meter is indoors, and it is not possible to read a meter when the resident is not there

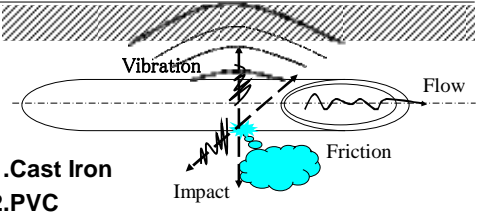
#### 4) Mechanism of a water leak

Leak noise consists on four elements, these are: impact, friction, flow and vibration.

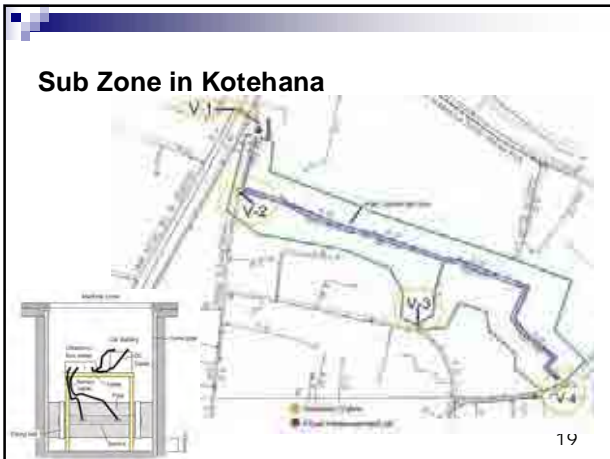
18

Flow measurement pt

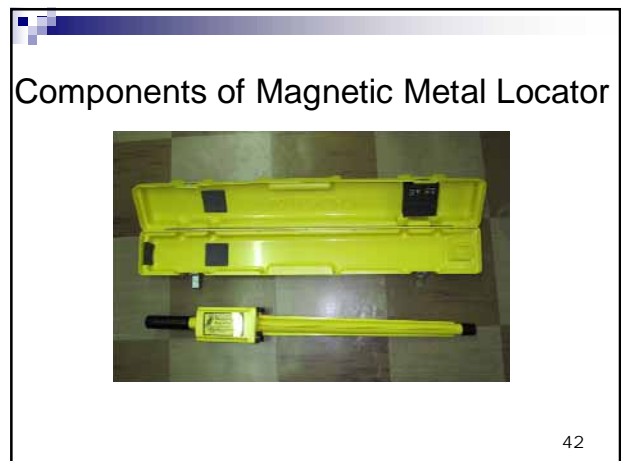
36

Set the transmitter on the pipe line

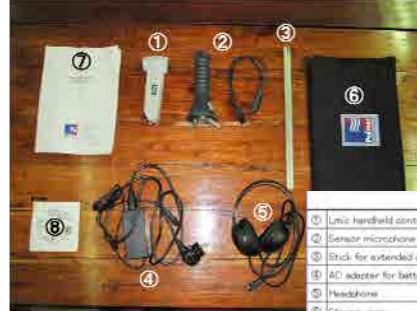
1-2 Electrical Acoustic Rod (3/3)

Components of Electrical Acoustic Rod

System Components		
①	Lytic handheld control unit	1 pc
②	Sensor microphone unit	1 pc
③	Stick for extended connection	2 pcs
④	AC adapter for battery charger	1 pc
⑤	Headphone	1 pc
⑥	Storage case	1 pc
⑦	Instruction manual (English)	2 pcs
⑧	Instruction manual CD (English)	1 pc

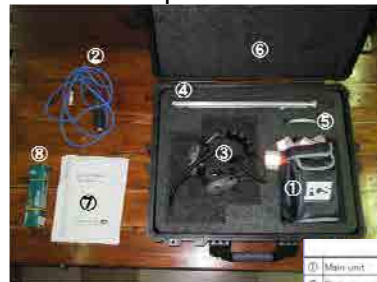
~ Components of Electric Leak Detector ~

System Components		
①	Main unit	1 pc
②	Pick up sensor	1 pc
③	Headphone	1 pc
④	Steel probe rod set	1 pc
⑤	Disk plate for acoustic of road surface	1 pc
⑥	Storage case	1 pc
⑦	Instruction manual (English)	2 pcs
⑧	Dielectric Grease	1 pc

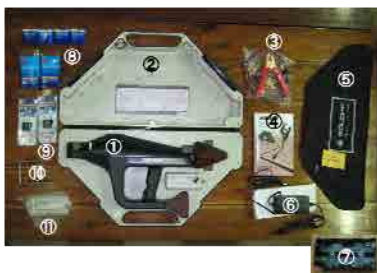
### 4-1 Pipe Locator (Metallic Pipe) (3/3) ~ Components ~

System Components	
1 Receiver	1 pc
2 Transmitter	1 pc
3 Heavy connection cable (with clip, 15m/50ft)	1 pc
4 Insulation cover (50cm)	1 pc
5 Accessory bag / Transport case	1 pc
6 AC adapter	1 pc
7 Battery box	1 pc
8 Rechargeable AA battery (3x) with battery charger	1 set
9 Transformer plug (C type to B type)	2 pcs
10 Spare key	1 pc
11 Storage case	1 pc

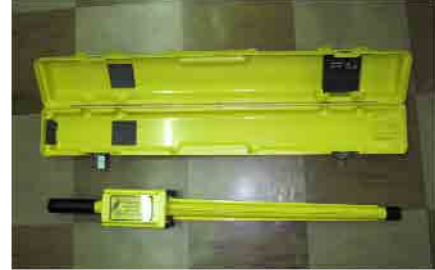
### 4-3 Magnetic Locator (3/3) ~ Components ~
