### 束状管路敷設替えマニュアル

Annex -4 Manual for Bundle Pipe Replacement

# ***Operation Manual of Leak Detection Equipment***

This operation manual is combined leak detection equipment and utilized for the NWSDB staff who are relating to water leak detection activity.

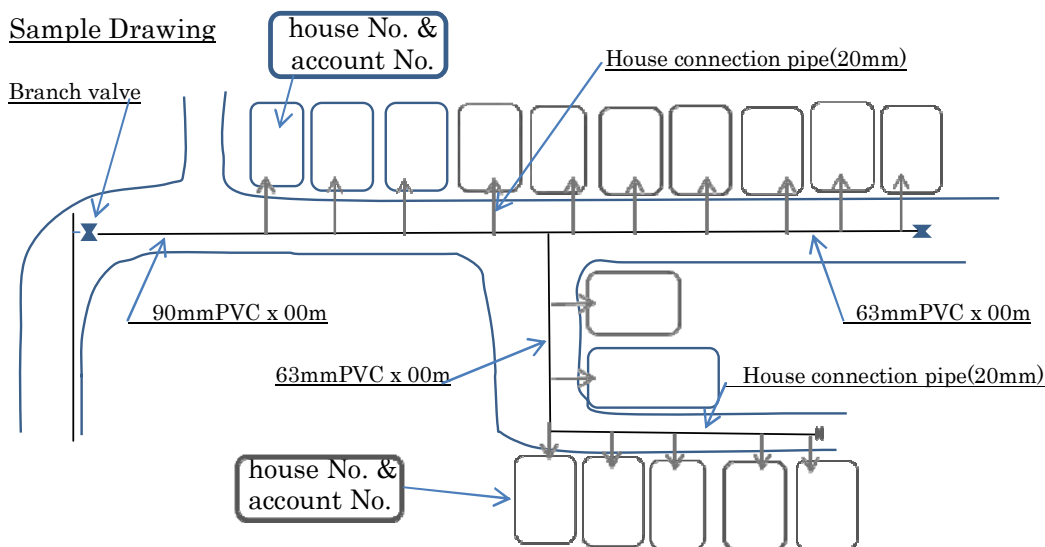
Sample Drawing

- 1 Enignners of O.I.C office shall conduct site survey and prepare drawings and BOQ to suite the survey result.

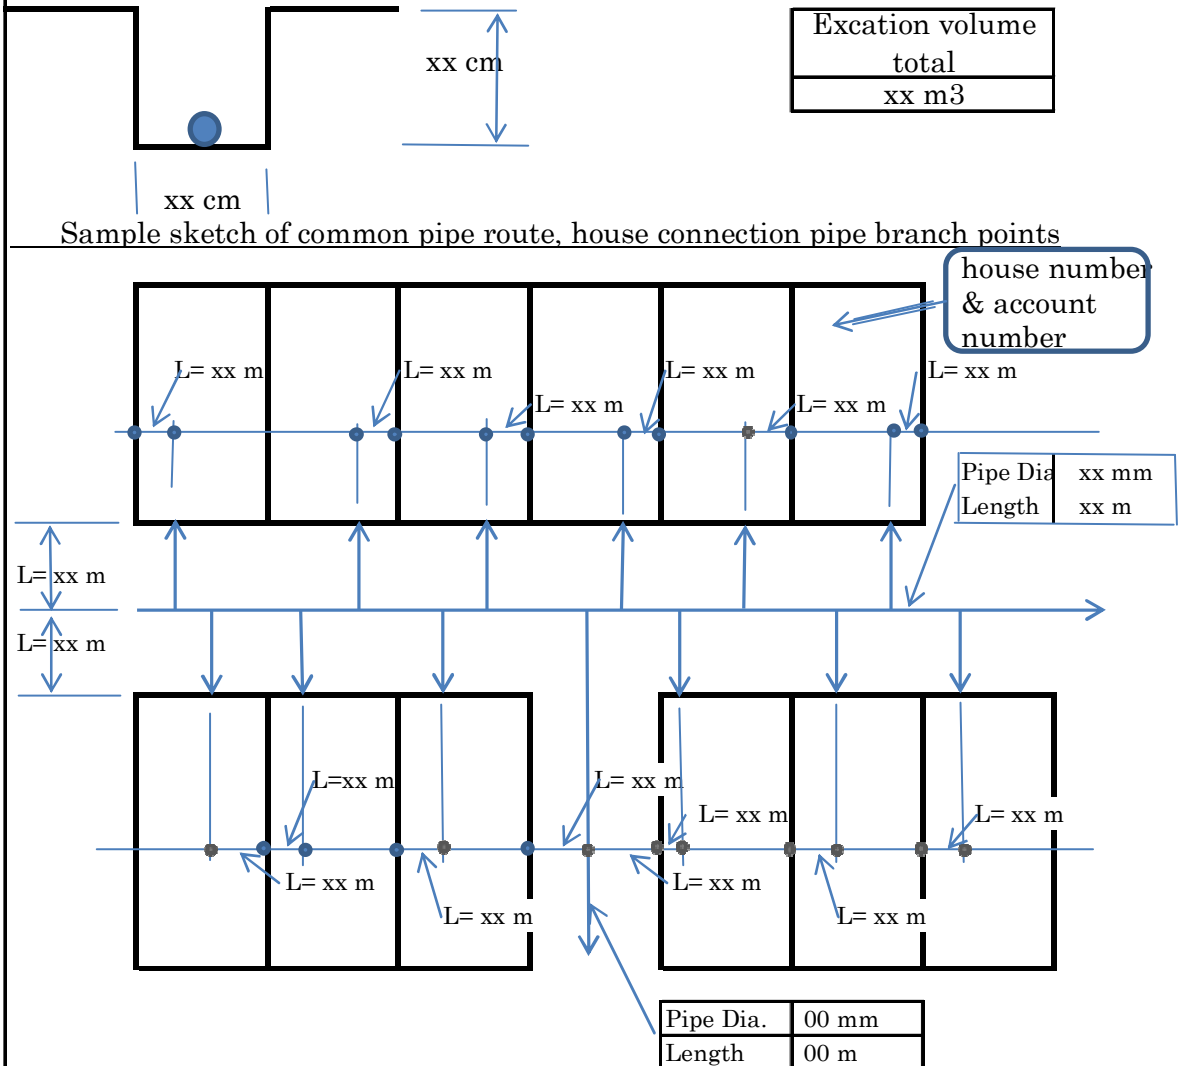
Sample sketch of trench measurement

Make the contractor record excavation depth, width, length and common pipe route and each house connection pipe branch point

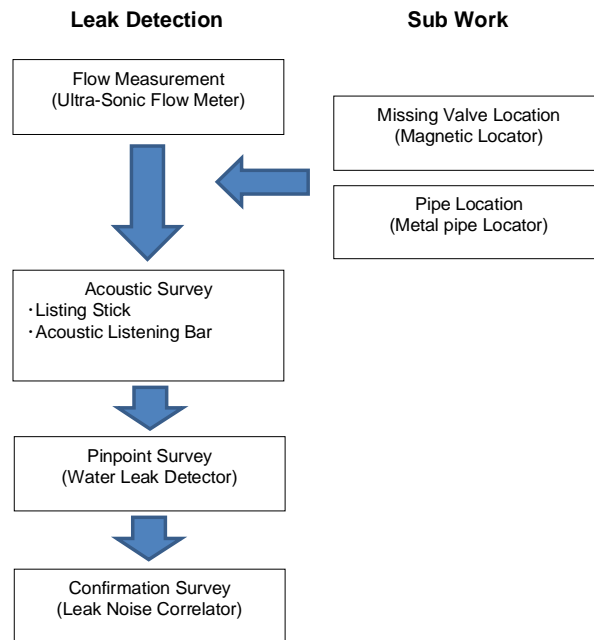
### Flow chart of Leak detection

Leak detection is conducted as shown in the following figures.

Leak detection is narrow downed to pinpoint in large area.

Leak sound is detected by leak detection equipment.

**Flow measurement** should be executed for realizing leak amount in the zone by the Flow meter before leak detection.

**A missing valve or unknown pipe** should be detected by the locators as a sub work.

**Acoustic survey** should be conducted to customer meter and other fittings to find leak sound by the listening stick.

**Pinpoint survey** should be conducted for pipe line from the surface by the water leak detector.

**Confirmation survey** is conducted to the suspicious point which are detected by the leak detection by the leak noise correlator.

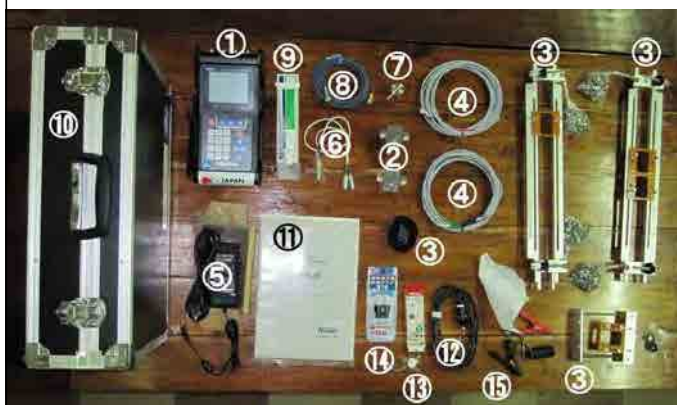
System Components

①	UFP-20 Main unit with Battery and Protection cover	1 pc
②	Medium transducer(nominal diameter 20A~50A (Z-path method) /65A~500A (V-path method))	1 set
③	Mounting fixture for medium transducer	1 set
④	Transducer cable (7m)	1 set
⑤	AC adapter	1 pc
⑥	Thickness gauge/sound speed measurement	1 set
⑦	Test piece	1 pc
⑧	Analog output cable	1 pc
⑨	Silicone grease for acoustic couplant	1 pc
⑩	Carrying case	1 pc
⑪	Instruction manual(English)	1 pc
⑫	Cigarette lighter cable	1 pc
⑬	USB memory(2GB)	1 pc
⑭	Transforming plug(C type to B type)	1 pc
⑮	Battery clamp cable with vehicle outlet	1 pc

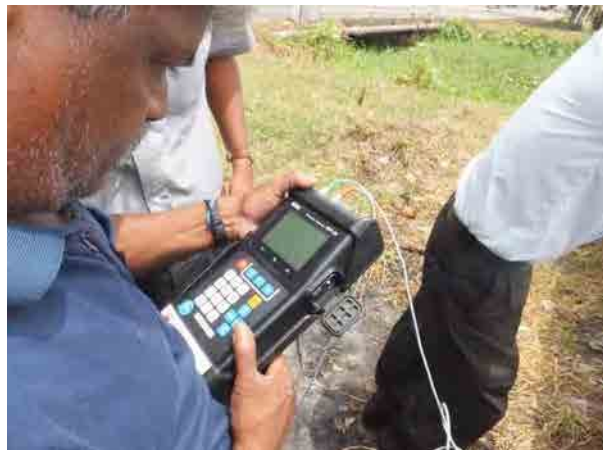
### ***(4) How to operate at beginning***

- Input pipe information such as outer diameter, pipe thickness, pipe material, sensor type, flow method as well as a liquid type for the mounting space of transducers.

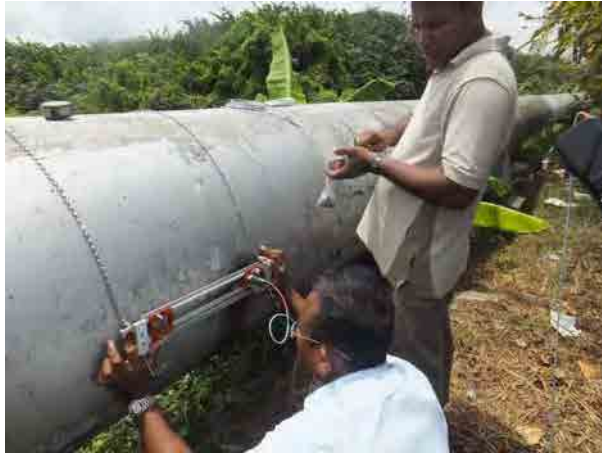
### **(5)How to mount the transducers**

- Polish the mounting place to keep clean between transducers and pipe surface.
- Adjust the mounting space on the guide
- Put the grease on the transducers.
- Hold the sensor guide tightly with guide chain and transducers are adhered to the pipe.

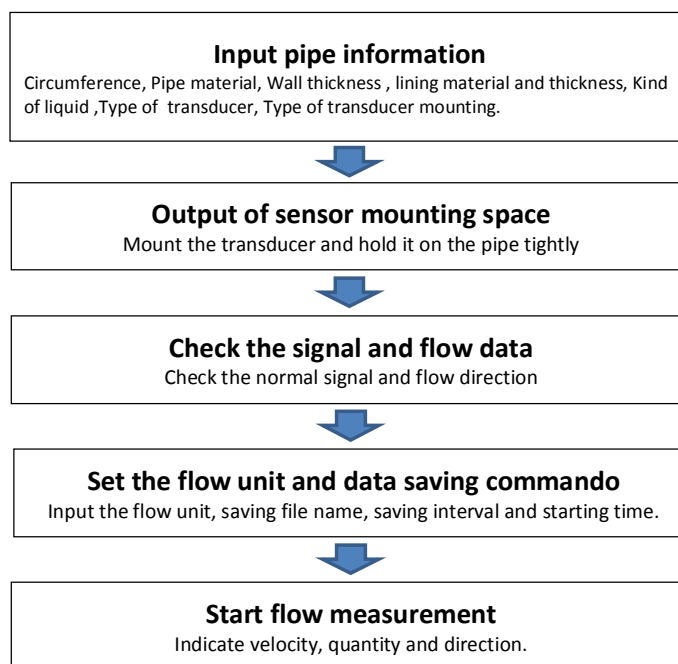
## **Procedure of flow measurement**

- Check the **Normal signal** after installing transducers on the pipe.
- Check the **Flow direction** by the positive or negative signal.  
If negative sign is turned on, reconnect the cable position and check it.
- Set the **“Zero clear”** commando which zero point is fixed automatically even water is moving.
- Set the **“Data recording”** commando which with starting time, flow unit, recording interval and integrated volume.  
flow data should be saved into the internal memory or storage media.

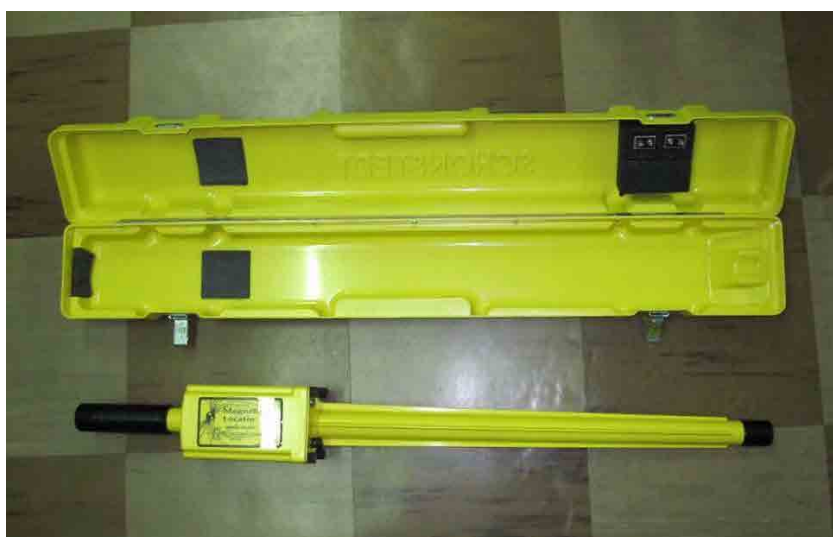
### **(3)Components**

Main unit  
Carrying case

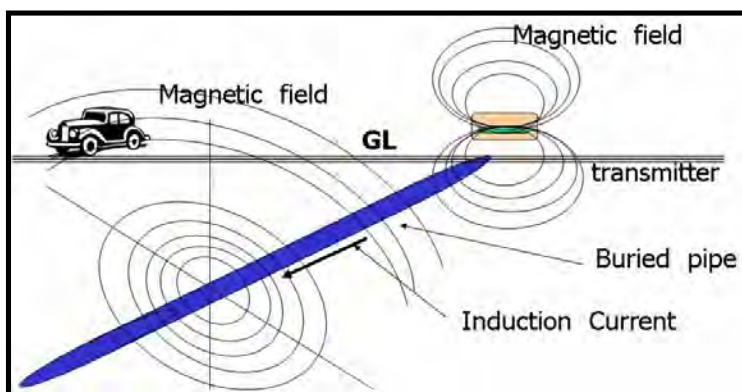
#### (2) Principle

When radio frequency current flow to the buried metallic pipe from the transmitter, it makes inductive loop around metallic pipe and receive it by the receiver unit.

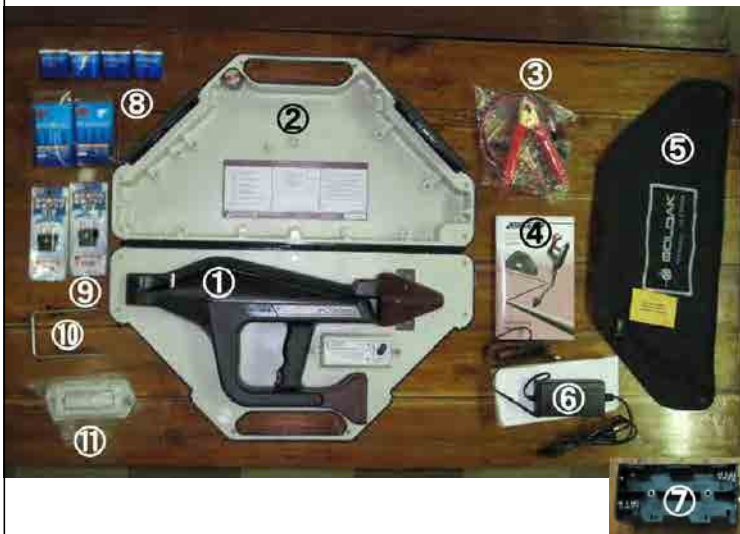
System Components		
①	Receiver	1 pc
②	Transmitter	1 pc
③	Direct connection cable (with clip, 1 bundle/set)	1 pc
④	Instruction manual (English)	1 pc
⑤	Accessory bag /transmitter case	1 pc
⑥	AC adapter	1 pc
⑦	Battery box	1 pc
⑧	Eneloop size AA battery(8pcs) with battery charger	1set
⑨	Transforming plug(C type to B type)	2pcs
⑩	Earth bar	1 pc
⑪	Battery case	1 pc

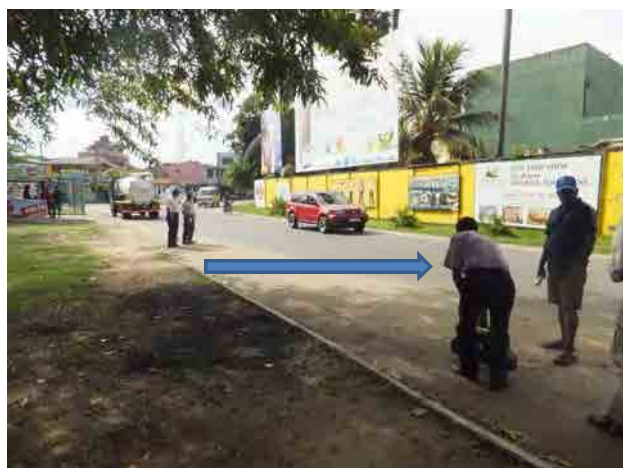
- Adjust the frequency on 116Hz and signal strength of transmitter and receiver before detection.
- Put on the transmitter above the pipe line if location is known.
- If not, across the road two persons who hold the transmitter and receiver parallel, and move them at same speed and same direction.

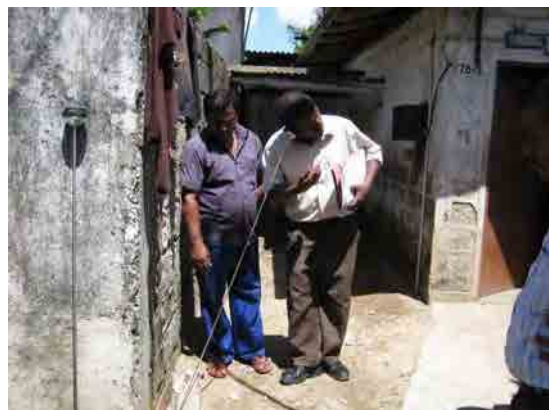
- Contact the listening stick to the meter, valve and fittings.
- listen to the sound carefully.
- If “Shee” or “Huee” sound on it, mark the location on the survey map with house number or landmark.
- When water leak detector find the leak, it is checked on the road by the listening stick.
- Listening stick can not only check the sound at meter but also can use as a device of confirmation survey.

- Do not hold the stick during listening otherwise vibration sound become small. Operator should hold the head part when listen.
- listening stick should be contacted to metal part because sound on non-metallic propagate shortly with low frequency.
- Do not hold to turn toward sharp edge to the people otherwise people will be received injuries.

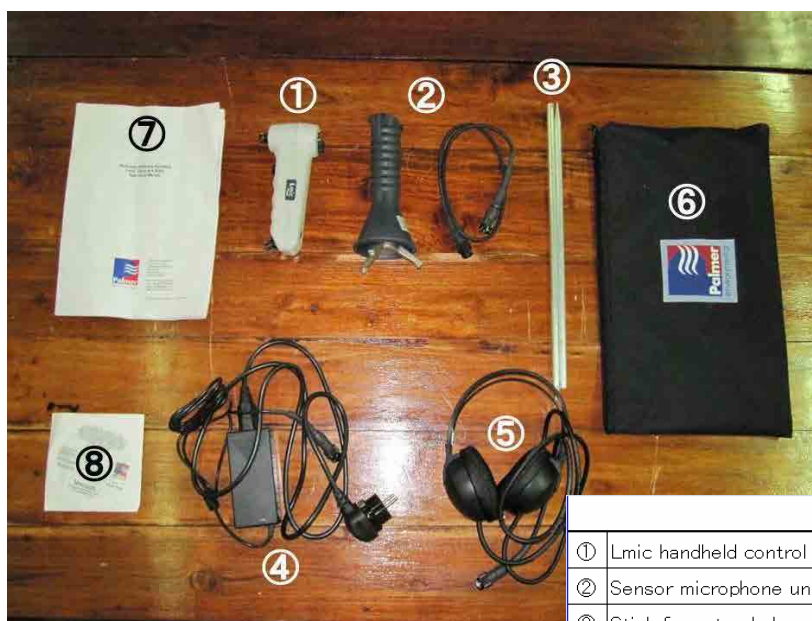
System Components		
①	Lmic handheld control unit	1 pc
②	Sensor microphone unit	1 pc
③	Stick for extended connection	2 pcs
④	AC adapter for battery charger	1 pc
⑤	Headphone	1 pc
⑥	Storage case	1 pc
⑦	Instruction manual (English)	2 pcs
⑧	Instruction manual CD (English)	1 pc

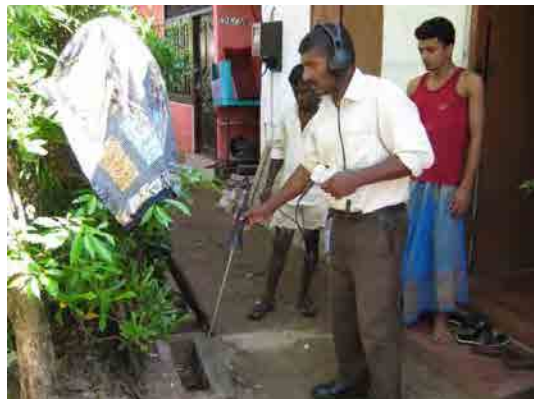
- Stick contact to the meter and press the button.
- Listen the sound carefully.
- If “Shee” or “Huee” sound on it, mark the location on the survey map with house number or landmark.
- Sensor microphone unit can be use as a leak detector.

- Check the residual battery before use.
- Recharge it fully If color is red, charge lamp changes color from red to green when recharge is completed.
- Do not give a strong shock to the hand prove because sensor will be broken.

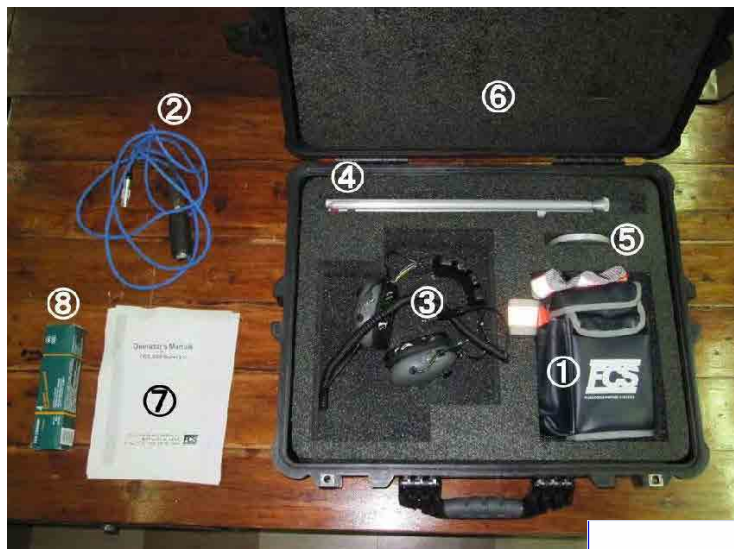
System Components

①	Main unit	1 pc
②	Pick up sensor	1 pc
③	Headphone	1 pc
④	Steel probe rod set	1 pc
⑤	Disk plate for acoustic of road surface	1 pc
⑥	Storing case	1 pc
⑦	Instruction manual (English)	2 pcs
⑧	Dielectric Grease	1 pc

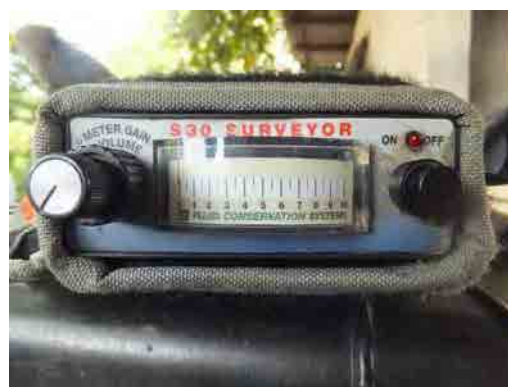
Level meter

- Connect the sensor cable and headphones to main unit.
- Check the residual battery quantity by the level gauge meter.
- Adjust the sound level with volume knob which a making it by the foot noises.

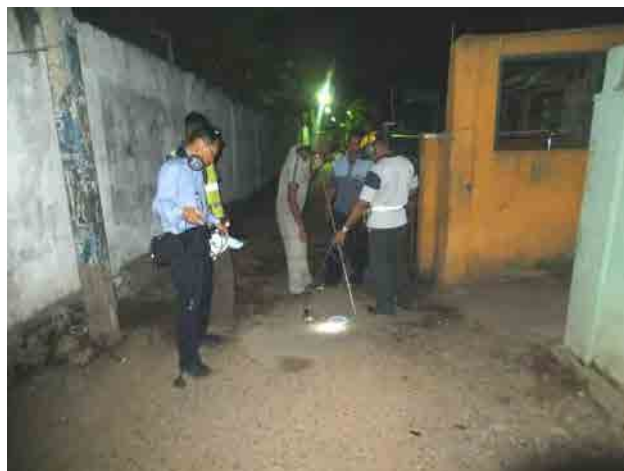
- Put on the sensor gently approximately 50cm on each step.
- Keep a distance at least 2m each other during survey due to avoiding foot noises.
- Move the sensor forward, backward, left and right side when find a suspicious sound.
- Mark the point which is detected the loudest point on the surface with color splay, and also mark the point on the survey map with house number.

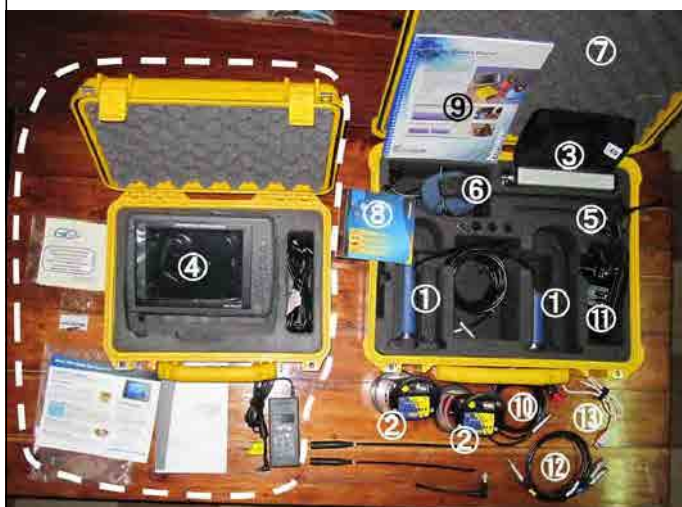
System Components	
① Acceleration sensor	2 pcs
② Digital radio transmitter	2 pcs
③ Reception module	1 pc
④ Hard tablet type Computer	1 pc
⑤ Magnetic Vehicle Mount Antenna	1 pc
⑥ Headphone	1 pc
⑦ Hard carry case (with battery charger)	1 pc
⑧ Software CD	1 pc
⑨ Instruction manual (English)	2 pcs
⑩ Car Charge Cable	1 pc
⑪ Mains Charger	1 pc
⑫ Transmitter Programming Y-Cable	1 pc
⑬ Receiver Unit USB Cable	1 pc

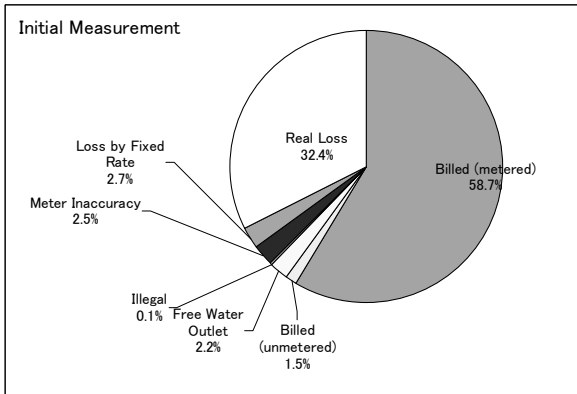
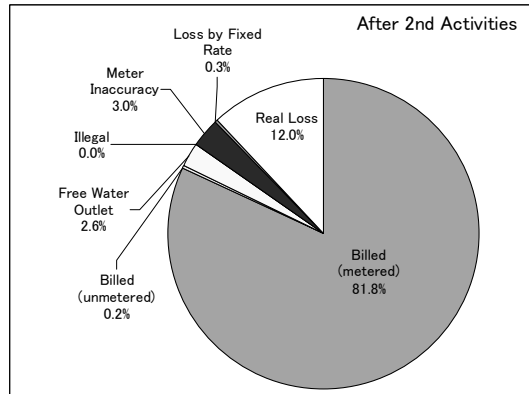
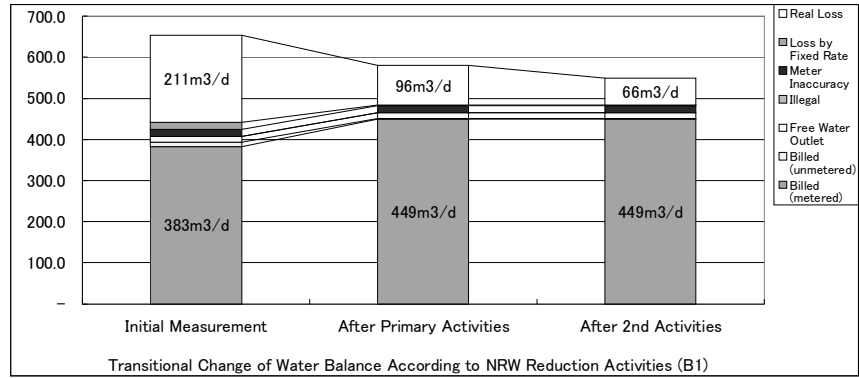
**Figure A3-1 Water Balance before and after NRW Reduction Activities (B1)**

Components			Initial Measurement		=>	After Primary Activities		=>	After 2nd Activities	
			m3/day	(%)		m3/day	(%)		m3/day	(%)
RW	Billed Consumption	Authorized (metered)	383.1	58.7%	=>	449.4	77.5%	=>	449.4	81.8%
		Unauthorized (unmetered)	9.7	1.5%	=>	1.3	0.2%	=>	1.3	0.2%
NRW	Apparent Losses	Free Water Outlet	14.4	2.2%	=>	14.4	2.5%	=>	14.4	2.6%
		Unauthorized Consumption	0.5	0.1%	=>	0.1	0.0%	=>	0.1	0.0%
	Metering Inaccuracy	Meter Inaccuracy	16.5	2.5%	=>	16.2	2.8%	=>	16.2	3.0%
		Loss by Fixed Rate	17.5	2.7%	=>	1.7	0.3%	=>	1.7	0.3%
	Real Losses	Real Loss	211.5	32.4%	=>	96.5	16.6%	=>	65.9	12.0%
Total System Input			653.1	100.0%	=>	579.6	100.0%	=>	549.0	100.0%
MNf (l/min)			312			249			206	
MNf (converted to m3/day)			449			359			297	
Pressure at MNf (m) (Canal)			18.2			19.6			19.0	
Pressure at MNf (m) (Gotami Rd)			14.2			16.2			15.0	
Measured on:			3-12 Jun, 2010			25 Aug - 2 Sep, 2010			3 - 7 Feb, 2011

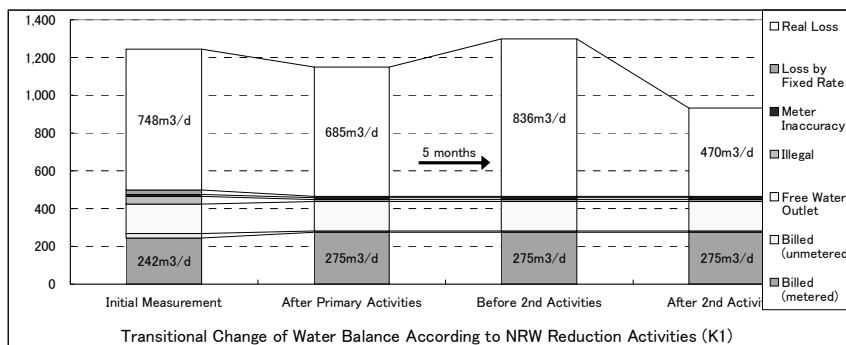
**Figure A3-9 Water Balance before and after NRW Reduction Activities (K2)**

Components			Initial Measurement		After Primary Activities		Before 2nd Activities		After 2nd Activities	
			m³/day	(%)	m³/day	(%)	m³/day	(%)	m³/day	(%)
RW	Billed Consumption	Authorized	242.1	19.4%	274.6	23.9%	274.6	21.1%	274.6	29.4%
		Unauthorized	25.3	2.0%	5.3	0.5%	5.3	0.4%	5.3	0.6%
NRW	Unbilled Authorized Consumption	Free Water Outlet	156.4	12.6%	156.4	13.6%	156.4	12.0%	156.4	16.8%
		Unauthorized	39.2	3.2%	11.8	1.0%	11.8	0.9%	11.8	1.3%
	Apparent Losses	Meter Inaccuracy	10.4	0.8%	10.1	0.9%	10.1	0.8%	10.1	1.1%
		Loss by Fixed Rate	23.6	1.9%	4.9	0.4%	4.9	0.4%	4.9	0.5%
	Real Losses	Real Loss	748.0	60.1%	685.0	59.7%	836.0	64.4%	470.0	50.4%
Total System Input			1,245.0	100.0%	1,148.0	100.0%	1,299.0	100.0%	933.0	100.0%

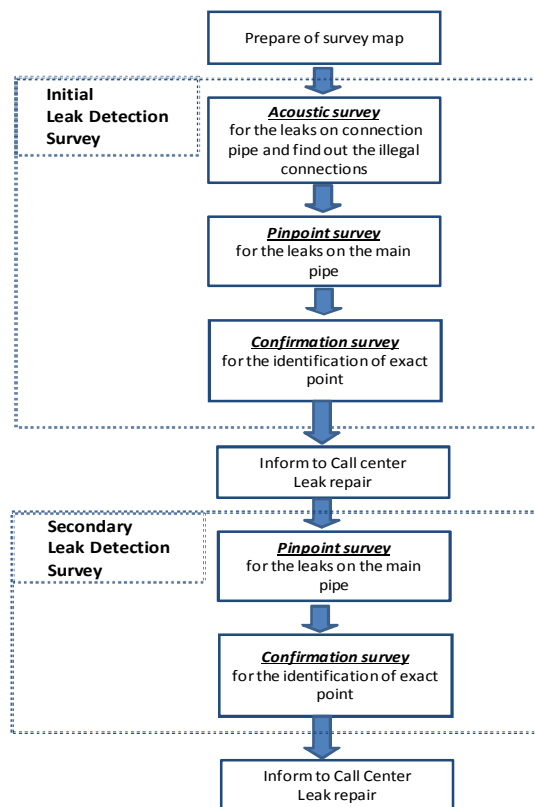
**Figure B5-1 Flow Chart of Leakage Detection and Repair**

The expected flow chart of leakage detection and repair is shown in Figure B5-1.
