The Project for Improvement of Equipment for Disaster Risk Management in the Republic of El Salvador				
Title Block Diagram of Data Acquisition for Strong Motion Accelerometer System and Broadband System				DWG. No. <b>SM-1</b>
DATE 5. Dec. 2012	DESIGNED M.Wada	CHECKED T.Kobayashi	APPROVED K.Tanaka	REVISION
YACHIYO ENGINEERING CO., LTD. TOKYO JAPAN

The Project for Improvement of Equipment for Disaster Risk Management in the Republic of El Salvador				
Title Data Transmitting Route of Strong Motion Accelerometer System, Broadband System and GPS Station System				DWG. No. <b>SM-2</b>
DATE	DESIGNED	CHECKED	APPROVED	REVISION
5. Dec. 2012	M.Wada	T.Kobayashi	K.Tanaka	
<b>YACHIO ENGINEERING CO., LTD.</b> TOKYO JAPAN

# LT-K-1 Location of the Site and Survey Photos

SR-1: VHF コミュニケーションネットワーク

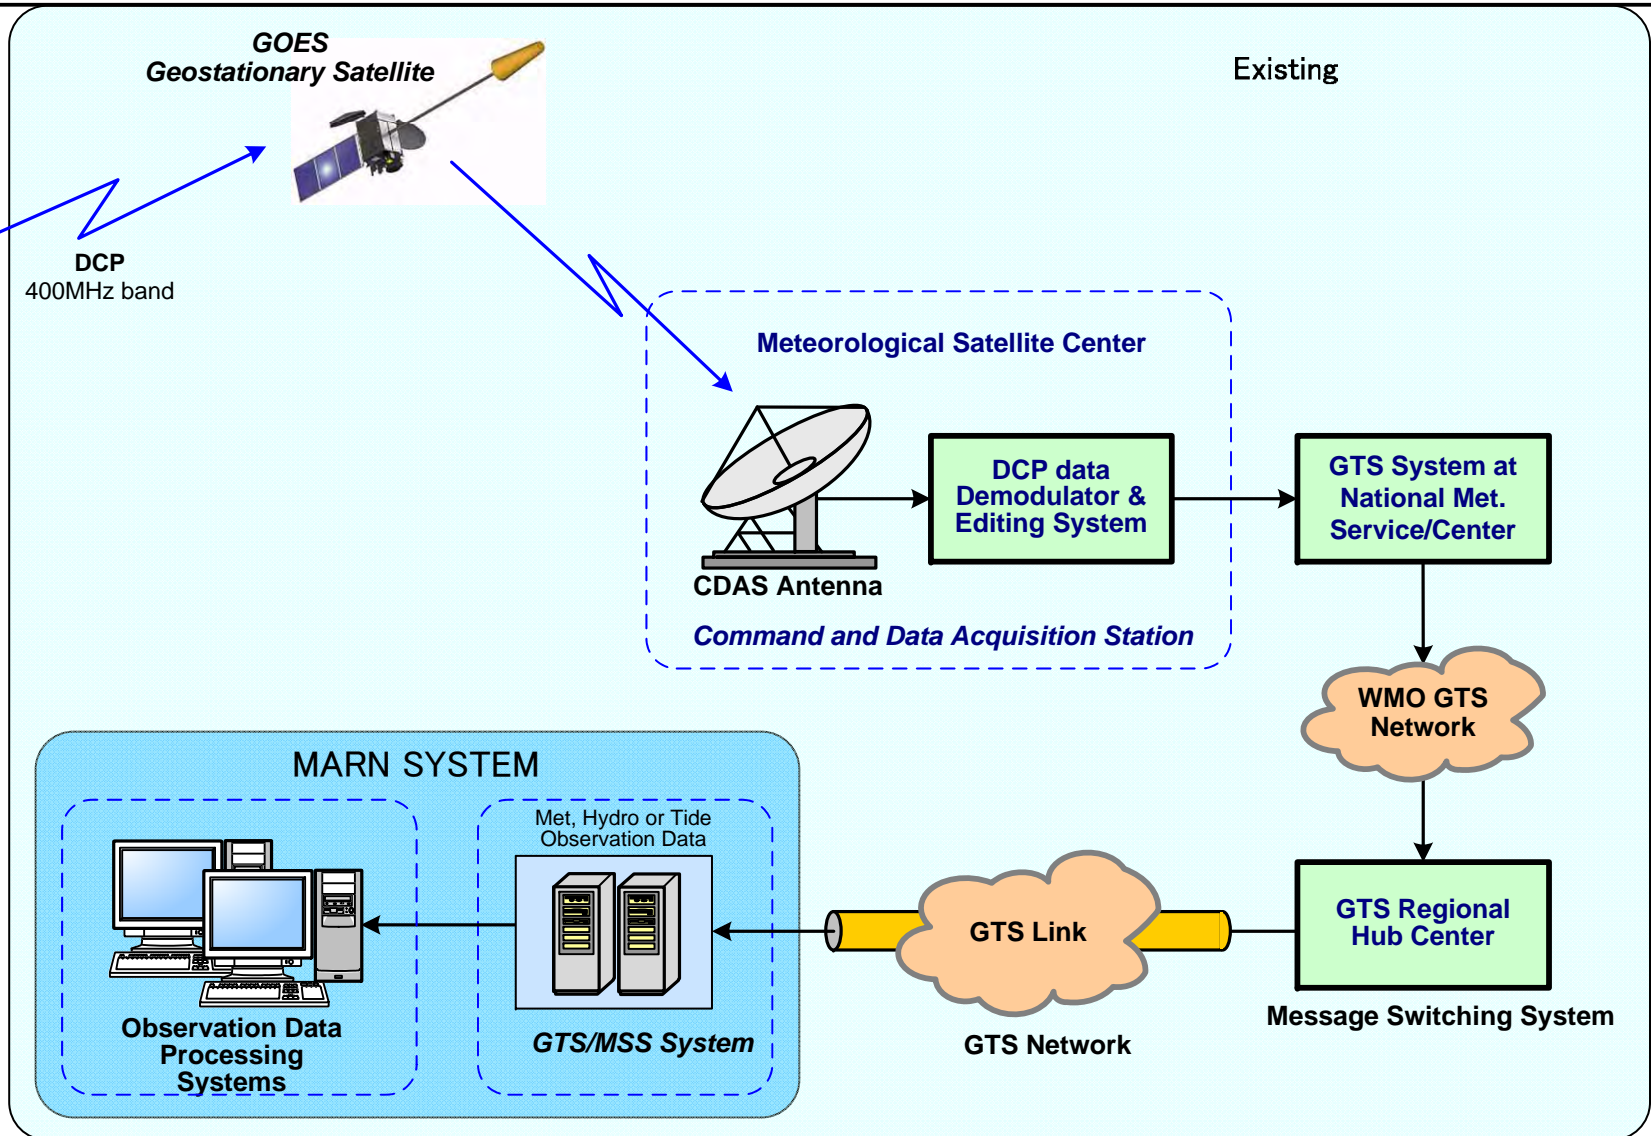
The Project for Improvement of Equipment for Disaster Risk Management in the Republic of El Salvador				
Title				DWG. No.
System Diagram of Tide Observation System				SM-3
DATE	DESIGNED	CHECKED	APPROVED	REVISION
5. Dec. 2012	M.Wada	T.Kobayashi	K.Tanaka	
YACHIYO ENGINEERING CO., L.TD. TOKYO JAPAN

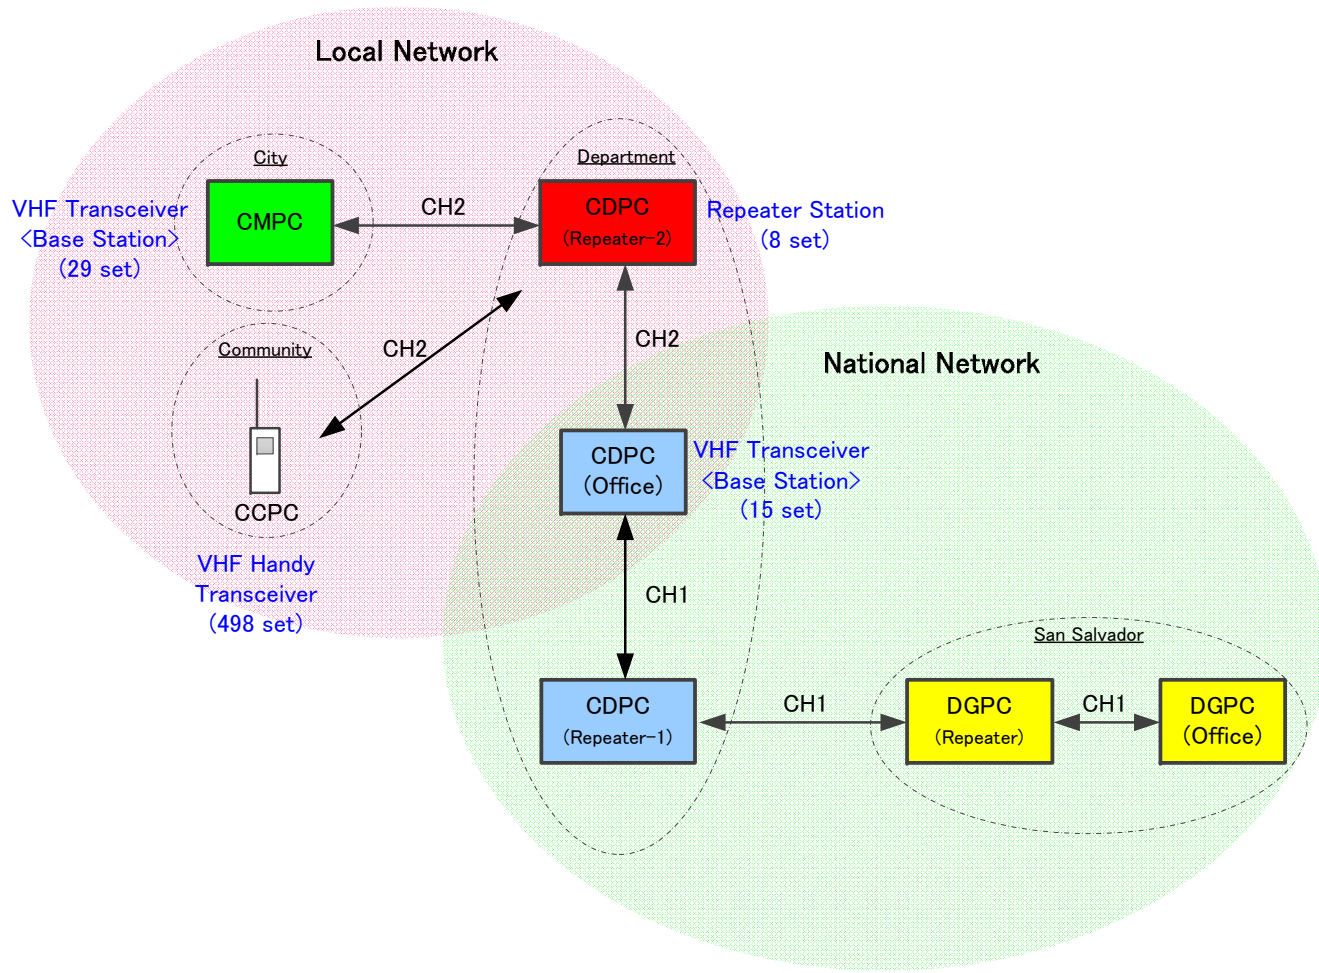
The Project for Improvement of Equipment for Disaster Risk Management in the Republic of El Salvador				
Title				DWG. No.
Relation of National and Local network				SR-2
DATE	DESIGNED	CHECKED	APPROVED	REVISION
5. Dec. 2012	M.Wada	T.Kobayashi	K.Tanaka

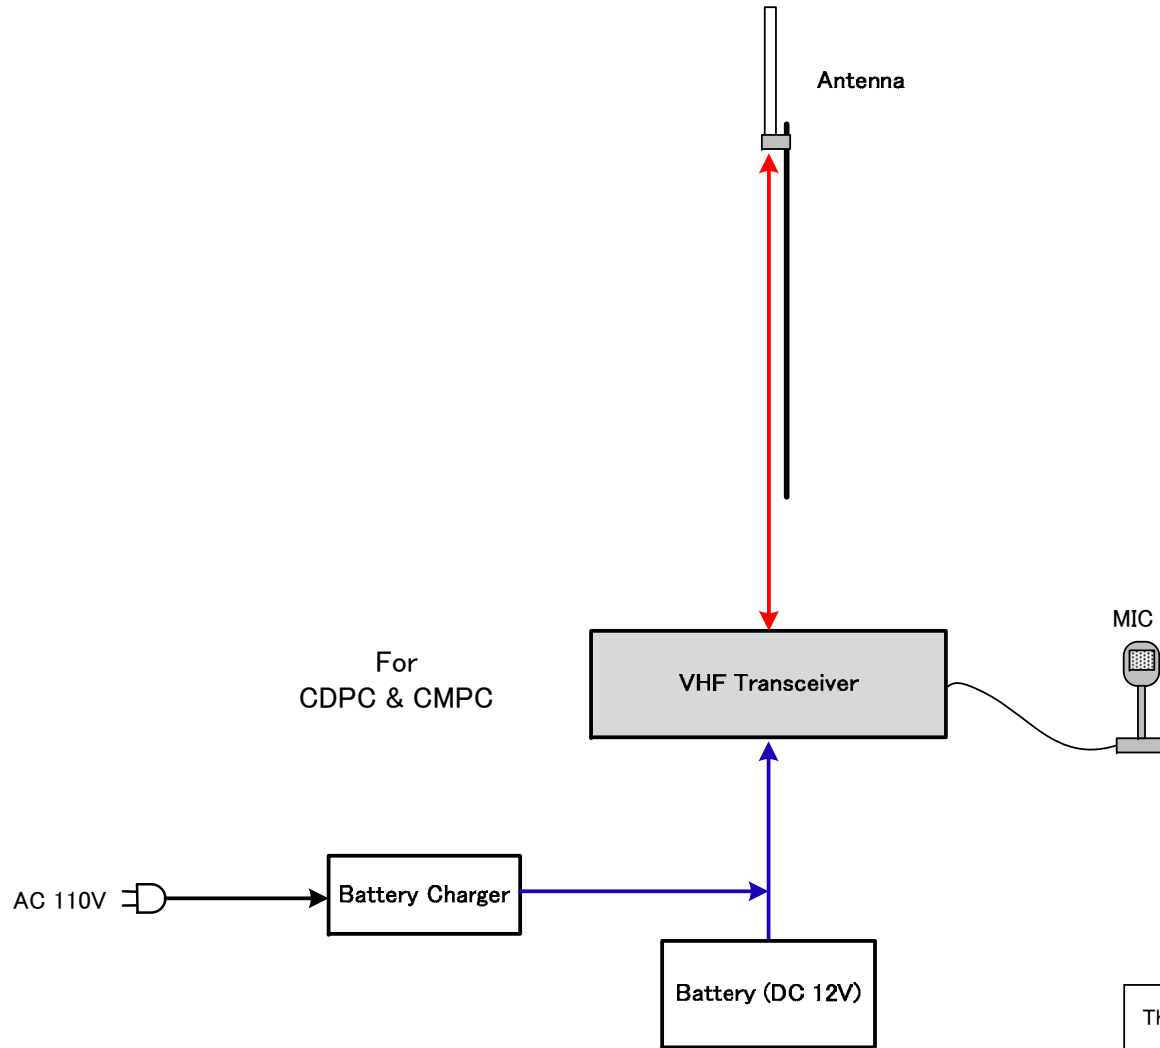
SR-5 : VHF固定無線機システム構成図

For  
CDPC & CMPC

The Project for Improvement of Equipment for Disaster Risk Management in the Republic of El Salvador				
Title				DWG. No.
Block Diagram of VHF Base Station System				SR-5
DATE	DESIGNED	CHECKED	APPROVED	REVISION
5. Dec. 2012	M.Wada	T.Kobayashi	K.Tanaka

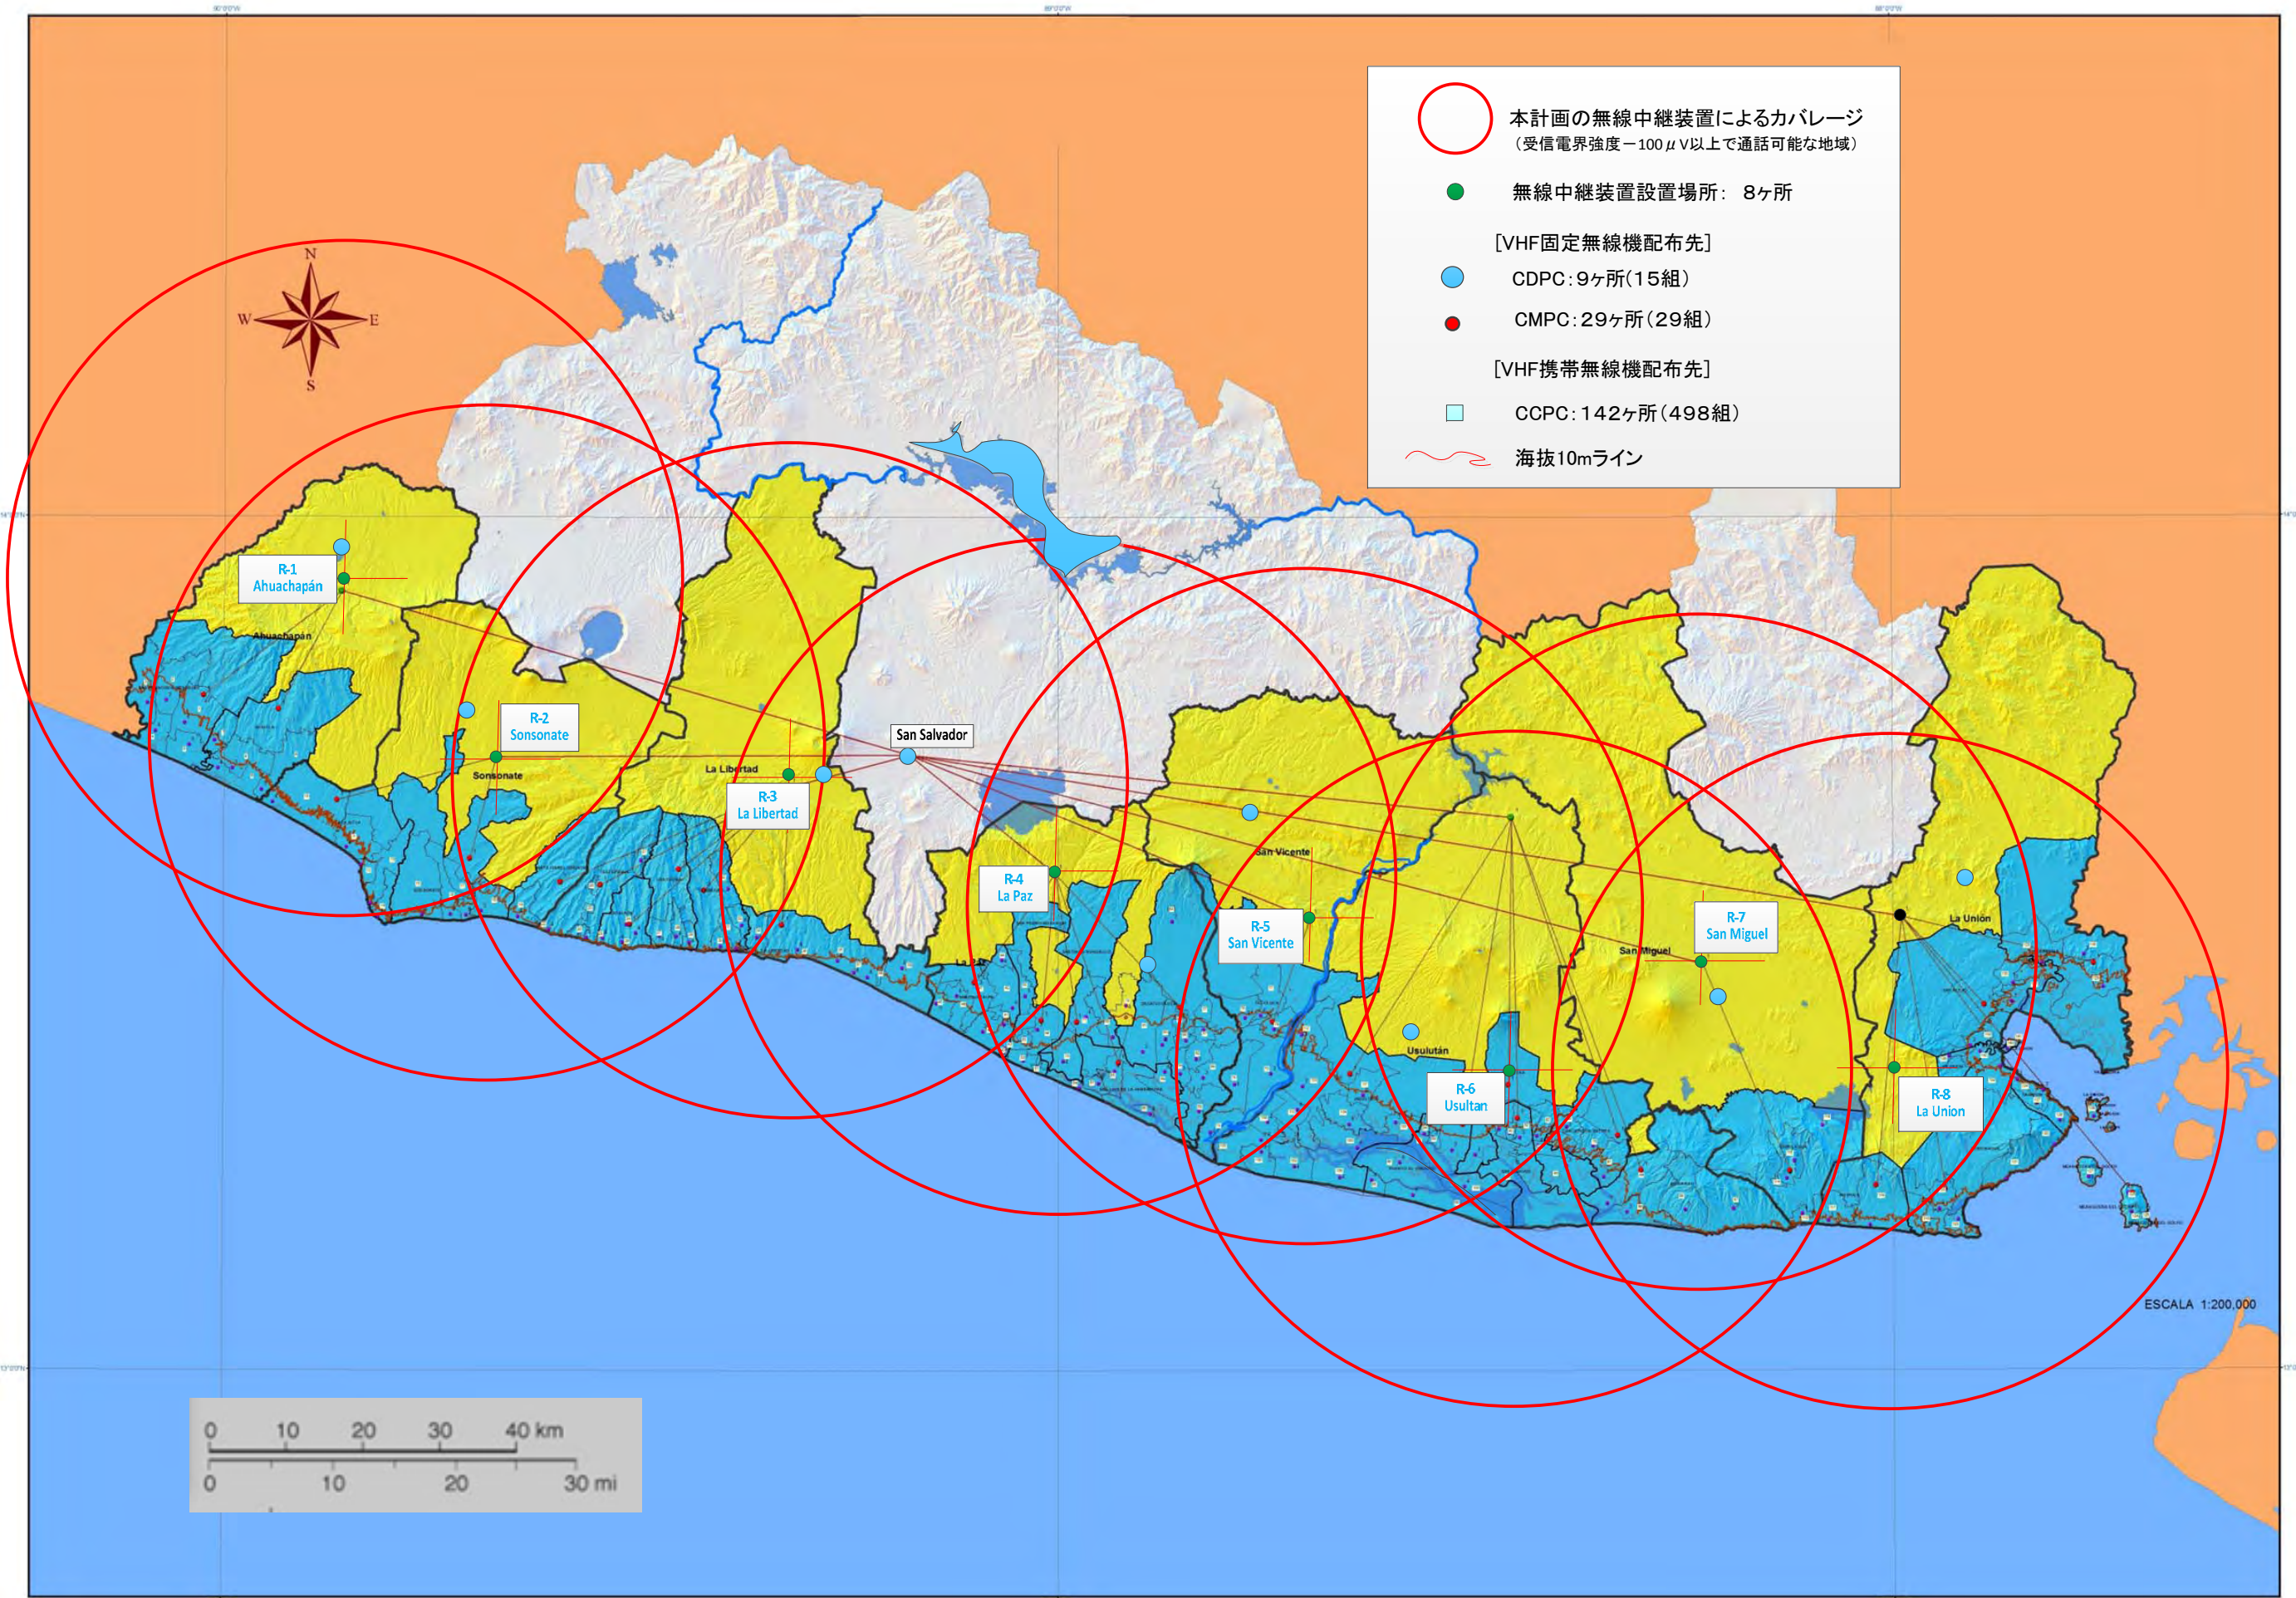
9. 本プロジェクトの無線中継装置カバレッジ(想定)及びVHF無線機配布先位置図

資料－9 本プロジェクトの無線中継装置カバレッジ(想定)  
及び VHF 無線機配布先配置図
