National Road No. 33 (from PK 46+000 to PK 51+000)		PK 46+000	PK 51+000	
Photograph of road condition

Straight Line Diagram
National Road No. 48
From Station 00+000 to 161+000
(Sre Ambel Intersection to Cham Yeam)

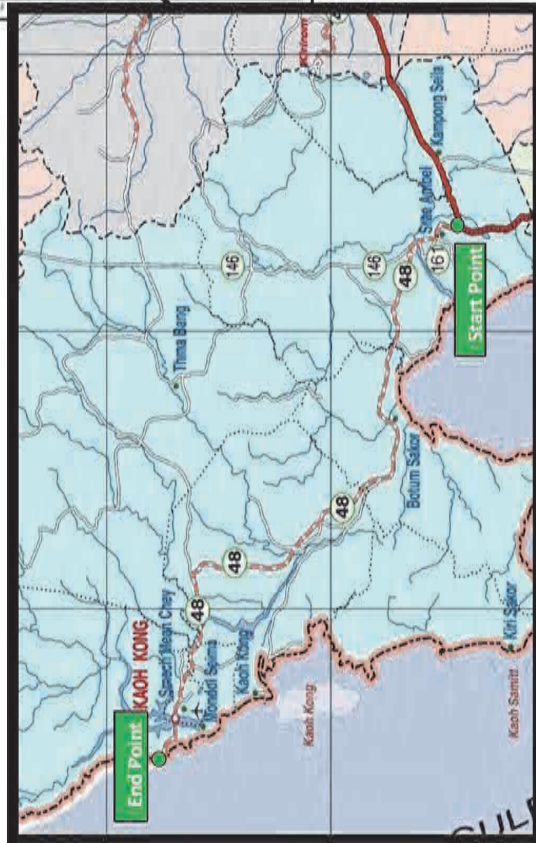
National Road No. 48 (from PK 00+000 to PK 50+000)		PK 00+000	PK 05+000	PK 10+000	PK 15+000	PK 20+000	PK 25+000	PK 30+000	PK 35+000	PK 40+000	PK 45+000	PK 50+000	
	Photograph of road condition												
	Photograph of road condition												
Right side	Terrain	2	1	2	2	2	1	1	1	1	4	2	
	Affect house	2	2	2	2	2	2	2	2	2	2	1	
	Land Use Type	7	1	1	7	7	5	7	5	7	5	1	
	Shoulder Condition	1	3	2	1	1	2	1	1	1	1	1	
	Shoulder Width (m)	1.9	1.1	1.0	1.0	1.5	3.0	0.5	1.5	1.2	1.4	1.0	
	Shoulder Type	laterite	DBST	DBST	DBST	DBST	laterite	DBST	laterite	DBST	SBST	SBST	
	Road Condition	1	2	1	1	1	1	1	2	1	1	1	
	Road Width (m)	5.0	3.9	4.0	4.0	4.5	4.0	4.0	4.0	4.0	4.0	4.0	
	Lane Number (no)	1	1	1	1	1	1	1	1	1	1	1	
	Road Pavement Type	DBST	DBST	DBST	DBST	DBST	DBST	DBST	DBST	DBST	DBST	DBST	
Left side	Lane Number (no)	-	1	1	1	1	1	1	1	1	1	1	
	Road Width (m)	-	3.5	4.0	4.0	4.0	4.5	4.0	4.0	4.0	4.0	4.0	
	Road Condition	-	2	1	1	1	1	1	1	1	1	1

Shoulder Type	-	DBST	DBST	DBST	DBST	DBST	DBST	DBST	DBST	DBST	DBST	
	Shoulder Width (m)	-	1.5	1.0	1.0	1.3	1.5	1.0	1.5	1.1	1.5	1.0	
	Shoulder Condition	-	2	2	1	1	1	1	2	1	1	2	
	Land Use Type	7	1	1	7	7	5	1	5	6	5	1	
	Affect house	2	1	2	2	2	2	2	2	2	2	1	
	Terrain	2	1	2	2	2	1	1	1	1	1	2	
Bridge	Remark	Many Potholes found along these PKs											
	Bridge Type	One Lane		PCDG		RCS		RCS		RCS		RCS	
	Span Number (no)	14		5		6		4		4		4	
	Photograph of Bridge condition
