**REPORT ON GEOTECHNICAL INVESTIGATIONS ON THE PROJECT FOR
CONSTRUCTION OF A TEACHER TRAINING COLLEGE FOR SECONDARY
SCHOOL TEACHERS IN LILONGWE**

6-3 井戸試掘調査結果

1. 井戸試掘調査結果

リロングエ中等教員養成校建設計画(以下 TTCL)において、対象 TTCL Nalikure サイトの給水施設建設に必要な地下水水源の確認を目的として試掘調査を実施した。試掘調査に当たっては、マラウイ共和国(以下、「マ」国)の現地の井戸掘削業者を選定し再委託により実施した。水質評価は「マ」国 農業・灌漑・水資源省の水質分析室により飲料水水質評価を行った。

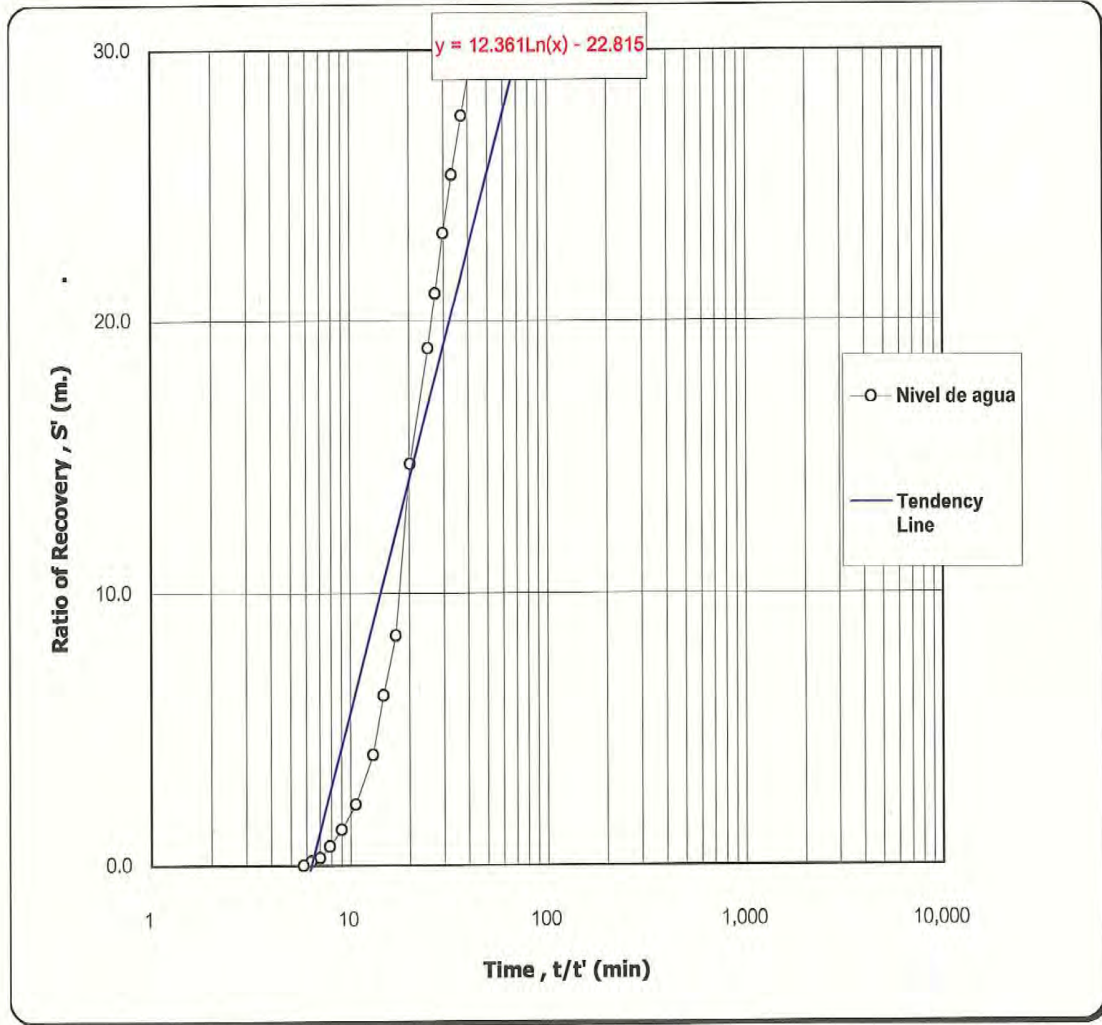
圖-6 TTC No. 2 回復試驗結果

PROJECT NAME	Malawi CDSS Phase II		
BOREHOLE No.	Ezondweni No.2	STATIC WATER LEVEL	9.50 m.
SITE	Ezondweni CDSS	DATE	27/09/11

DESCRIPTION	
Discharge, Q (m ³ /hr.)	0.90 m ³ /hr.
Water Level, ΔS (m.)	40.50 m.
Transmissivity, T (m ² /hr.)	
$T = (2.30 Q) / (4\pi \Delta S)$	0.00 m ² /hr.
Screen Length, b (m.)	15.00 m.
Hydraulic Gradient, K (m./hr.)	
$K = T/b$	2.712E-04 m./hr.

(2) 試掘井戸 (TTC No. 2) の揚水試験結果を図-4～図-6 に示す。

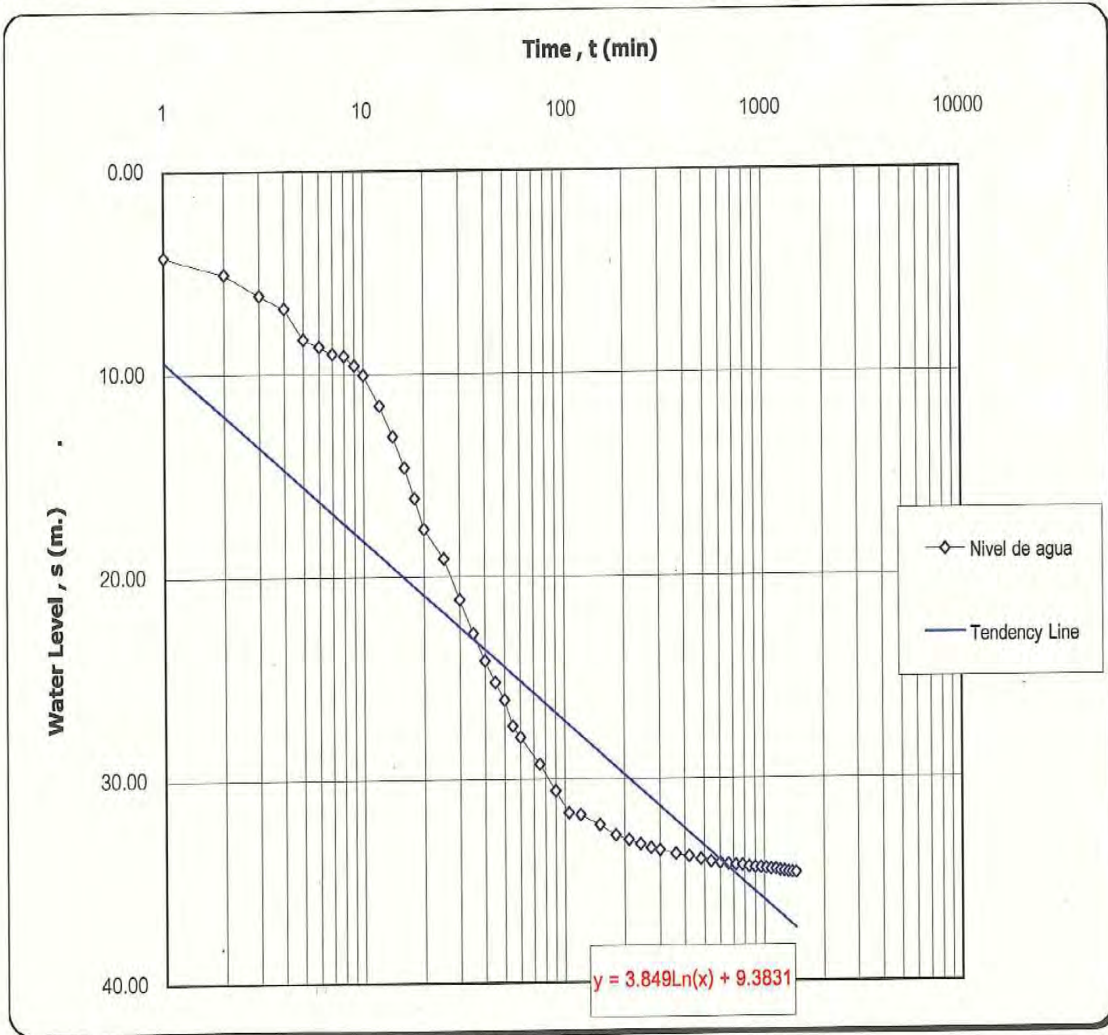
図-9 TTC No. 3 定流量揚水試験結果

PROYECT NAME	Malawi CDSS Phase II Malawi DSS Phase II		
BOREHOLE No.	TTC No.3	STATIC WATER LEVEL	3.49 m.
SITE	TTC Nalikule	DATE	23/10/11

DESCRIPTION	
Discharge, Q (m ³ /hr.)	1.80 m ³ /hr.
water Level ,ΔS (m.)	34.67 m.
Transmissivity , T (m ² /hr.)	0.010 m ² /hr.
$T = (2.30 Q)/(4\pi\Delta S)$	
Screen Length , b (m.)	15.00 m.
Hydraulic Gradient , K (m./hr.)	6.335E-04 m./hr.
$K = T/b$

表-6 に定流量(連続)揚水試験の結果を示す。対象 TTC の試掘井 4 井のうち TTC No.3 ($43.2\text{m}^3/\text{day}$) と TTC No.4 ($20.7\text{m}^3/\text{day}$) は水量水質ともに良好で、給水施設の深井戸水源として動力ポンプの設置可能である。但し、TTC No.1 は完全な空井戸、TTC No.2 には地下水が存在したが、揚水試験の結果、少量の地下水 ($2.3\text{m}^3/\text{day}$) しか得られず活用はかなり困難と思われる。また、回復試験では 4 時間 30 分で TTC No.3 が 98.3%、TTC No.4 が 99.0% と良好な回復率を示したが、水位降下では前者では 34.67m、後者が 48.04m と大きな降下量を示した。

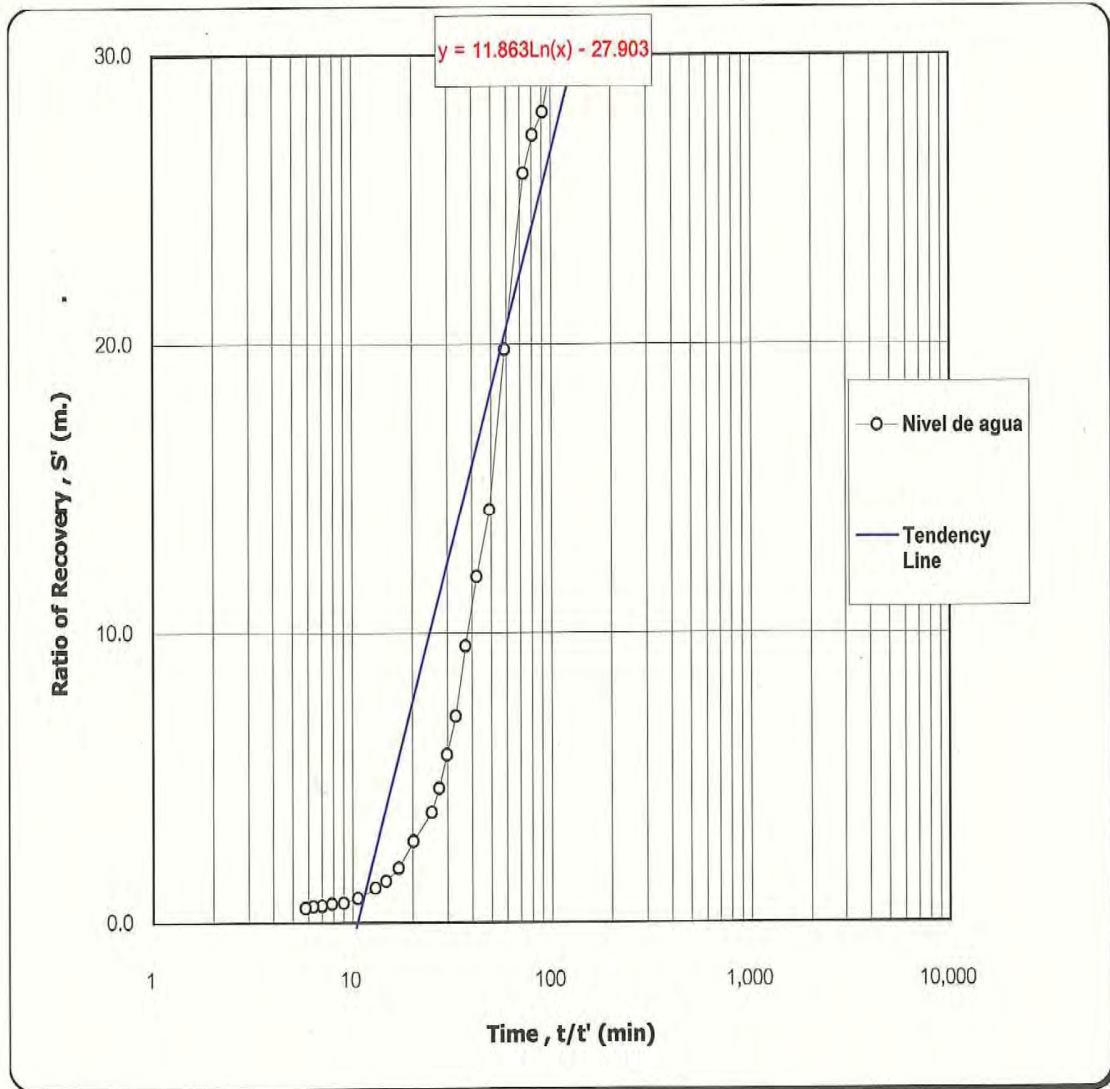
圖-14 TTC No. 4 回復試驗結果

PROJECT NAME	Malawi CDSS & TTC Phase II		
BOREHOLE No.	TTC No.4	STATIC WATER LEVEL	1.96 m.
SITE	TTC Nalikule	DATE	29/10/11

DESCRIPTION	
Discharge, Q (m ³ /hr.)	1.48 m ³ /hr.
Water Level, ΔS (m.)	48.04 m.
Transmissivity, T (m ² /hr.)	
$T = (2.30 Q) / (4\pi\Delta S)$	0.01 m ² /hr.
Screen Length, b (m.)	21.00 m.
Hydraulic Gradient, K (m./hr.)	
$K = T/b$	2.685E-04 m./hr.

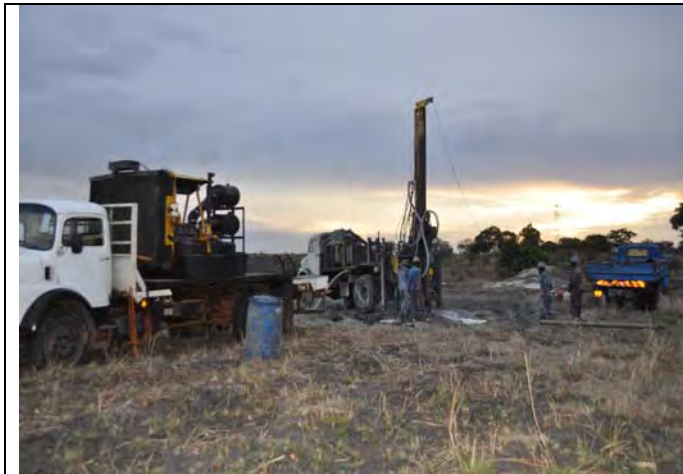
1. 井戸掘さく中 (TTC No. 1)

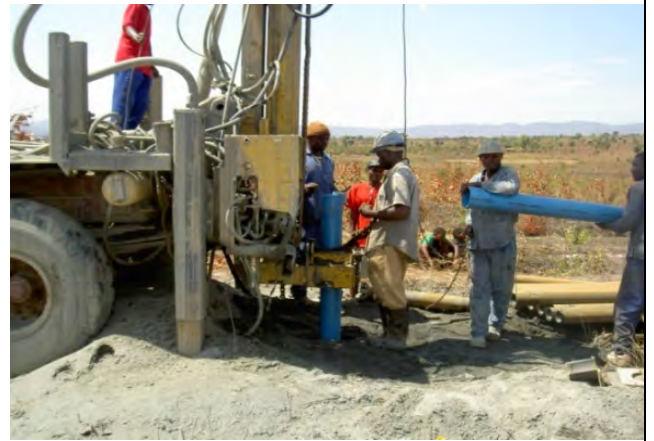
2. ケーシングの設置(口径 160mm) TTC No. 3

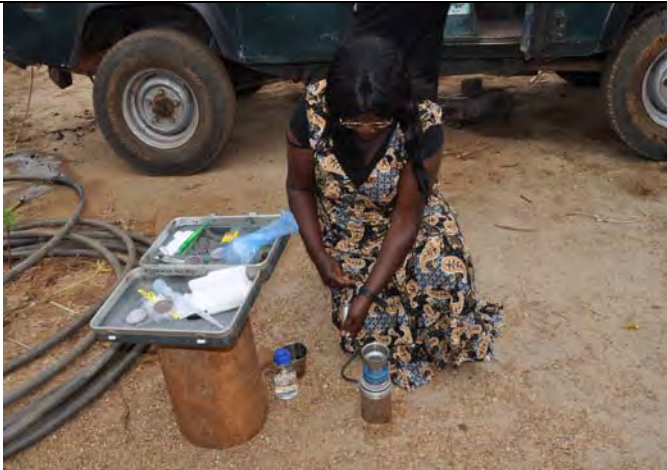
3. 現場水質分析(一般細菌及び大腸菌群)
水資源省水質分析係官 (TTC No. 3)

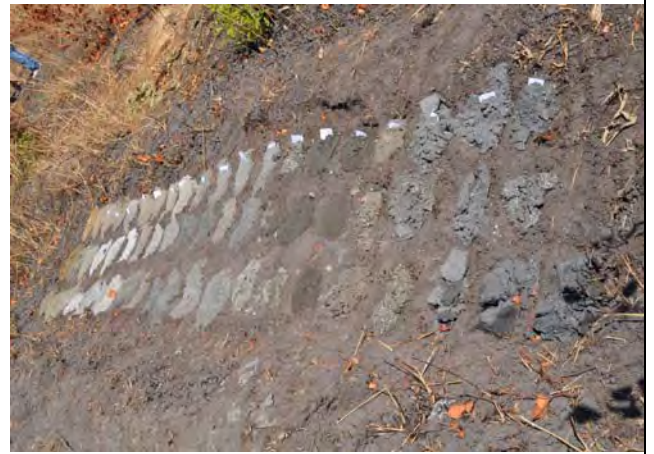
4. 地質サンプル(深度 3m~61m) TTC No. 3

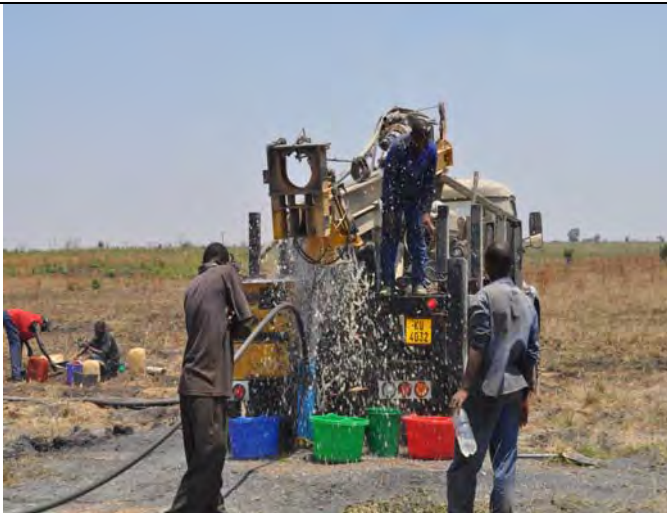
5. 井戸洗浄 TTC No. 4

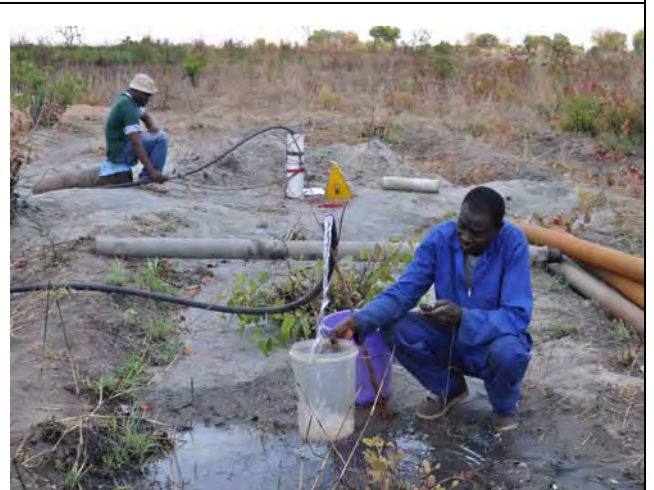
6. 揚水試験 (水量と水位計測) TTC No. 3
