Annex 11.2-1 JICA Environmental Checklist (For Power Transmission and Distribution Lines / Roads)

400 kV Sampoor – New Habarana T/L Project

Annex 11.3-3 (2) Photographs of land use and habitats along the proposed transmission line from Sampoor to Kappalturai (8th, 9th and 10th August 2015)

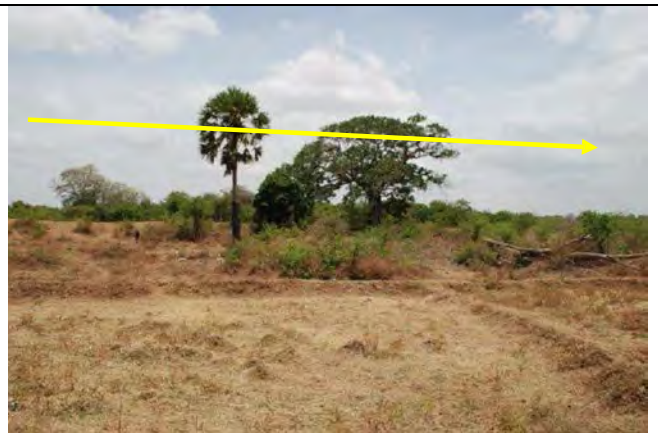
Plate 10. Angle Point 1 in the paddy field in front of GSS land, the tower base is close to the Siyambala (*Tamarindus indicus*) tree in the photograph

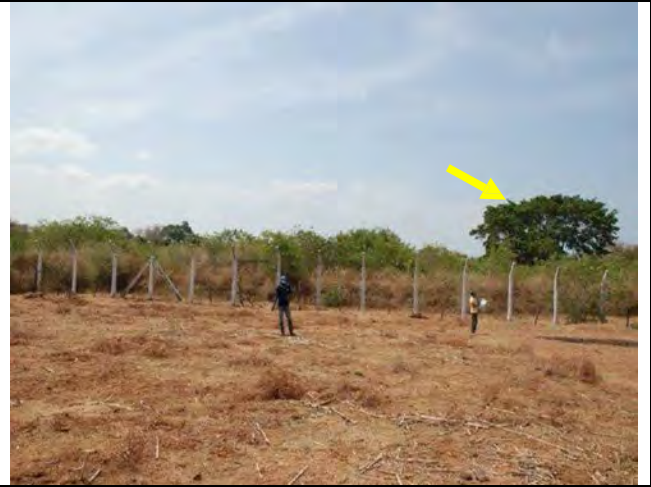
Plate 15. Angle point 2 is on a private land, previously occupied by the Navy. The fence constructed by the Navy can be seen in the background.

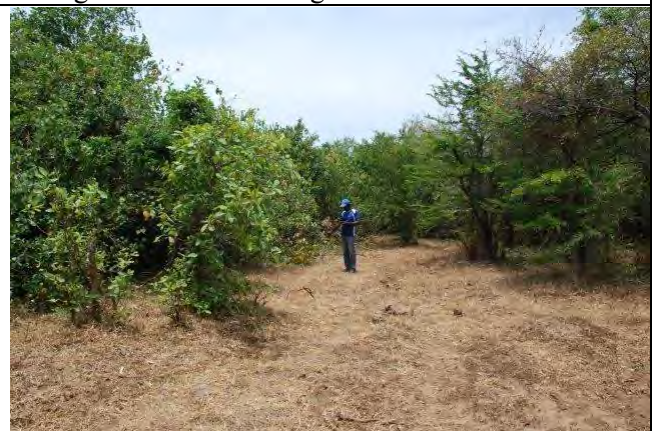
Plate 60. Angle point 8 in a scrubland near Mahaweli river, about 275 m from the ring road

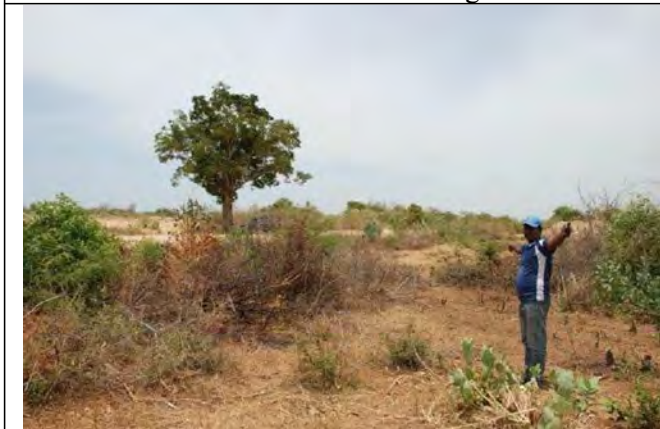
Plate 65. The line crosses the ring road about 900 m from the AP 8 (coordinates: 08.430169, 81.200606)

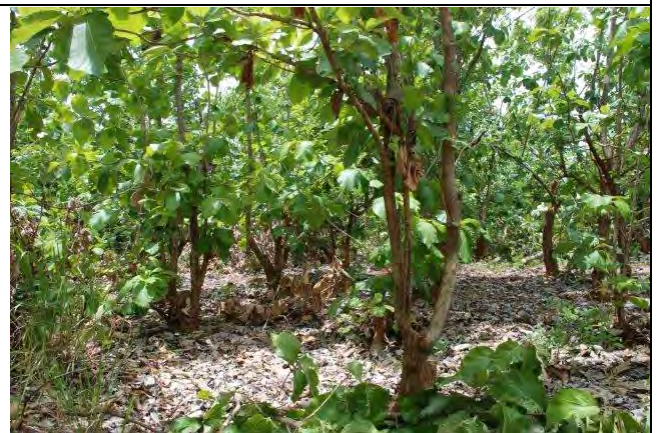
Plate 114. GSS land (300x 225 m, 6.8 ha) is in a Teak plantation/ degraded dry-mixed evergreen forest bordering the Trincomalee main road (A6)

GSS land- Kappalturai					Teak plantation, Kappalturai	The extent of the Kappalturai GSS land is 6.4 ha. This is a degraded teak plantation established by the Forest Department. In addition to elephant damaged teak trees, other indigenous dry zone tree species such as Welan, Wira, Dikwenna, Mahaandara, Ketakela, Kon, Milla, Madan, Palu, Godakirilla and Karaw are found in this land.	Plate 118-126
Total				37.433

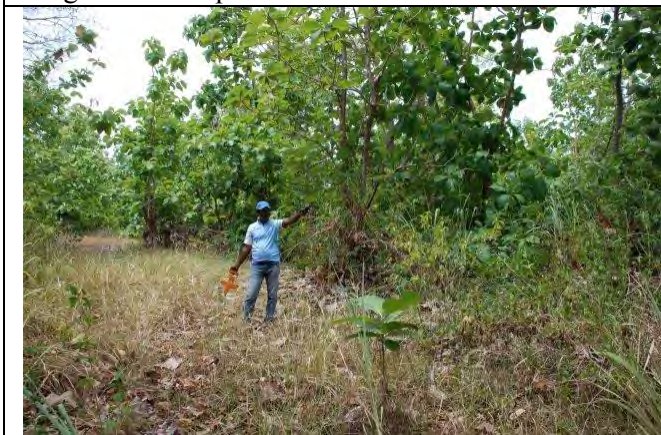
Plate 117. Location of terminal tower 2 (TT2) in the teak plantation
