Construction Work	1 set
6. Foundation for the Equipment of the Project (Gas Insulated Switchgears, Transformers, Towers for 161 kV Transmission Line)	
7. Building for a control room of Accra Central BSP	1 building

This report describes the field and laboratory investigations carried out at the project site and makes recommendation for the efficient design of the substation.

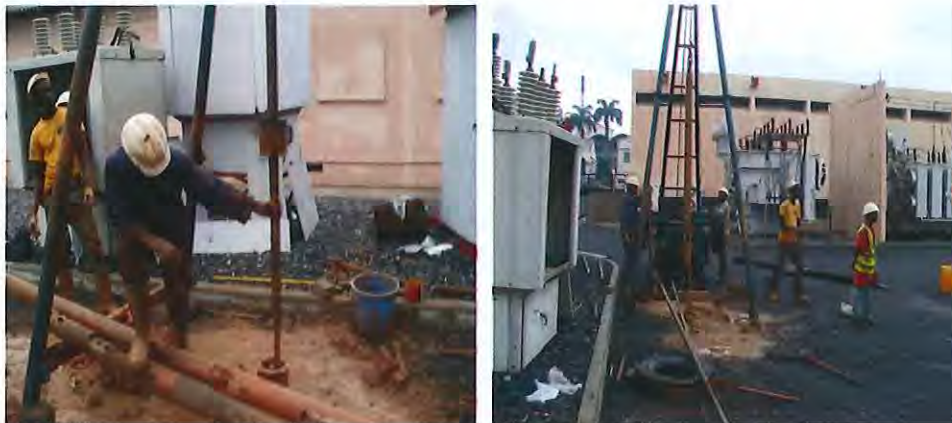
Plate_1: Borehole Drilling In Progress

Three boreholes were drilled at the proposed locations indicated by the Engineer. The location of the boreholes has been shown in Appendix A. The boreholes were drilled using the shell and auger method. The Pilcon wayfarer 1 ton cable percussion rig was employed to advance 150-mm diameter holes using steel casings and standard cable percussion tools. The boreholes were terminated when the standard penetration test (SPT) recorded refusal (i.e. $N > 50$ blows/300mm) and chiselling could not advance the hole appreciably. The borehole logs are presented in Appendix B.

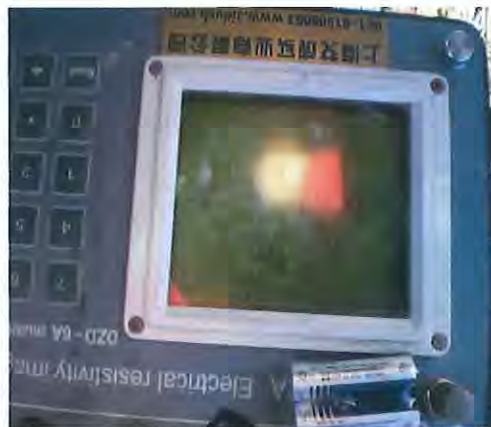
Plate_2: Electrical Sounding Was Also Employed In The Investigations

The geophysical technique employed was the Vertical Electrical Sounding (VES). The VES was used to estimate the depth to bedrock, the number of subsurface geological layers, and their corresponding resistivities as well as their conductivity values.

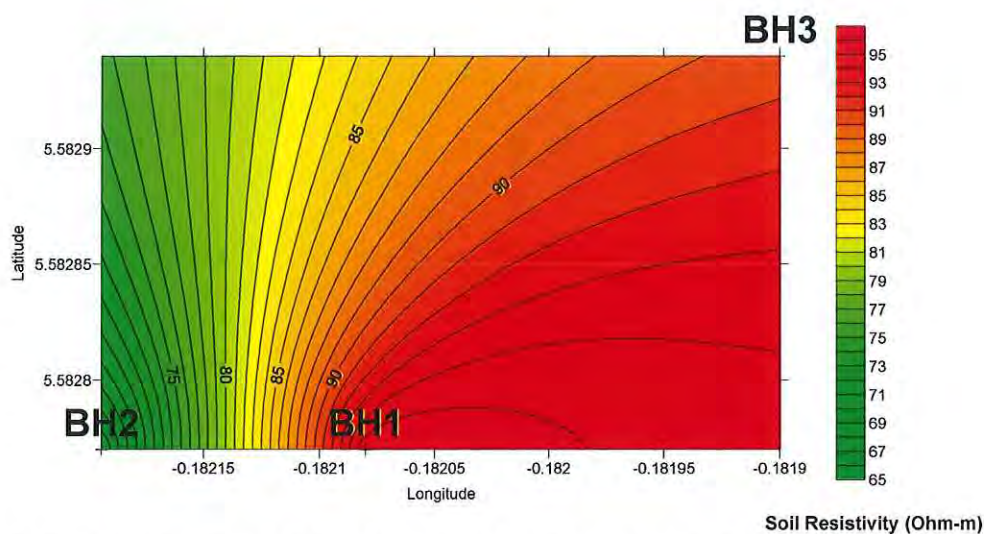
The topsoil had apparent resistivity values ranging between 66.0- 95.8 Ω -m. The soil resistivity values seek to suggest that the soil is most or clayey contains some amount of clay component. A contoured section of resistivity distribution is presented in Figure 2. Qualitatively, the soil resistivity section suggests that the soil cover at BH3 is dry or the bedrock outcrops there. The soil resistivity tends to reduce towards BH2 with BH1 having relatively moderate soil resistivity value.

Figure 2: Contoured soil resistivity of the area showing the borehole points

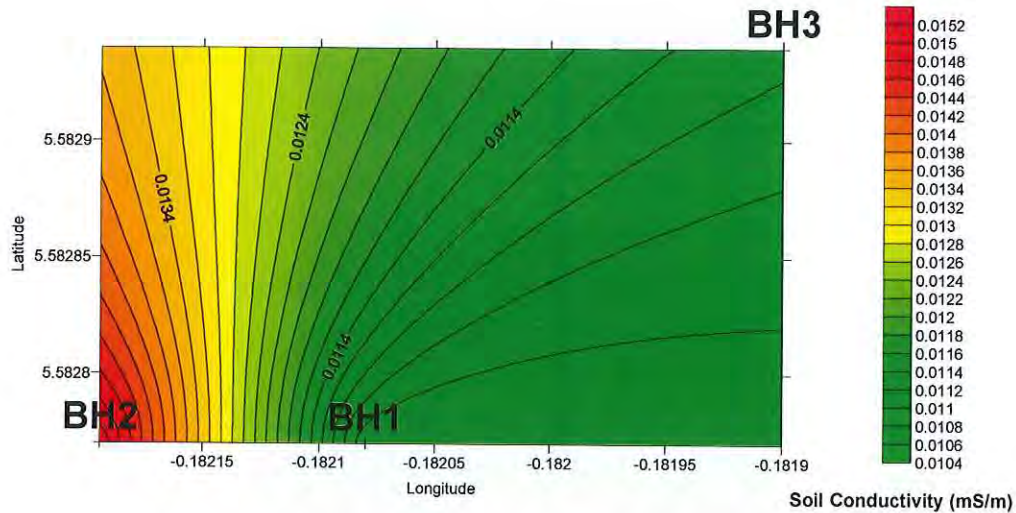
On the other hand, a contoured section of the soil conductivity values indicates that borehole BH3 has the least value with BH2 having the highest value. Thus, the soil conductivity tends to increase from east to west. The soil conductivity values ranged between 1.04×10^{-2} mS/m and 1.52×10^{-2} mS/m with an average value of 1.22×10^{-2} mS/m.

Figure 3: Contoured soil conductivity of the area showing the borehole points

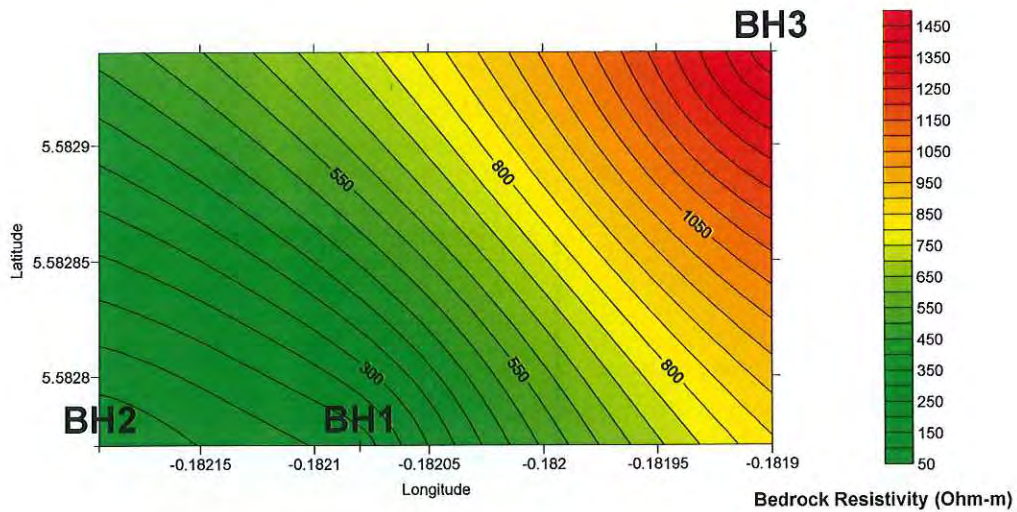
The bedrock resistivity, which is a measure of the hardness of the rock, varied widely from 451 - 1440 Ω -m with an average value of 553.67 Ω -m. Contoured sections of the bedrock resistivity are presented in Figure 4 and Figure 5. From these sections it can be deduced that the north-western corner around BH3 is more resistive similarly to the soil resistivity section. Thus it can be inferred the bedrock is less resistive at the south-western portion as compared to the northern section.

Figure 4: Contoured bedrock resistivity showing the borehole points

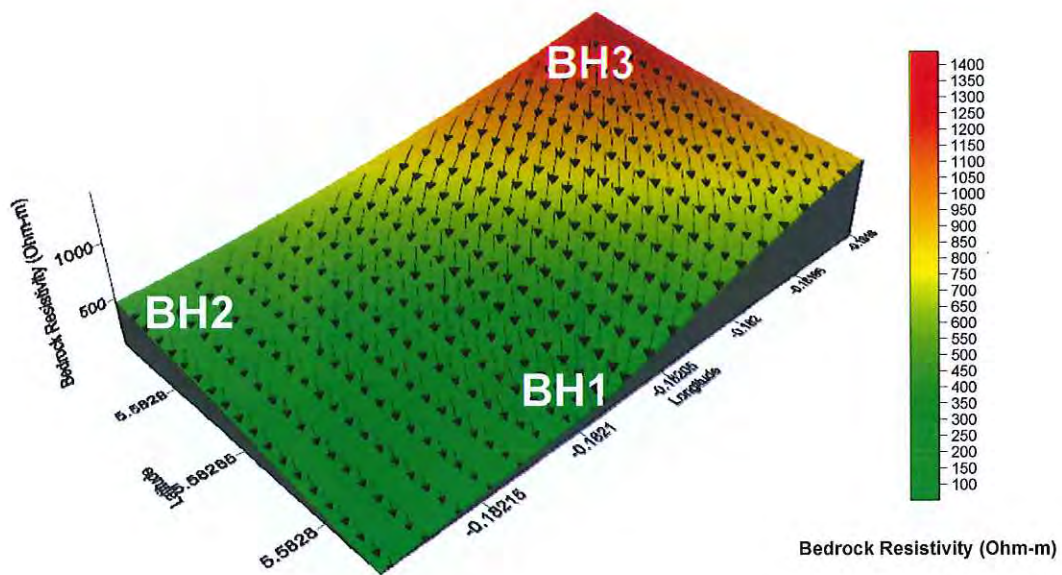
Figure 5: Topography of Bedrock Resistivity showing the VES points

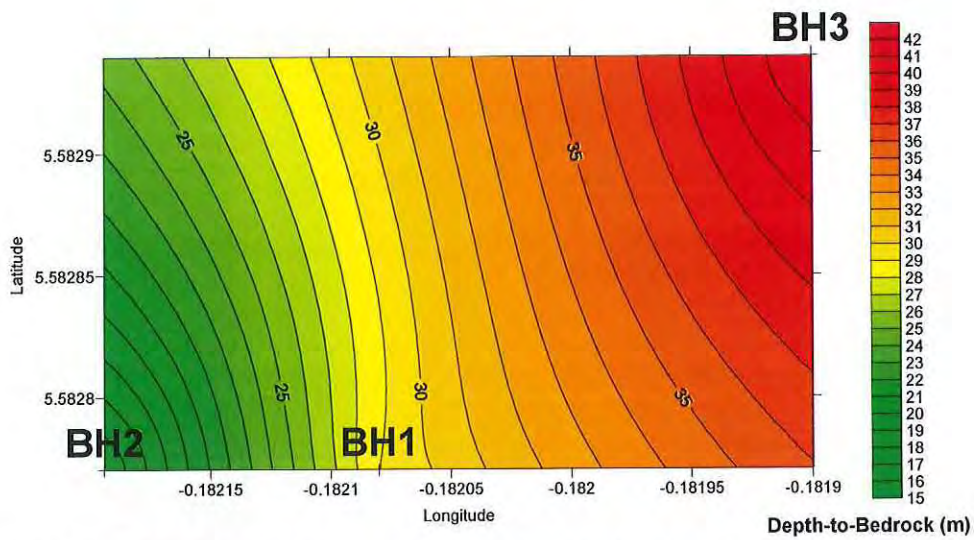
Figure 6: Contoured depth-to-bedrock at the showing the borehole points

The spatial variation of depth-to-bedrock is presented in Figure 6 and Figure 7. Qualitatively, the depth-to-bedrock increases south-western corner around BH2 towards the north eastern section of the area around BH3 . The depth-to-bedrock ranges between 16 – 41 m as clearly indicated in Figure 6.

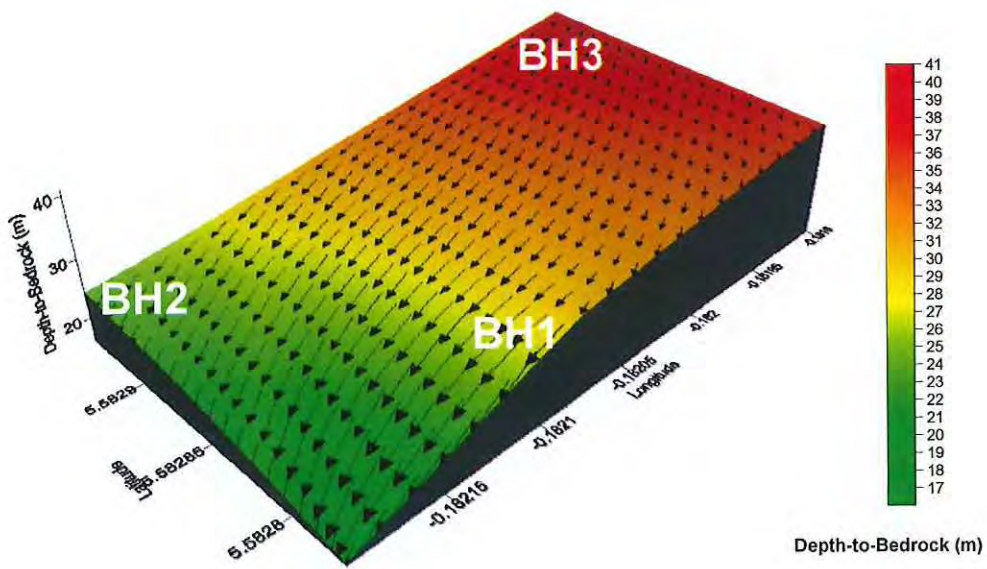
Figure 7: Topography of Depth-to-Bedrock showing the borehole points

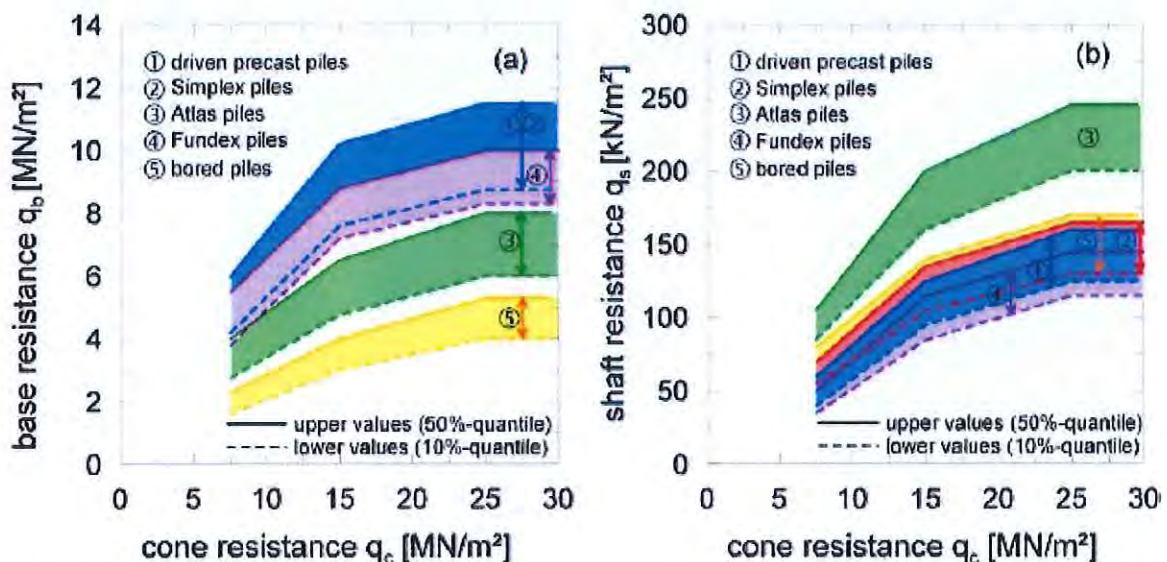
Fig_8

Comparison of the base resistance against pile system and the bearing capacity was analysed using various pile installation methods, these produced a graph shown below as Figure 5. Driven displacement piles generate a higher base resistance because of the displacement and compaction of the soil below the pile tip while driving the pile. The empirical values for the base resistance in non cohesive soils for driven precast pile sand cast in place simplex piles are similar because the installation method is the same. On the other hand, the shaft resistance of the driven piles is lower than the other pile systems as it can be seen in the figure below. The ratio between the upper and lower empirical values falls approximately between 1.3 and 1.4.

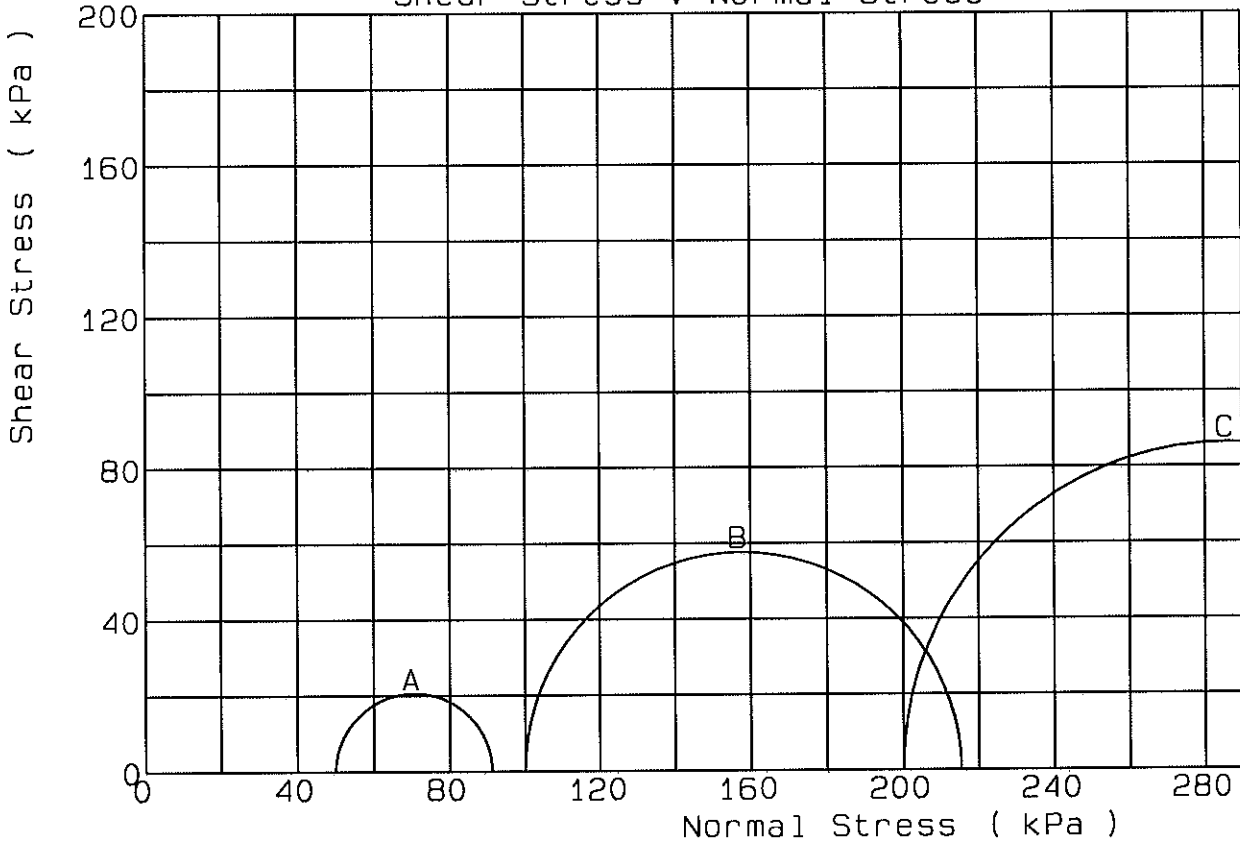
Reference		A	B	C
Height	mm	100.0	100.0	100.0
Diameter	mm	50.0	50.0	50.0
Bulk Density	Mg/cum	1.988	1.988	1.988
Moisture content	%	30.06	32.31	30.11
Dry Density	Mg/cum	1.528	1.502	1.528
Cell pressure	kPa	50	100	200
Loading rate	mm/min	0.900	0.968	0.889
Shear Stress *	kPa	20.6	57.6	86.3
Strain *	%	2.4	5.1	3.5

Cohesion (c) 10 kPa
 Angle of Shear Resistance (phi) 4 deg

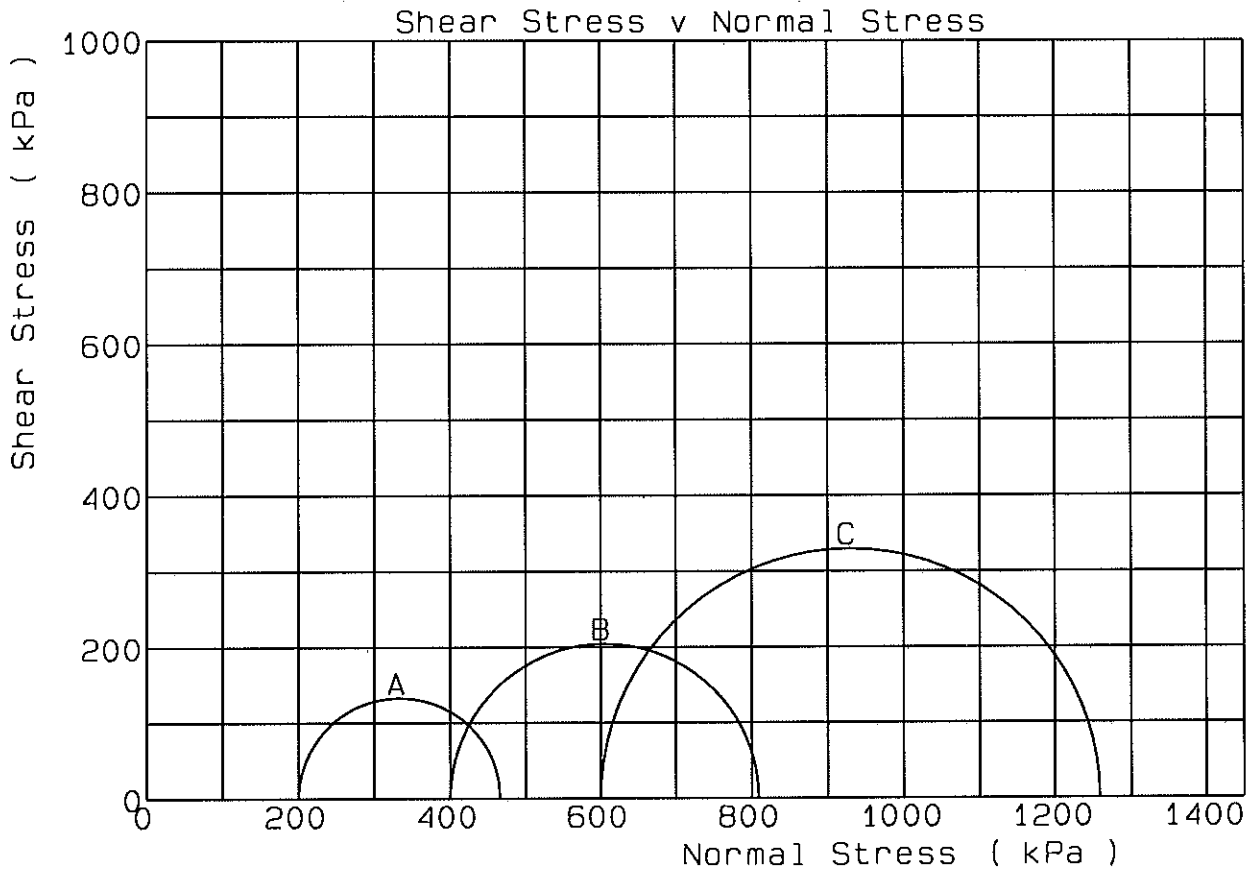
Reference		A	B	C
Height	mm	100.0	100.0	100.0
Diameter	mm	50.0	50.0	50.0
Bulk Density	Mg/cum	1.997	1.997	1.997
Moisture content	%	20.32	20.62	20.62
Dry Density	Mg/cum	1.660	1.656	1.656
Cell pressure	kPa	200	400	600
Loading rate	mm/min	0.910	0.874	0.877
Shear Stress *	kPa	133.2	204.7	329.5
Strain *	%	2.1	5.1	8.2

Cohesion (c) 50 kPa
 Angle of Shear Resistance (phi) 20 deg

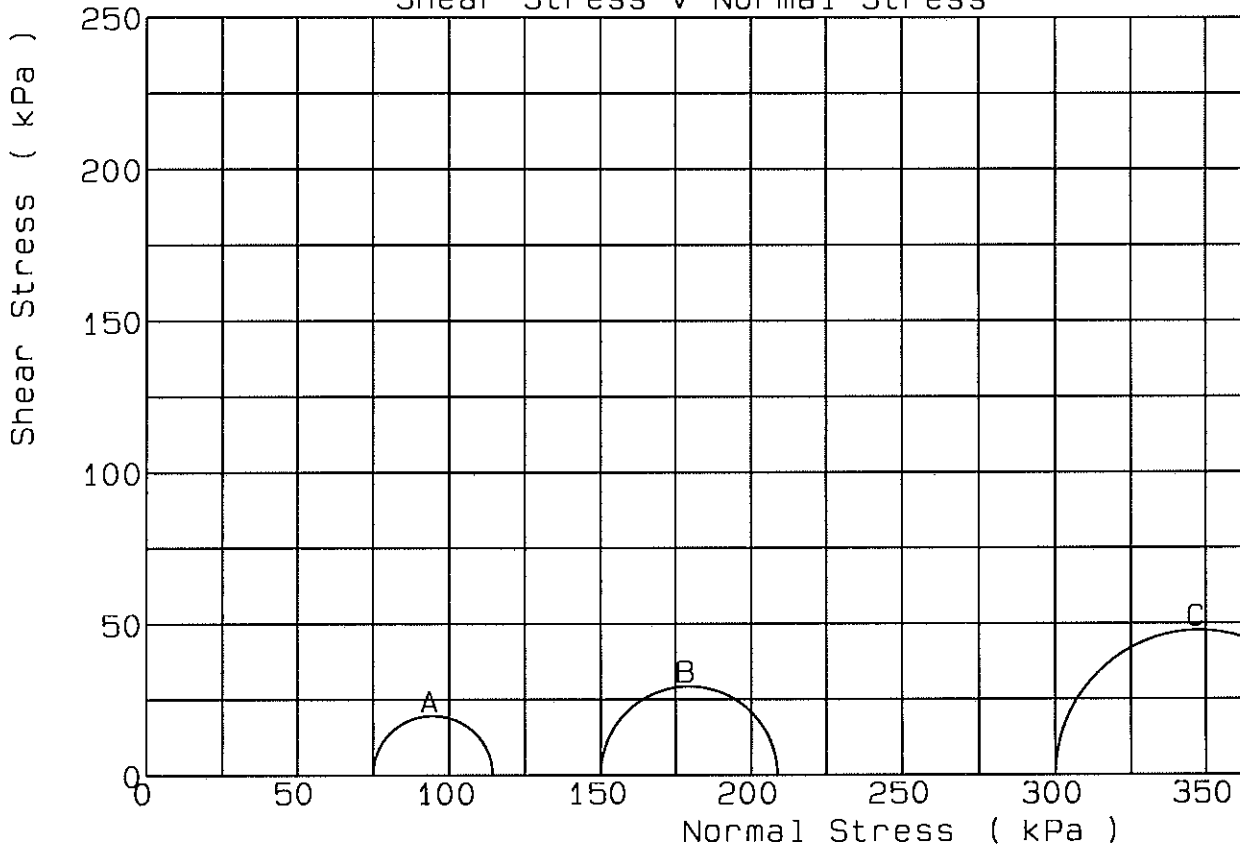
Reference		A	B	C
Height	mm	100.0	100.0	100.0
Diameter	mm	50.0	50.0	50.0
Bulk Density	Mg/cum	2.008	2.008	2.008
Moisture content	%	7.07	7.07	7.07
Dry Density	Mg/cum	1.875	1.875	1.875
Cell pressure	kPa	75	150	300
Loading rate	mm/min	1.017	0.993	0.975
Shear Stress *	kPa	19.7	29.4	47.7
Strain *	%	1.4	2.9	1.5

Cohesion (c) 15 kPa

Angle of Shear Resistance (phi) 5 deg

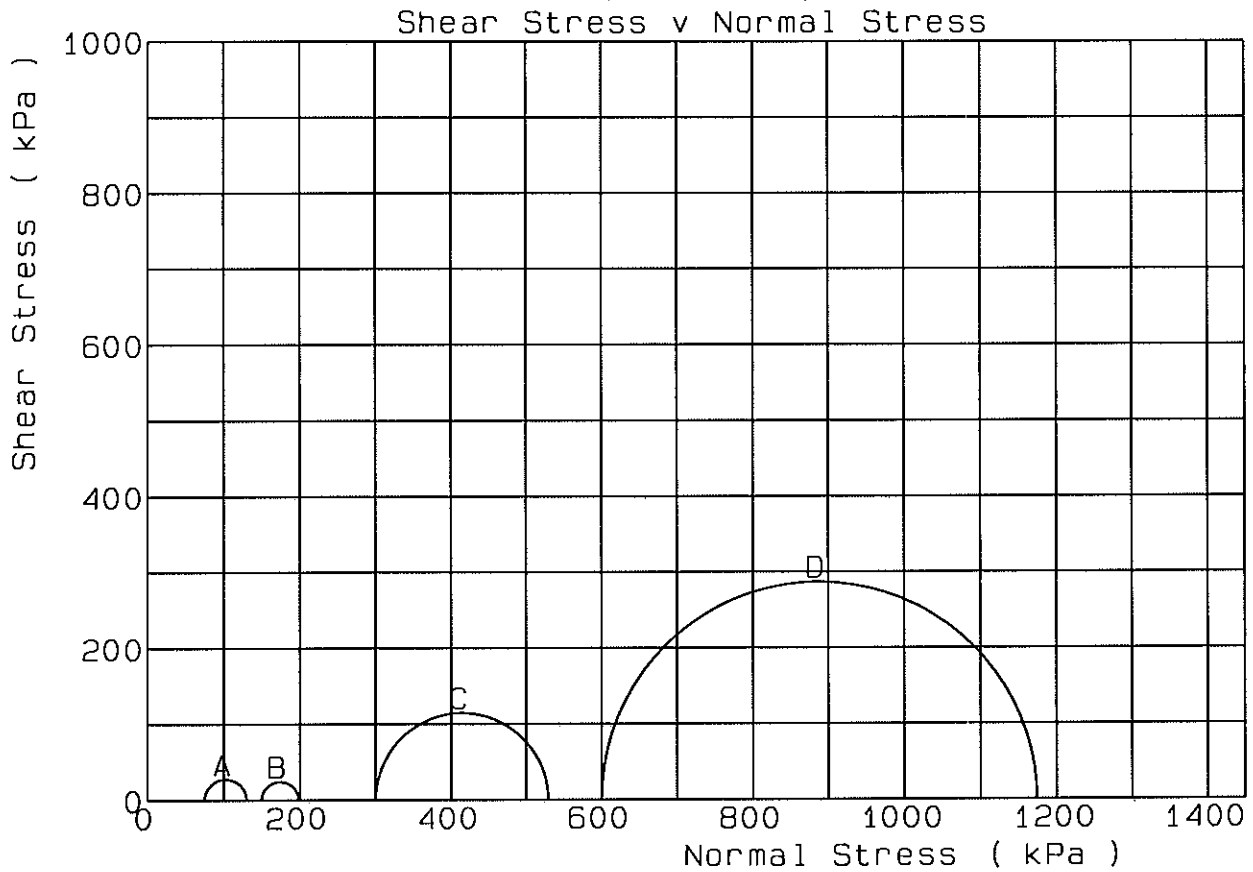
Reference		A	B	C	D
Height	mm	100.0	100.0	100.0	100.0
Diameter	mm	50.0	50.0	50.0	50.0
Bulk Density	Mg/cum	1.789	1.789	1.789	1.789
Moisture content	%	46.39	46.32	45.71	46.33
Dry Density	Mg/cum	1.222	1.223	1.228	1.223
Cell pressure	kPa	75	150	300	600
Loading rate	mm/min	0.968	0.976	0.968	0.966
Shear Stress *	kPa	27.4	24.1	114.5	287.0
Strain *	%	2.4	4.9	10.5	4.9

Cohesion (c) 30 kPa
 Angle of Shear Resistance (phi) 23 deg

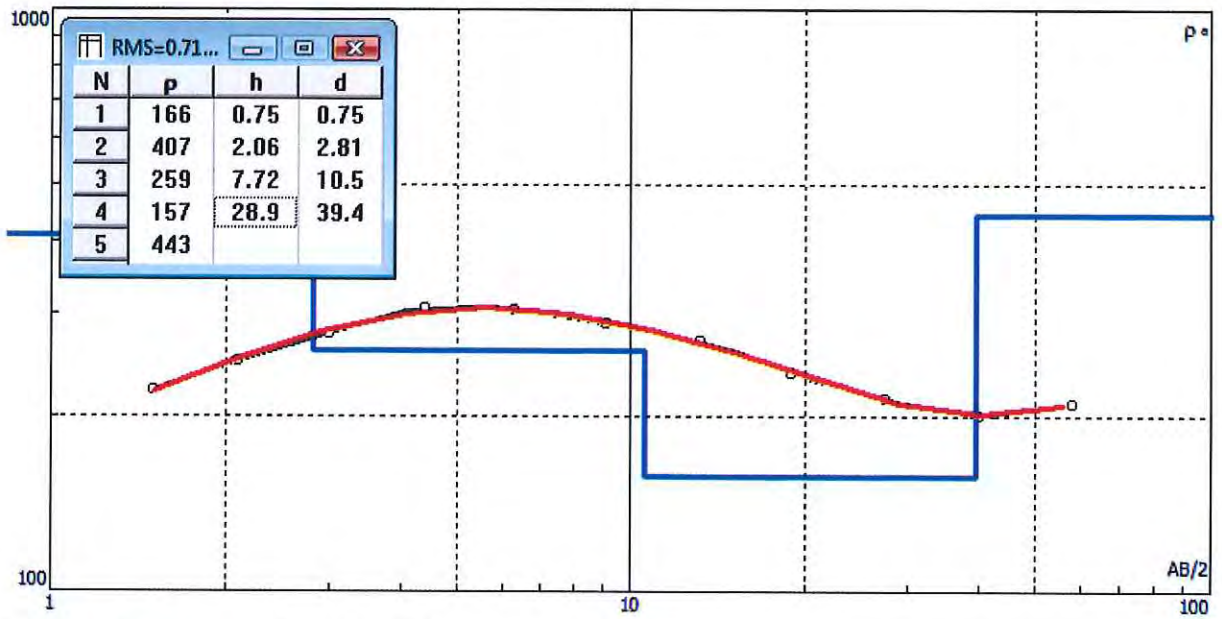
Analyzed VES curve for point BH1

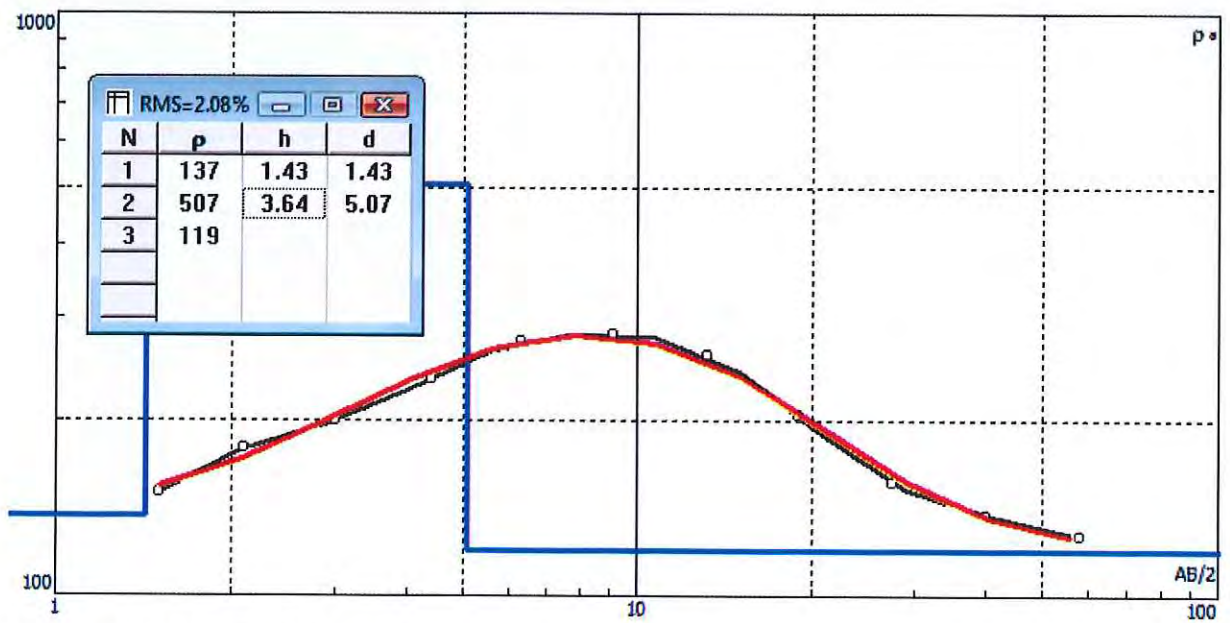
Analyzed VES curve for point BH2

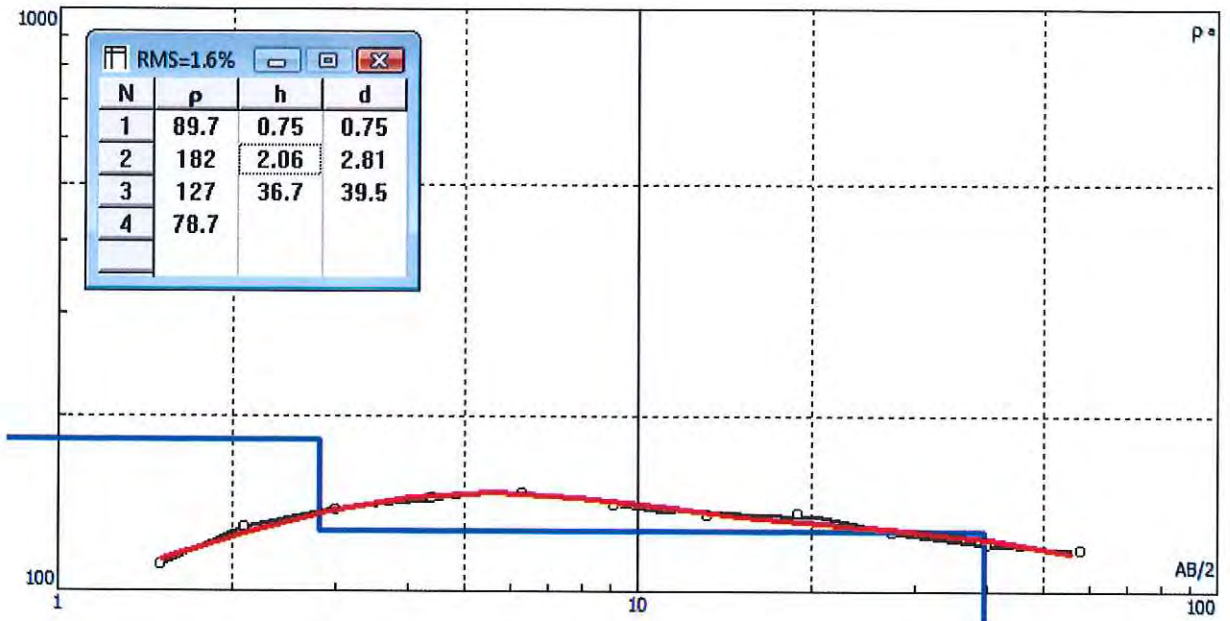
Analyzed VES curve for point BH3
