7. その他資料
7-1. 敷地測量図

7-2. 地質・地盤調査報告書(抜粋)

Hisham’s palace is an important archaeological site located five KM north of the town center of Jericho City. It consists of three main parts: a palace, Great bath Hall and an agricultural estate. An elaborate irrigation system provided the complex with water from nearby springs. The most famous artistic aspect of the site is the “tree of life” mosaic in the Diwan of the bath complex, although the mosaic floor of the main Bath Hall is considered the most famous mosaic area in the region.

The designated rehabilitation is to consider building a proper roofing structure to cover the Bath Hall to expose the mosaic flooring for tourism.

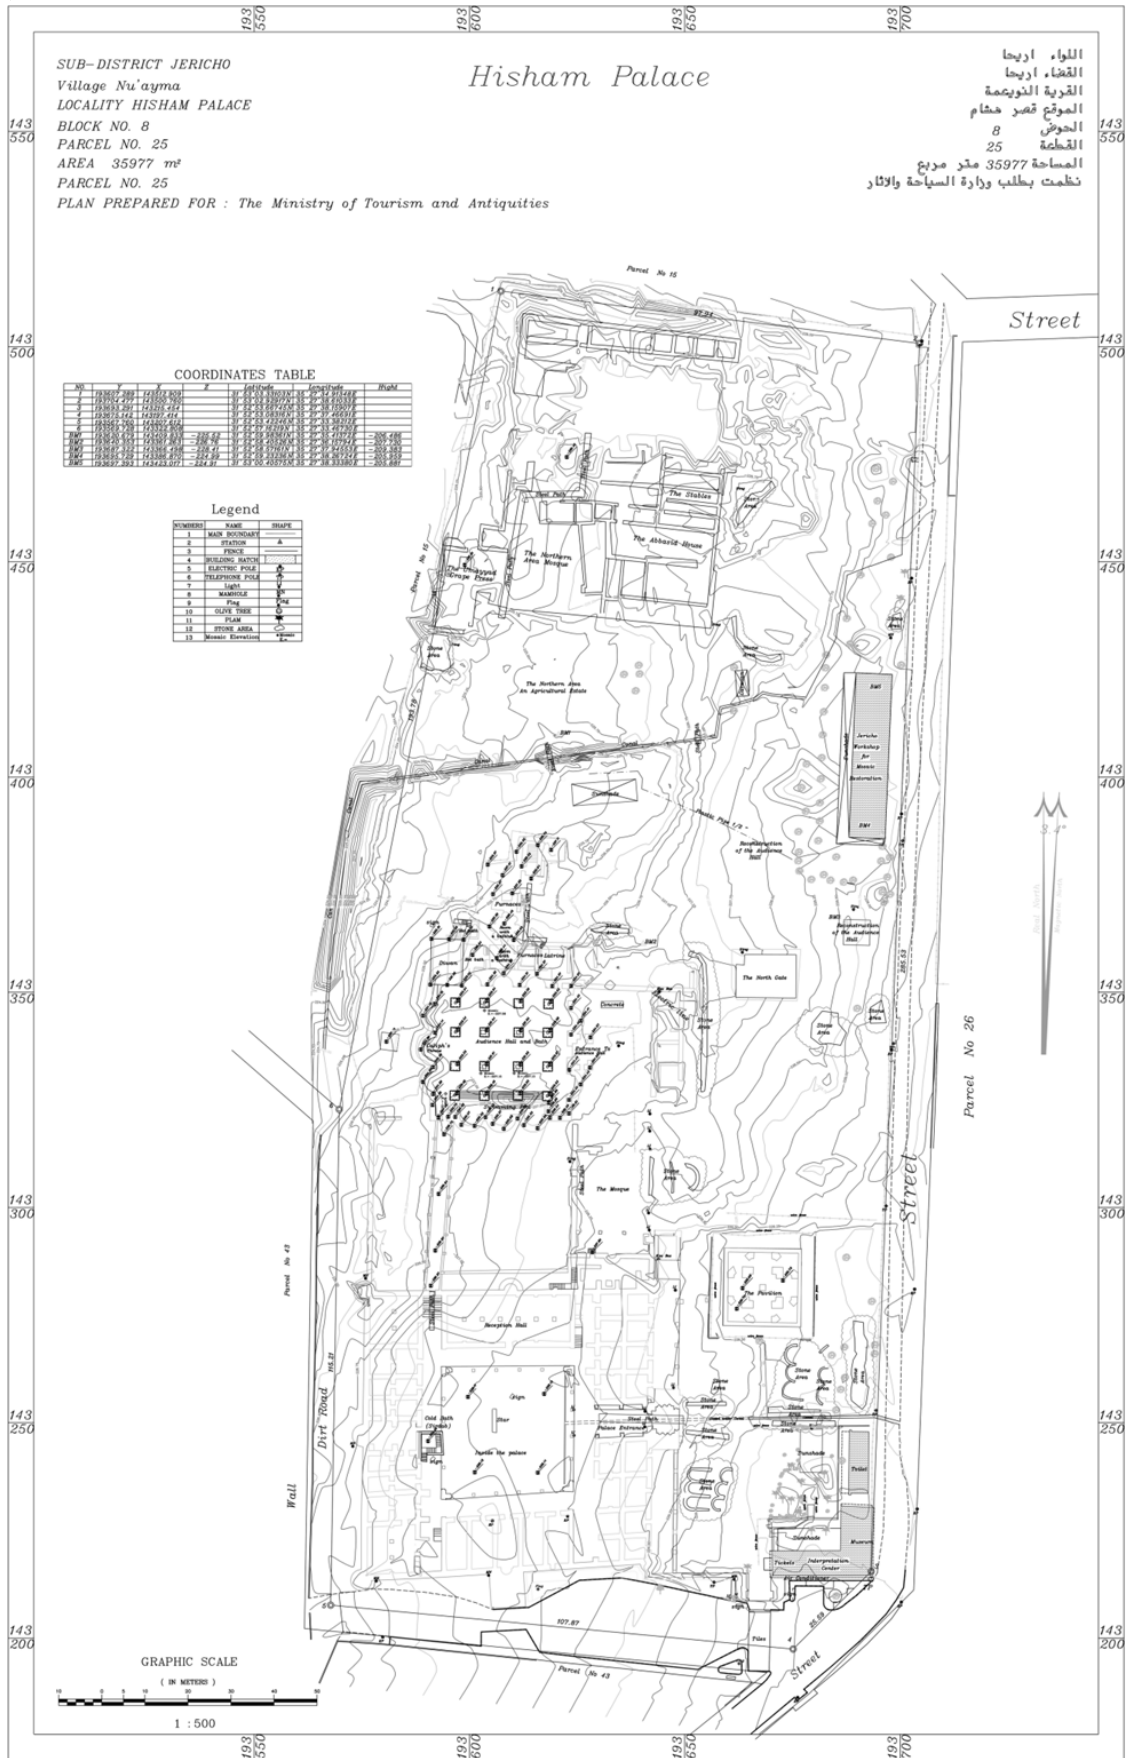
SUB-DISTRICT JERICHO
 Village Nu'ayma
 LOCALITY HISHAM PALACE
 BLOCK NO. 8
 PARCEL NO. 25
 AREA 35977 m
 PARCEL NO. 25
