7. その他資料

7-1. 敷地測量図

7-2. 地質・地盤調査報告書(抜粋)

3. Project Description

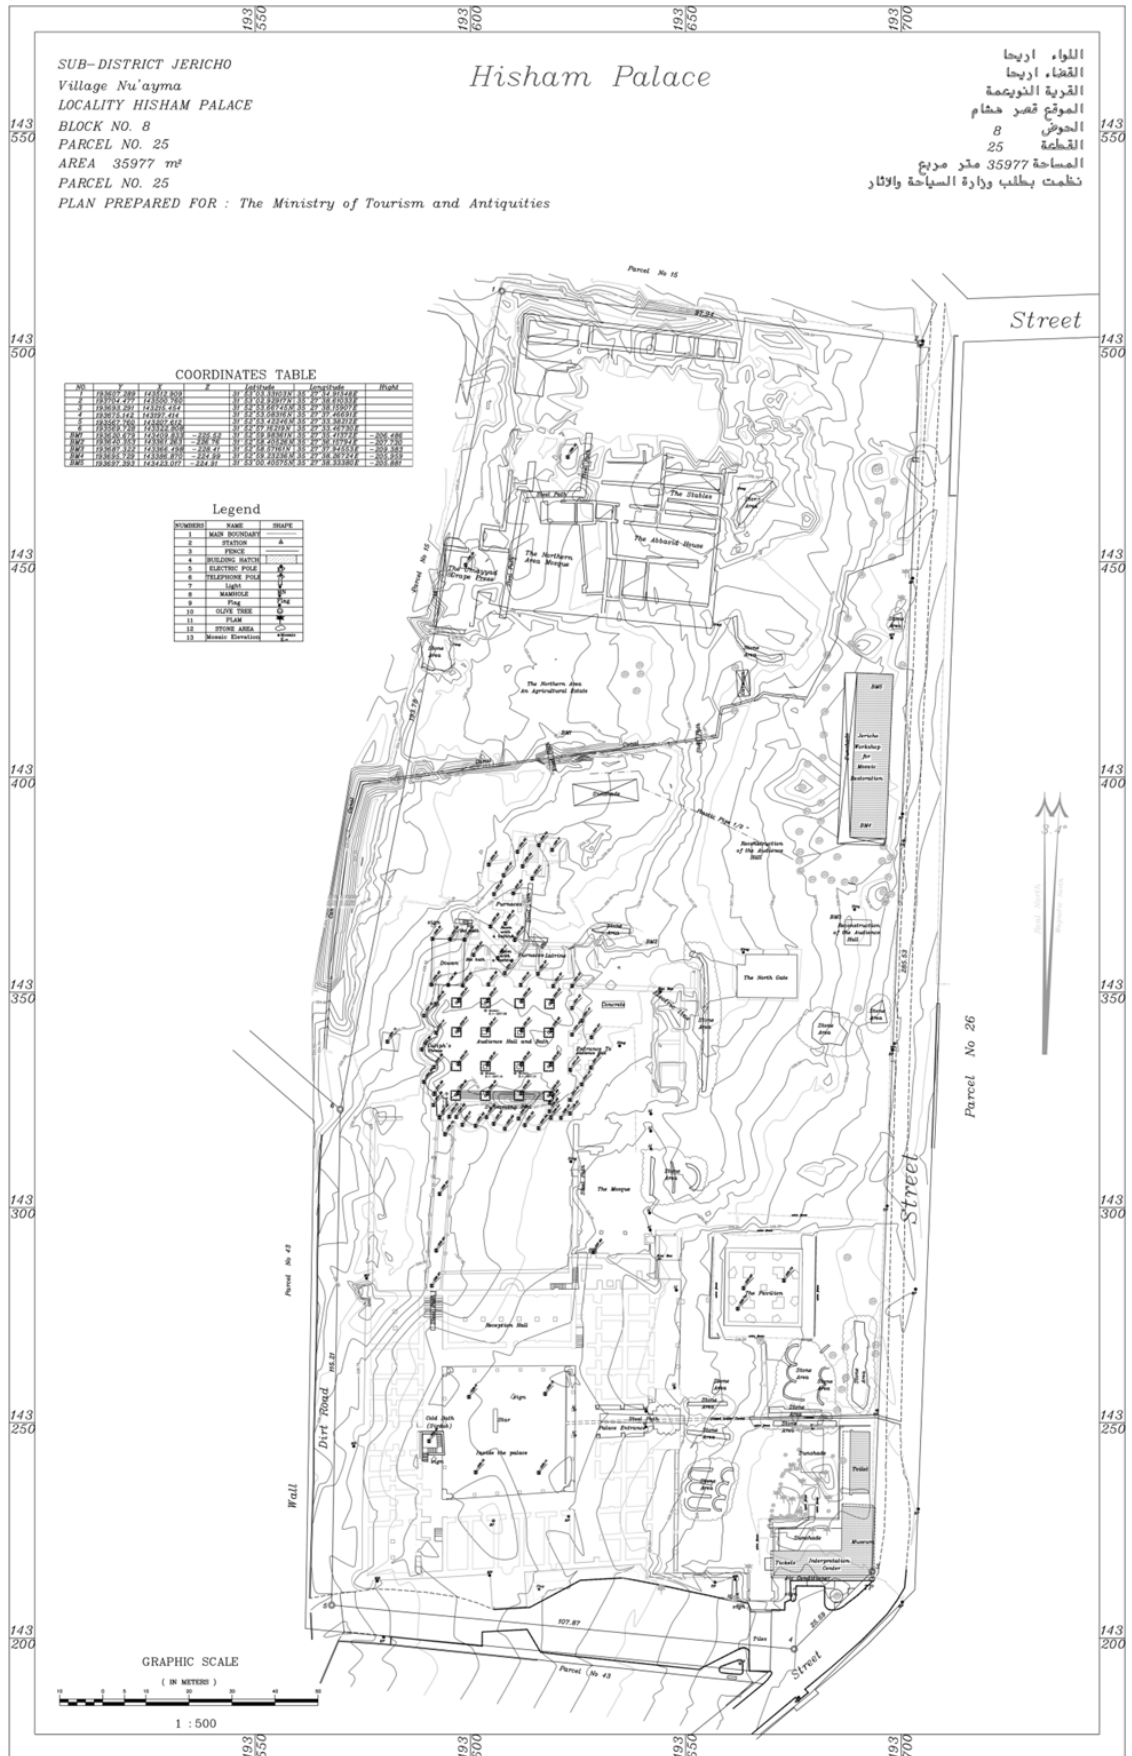
SUB-DISTRICT JERICHO
 Village Nu'ayma
 LOCALITY HISHAM PALACE
 BLOCK NO. 8
 PARCEL NO. 25
 AREA 35977 m
 PARCEL NO. 25

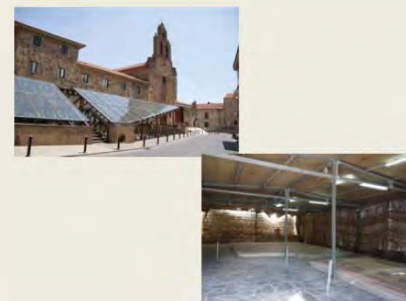
5b. Lighting

- Obscure bright space by diffusion light from **translucent membrane**
- There is **no shadow** and this type of lighting is applied to many protecting shelter

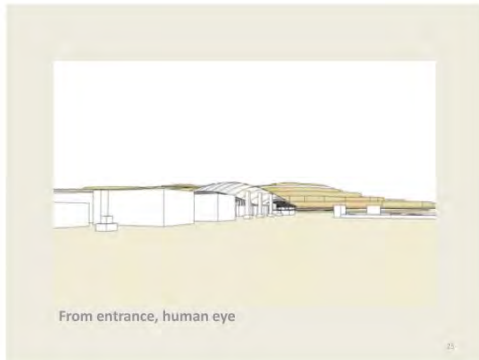
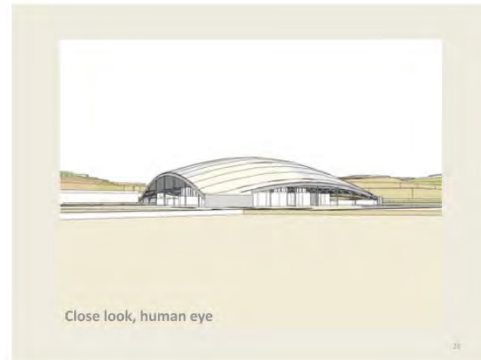
Feature of cut-off dome

- Mountain-like shape and small shade area
- Low impact to the scenery
- Structure to be hidden from sunlight
- Exposed structures inside and organic shape of ceiling
- Continuous foundation is needed
