Appendix-9 Result of the Soil Investigation

1. Summarized result of analysis in Buloba Substation

This report mainly deals with the geotechnical investigation finding for Buloba substation. It discusses the index and engineering properties of soil based on the geotechnical field investigation which was conducted during the period December 2015 to January 2016 and laboratory test conducted in January 2016. Relevant non-geotechnical parameters are outlined including the analysis and calculation results are given as part of this report (i.e. bearing capacity and settlements). Finally, recommendations were made for design and construction of the proposed development foundation.

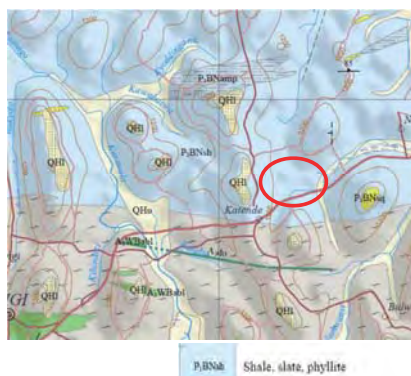
Figure 2. 2: Extract of geological map of the project site

According to DGSN 1:100 000 sheet 70 for Entebbe, the regional geology is composed of sedimentary, volcanic and metamorphic complexes. The main rocks in the region include shale, slate and phyllite (see Figure 2.2). These are metamorphic rocks with shale being the parent rock and produces a sequence of metamorphic rocks that goes through slate, then through phyllite, schist and gneiss. These rocks are underlain by other rocks such as quartzite and granatoids or granitic rocks. These rocks belong the Buganda group which is in the lower Proterozoic series.

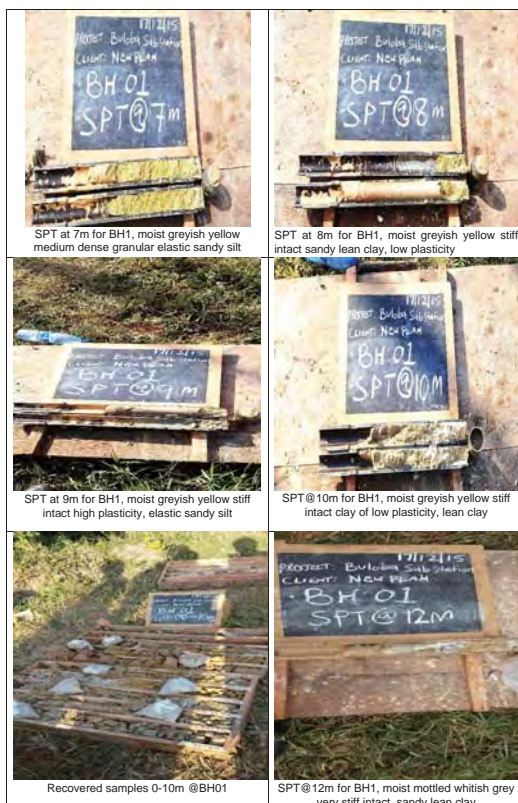
Recovered samples 0-10m @BH01

SPT @ 12m for BH1, moist mottled whitish grey very stiff intact sandy lean clay

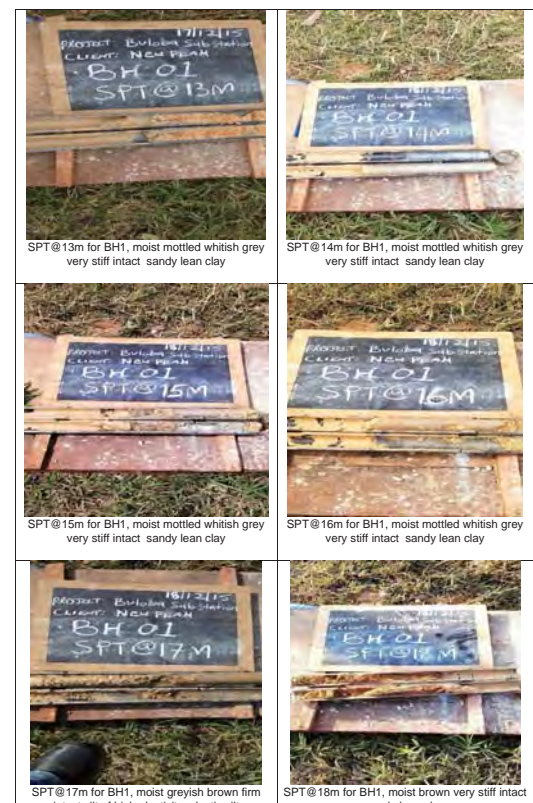
SPT @ 17m for BH1, moist greyish brown firm intact silt of high plasticity, elastic silt

SPT @ 18m for BH1, moist brown very stiff intact sandy lean clay

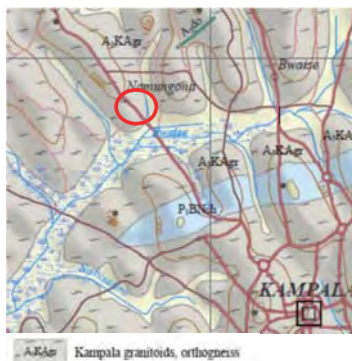
Figure 1. 1: Extract of geological map showing project site

Kampala is found in the Buganda region underlain by Porphyroblastic Phyllite (P₁BNamp), Shale, Slate Phyllite (P₁BNsh), and granitoids, orthogneiss (A₃KAgr). The site is underlain by rocks composed of Kampala granitoids which are rocks predominantly composed of feldspar and quartz and orthogneiss (A₃KAgr) of complex formation comprising sedimentary, metamorphic and volcanic rocks (see Figure 1-1)

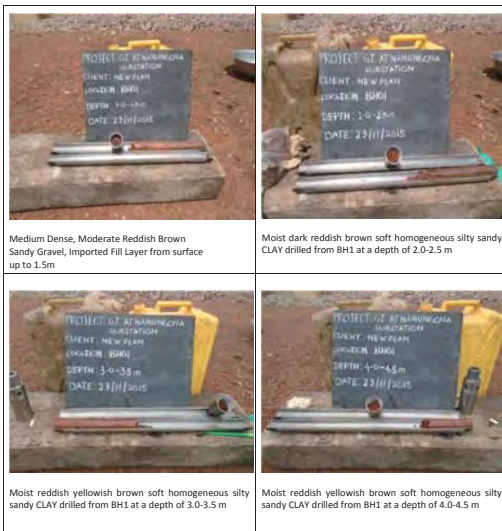
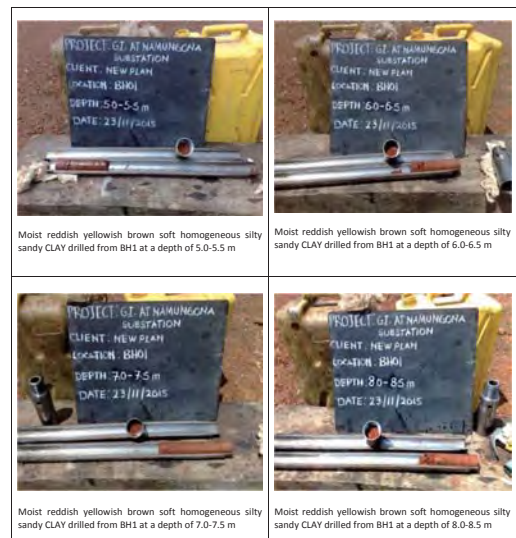
Moist reddish brown stiff homogeneous silty sandy CLAY drilled from BH1 at a depth of 9.0-9.5 m
