**PREPARATORY SURVEY FOR YEGHVAR  
IRRIGATION SYSTEM IMPROVEMENT  
PROJECT**

**FINAL REPORT  
(FR)**

**NOVEMBER 2016**

**SANYU CONSULTANTS INC. (SCI)  
ORIENTAL CONSULTANTS GLOBAL CO., LTD. (OCG)**

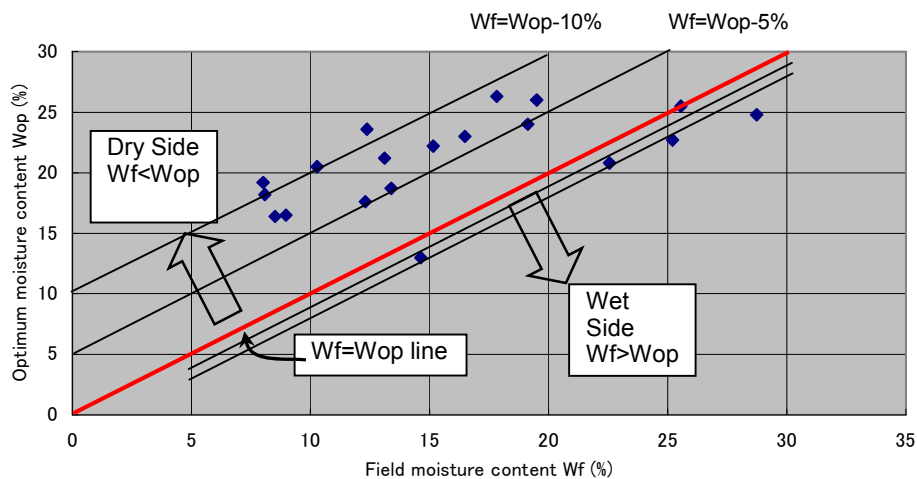
Most of the soils have the field moisture content lower than the optimum moisture content by 5% to 12% except for the some exceptional ones with the field moisture content higher than the optimum moisture content by 1% to 2% as shown in Figure 4-4, so that to conduct the compaction work to the soils with optimum moisture content condition, a large amount of water shall be needed for moisture content adjustment.

**Figure 4-4 Relationship between Field Moisture Content and Optimum Moisture Content**

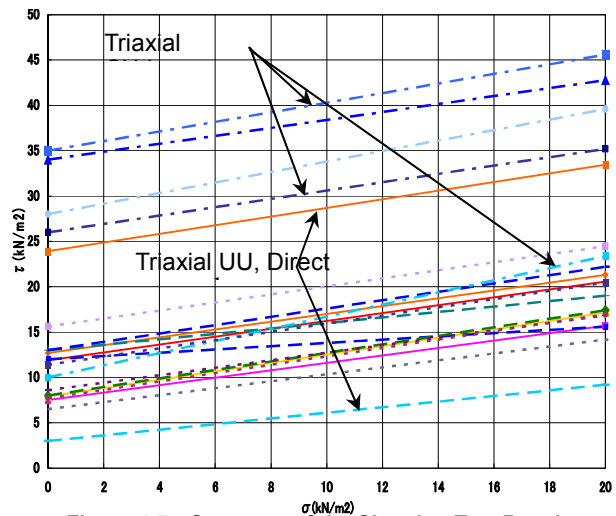
Shear strength of the sandy loam is evaluated to be medium class, not good but not so bad as shown in Figure 4-7. It should be noted that a relatively definite differential between the UU strength and the CU strength.

Figure 4-7 Summary of the Shearing Test Results

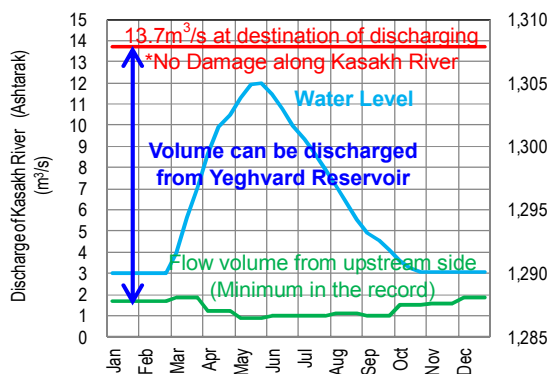
**Figure 6-3 Discharge volume from Yeghvard Reservoir**

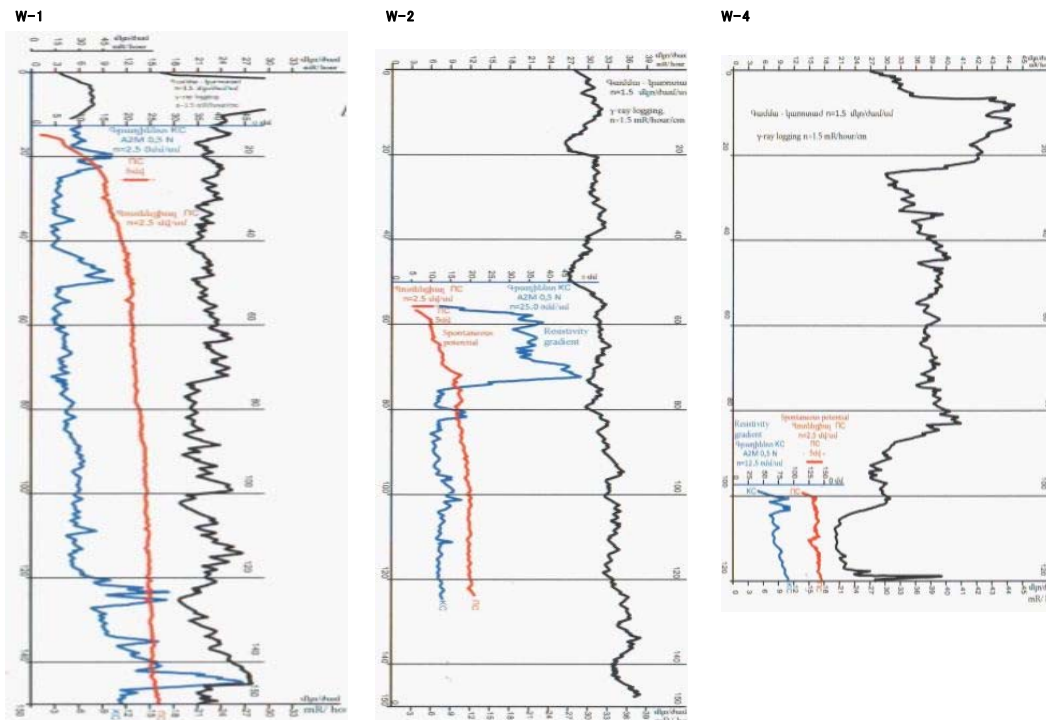
**Figure 4-3-2.12 Results of  $\gamma$ -ray and Resistivity Logging**

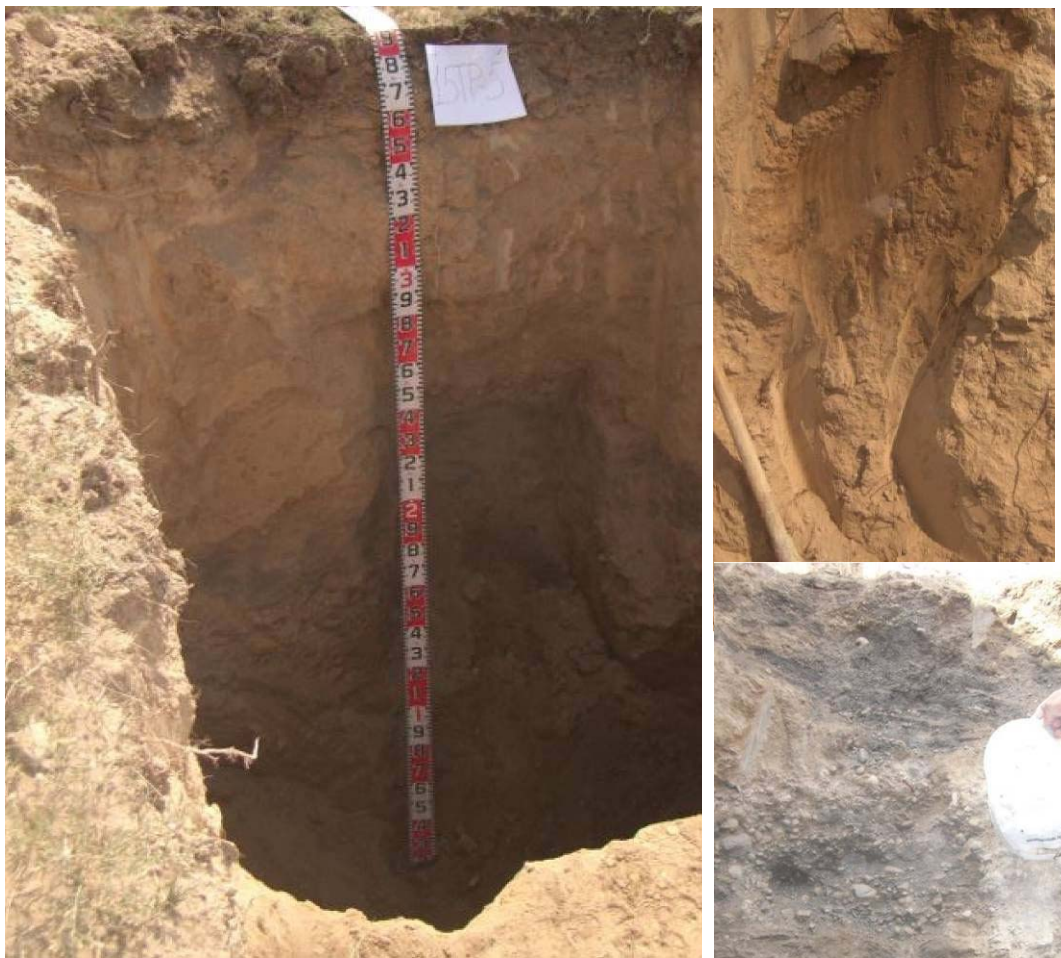
**Figure 4-3-4.2 Typical Test Pit Log and the Profile Photos**

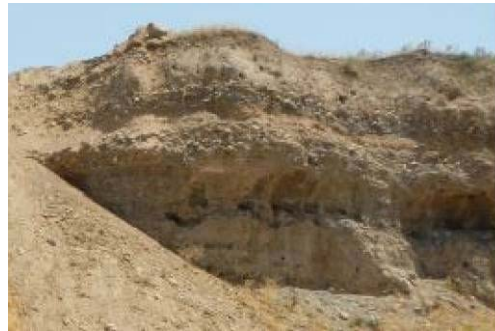
**Figure 4-3-4.4 Profile of the Sand-and-Gravel Layer**

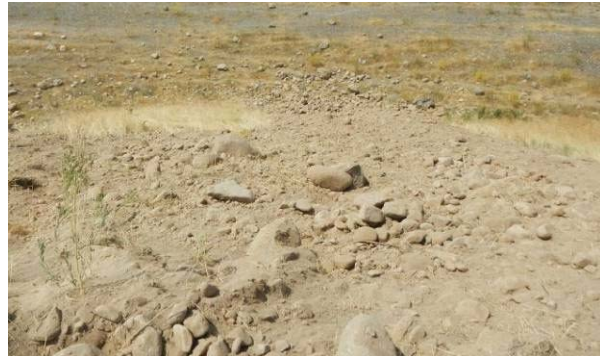
**Figure 4-3-4.5 Conditions of Sand-and-Gravel**

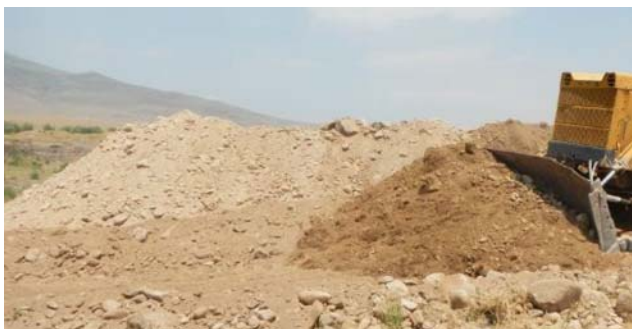
**Figure 4-3-4.6 Mounded Sand-and-Gravels after Excavation**

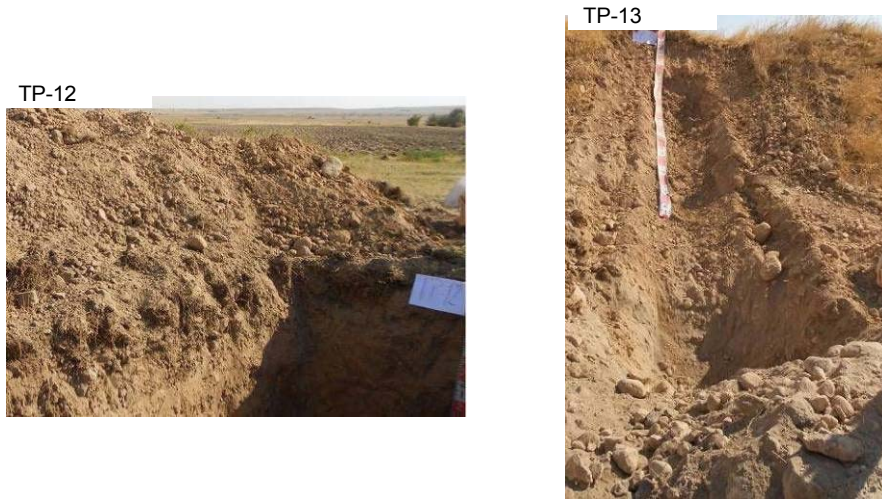
**Figure 4-3-4.12 Sand-and-gravel with Rich Silty Sand**
