# BH-3 Photos - Teouma Bridge, Vanuatu

## BH-4 Photos – Teouma Bridge, Vanuatu

## Appendix D: Laboratory Test Results

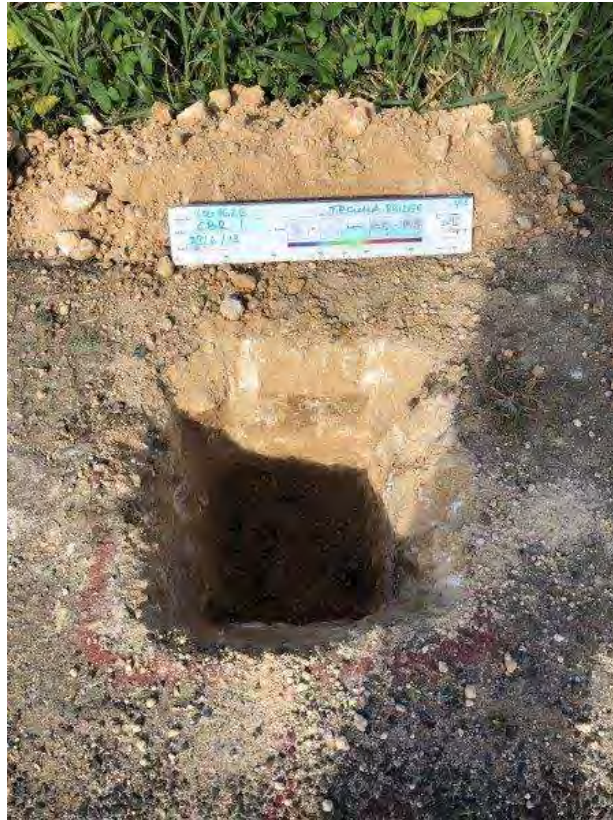
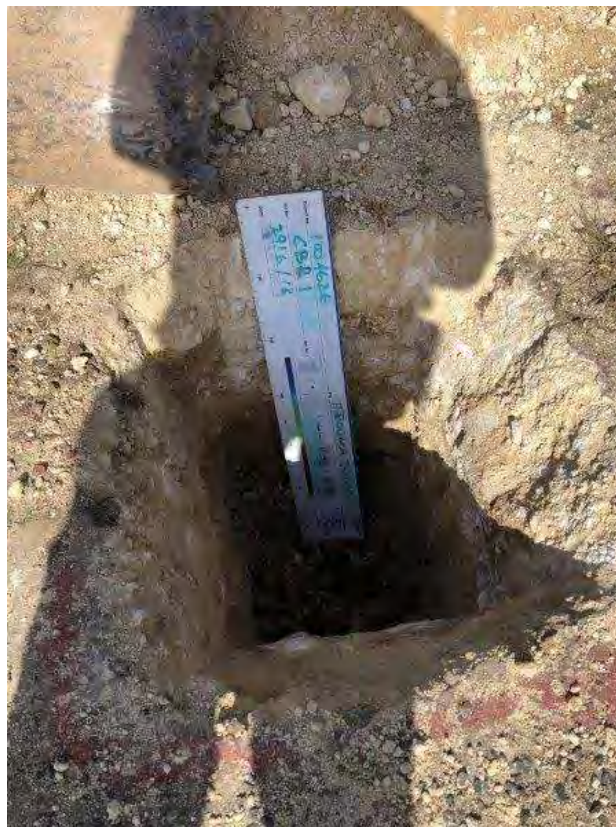
CBR-1:

## CBR-1 to CBR-3 test sampling locations – Efate Ring Road, Vanuatu
