**DATA COLLECTION SURVEY
FOR
RECONSTRUCTION OF TEOUMA BRIDGE
ON EFATE RING ROAD**

SURVEY REPORT

JANUARY 2017

CTI ENGINEERING INTERNATIONAL CO., LTD.

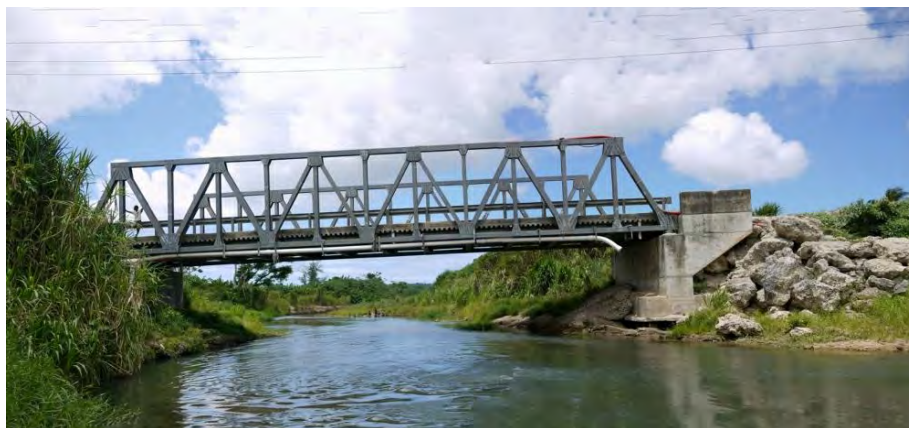
In Efate Island, Cyclone Pam inflicted enormous damage on the ring road. Especially, at Teouma Bridge, the approach road at the right bank was washed away, right abutment and revetment in the upstream and downstream side of the bridge were scoured and approach road at the left bank was submerged. Those damages prevented the traffic for 6 days. The other damages on the structures along the ring road in Efate Island are shown in Table 3.2-3.

Photo 3—1 Urgently Rehabilitated Teouma Bridge (Upstream View)
