Inventory Sheet A

District	Nuwara Eliya	Management office	Nuwara Eliya	Road No	A-005	Road Name	Peradeniya - Badulla - Chenkaladi road						
Site No.	2		Disaster Type	Landslide	Location	Start	46/2	End	46/3	latitude	7°02'57.7"N	longitude	80°41'57.8"E
Main body	Both	Traffic control	Hourly	mm	Traffic volume	Week day	4442/12h	holiday		Bus route		Detour

Inventory Sheet B

Checked by	Yang Pucai
Organization	JICA Survey Team

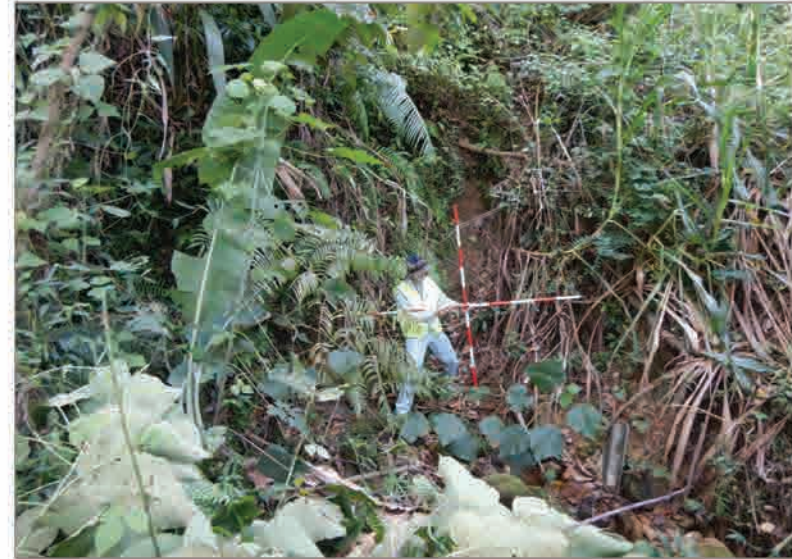
P2 Planned location of horizontal drain boreholes

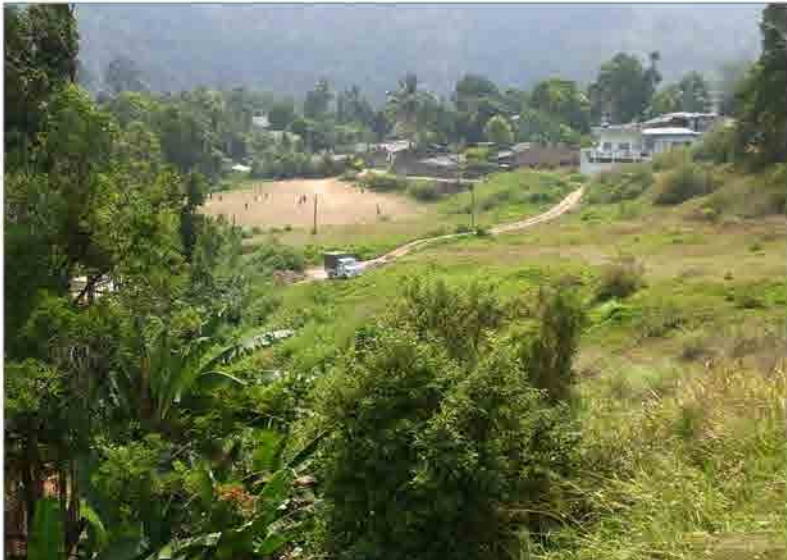
<p>P3 Whole view of the landslide area looking from upper slope.</p>		<p>P4 Whole view of landslide area looking upper slope from down slope</p>

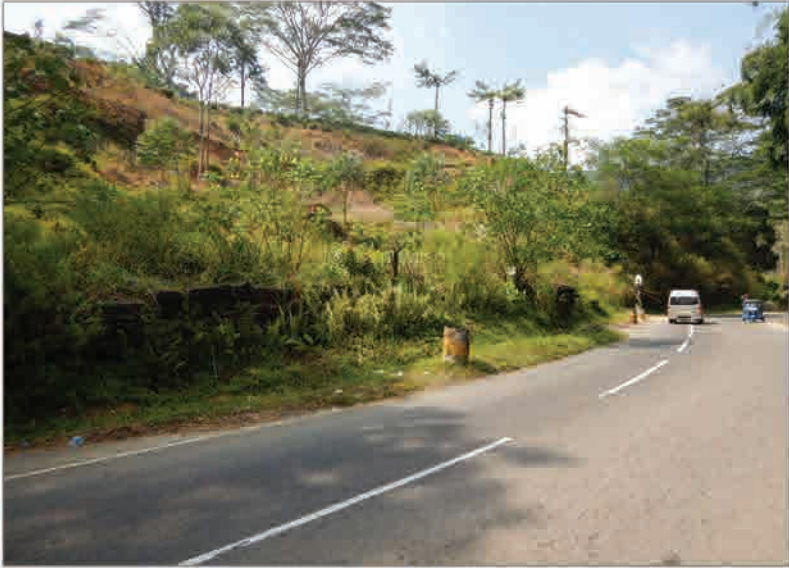
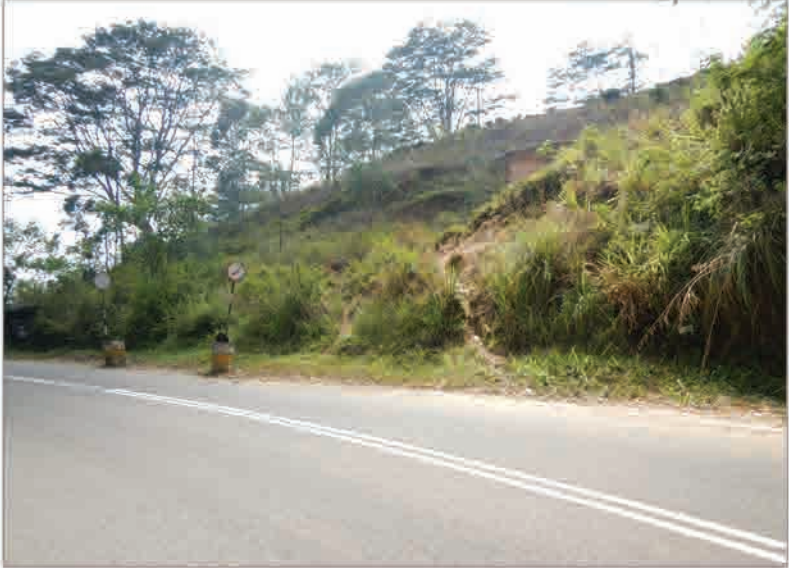
<p>P1 Landslide occurring along road cut slope, due presume to road excavation</p>			<p>P2 Same as that in P1</p>
