**INFORMATION COLLECTION AND  
PRELIMINARY SURVEY  
FOR THE FORMATION OF  
DISASTER RECOVERY PROJECTS  
AGAINST VOLCANIC ERUPTIONS AND  
TSUNAMI DAMAGE  
IN KINGDOM OF TONGA**

**FINAL REPORT**

**OCTOBER 2023**

**JAPAN INTERNATIONAL COOPERATION AGENCY (JICA)**

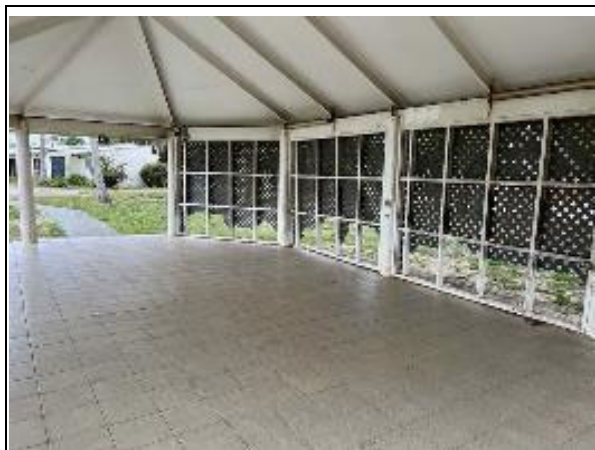
**Photo 2.7.7 The Lower Frame Destroyed by Tsunami**

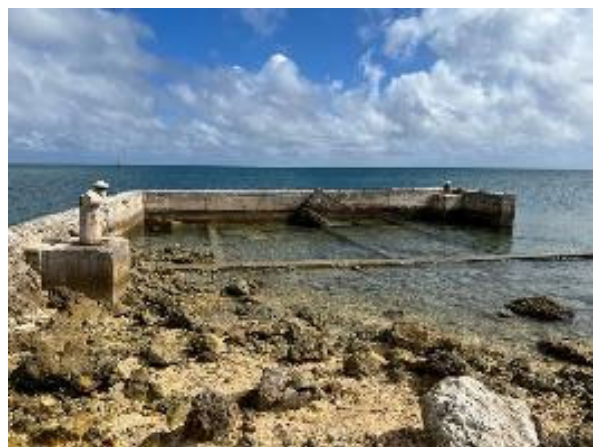
Based on the assessment of the JICA Study Team from this field survey at site, it seems that the damages of the port are actually concentrated at the northern seawall and on the caisson type mixed breakwater. This is the reason why the effect of breakwater is very important, because this breakwater installed in the sea was not able to protect the quay on the north side.

Photo 2.7.28 ④Caisson type mixed breakwater

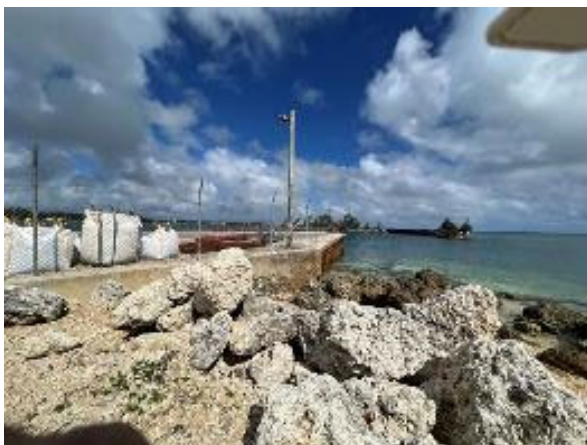
Although the upper structure has suffered some damage, the sheet pile wharf could surely resist against waves as the foundation.

Photo 2.7.29 ⑤Sheet pile wharf can be seen

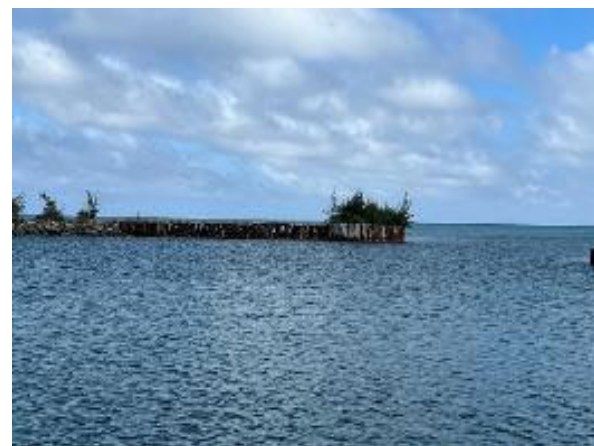
Photo 2.7.34 ⑩Offshore breakwater

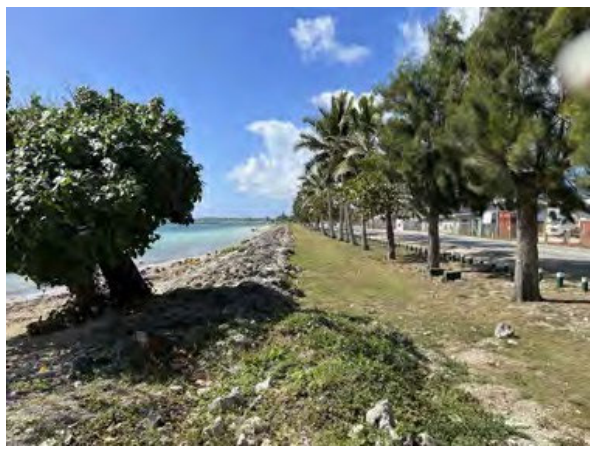
**Photo 4.1.5 East side is low and inconspicuous**

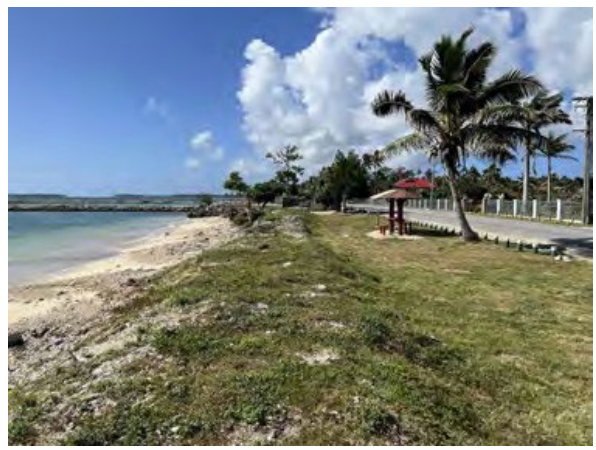
**Photo 4.1.6 It becomes gentle hills**

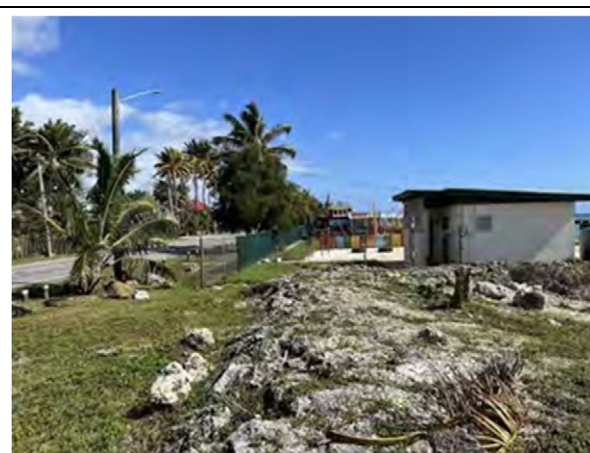
**Photo 4.1.7 Rocks are still scattered.**
