**THE ROMANIA EARTHQUAKE  
SURVEY GROUP OF EXPERTS AND SPECIALISTS  
DISPATCHED BY THE GOVERNMENT OF JAPAN  
SURVEY REPORT**

**June 1977**

**Japan International Cooperation Agency**

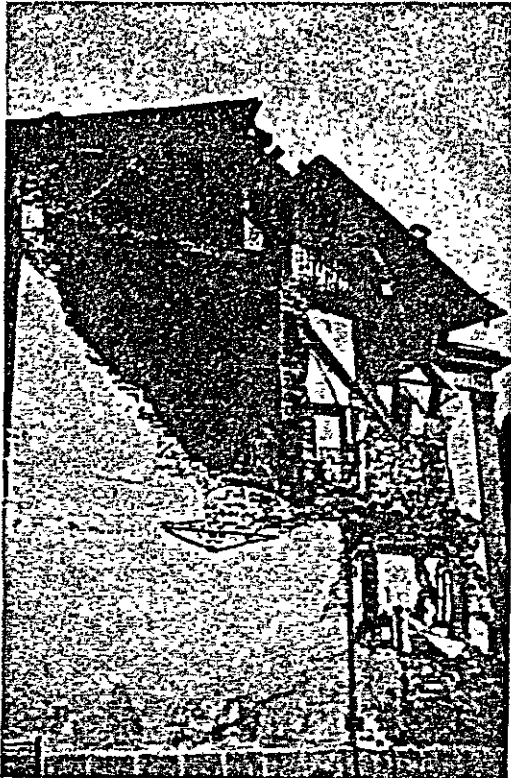
Photo 5.1

A close examination of damage to these buildings revealed two different types of collapse. One is the collapse of brick walls by in-plane shear force that caused diagonal shear cracks running mainly along joint lines. The other is the falling down of walls toward the outside. The latter occurred in walls not restrained horizontally by roofs or floor materials. Many of the walls were on the northern side of houses and they fell in the northern direction, toward the epicenter. (See photos 5.1, 5.2, and 5.3)

A Destroyed Brick House in Craiova

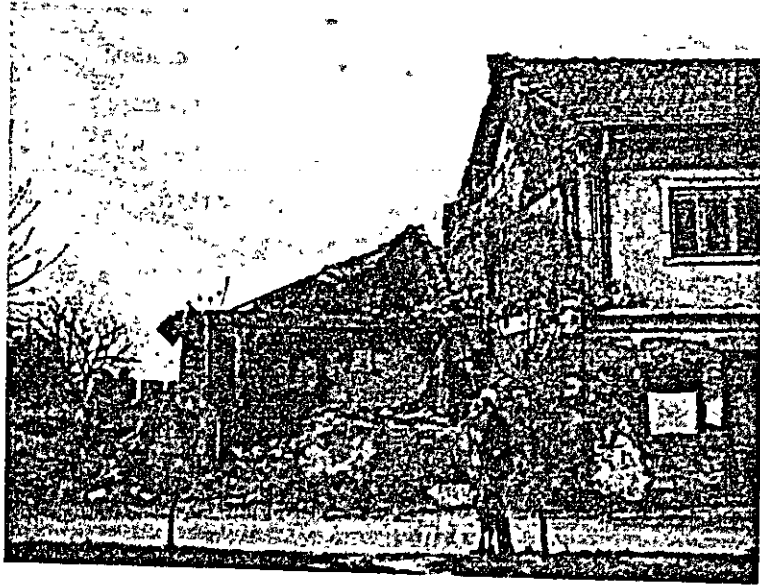
Photo 5.2 A destroyed brick house in Craiova

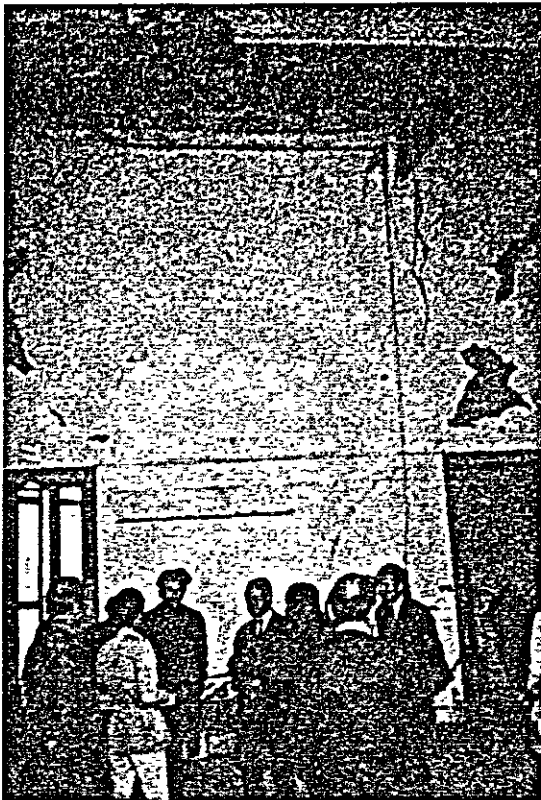
Photo 5.9  
Wrecked interior of the Museum of History

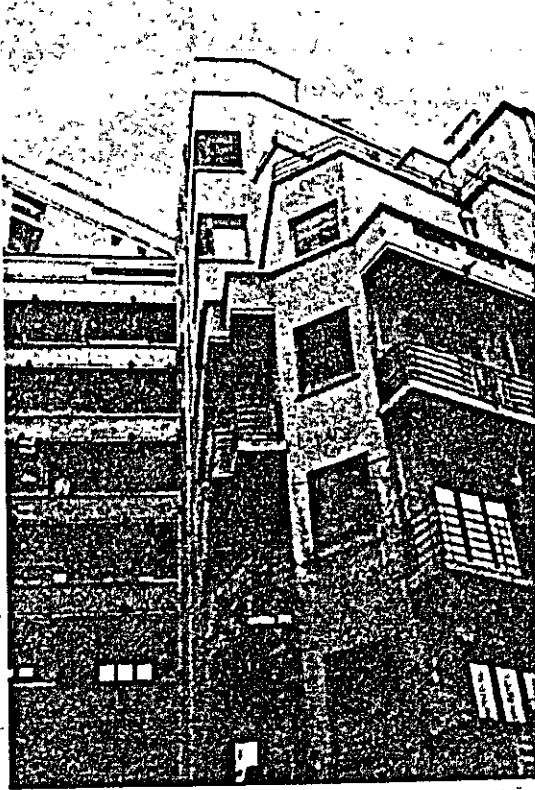
An 11-story reinforced concrete-strengthened brick apartment house built before 1940.

As a result, those being repaired include even such old buildings lacking aseismic designs that had been damaged in the earthquake in 1940 and again this time. Some of these are seen in Photo 5.28 and Fig. 5.7.

Photo 5.84 Reinforcement of decayed bars in a basement column of an 11-story reinforced brick apartment building, Bucharest. (The same building as in Photo 5.28)

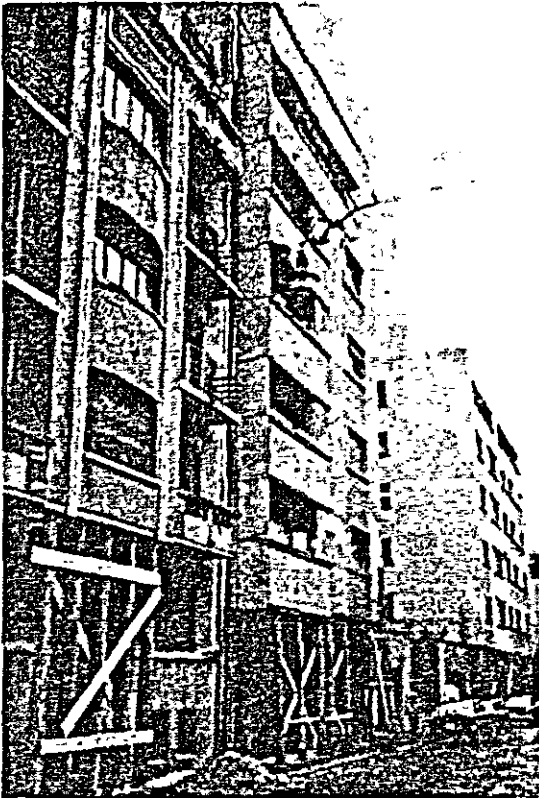
Photo 5.31

Log-support to prevent the collapse of the apartment house in Photo 5.28.

There are also many buildings, which, though not listed as destroyed, sustained almost irreparable damage, such as the collapse of reinforced concrete columns or the breakdown of brick

walls as shown in Photos 5.30 and 5.31. These buildings are estimated to number about 10,000.

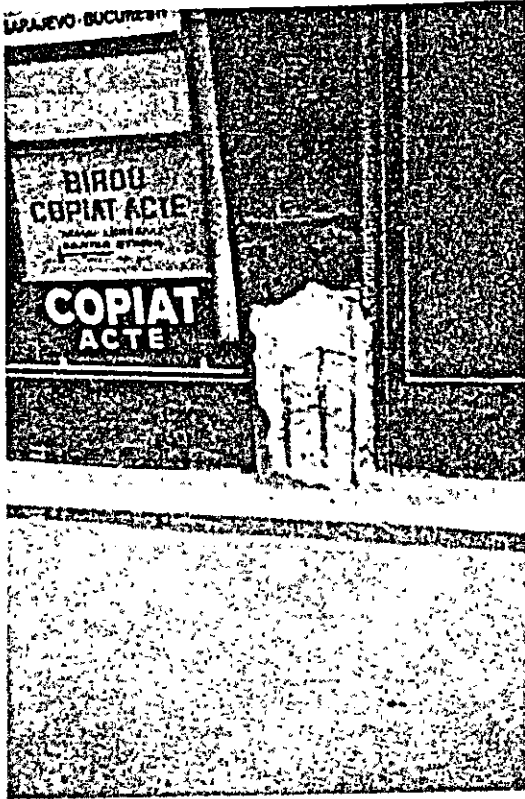
Photo 5.41

Falldown of concrete on a 1st story column base of the same building.

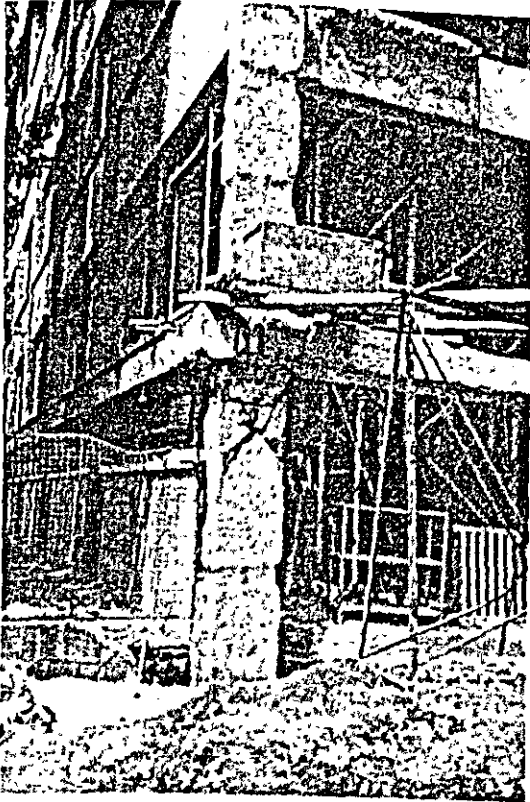
Photo 5.51

A shear failure in a short column consisting of a non-structural beam and brick walls of the same building, Bucharest.

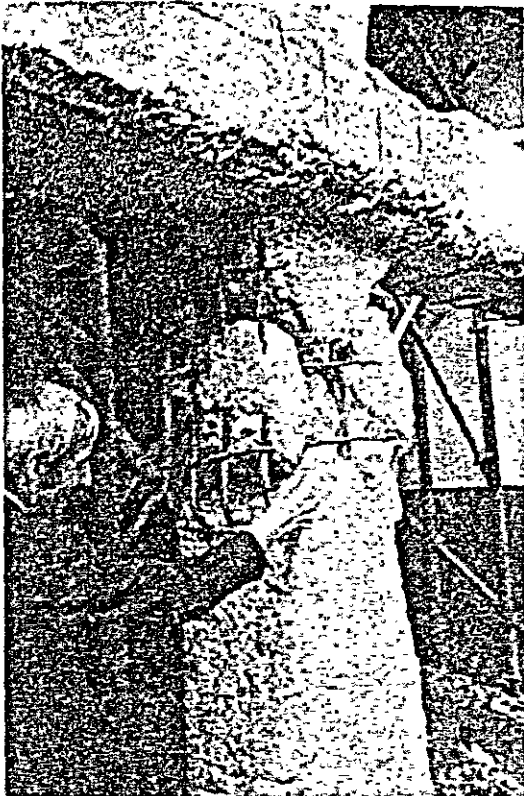
Photo 5.52

Buckling of main reinforcing column bars caused by a shear failure of the same building, Bucharest. (Hoops  $8\phi$  , 20 cm spacing)

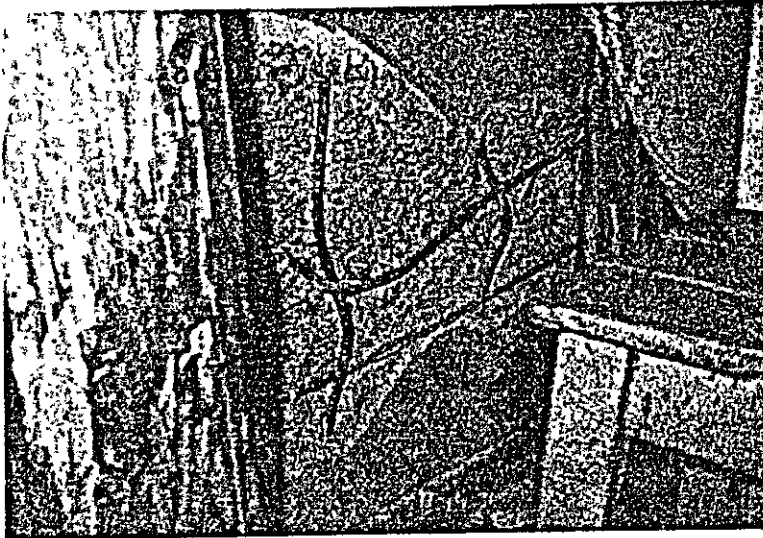
Photo 5.71 Failure of a 1st story wall in the span direction and buckling of reinforcing bars of a building of similar type, Bucharest.

This building is almost the same type as those noted above. It did not collapse, but its first story was badly damaged. Possible causes for this, as shown in Photos 5.69 and 5.70, are malcasting of concrete in wall columns and extreme maladjustment of main vertical bars in the other wall columns. Photo 5.71 shows that collapse and buckling extended to earthquake-resistant walls inside.

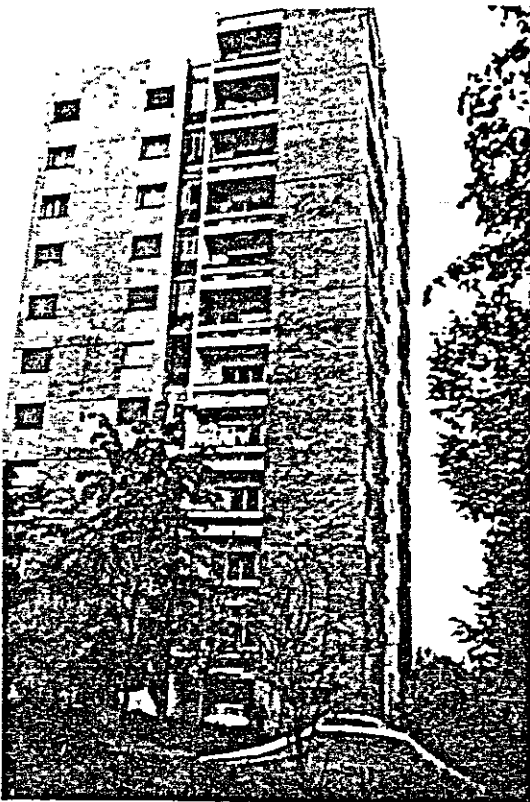
Photo 5.76

A 12-story apartment building with a basement. The reinforced concrete structure combines a rigid frame and earthquake resistant walls, Bucharest. (Measured natural period was about 0.7 seconds; slightly damaged.)
