7.3 Manila North Super Highway, Three Main Routes to Bagio and Soil Liquefaction (Road 2 group)

7.3.1 Role of the Road 2 Group and the Route of its Reconnaissance

7.3.2 Results of the Reconnaissance

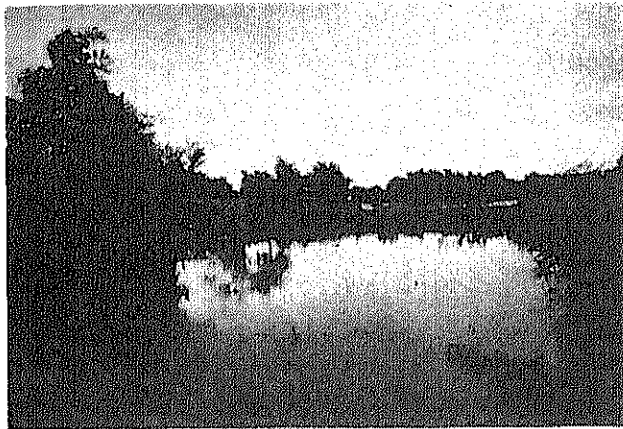
Photo 7.3.10 Sinking of ground inside revetment and embankment on downstream left bank of S. Ishidro Bridge

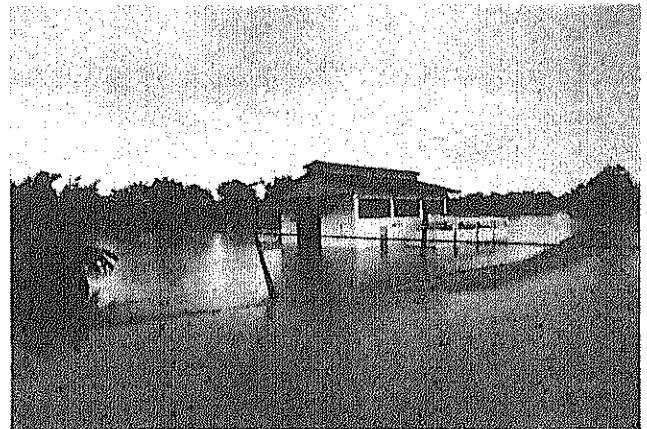
Photo 7.3.11 Depression of surface near the 200km spot on No. 13 Line

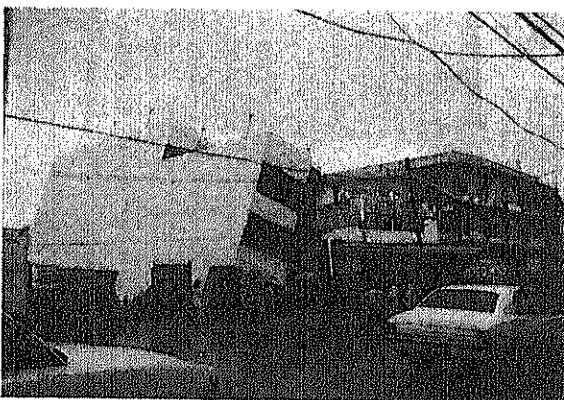
Photo 7.3.29 In Dagupan City

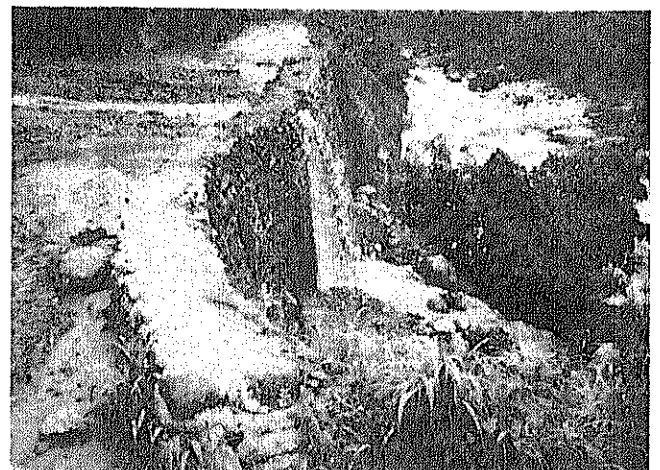
Photo 7.3.54 Around 222 + 500km on Kennon Road

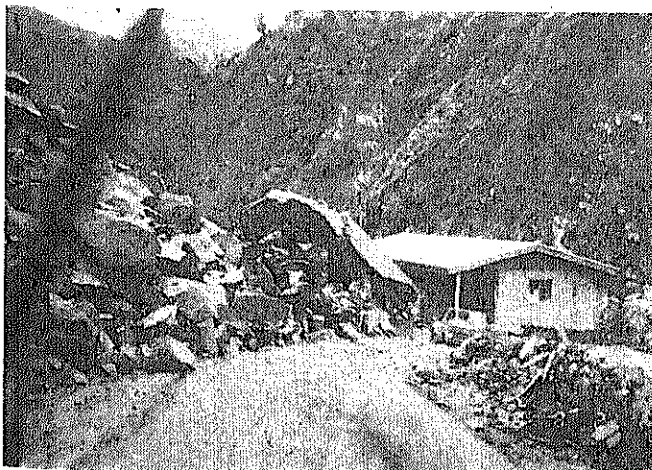
Photo 7.3.59 Masses of collapsed and fallen rocks along the Baguio side of the Kennon Road
