7.6 Buildings

7.6.1 Damage in Dagupan City

7.6.2 Damage in Baguio City

7.6.3 Damage to the Metro-Manila

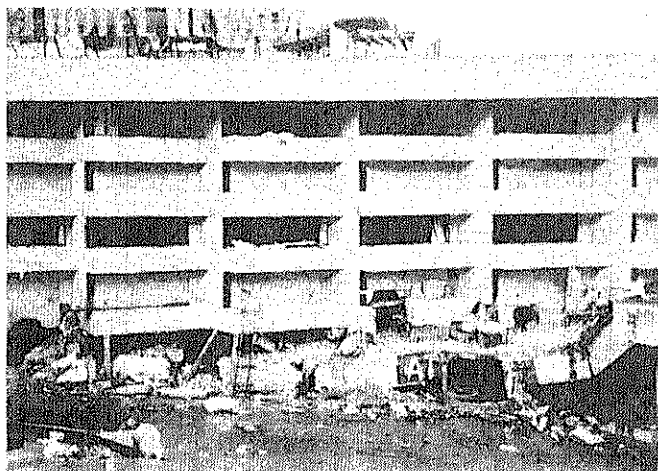
Photo 7.6.17

Name of the building: Nevada Hotel

Damage conditions:
Collapse of the 1F part

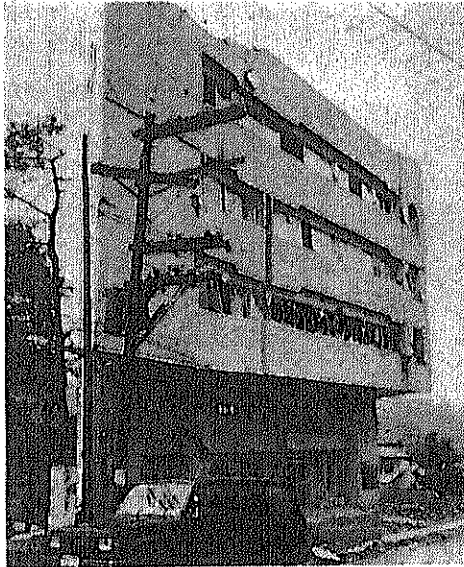
Photo 7.6.33

9	FRB Hotel	Hotel	RC	5	Collapse of 1F and 2F parts.	Collapse	7.6.31 - 32
10	Cowye Burl Bill	Office	RC	5	Serious damage to the columns and the walls of 1F and 2F.	Serious damage	7.6.33

Name of the building:
Cowye Burl Bill

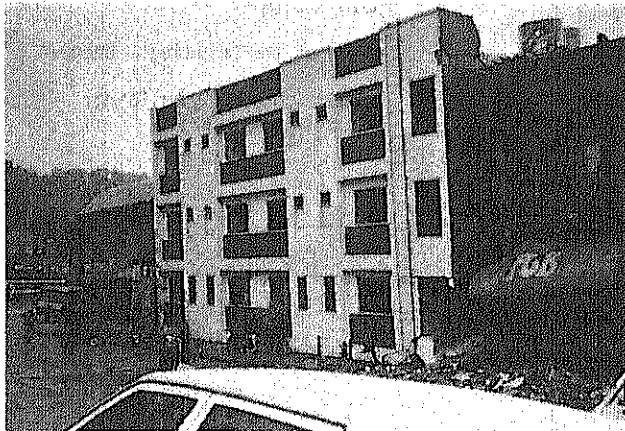
Photo 7.6.36

Name of the building: Siesta Inn

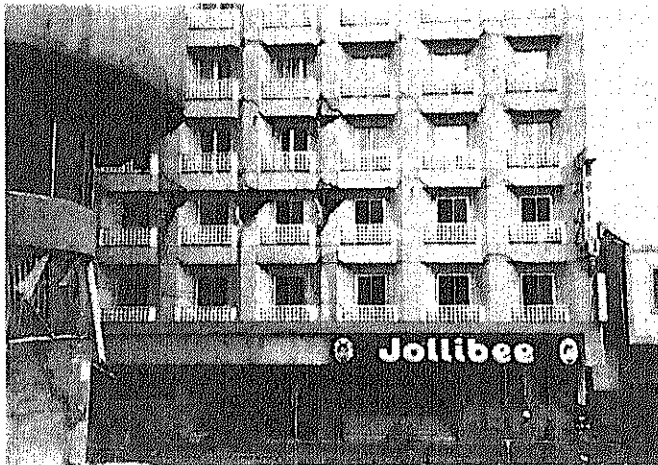
Photo 7.6.42

See the Benguest Prime Hotel from Sky World.

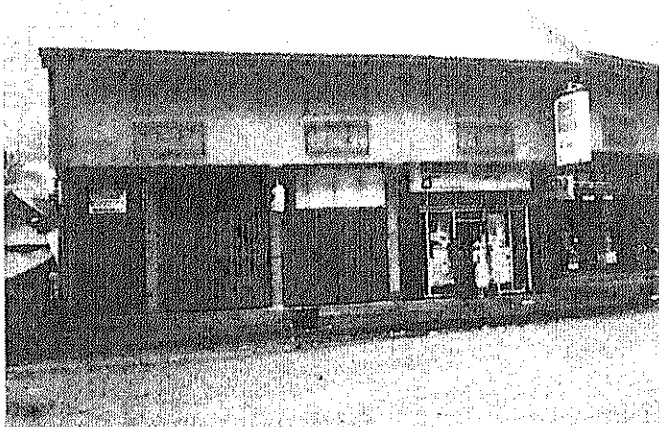
Photo 7.6.43

Baden Powell Hill at the head of a slope.

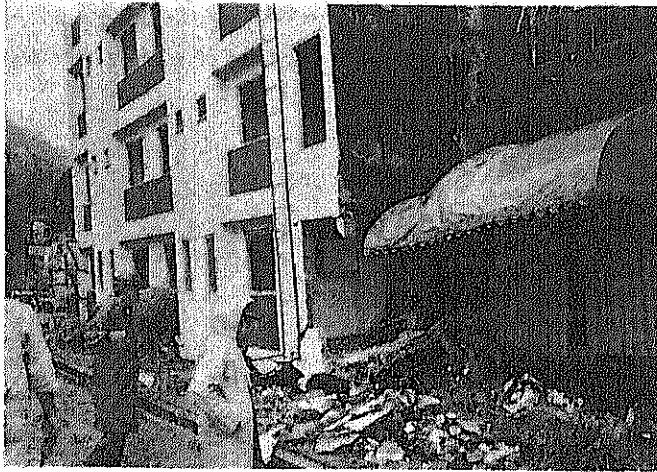
Photo 7.6.44

This side is Anapola, and the other side is the Siesta Inn.

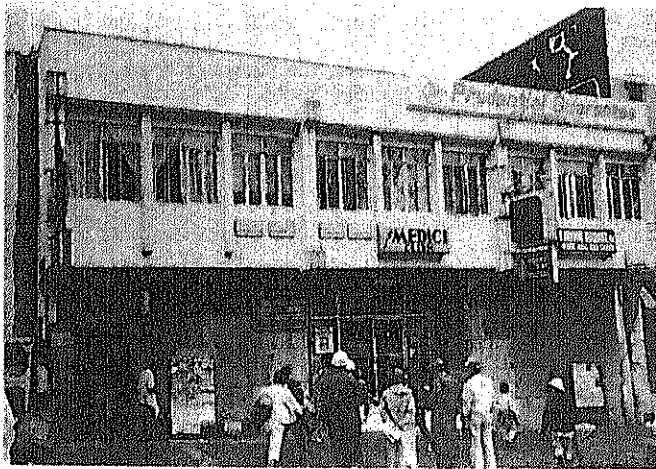
Photo 7.6.45

BPI building

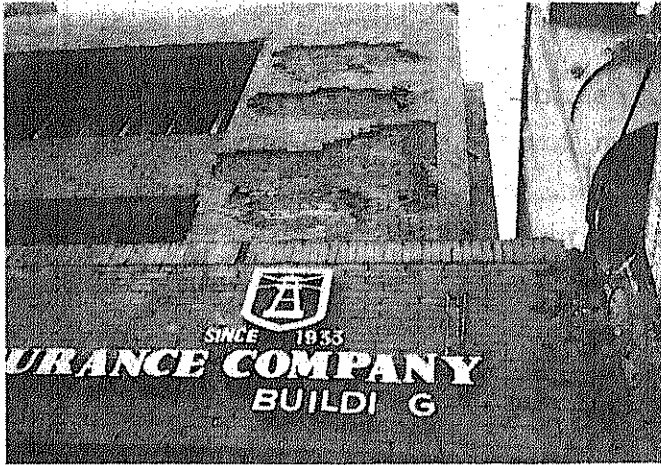
Photo 7.6.47

City Trust building

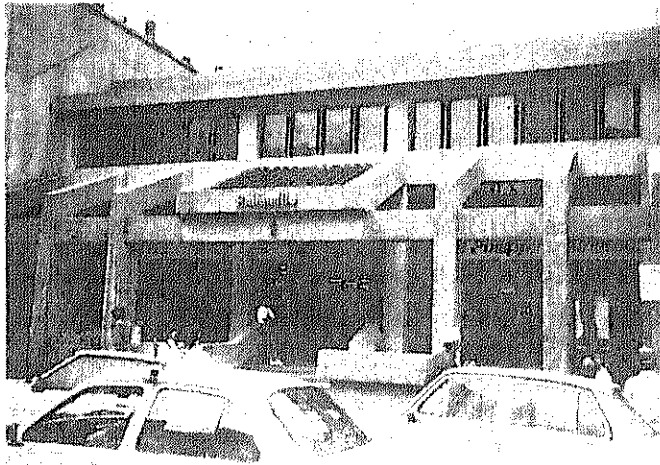
Photo 7.6.48

Philam Life building

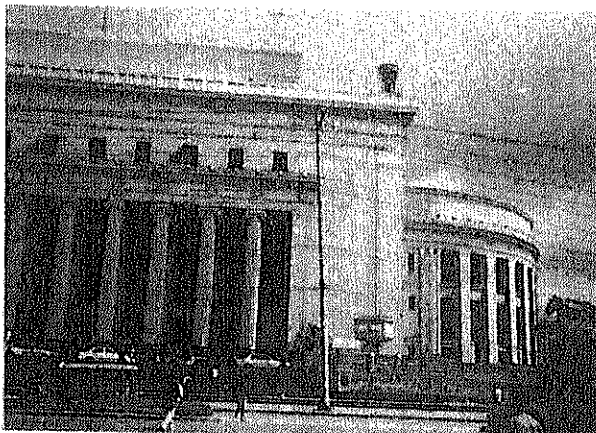
Photo 7.6.67

The RC columns for strengthening
after the earthquake in 1974 are
projected from the wall surface.
