LOCAL GOVERNMENT ENGINEERING DEPARTMENT,
MINISTRY OF LOCAL GOVERNMENT, RURAL DEVELOPMENT
AND COOPERATIVES
THE PEOPLE'S REPUBLIC OF BANGLADESH

BASIC DESIGN STUDY REPORT
ON
THE PROJECT FOR THE CONSTRUCTION OF
MULTIPURPOSE CYCLONE SHELTERS (II)
IN
THE PEOPLE'S REPUBLIC OF BANGLADESH

(APPENDIX 9. RESULTS OF SITE CONDITIONS SURVEY
APPENDIX 10. RESULTS OF NATURAL CONDITIONS SURVEY)

JAPAN INTERNATIONAL COOPERATION AGENCY
JAPAN ENGINEERING CONSULTANTS CO., LTD.

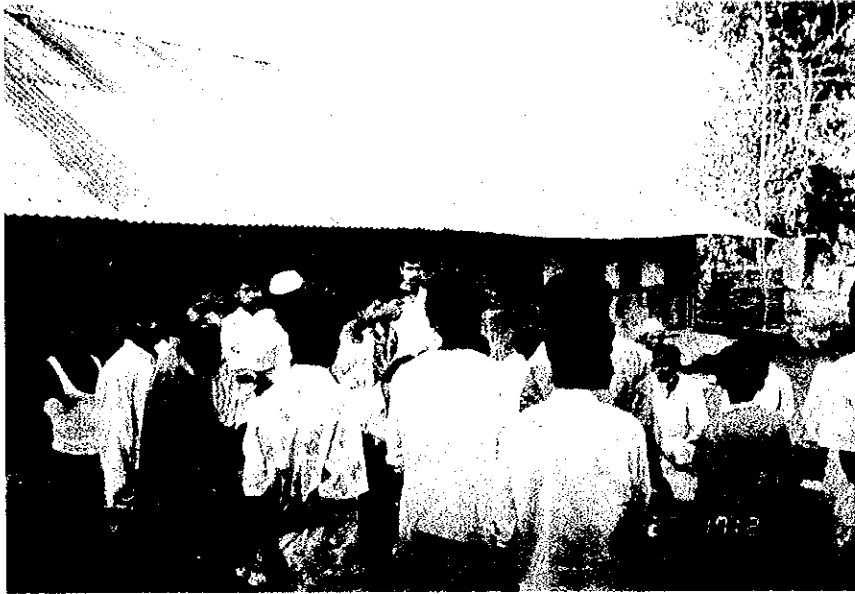
View of the School Building

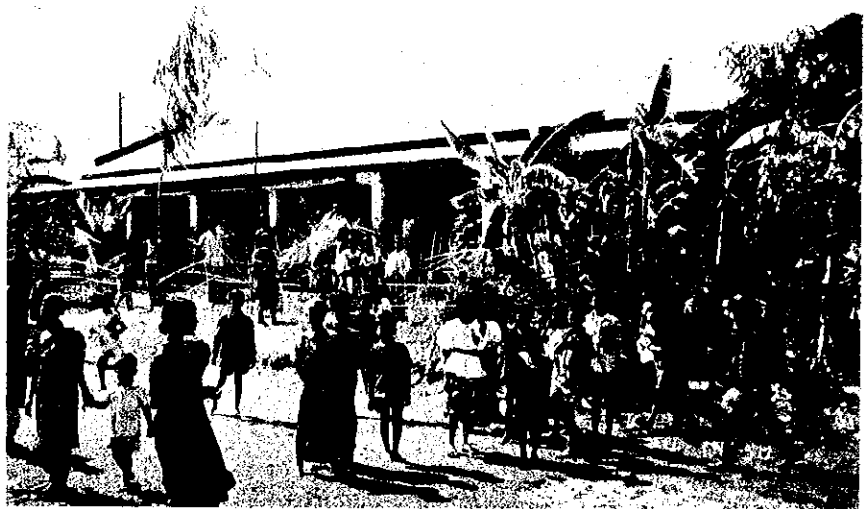
View of the School
Building

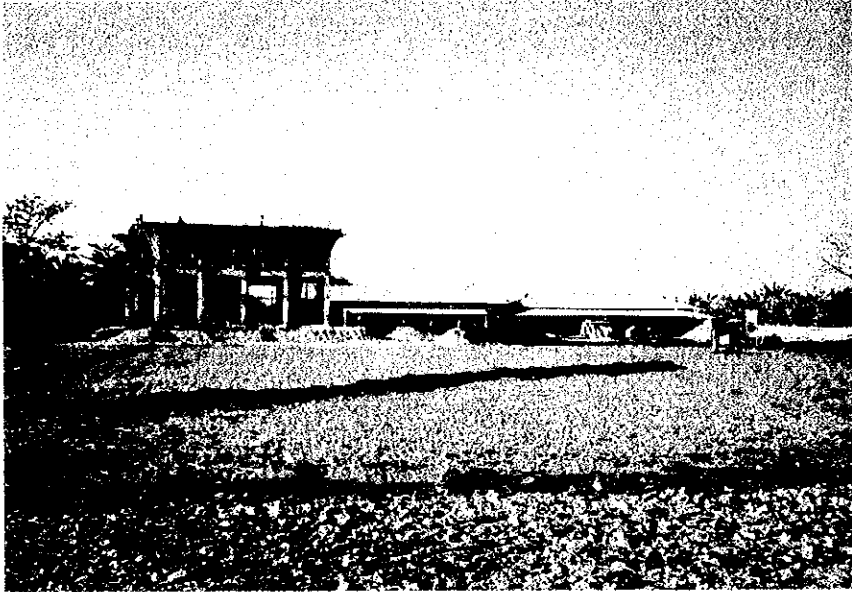
Overall View of
the School Site
