SITE SURVEY CHECK LIST

(Date: 1995/ 3 / 24)

1. Site No. 27
2. Name of School: East Char Algi Registered NGPS
3. Site Location : District; Laxmipur Thana : Rangate
 Union : Char Algi no. 9 Village: Char Algi

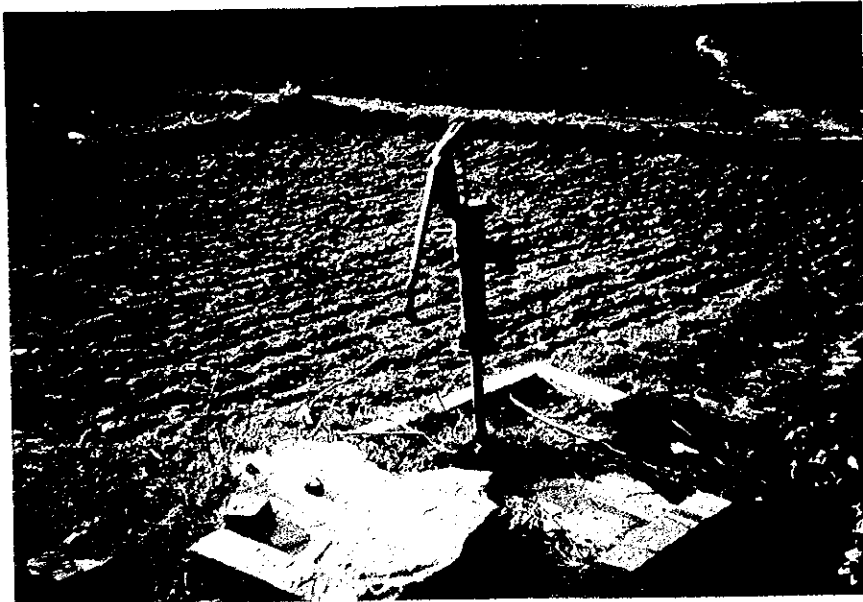
Auxiliary Facilities of
the School Building

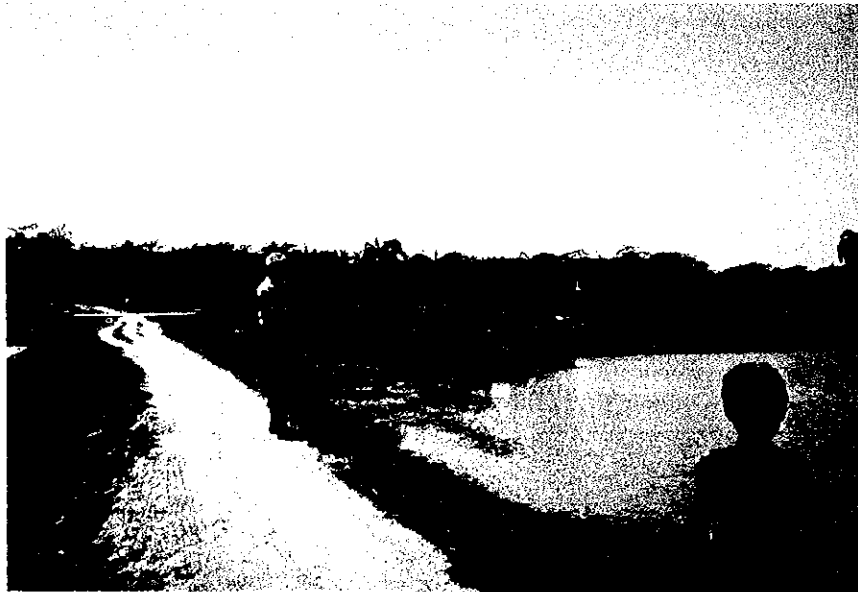
Current Conditions
near the Site
(including topographic
features)

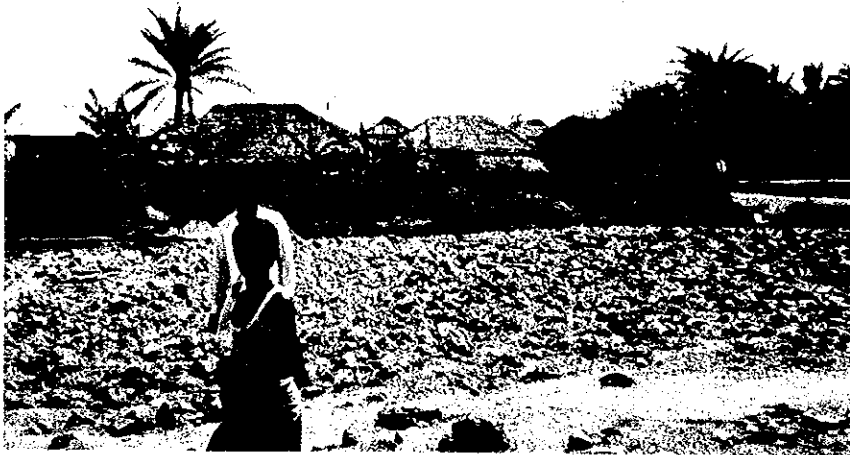
Current Conditions
near the Site
(including topographic
features)

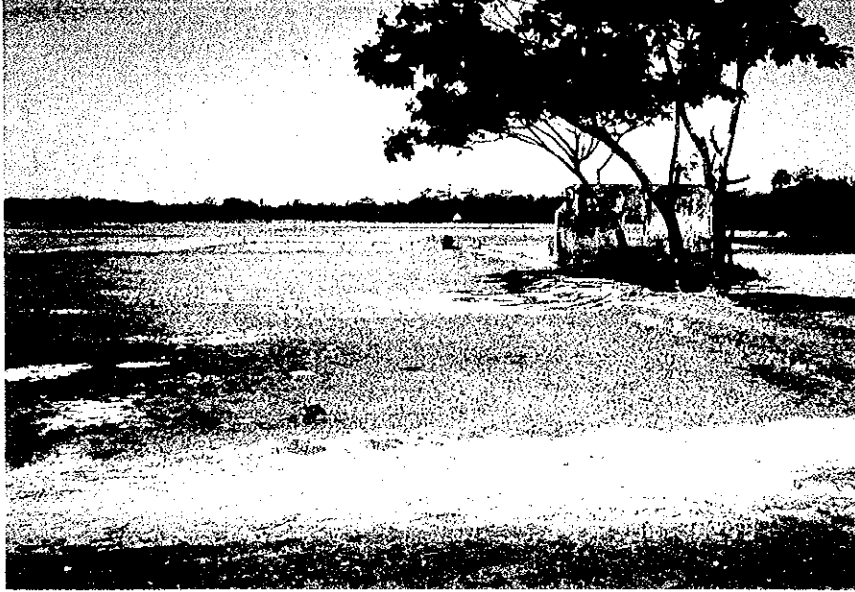
Current Conditions
near the Site
(including topographic
features)
