バングラデシュ人民共和国  
 第3次多目的サイクロンシェルター建設計画  
 基本設計調査報告書

バングラデシュ人民共和国  
第3次多目的サイクロンシェルター建設計画  
基本設計調査報告書

〔資料10. サイト状況確認調査結果〕  
〔資料11. 自然条件調査結果〕

平成7年10月

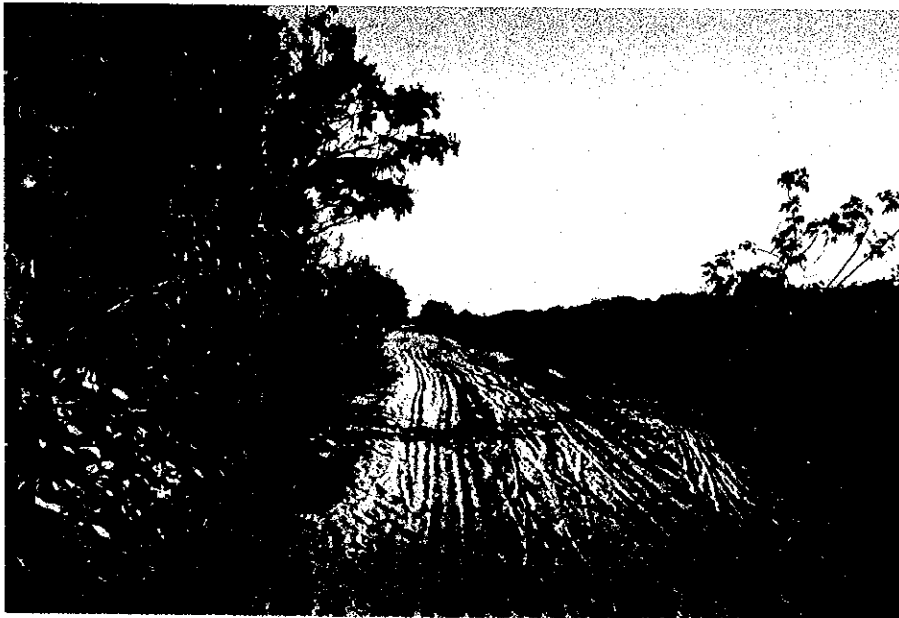
周辺の道路状況

- 2) Road Conditions
    - Kind of Pavement: Earth, Gravel, Brick, Asphalt, Concrete.
    - Condition of Pavement: Good, Not so good, Bad
    - Road Width : 2.5 m

- Passable Vehicle: Motor cycle, Rikisha, Sedan, Jeep, Truck ( ton)
    - Necessity for Repair of Road: Yes No. *(only in dry season)*
    - Necessity for Repair of Bridges or Culverts: Yes. No
