サイト状況確認調査チェック・リスト

1. Site No. 30
2. Name of School: *Char Gazi*
3. Site Location : District: *Larmipur* Thana : *Rangati*
 Union : *Barakhari* Village: *Barakhari*
4. Interviewee : Name : *Mr. G.K.R. Chowdhury* Position: *Headmaster*

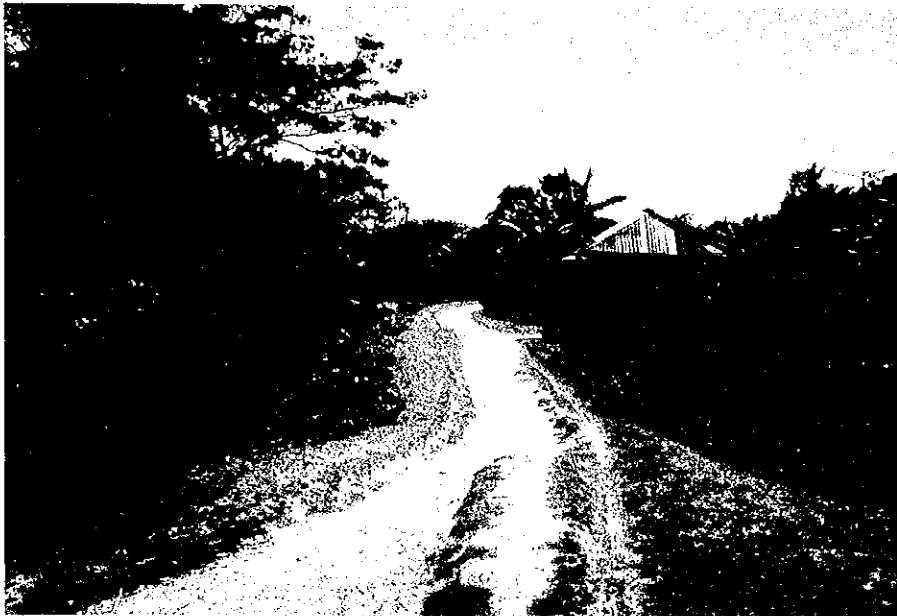
周辺の道路状況

5. Accessibility Ramgati Thana H.Q.
 - 1) ~~Nearest Station, Port, Main Road:~~ Distance: 8 km
 - 2) Road Conditions
 - Kind of Pavement: Earth, Gravel, Brick, Asphalt, Concrete, K Walk.

- Condition of Pavement: Good, Not so good, Bad
 - Road Width : 1.5 m
 - Passable Vehicle: Motor cycle, Rikisha, Sedan, Jeep, Truck (2.0 ton) k on foot (2.0 km)

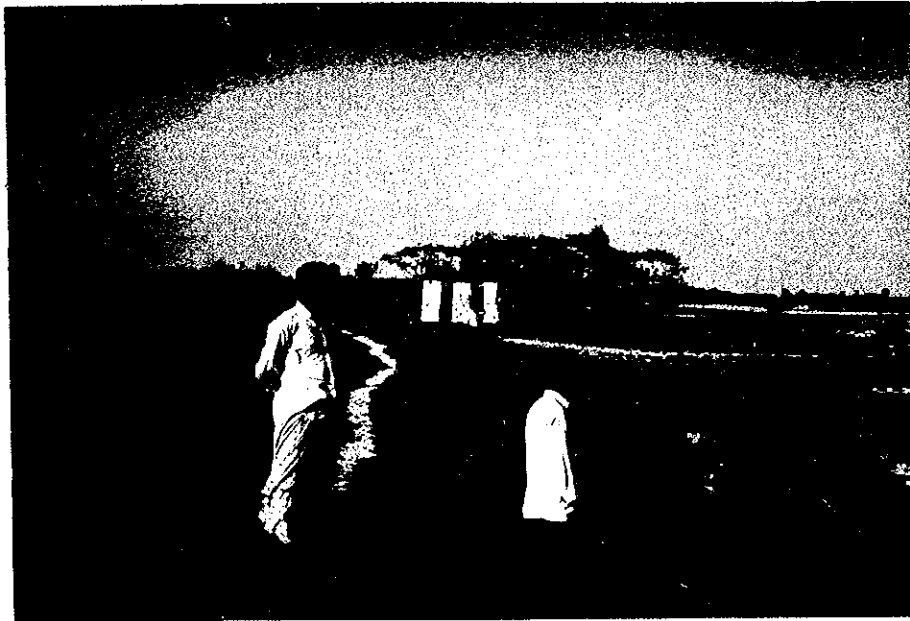
学校敷地全景

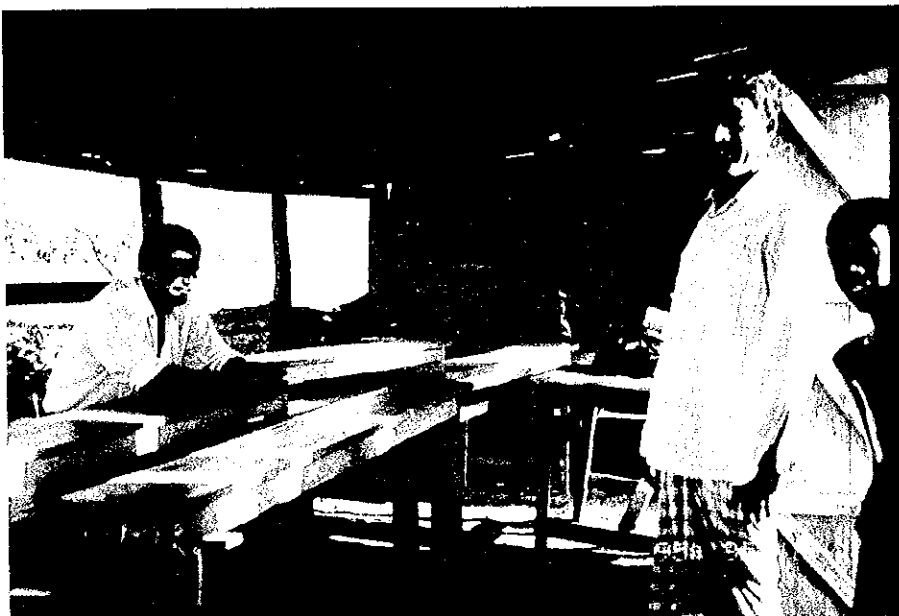
教室内の状況

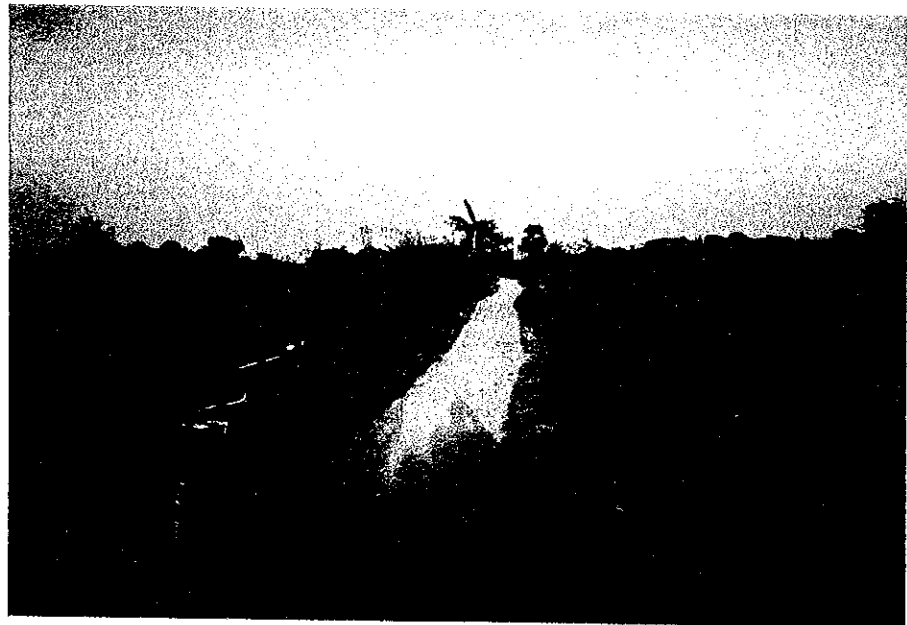
周辺の道路状況

- Condition of Pavement: Good, Not so good, Bad.
 - Road Width : 3.2 m
 - Passable Vehicle: Motor cycle, Rikisha, Sedan, Jeep, Truck (6 ton)
 - Necessity for Repair of Road: Yes, No.

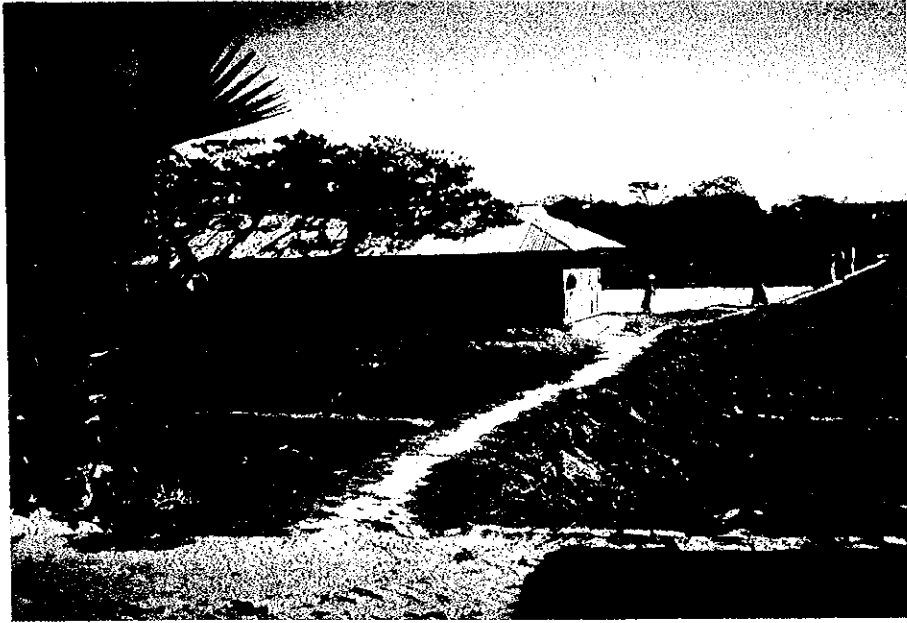
学校敷地全景

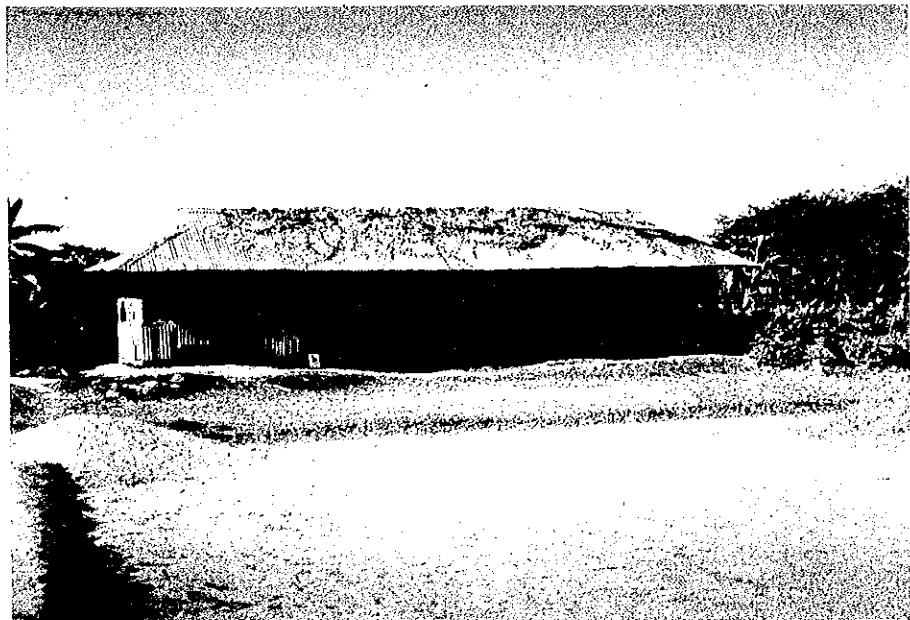
校舎全景

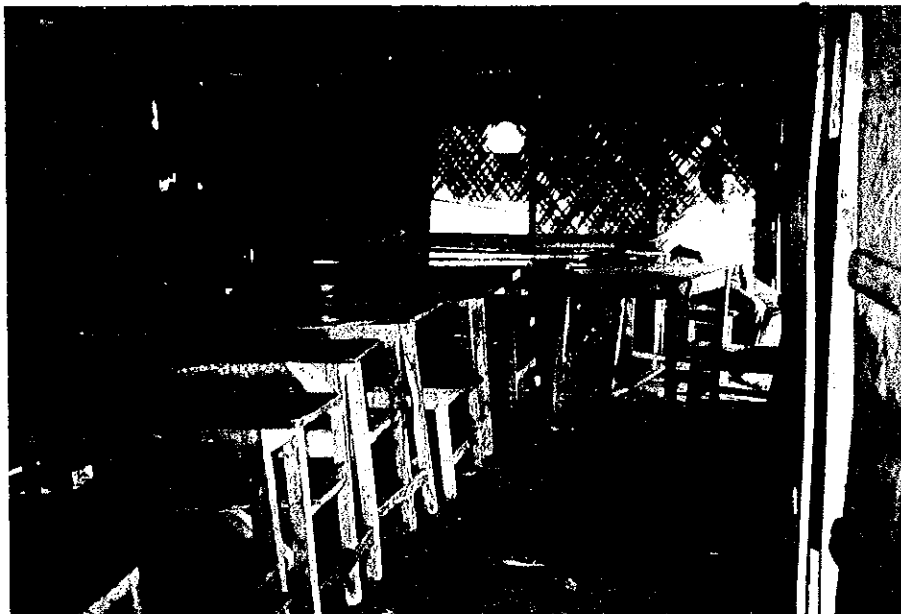
教室内の状況

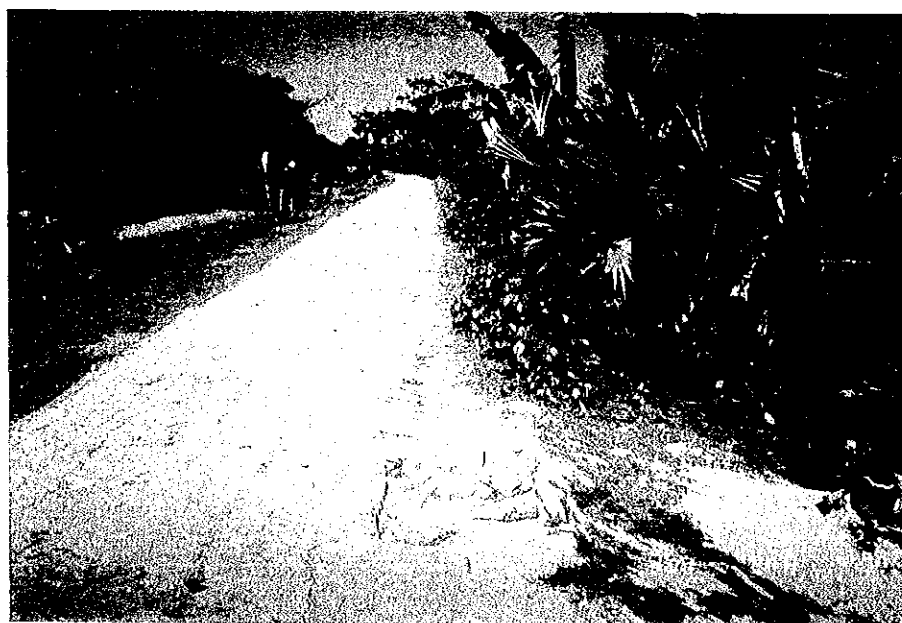
周辺の道路状況
