### 3.7 Bridge Detailed Investigation

## CHAPTER 4 BRIDGE ASSESSMENT PROCEDURE

**Table 4-1 Degree of Defects of Each Rating**

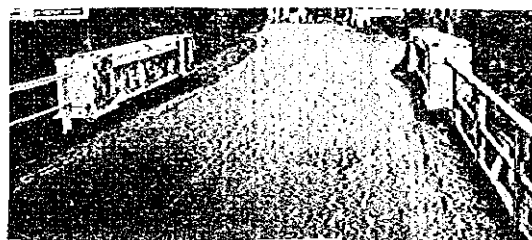
Rating 3

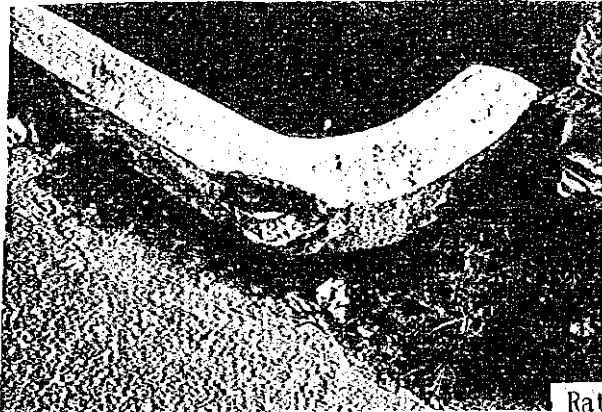
Rating 2

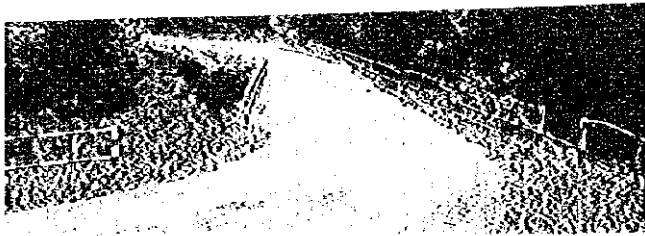
No railing

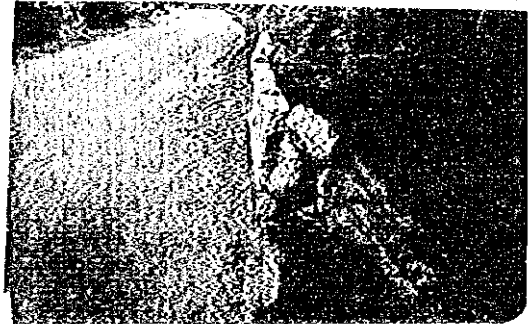
Rating 3

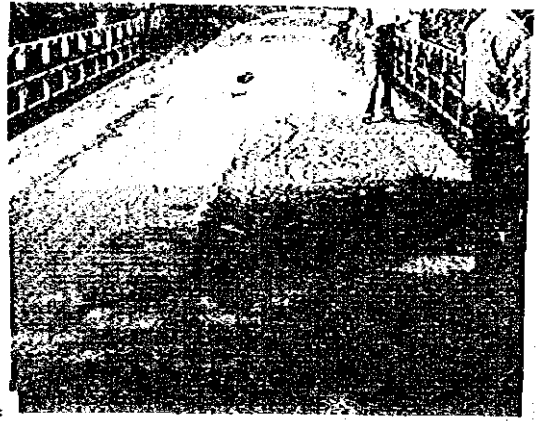
Rating 4

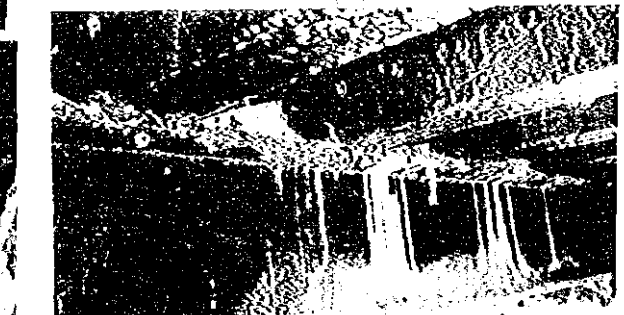
Crack on stone pavement

Major free lime Waterleakage

Rating 3

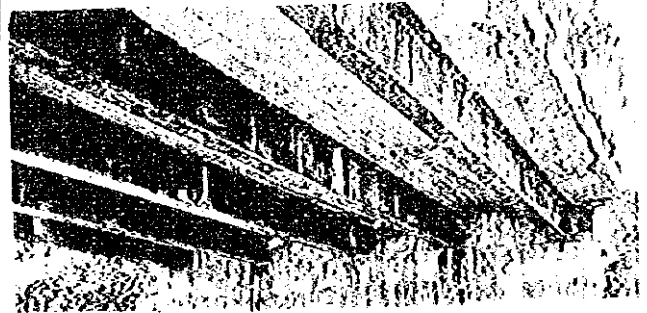
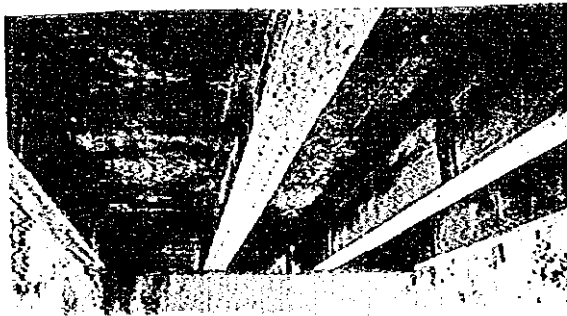
Rating 1

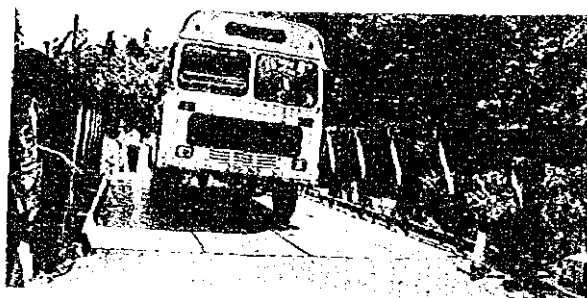
Steel plate deck

Rating 1

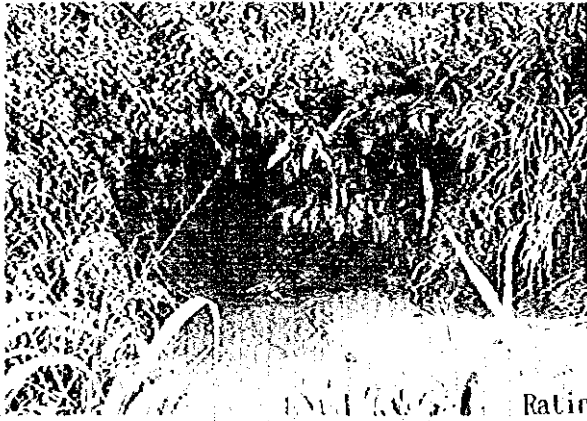
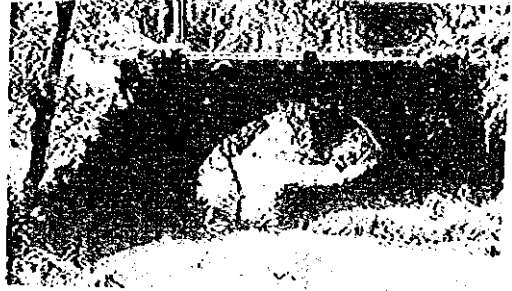
Arch Steel, Concrete

Rating 4

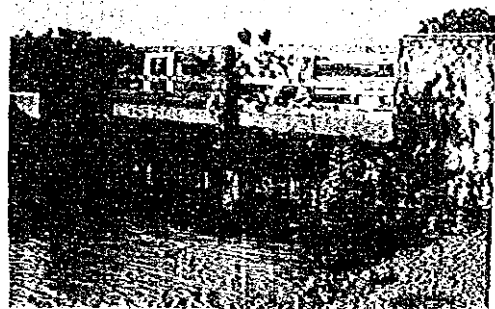
Rating 1

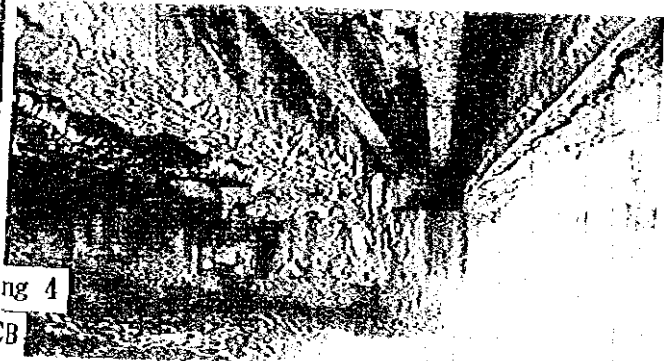
Rating 4

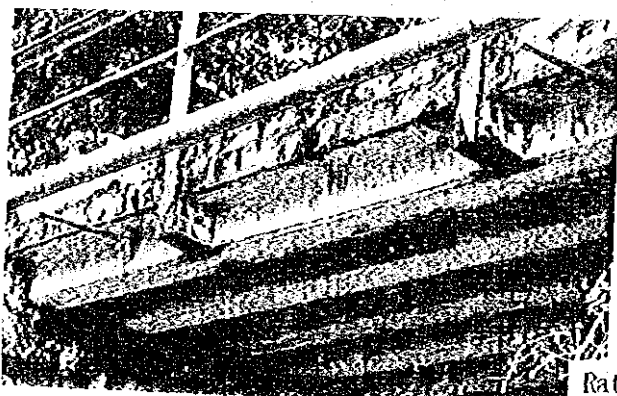
Rating 1
