Corrosion on main beams

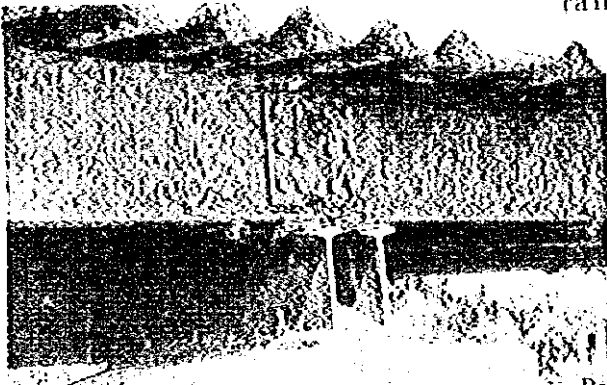
Painting

Rating 4

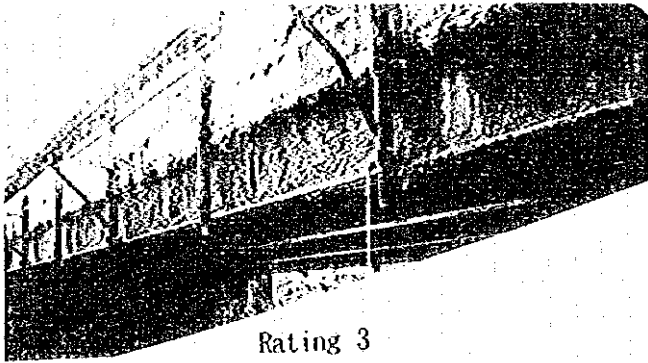
Rating 3

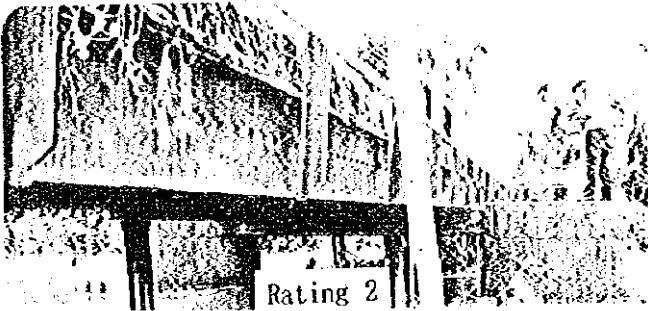
Rating 2

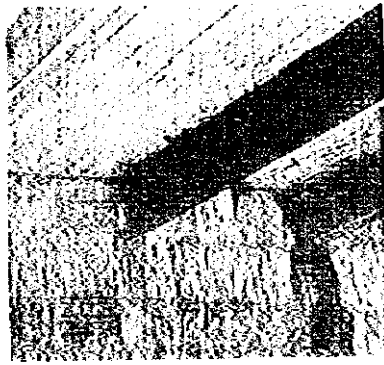
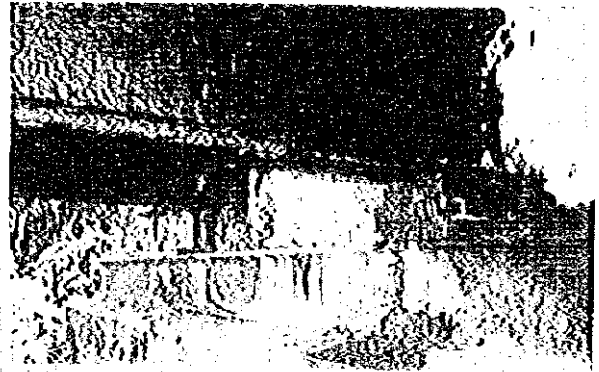
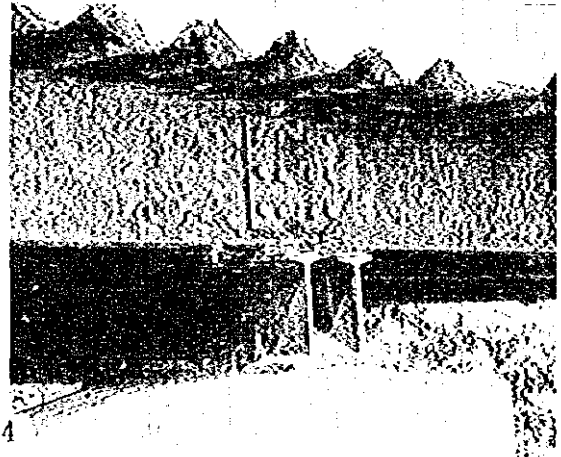
Bearing

Rating 4

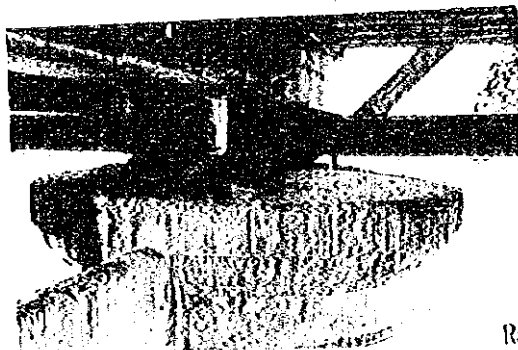
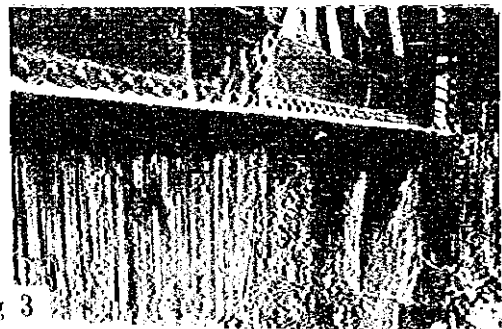
Rating 3

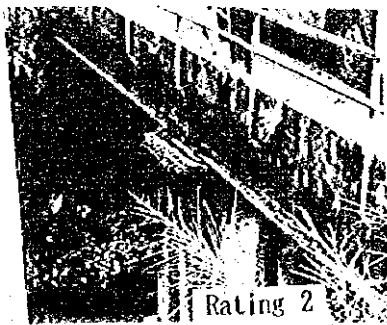
Rating 2

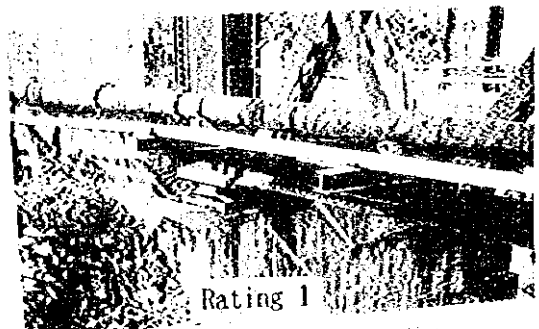
Rating 1

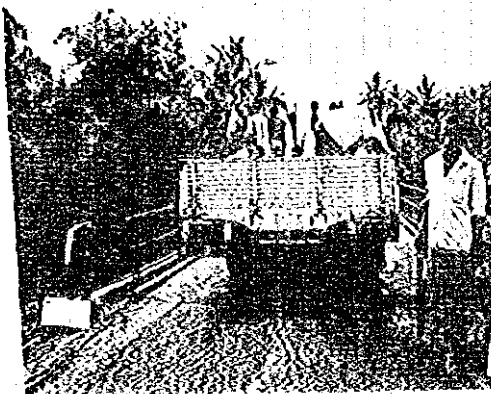
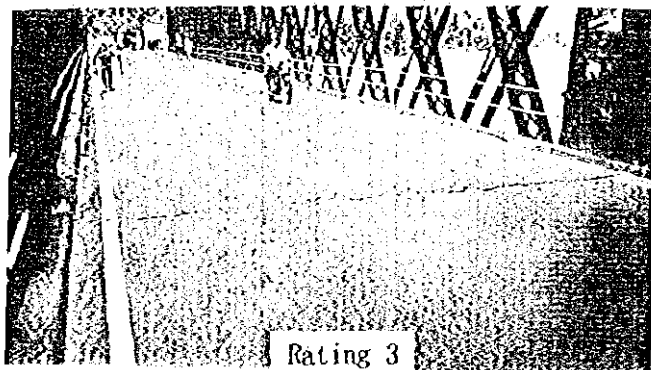
Rating 3

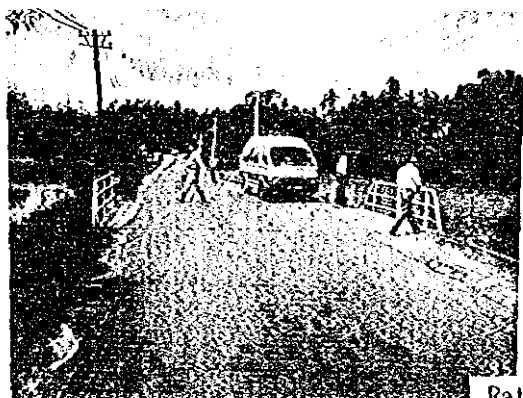
Rating 2

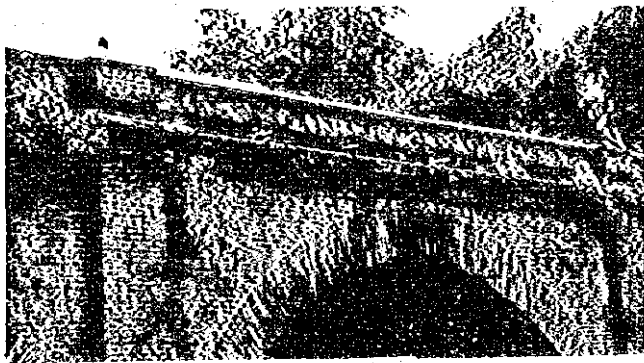
Too small

Rating 2

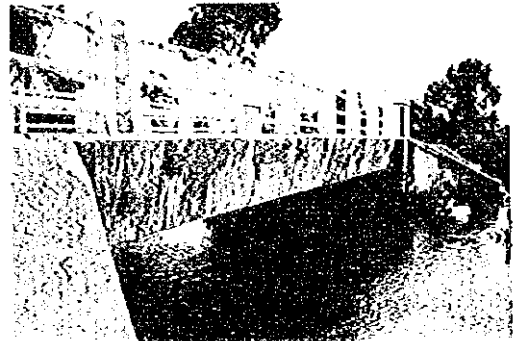
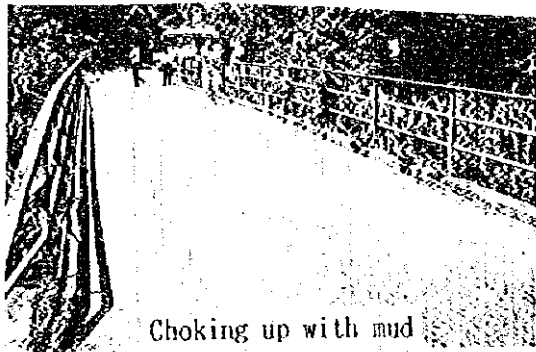
Choking up with mud

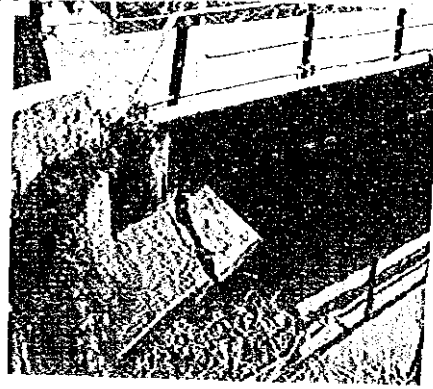
Substructure

Rating 4

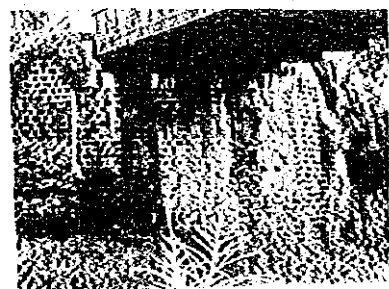
Rating 1

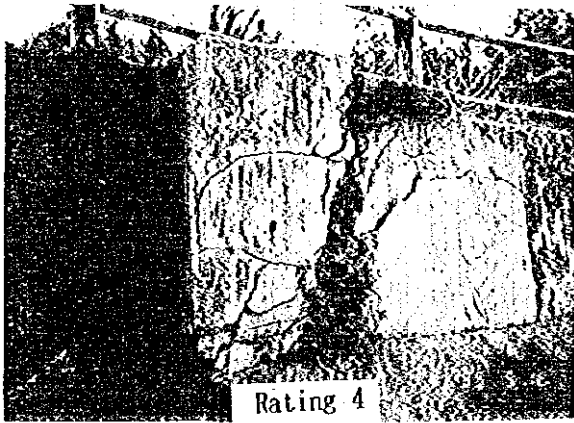
Rating 4

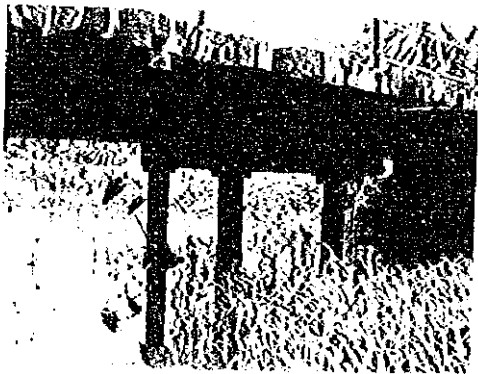
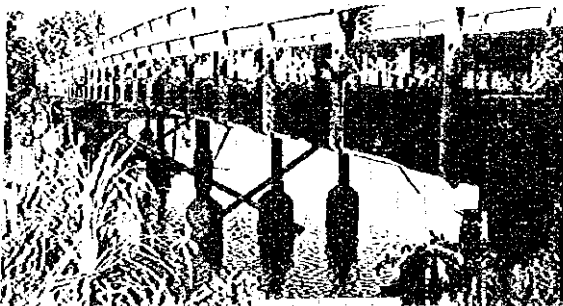
Huge opening

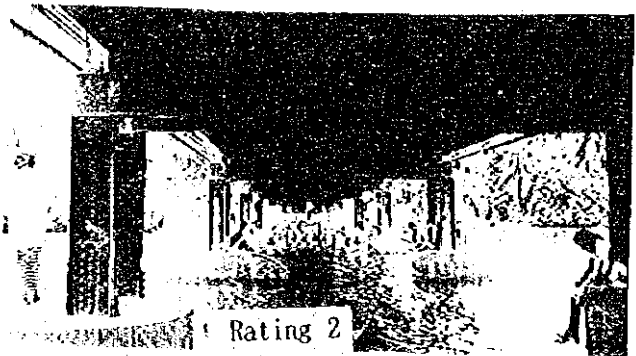
Rating 2

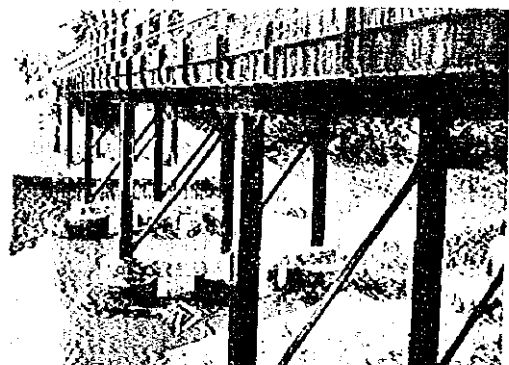
Rating 2

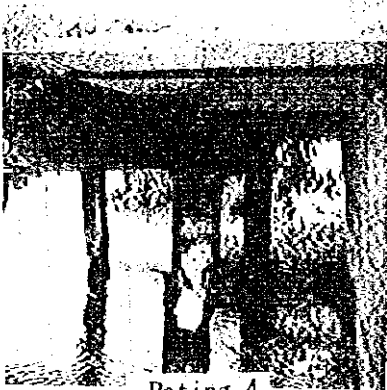
Rating 4

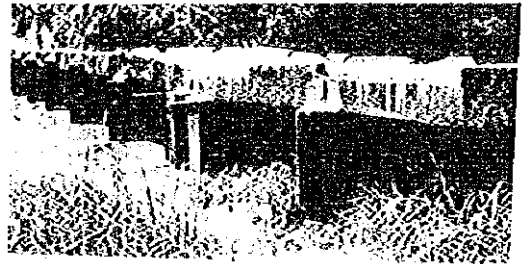
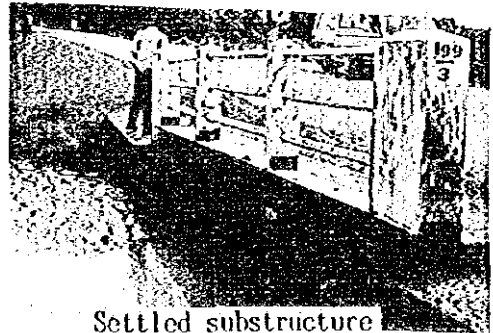
Rating 4

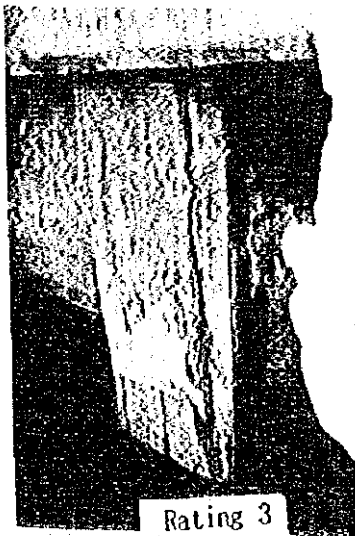
Settled substructure

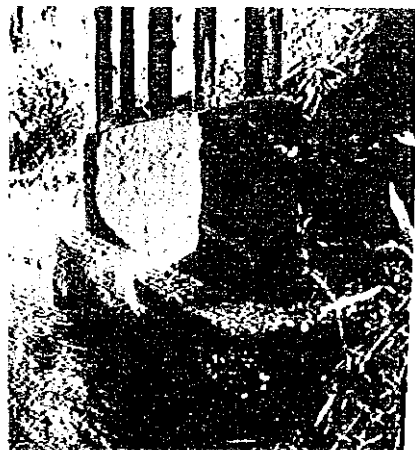
Scoring

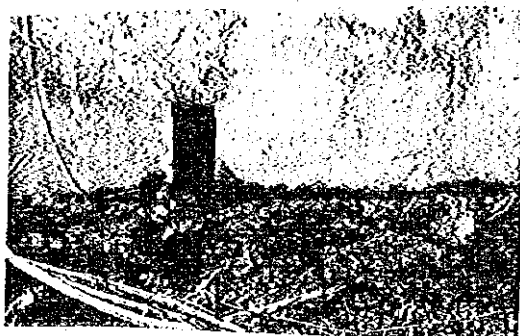
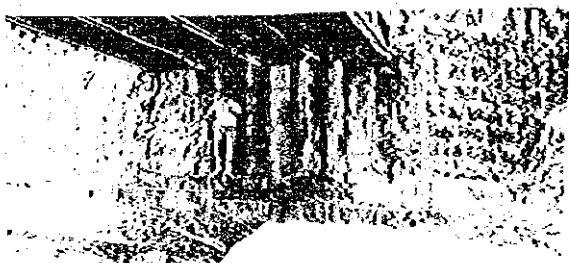
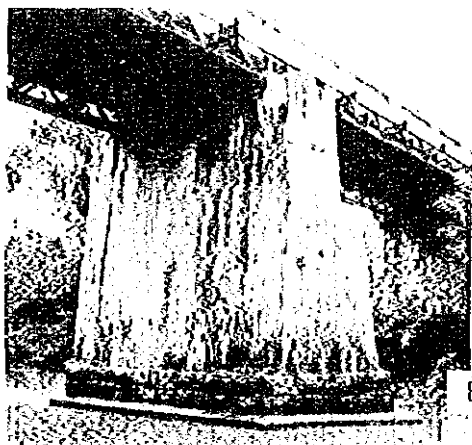
Rating 1

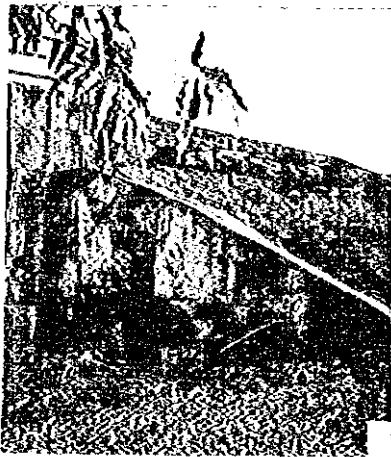
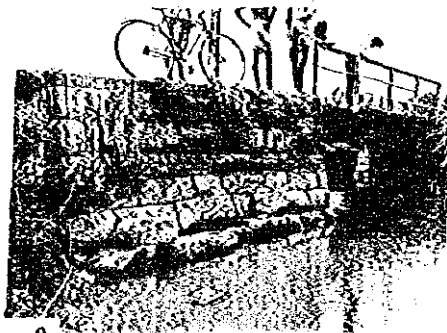
Rating 4
