INVENTORY OF PAVEMENT SURFACE CONDITION

PAN-PHILIPPINE HIGHWAY IMPROVEMENT PROJECT
(MINDANAO SECTION)

PAVEMENT DISTRESS SURVEY
PACKAGE II
Km. 1349+000 - Km. 1364+000

DECEMBER , 1996

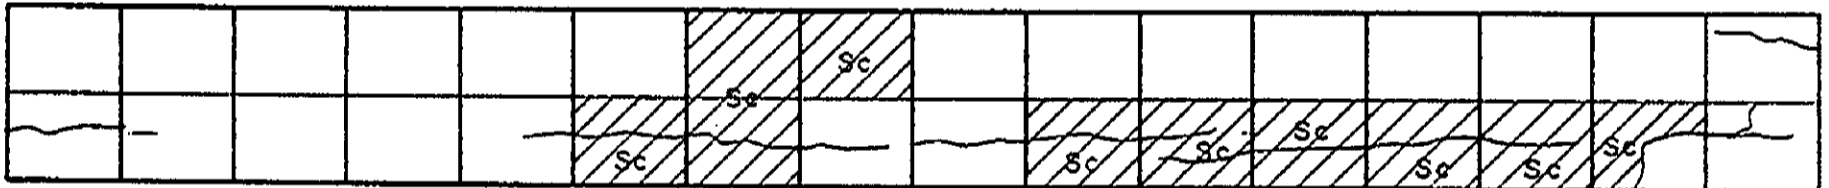
INVENTORY OF PAVEMENT SURFACE CONDITION

Fc			E							
					Sc			Sc		Sc	Sc	Sc	Sc	Sc	Sc

Sc	Sc	Sc	Sc	Sc	Sc	Sc	Sc	Sc	Sc	Sc	Sc	Sc	Sc		
													De	Sc

Fc	Fc	Sc	Sc	Sc	Sc	Sc	Sc	Sc	Sc	Sc	Sc	Sc	Sc	Sc	Sc
E								Fc	Pa	Sc	Sc	Sc	Sc	De	De

Sc	Sc	Sc	Sc	Sc				Sc	Sc	Sc	Sc	Sc	Sc	Sc	Sc
			De								E	Sc	Sc	Sc	Sc

Sc	Sc	Sc	Sc								Sc	Sc			Sc
		Oph

Sc	Sc			Sc	Sc	E	Sc	Sc	Sc	Sc		Sc	Sc	Sc	Sc
												Sc	Sc	Sc	Sc

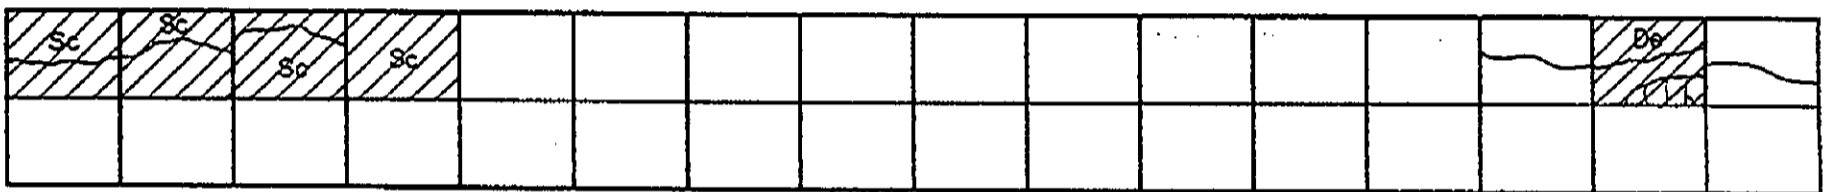
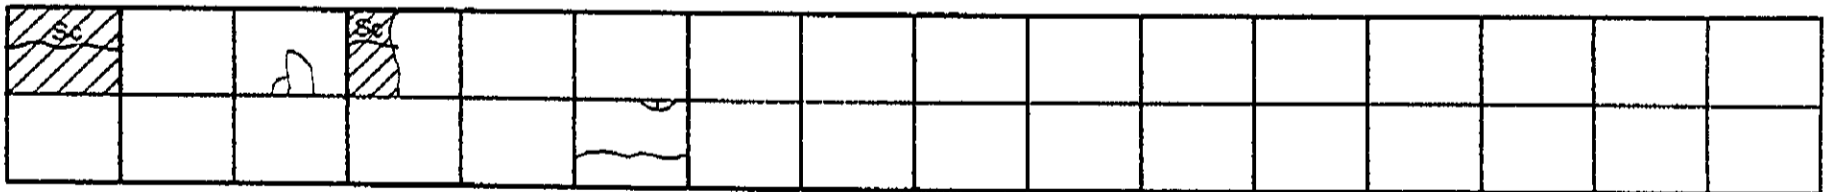
Sheet No: 1/2

4.00 1.40 3.10
 ☒ KP 1358+000
