PAN-PHILIPPINE HIGHWAY IMPROVEMENT PROJECT
(MINDANAO SECTION)

PAVEMENT DISTRESS SURVEY
PACKAGE 13
End of Lankilaan Br. - Km.1396+000

DECEMBER , 1996

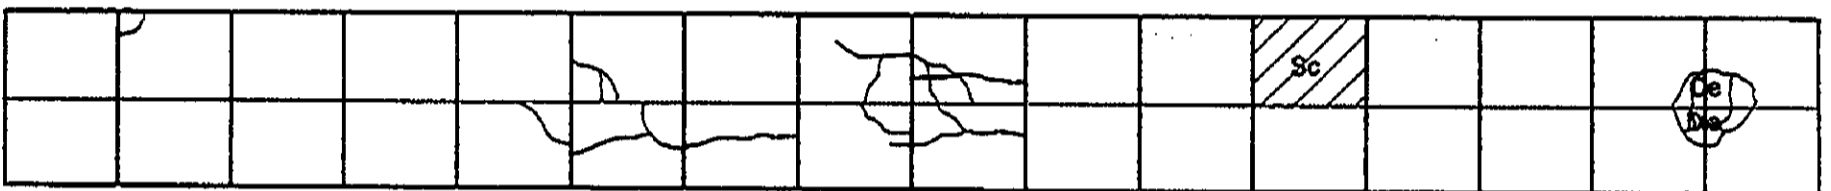
Km. 1378+000

Under construction slope & embankment side

Under const'n. slope & emb. side
