INVENTORY OF PAVEMENT SURFACE CONDITION

PAN-PHILIPPINE HIGHWAY IMPROVEMENT PROJECT
(MINDANAO SECTION)

PAVEMENT DISTRESS SURVEY
PACKAGE 16
Km.1425+000 - Km.1456+000

DECEMBER, 1996

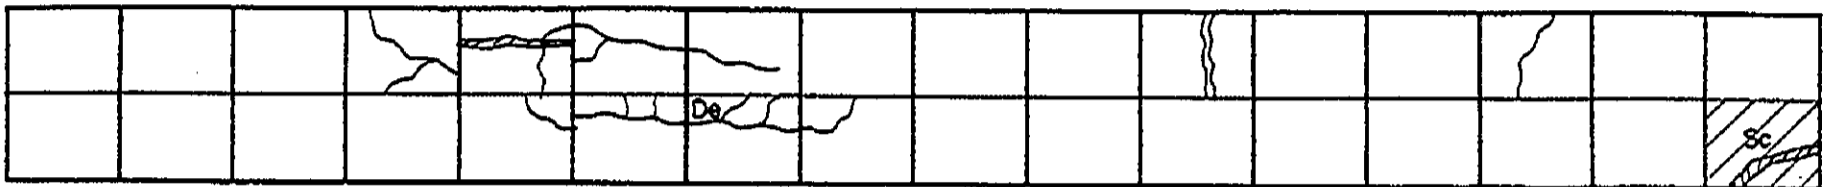
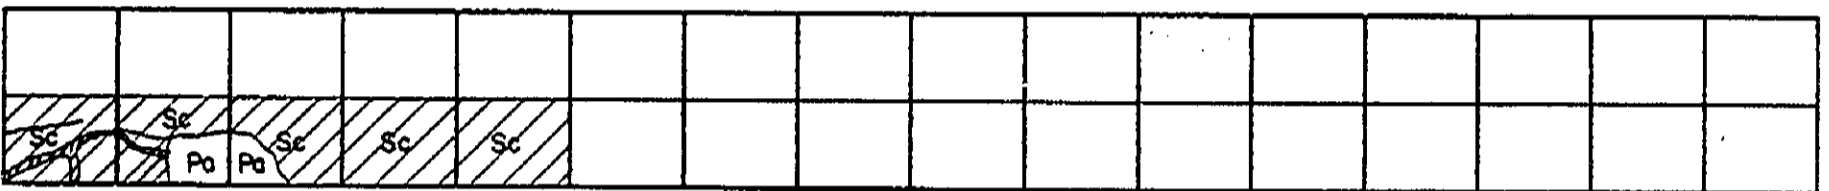
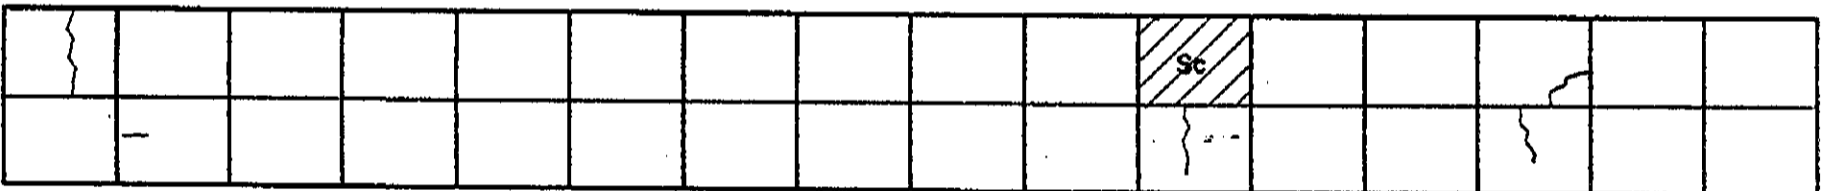
Km. 1405+000

Impounded water

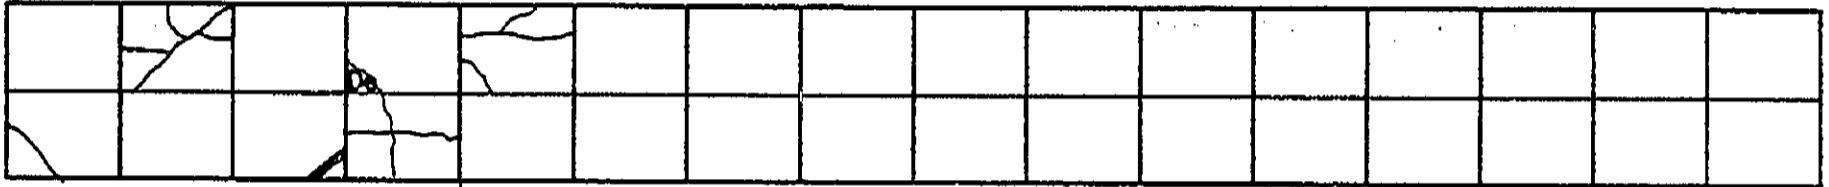
Fc through center line Joint

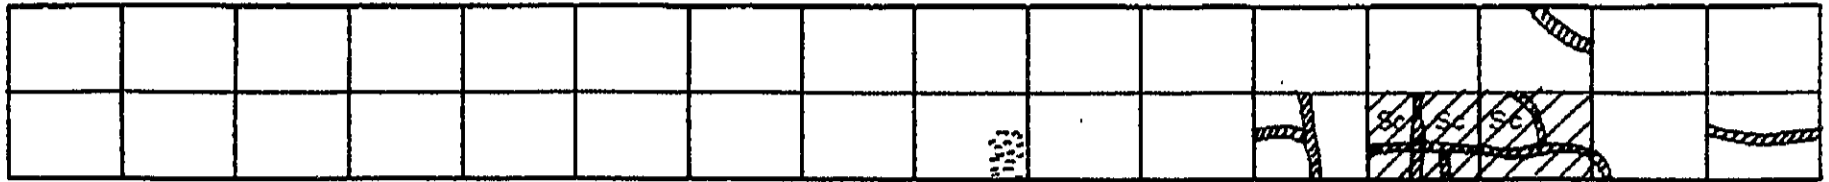
Km. 1422 + 000

Fc
