INVENTORY OF PAVEMENT SURFACE CONDITION

Km. 1472+000

To Carmen
Proper

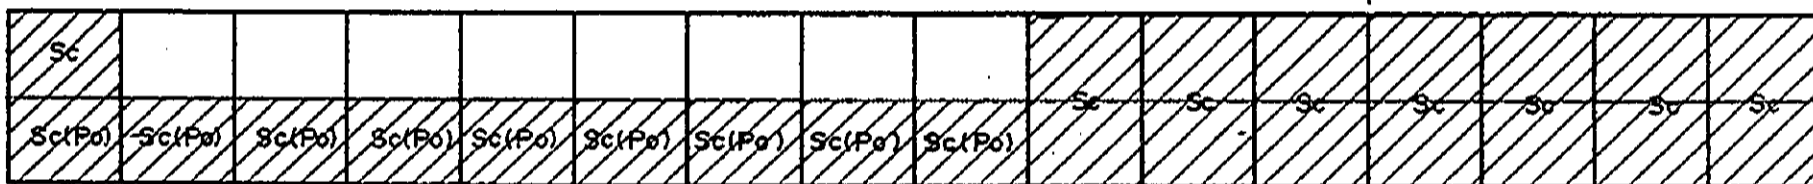
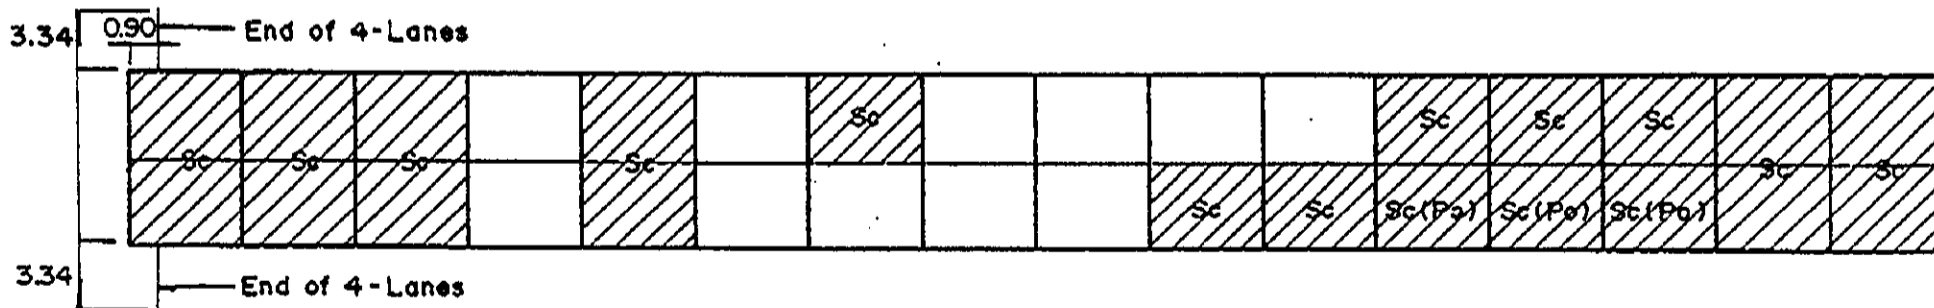
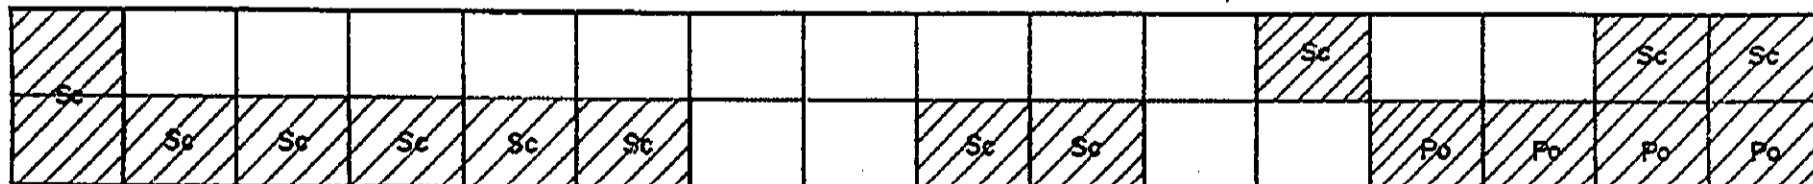
Undulating Pavt.
