INVENTORY OF PAVEMENT SURFACE CONDITION

Date : 11-15-95

Km. 1132+000

Sheet No : 1/2

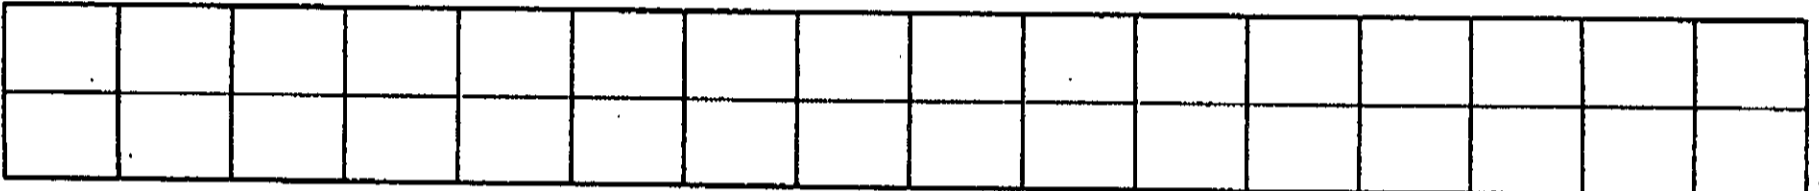
End of stockpile area

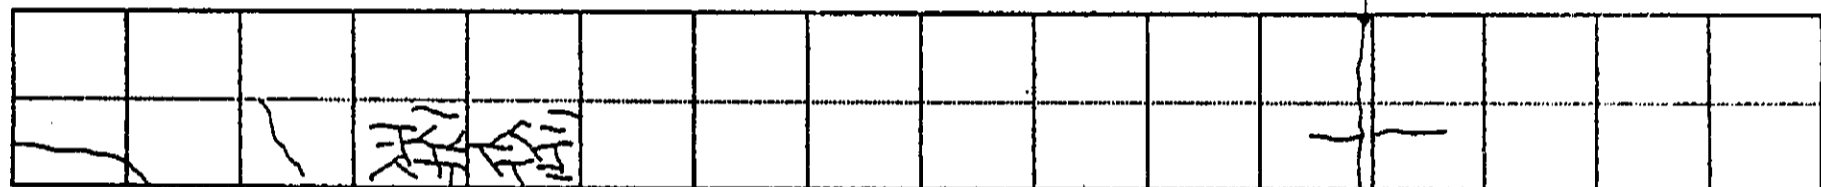
Open crack
