BASIC DESIGN STUDY REPORT
ON
THE PROJECT FOR PROTECTION WORKS
FOR MEGHNA BRIDGE
IN
THE PEOPLE'S REPUBLIC OF BANGLADESH

FEBRUARY 1998

JAPAN INTERNATIONAL COOPERATION AGENCY
PACIFIC CONSULTANTS INTERNATIONAL
NIPPON KOEI CO., LTD.

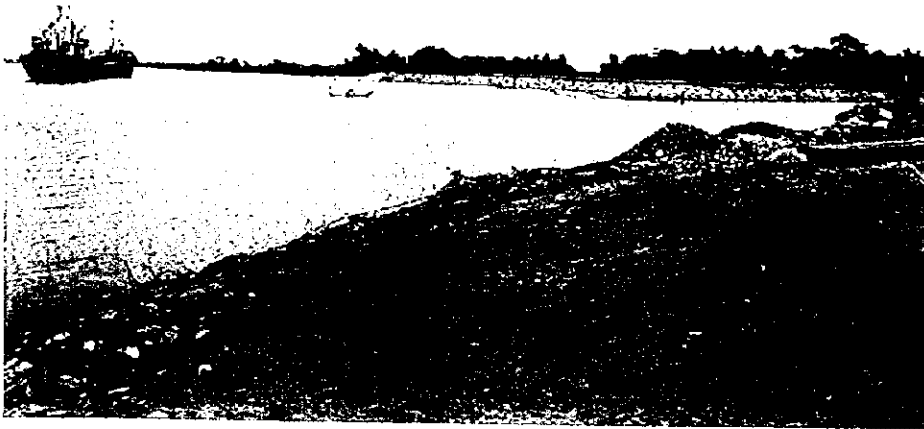
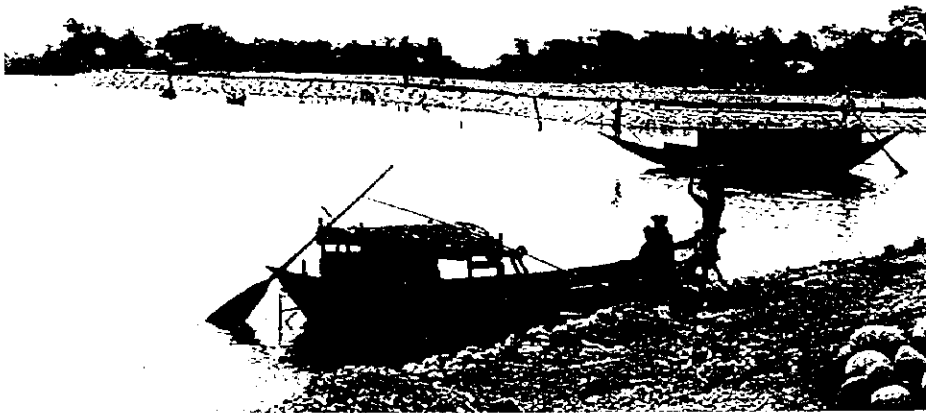
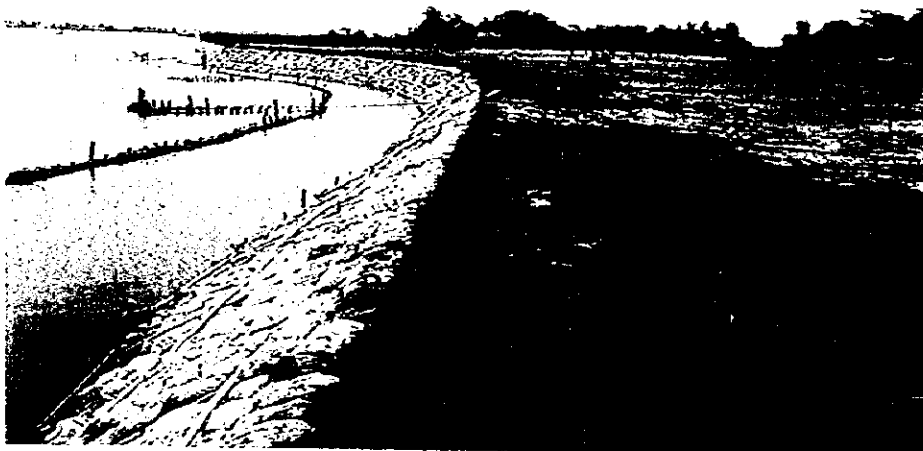
Left Bank, Upstream
(0.5 km)
Private Land
Reclamation

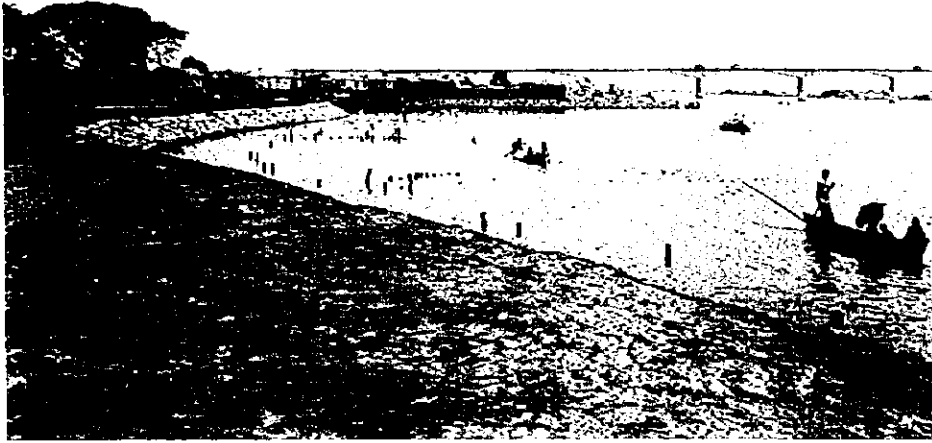
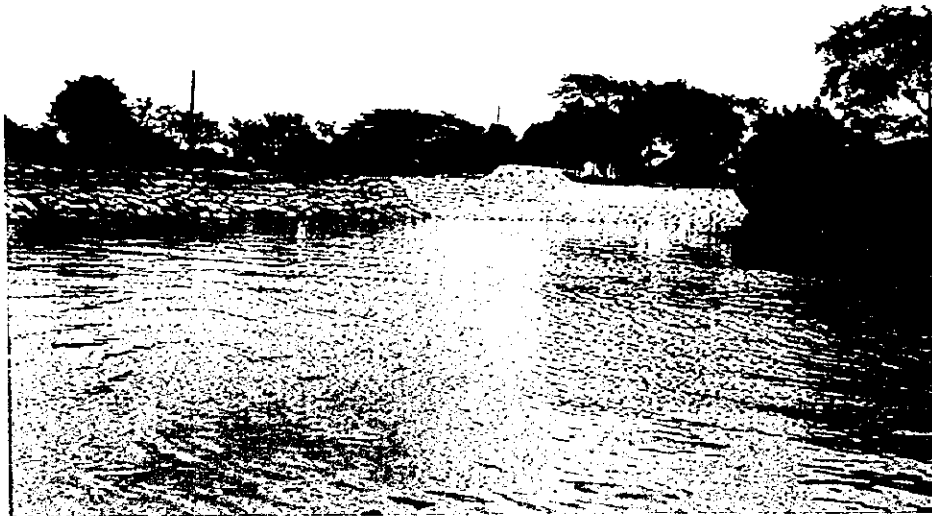
Left Bank, Upstream
(0.5 km)
Private Land
Reclamation
