Appendix-B

Photographs of Site Conditions (5 Bridges)

Appendix-C

Bridges Survey Results (22 Bridges)

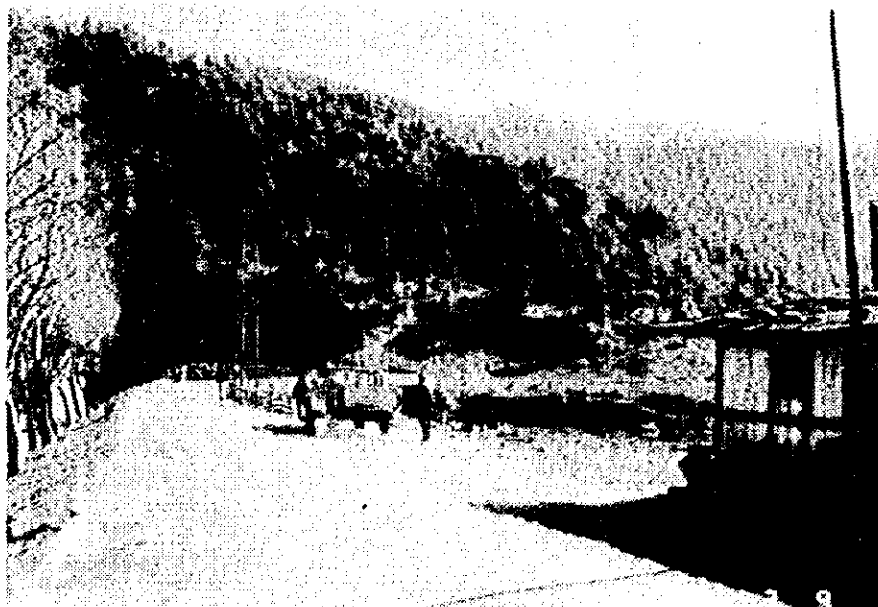
Approach road
on right bank
(Jakar side)

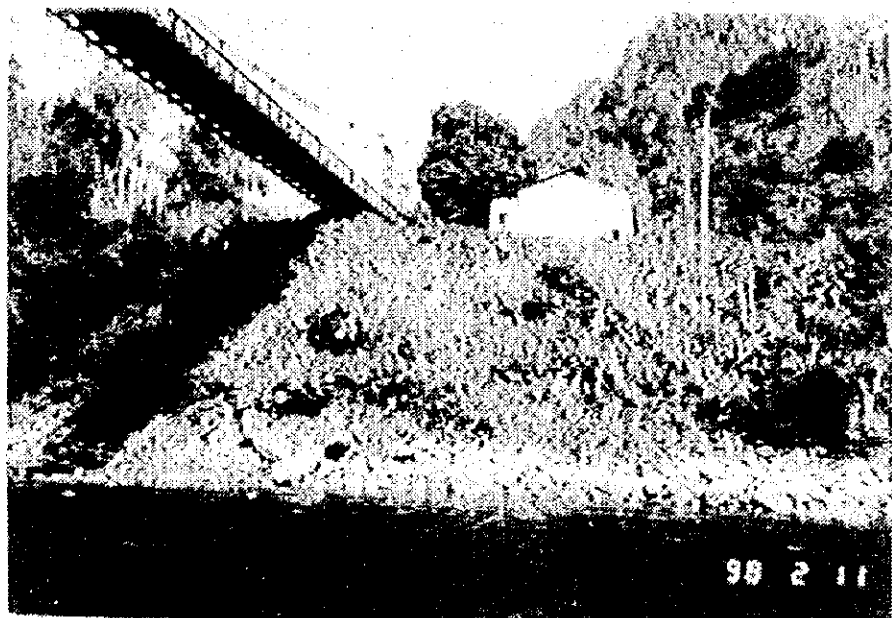
Left bank

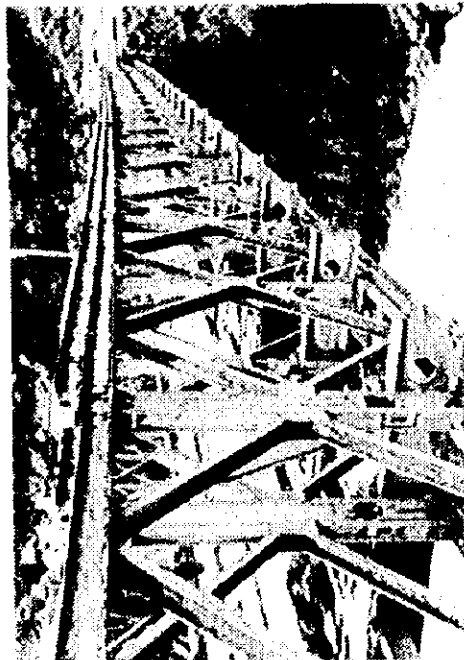
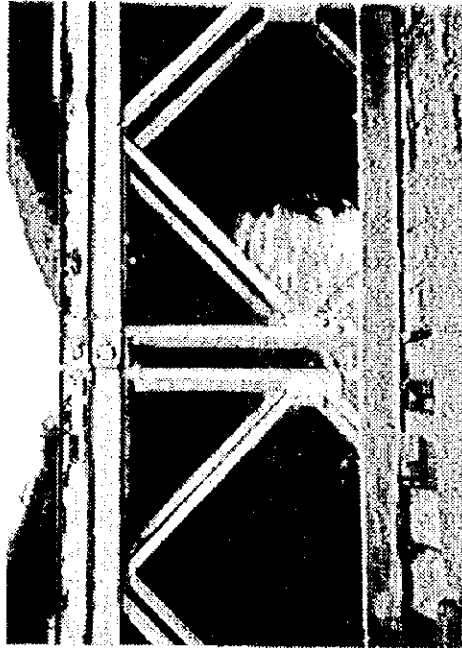
Rust

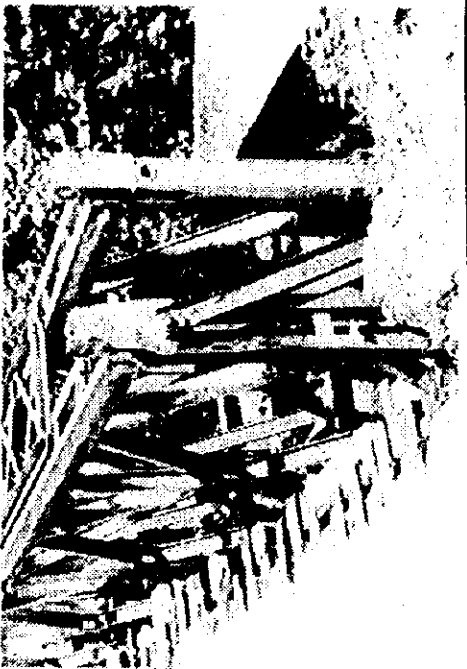
End post was
crushed.
