Bridge Inventory

SER No. 6 155.6 Km

NAME OF BRIDGE Wondisarj		CLASS OF ROAD N.H. 4		CROSSING: NAME OF RIVER OR ROAD Wandari, Panchkoti		COMPLETED 1989		MAINTENANCE BY Wondisarj	
Design Information		No		Date of Preparation 15/9/99		Prepared by Wondisarj		Load Intention No	
Type of Bridge		Superstructure RC. / DS		Design Loading DKL Timber		BS		No. of Joints 151	
Substructure		Abutment MASON		Pier		Skew		deg. Abt.	
Length of Bridge		30.5		m Span		30.3		m	
Width of Bridge		9.96		m Carriageway		2.35		m	
Allied Ancies		Overall		Pedestrianway		m		Design Quantity	
Traffic Volume		(Year)		Ratio of Heavy Vehicle		%		m	
Final Record of Repair		Pavement		Deck Slab		Painting		m	
Others		Main Beam		Others		Repair etc.		m

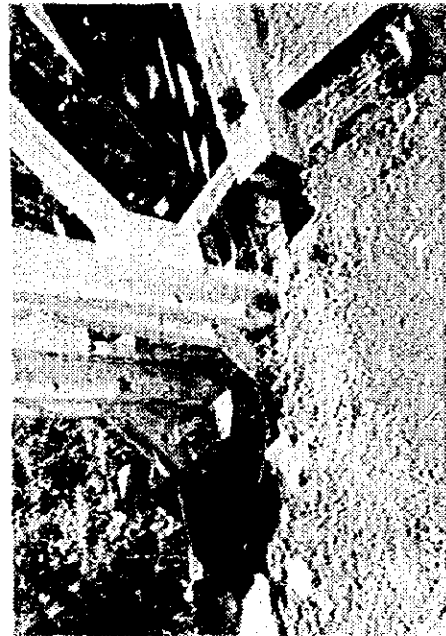
*Post maintenance
on bearings.*

Rusty pins

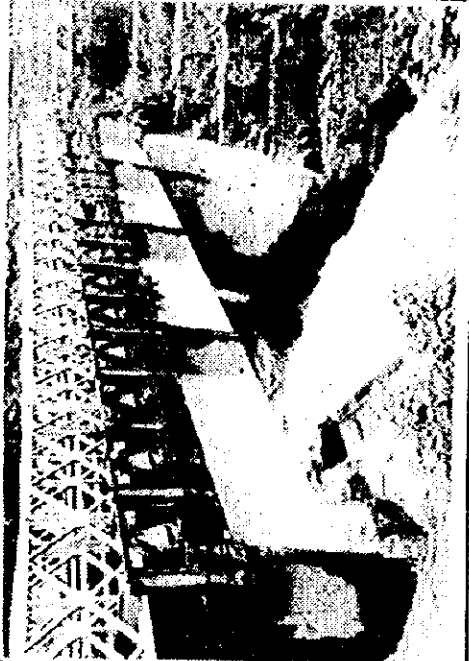
Photo Album No. (57)

No space behind bearing.

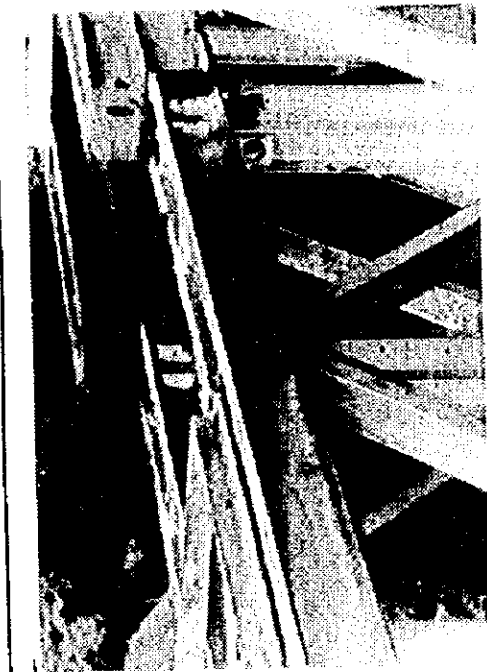
Steel is very rusty.

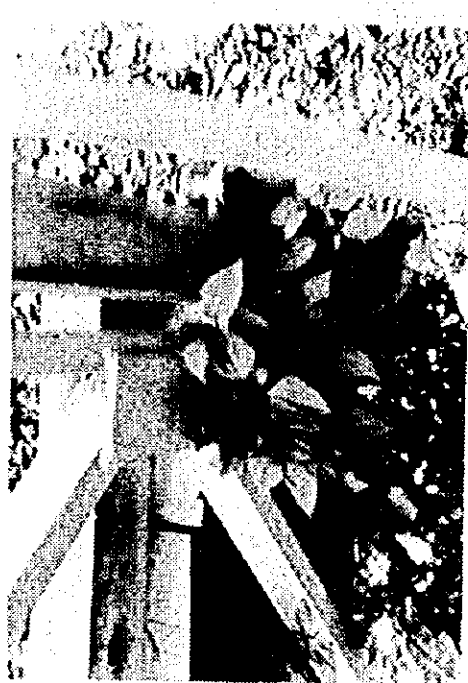
Elevation

1. There is no sag.
2. Lateral displacement is 3cm, from the time of completion.

Lateral displacement of 3cm
