Inspection Memo 3 Inspection of Hopin Small Hydropower Station in Hopin, Kachin

26.11.2002

Inspection Memo 4 Inspection of Zi Chaung Power Station during De-Watering

23 to 29 May 2003

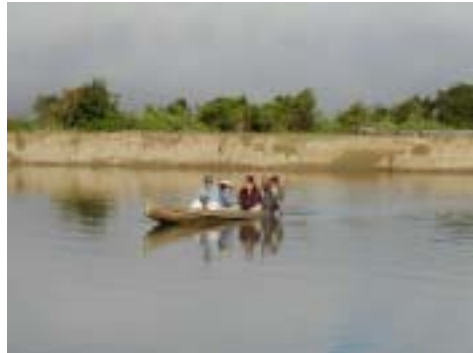
River crossing toward Hopin Station

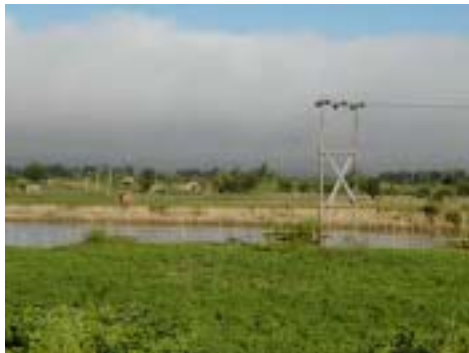
11 kV Distribution Line crossing the river

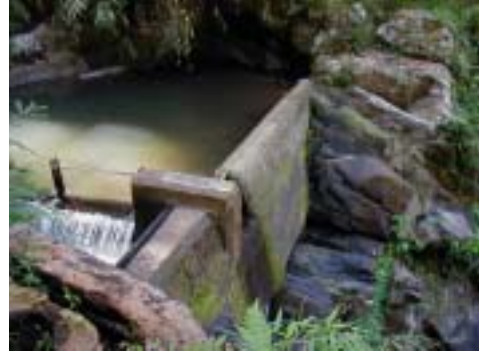
Looking intake weir from downstream

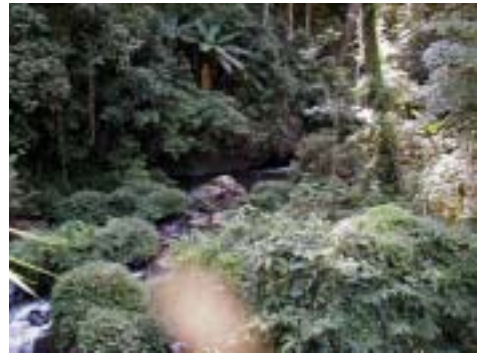
Water flowing into headtank

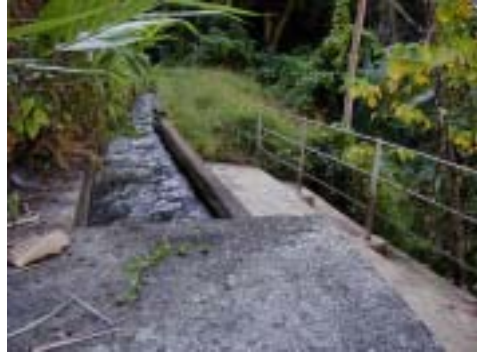
Side-overflow of headrace channel

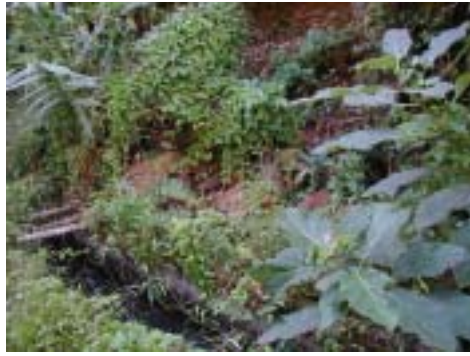
Trace of small slide upside the channel

- It was observed at the open canal that slope sliding above the waterway entered the canal once and dammed off the flow, of which overflow induced the slope failure below the canal.
- It appears that the Head Tank was designed to supply the maximum design discharge for just 1.0 hour only ($0.85 \text{ m}^3/\text{s} \times 3,600 = 3,060 \text{ m}^3$)
- The water leakage was observed at 2 locations of expansion joints of Penstock.

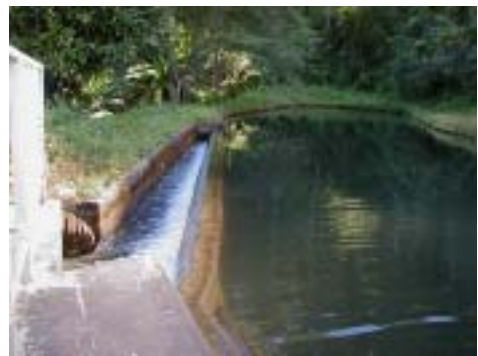
Excess water spillway

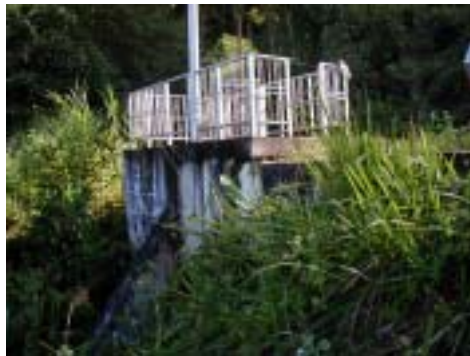
Inlet gate

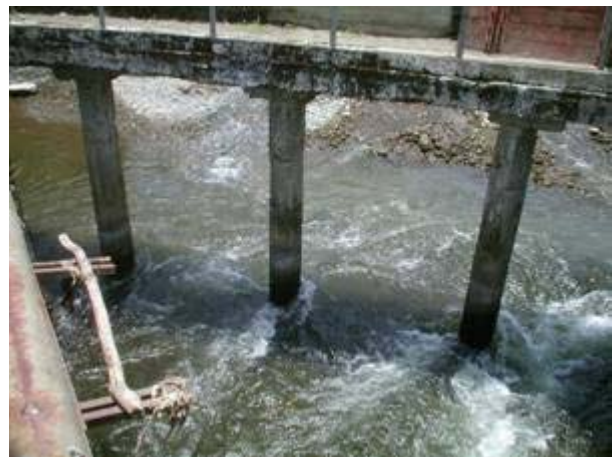
Piers in front of intake trashracks

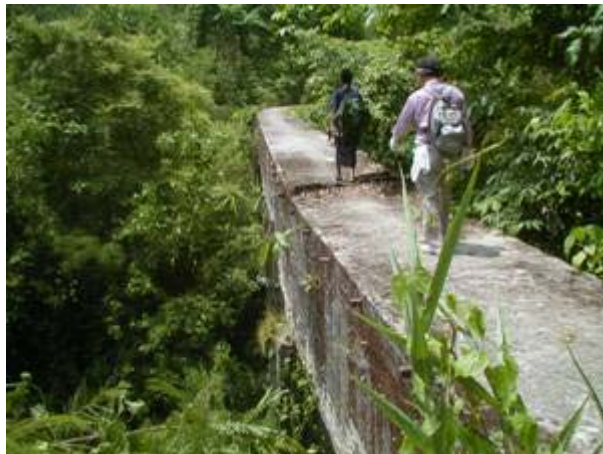
Channel bridge over a tributary

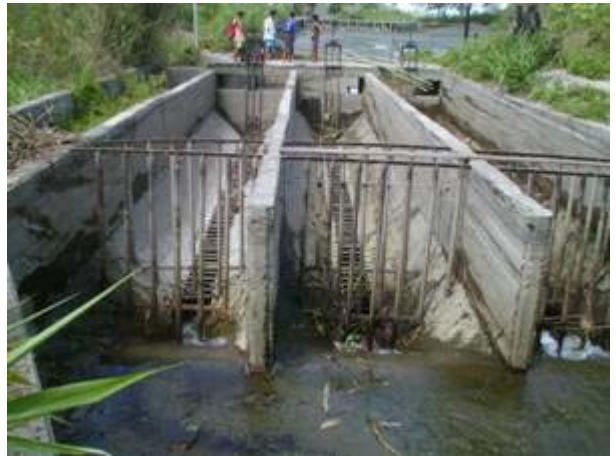
De-sanding basin

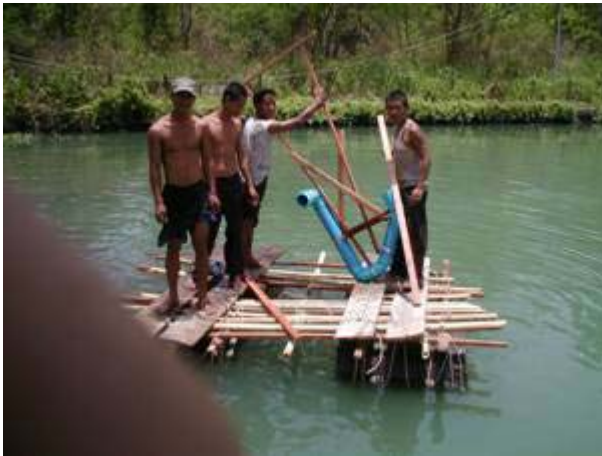
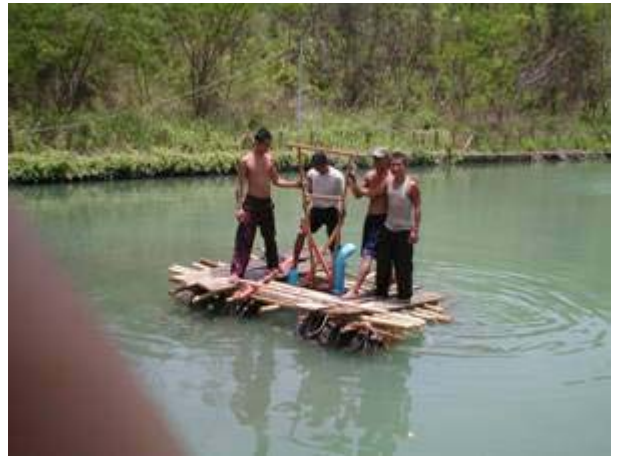
Test operation of Saxophone Type 1 (with smaller slits) from on a raft

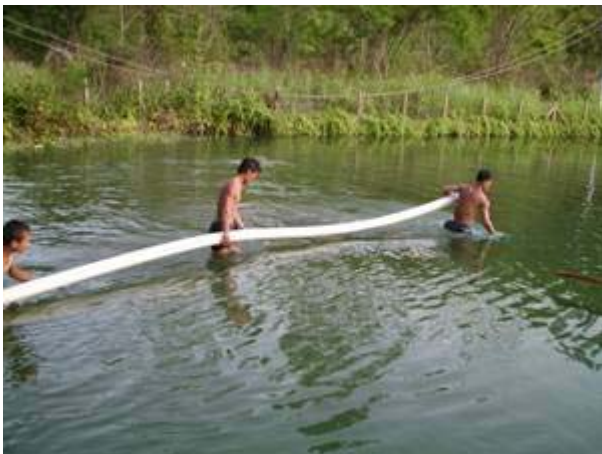
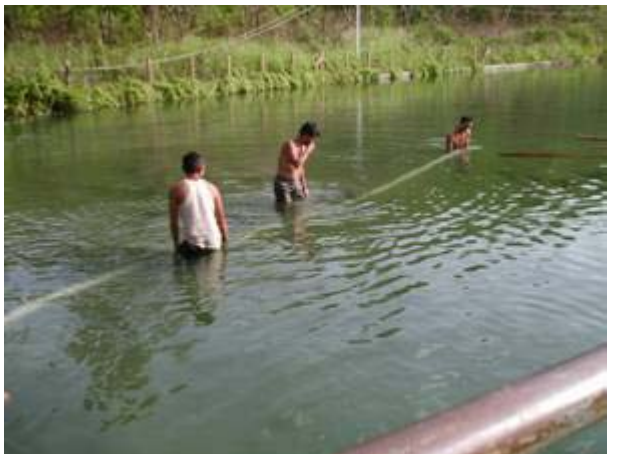
Pipe connection to Flushing head and removing air from pipe

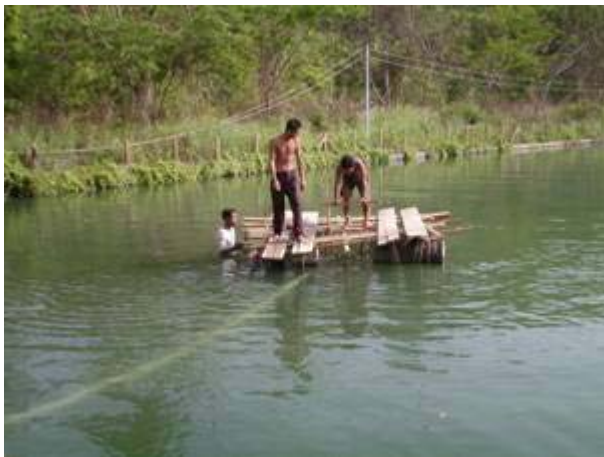
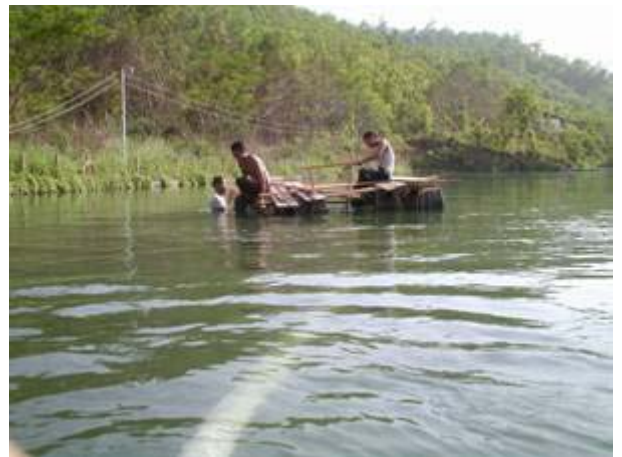
under flushing operation with Flushing head being moved

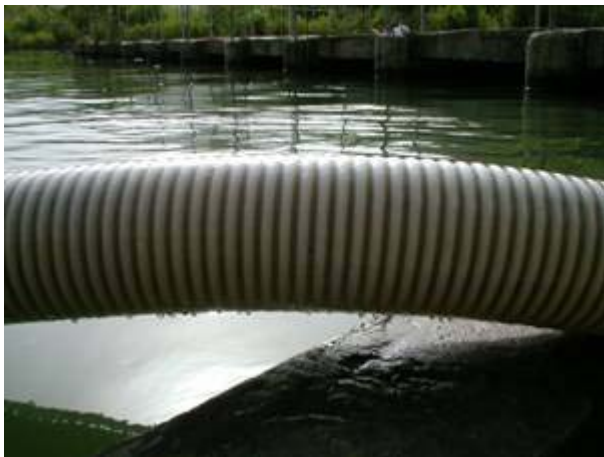
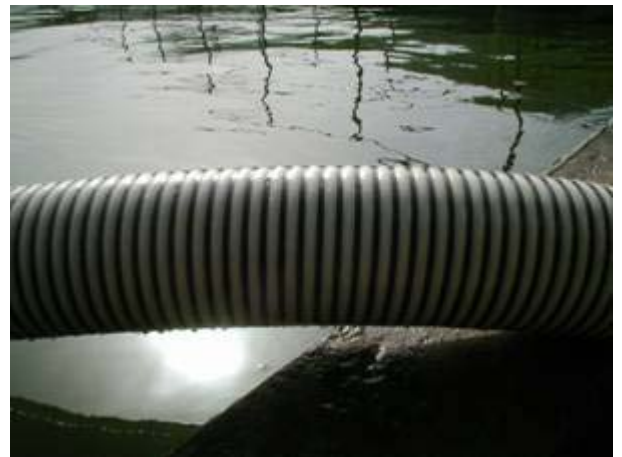
White color of the pipe shows less sacking of sand (left) while black full sacking (right)

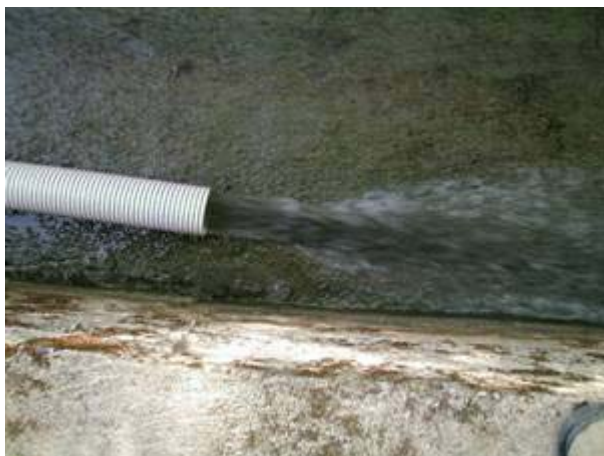
Flushing at a head of 4 m

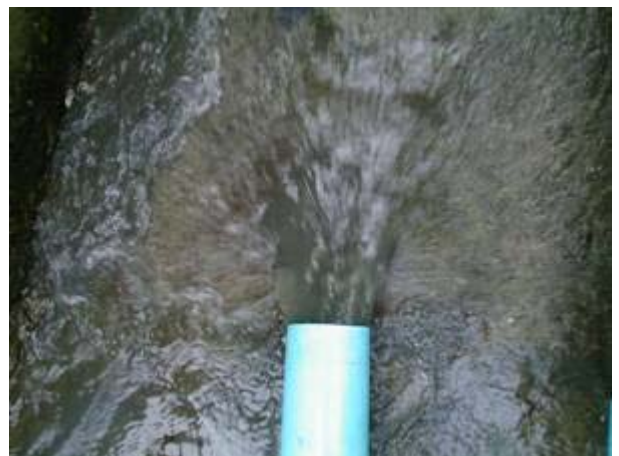
Flushing at a head of 1.8 m

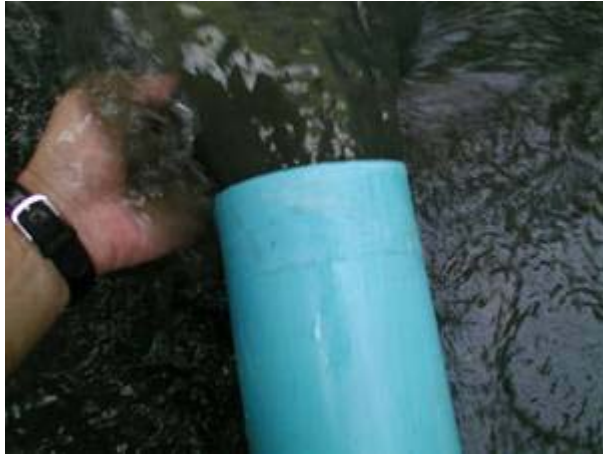
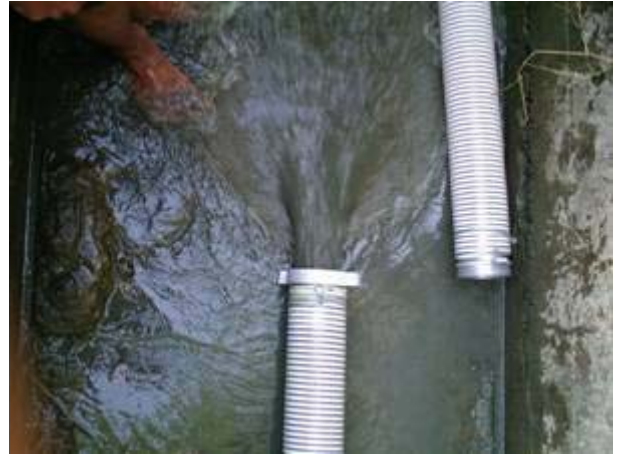
Flushing at a head of 0.8 m
