**THE STUDY ON IMPROVEMENT OF  
WATER SUPPLY SYSTEM  
IN MANAGUA IN THE REPUBLIC OF  
NICARAGUA**

**FINAL REPORT**

**Supporting Report No.4  
Leakage Survey**

**DECEMBER 2005**

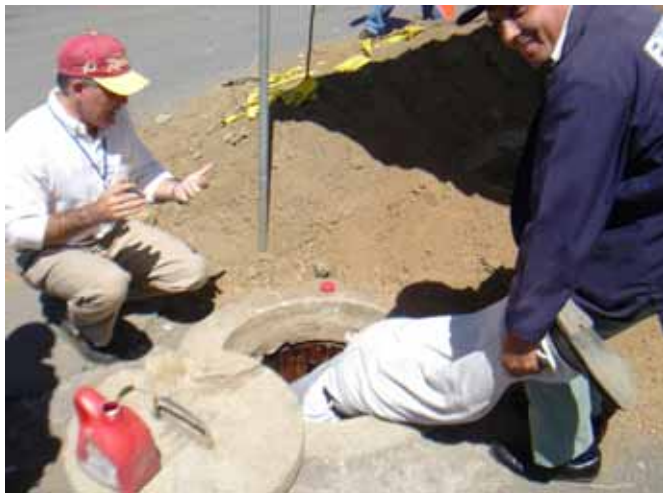
Meter Reading

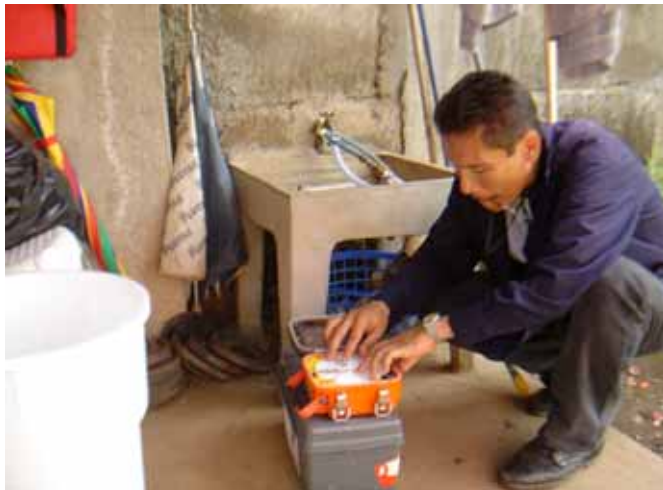
Pressure Measurement

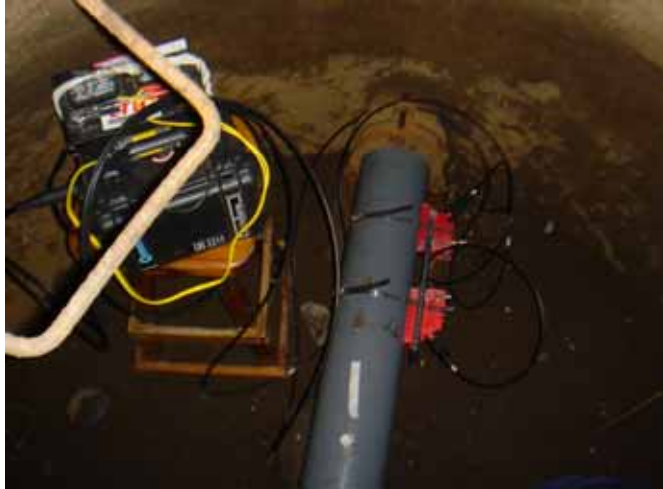
Micro Sector : El Eden

Flow Measurement

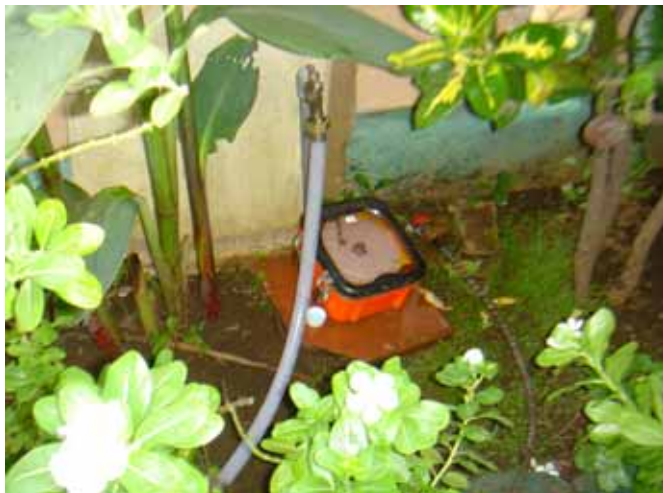
Pressure Measurement

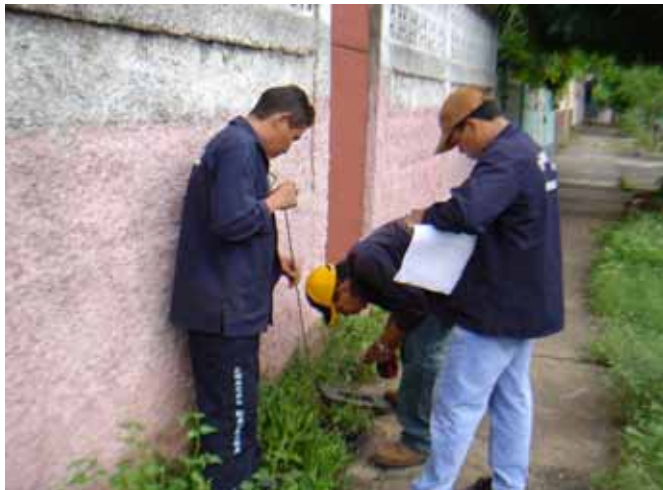
Meter Reading

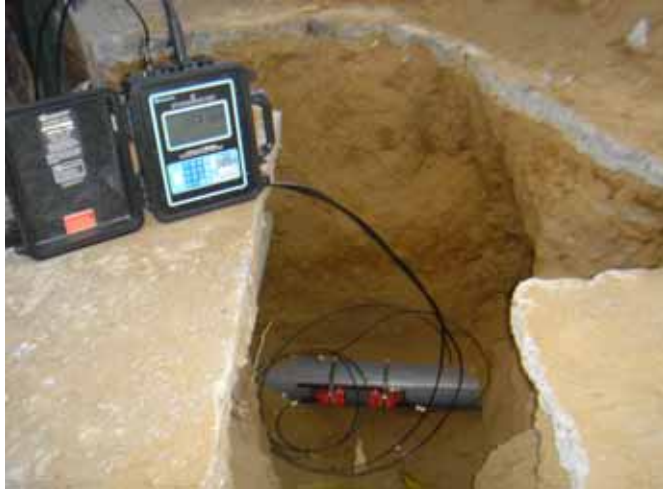
Micro Sector : Reparto Tiscapa

Flow Measurement

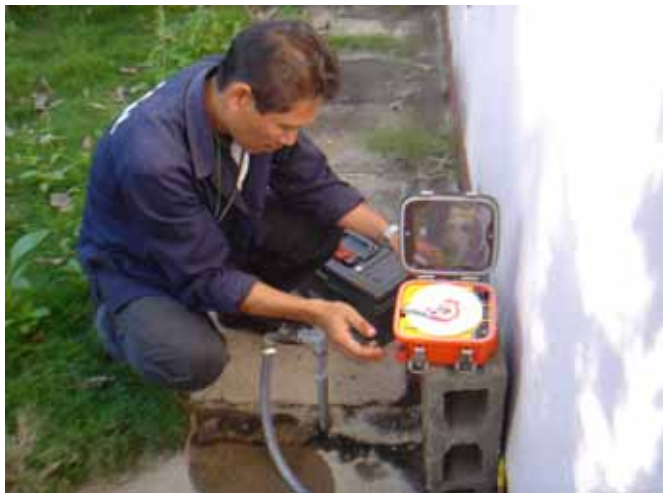
Pressure Measurement

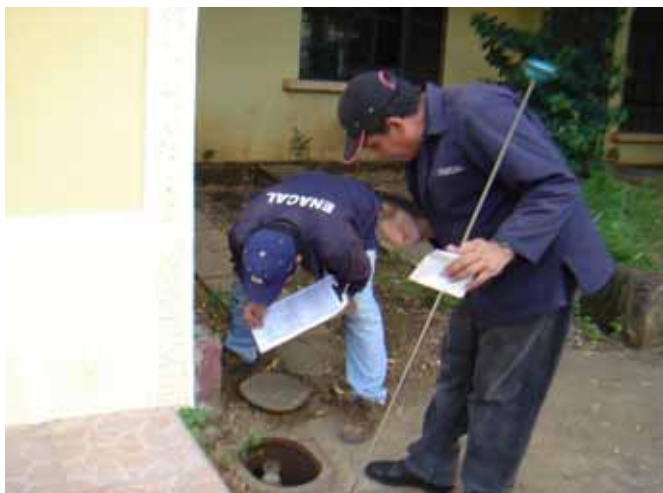
Meter Reading

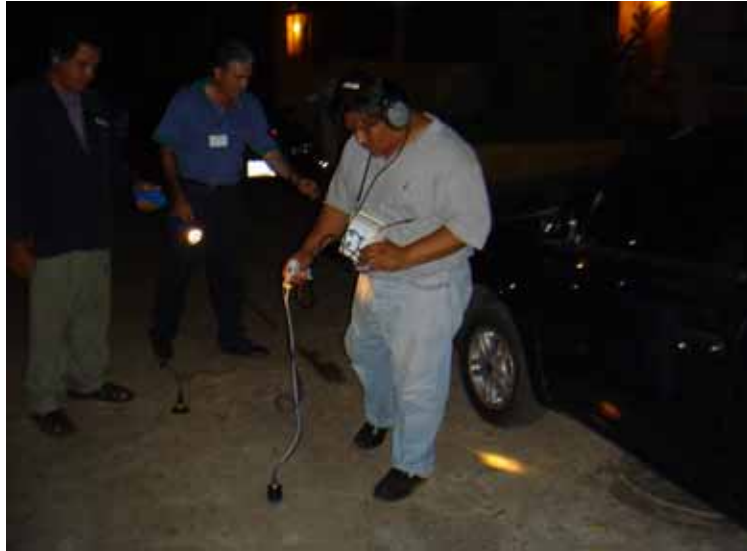
Micro Sector : Reparto Tiscapa

Night Survey

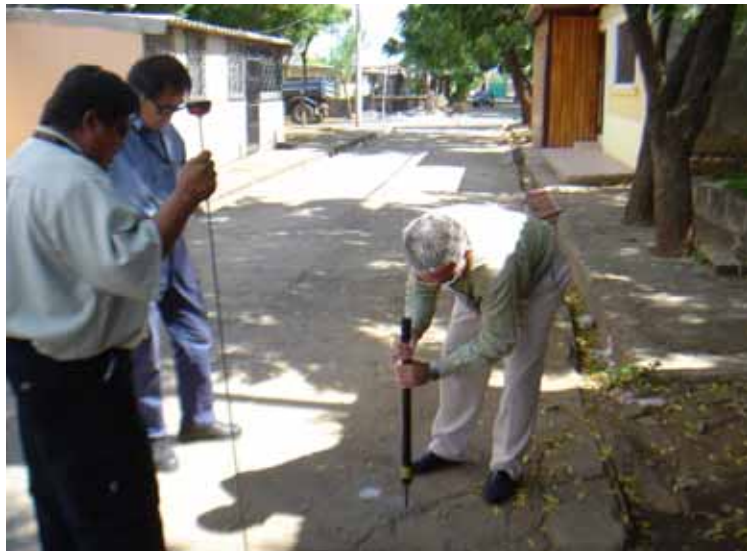
Leakage Survey

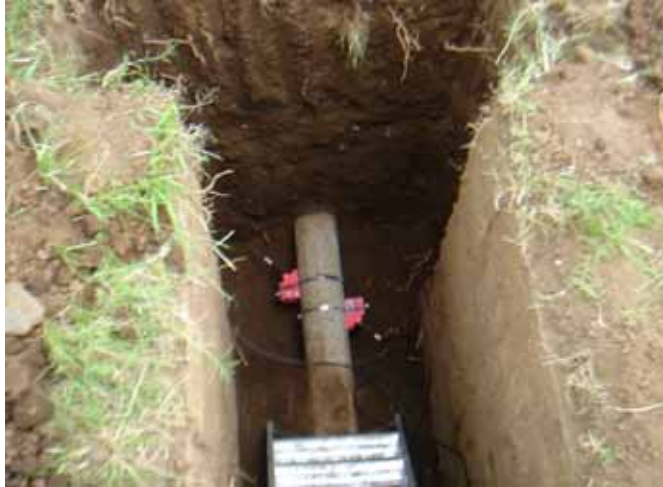
Micro Sector : El Dorado

Flow Measurement

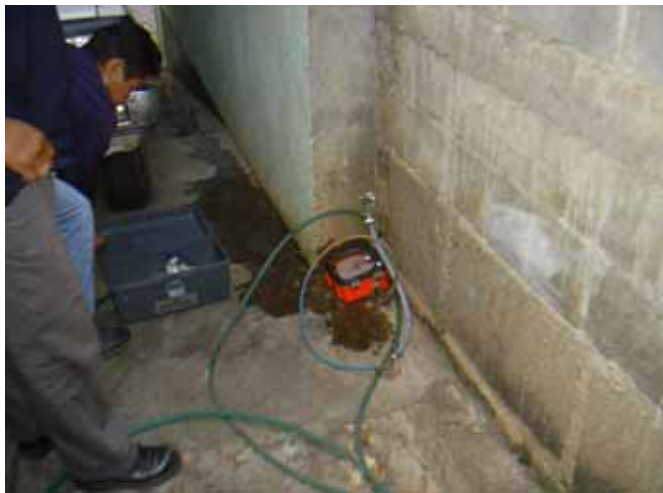
Pressure Measurement

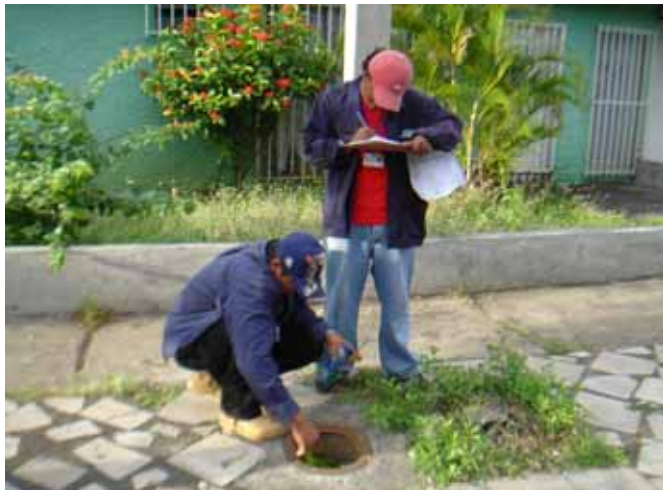
Meter Reading

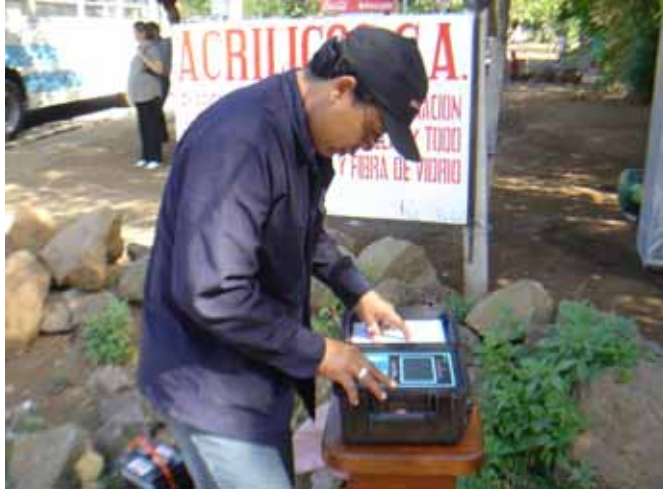
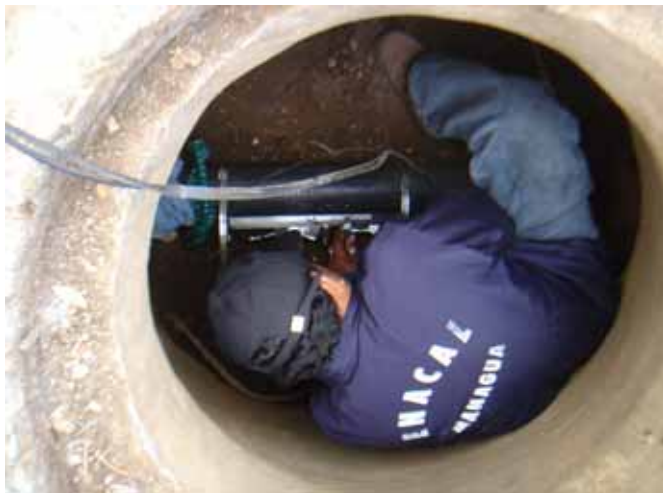
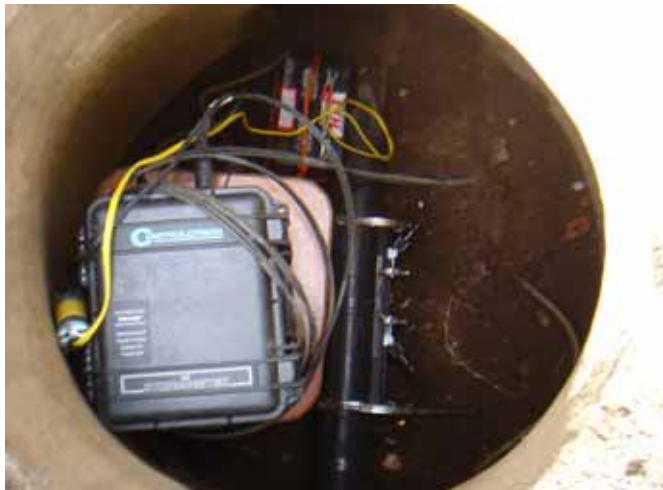
Site Name : Dinamarca

Flow Measurement
