## **Annexe B Rehabilitation Works for Khettaras**

### **Contents**

## B.1 Present Condition of Khettaras

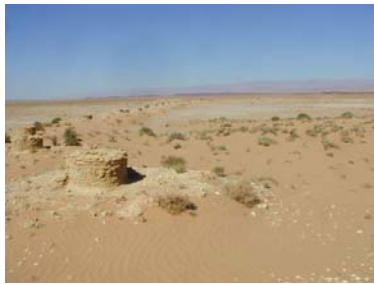
Khettara Ait Ben Omar

View of ground surface

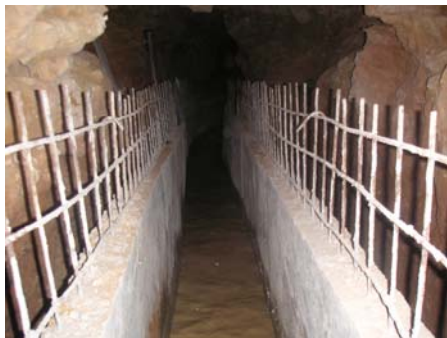
Concrete placing

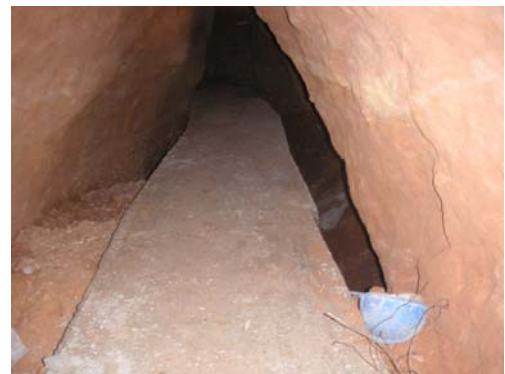
Top surface of concrete culvert

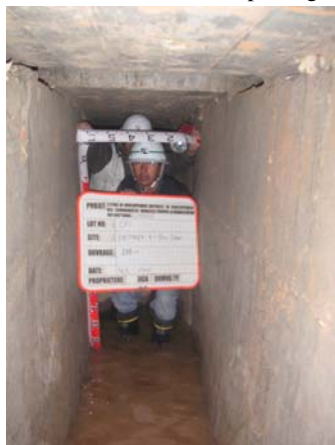
Inside of concrete culvert  
Width: 0.6m, height: 1.5m

Opening for entering into the gallery at interval of 30 m

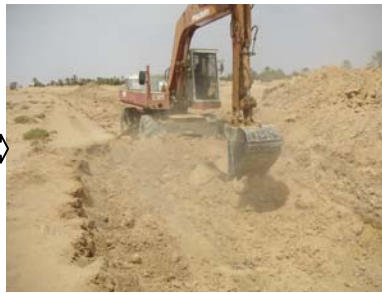
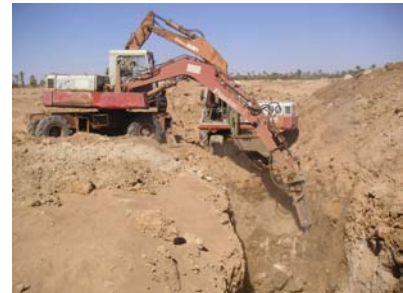
Excavation by backhoe and giant beaker for rock excavation

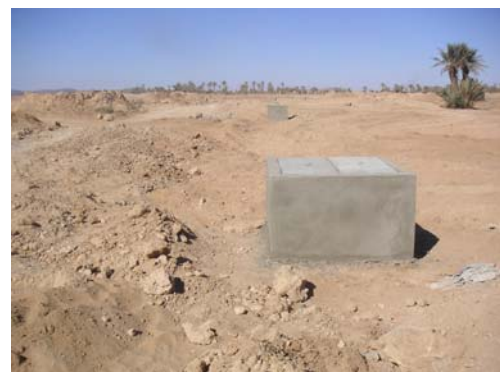
After refilling

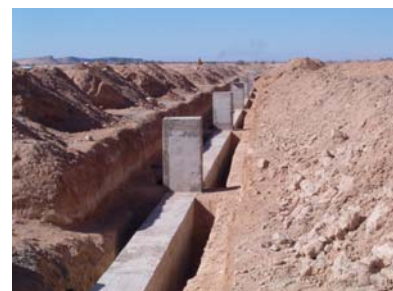
Gallery and vertical shafts of interval 30 m  
( Downstream portion )

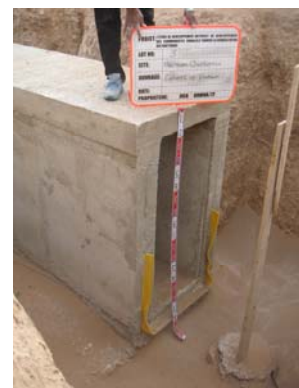
Inside of concrete culvert  
Width: 0.6m, height: 1.5m

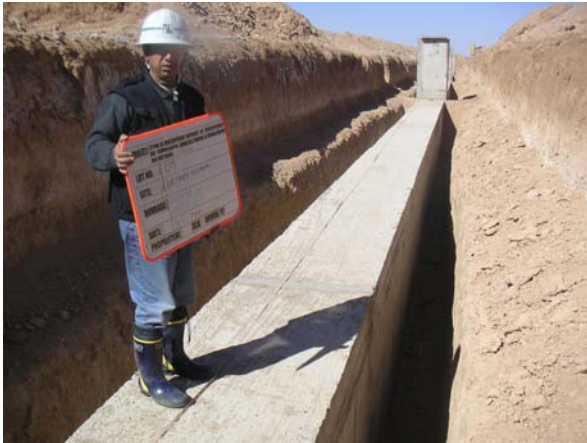
Gallery and vertical shaft with its interval of 30 m

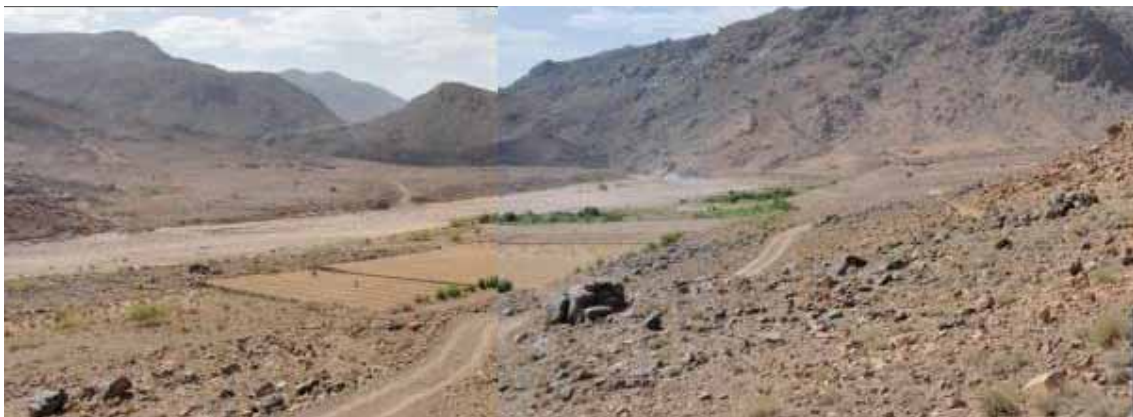
Proposed dam axis (left side of photograph) and reservoir seeing from the left side of reservoir

Larger tributary merges immediately upstream of the dam from the right side bank. A few families live in the reservoir area (center of photograph)

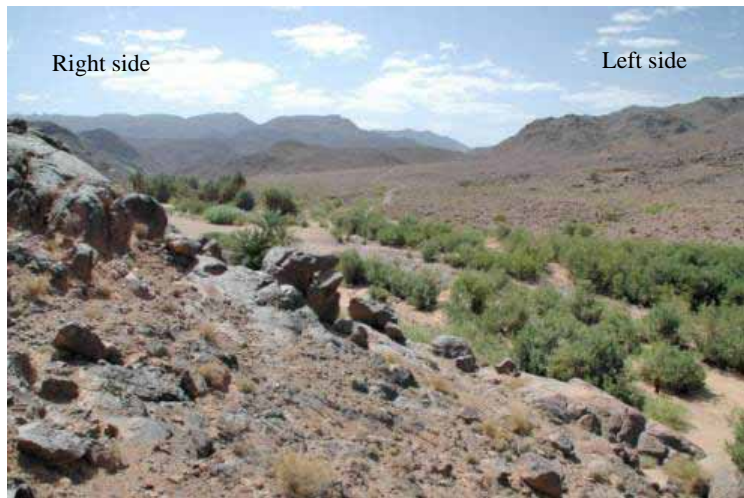
Reservoir seeing from  
downstream

Large amount of talus deposits  
has accumulated in the  
reservoir.

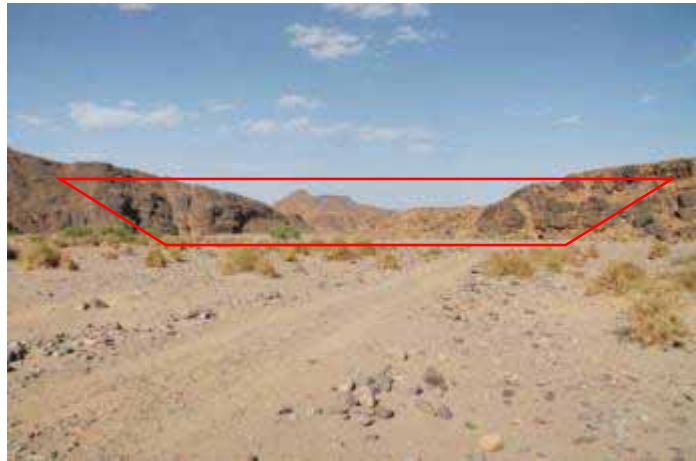
Dam axis seeing toward downstream

The ridge at the right side abutment is thin and its height also low, about 20 m.

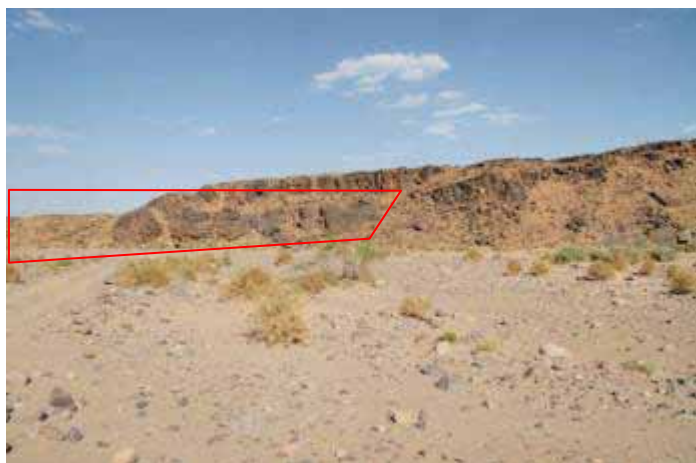
It is proposed to investigate permeability along fissures. Most of fissures have developed horizontally originated by depositional surface and those perpendicularly to the horizontal one. Continuation of these fissures from up to downstream of dam may form a path of percolation. When either abutment is thin, special attention shall be paid for a possibility of percolation induced by shorter pass of percolation.

Photograph shows the right side abutment

The abutment is only 10 m wide, and well developed fissures may cause seepage route from up to downstream of the reservoir.

Ordinary grouting is available to improve permeability for rocks with fissures. In case abutment is thin, it is necessary to put grouting into practice with certainty.

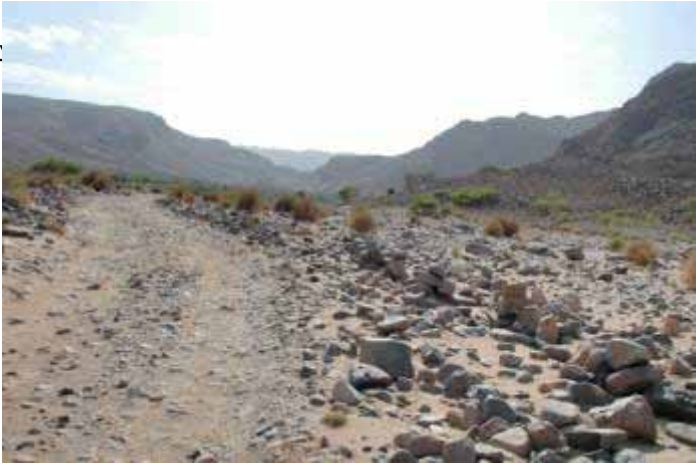
<p style="text-align: center;">Proposed dam axis (seeing toward upstream) Right side abutment is composed of thin ridge, and its elevation also not so high.</p>
<p>Riverbed of the reservoir area River deposits are accumulated mainly composed of sand and gravel.</p>	<p style="text-align: center;">Right side <span style="float: right;">Left side</span></p>

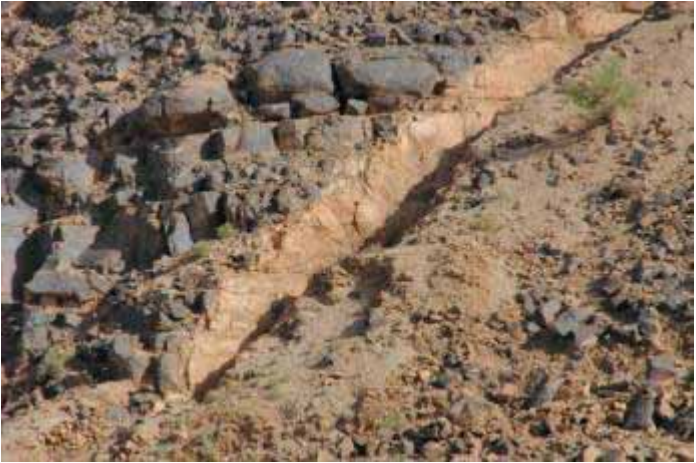
<p>Right side abutment</p> <p>An intrusive rock exists in the right side abutment crossing sandstone and shale alternation of strata.</p>	<p style="text-align: center;">Enlarged photo further for the details of an intrusive rock shown on the left photograph</p>

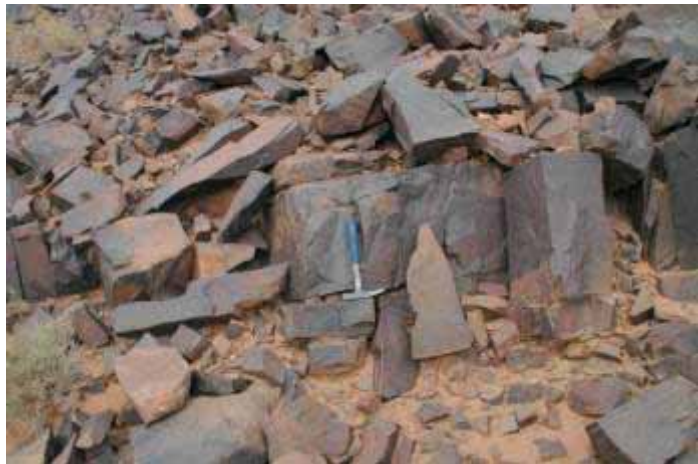
It is proposed to investigate permeability along fissures. Most of fissures have developed horizontally originated by depositional surface and those perpendicularly to the horizontal one. Continuation of these fissures from up to downstream of dam may form a path of percolation.

Outcrop of the left side dam abutment

Abutment is composed of firm sandstone and shale alternation of strata. Low angle bedding with fissures may become seepage route in the case fissures continues to downstream of the dam body.

Ordinary grouting is available to improve permeability for rocks with fissures. In case abutment is thin, it is necessary to put grouting into practice with certainty.

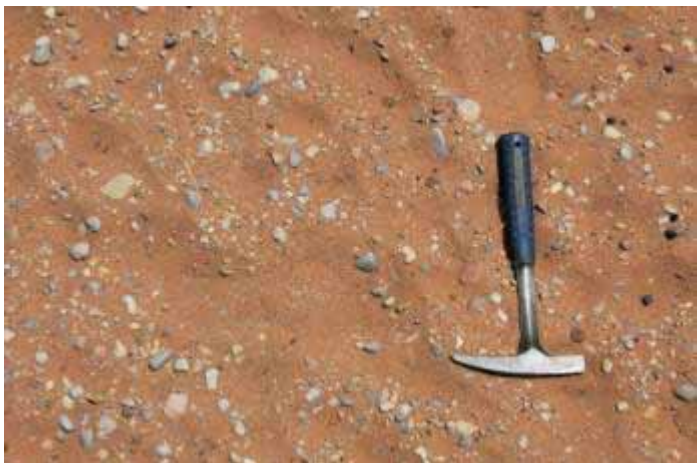
River deposits shown in the reservoir.

Riverbed material is composed of mainly sand and gravel. Its thickness is assumed at about 20 m referring to the groundwater level observed in the well near the dam site.
