付録-6 橋梁目視調査票

Inspection sheet of visual survey

Bridge No. 1

Bridge name		Patum Thani Bridge		Route name		3110, 346		Authority		DOH		Code of authority		-		
Place		from Amphue Lat Lun Kaeo		Distance		from km+ 0						No.		-		
		to Amphoe Mueang Pathum Thani				to km+ 0						Survey date		2009/10/28		
Bridge properties	Bridge type(1)	main road · side road · ramp														
	Bridge type(2)	bridge · viaduct · plank pass														
	Bridge type(3)	4-span continuous PC box girder														
	Total length	240.00 (m)														
	Span	47 + 73 + 73 + 47 (m)														
	Nos. of span	4 span														
	Width	32.21 (m) / 10.6-original (m)														
	Completion	1984 original, 2006 additional														
Road information	Horizontal	Straight · incli ($\theta = 1.5^\circ$) · Curve (R m)														
	Gradient	One way (\nearrow · \searrow) parabo (\square · \square)														
	Nearby tunnel	yes · no (m)														
	Nearby crossing	yes · no (m)

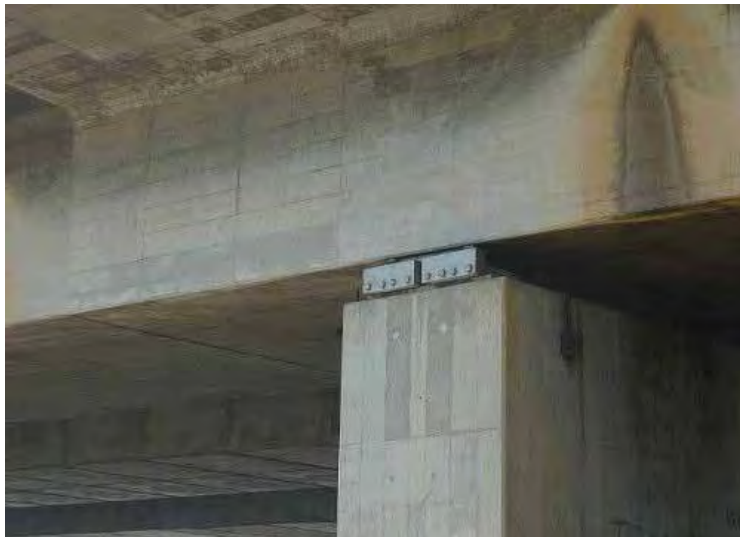
Picture No.	11
Span	1
Member	bearing
Spacing of side block	
<i>*Survey on board, 31-oct</i>

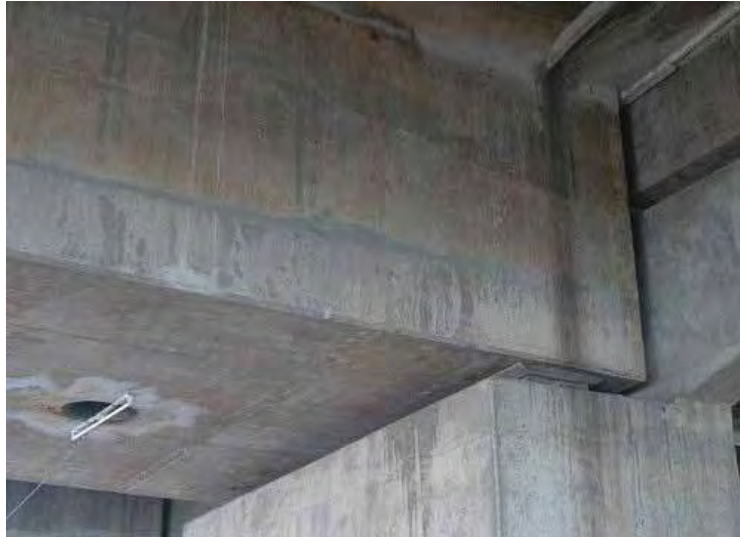
Picture No.	7
Span	1
Member	manhole
About 5m.

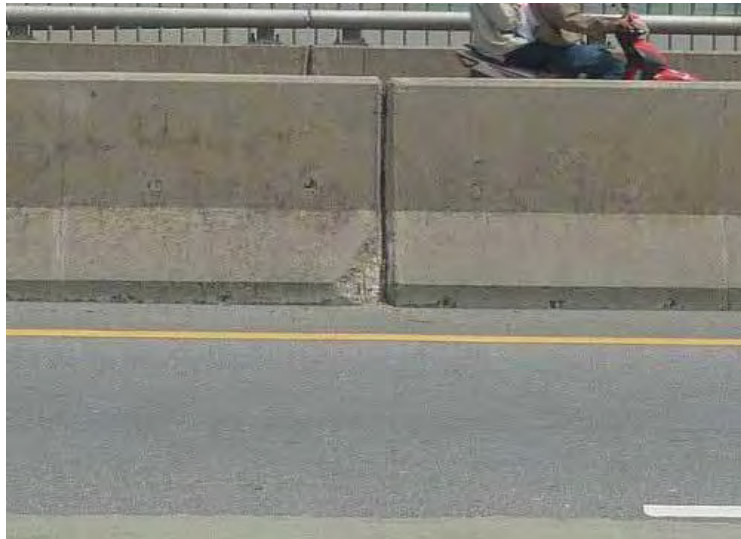
Picture No.	10
Span	1
Member	Barrier
Chipping of barrier

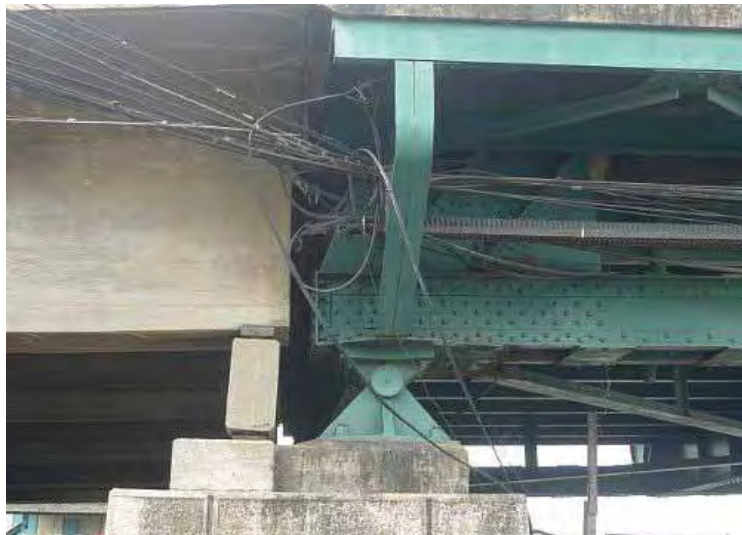
Picture No.	8
	Span	1
	Member	Bearing
	Structure around bearing

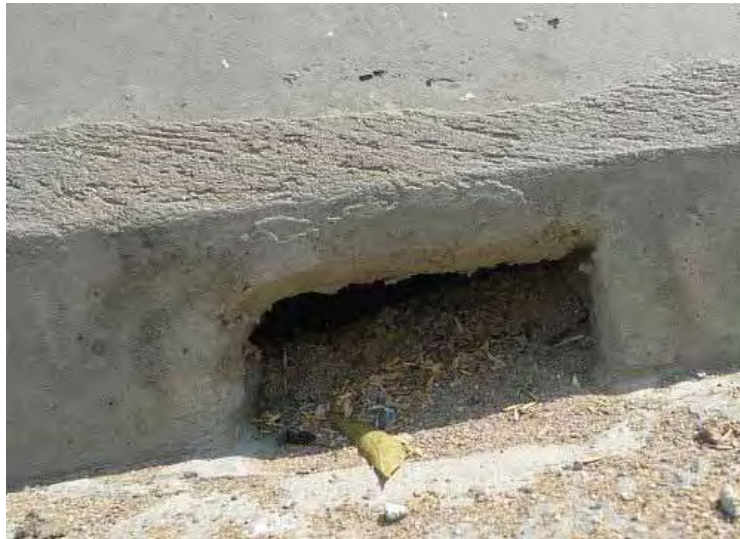
Picture No.	25
Span	1
Member	Drainage
Drainage under barrier

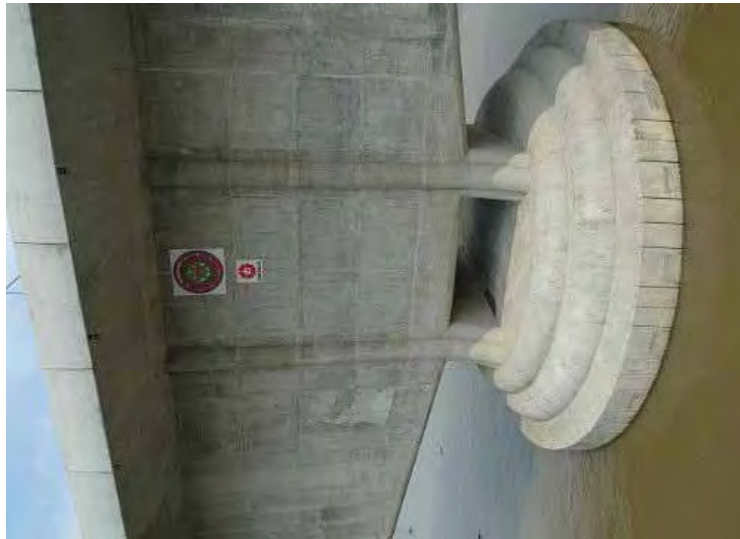
Picture No.	4
Span	1
Member	Pier
Pier height is low	
The structure may occur large moment after shrinkage, creep and temperature.	
Continuous careful checking is required.

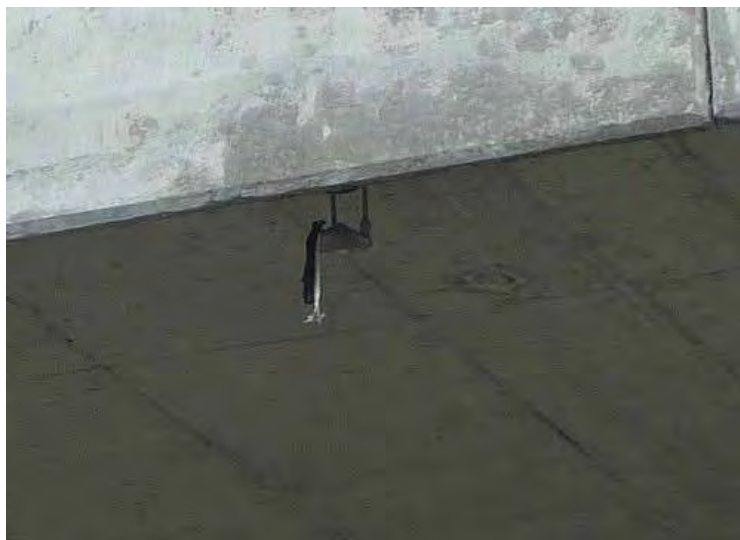
Picture No.	5
Span	1
Member	Drainage
Parts for water sprinkling	
Garbage
