# Inspection sheet of visual survey

Bridge No. 6

Bridge name		Pra Nangklao Bridge		Route name		-		Authority		DOH		Code of authority		-		
Place		from Anphoe Bang Bua Thong		Distance		from km+ 0						No.		-		
		to Anphoe mueang Nonthaburi				to km+ 0						Survey date		24-oct-2009		
Bridge properties	Bridge type(1)	main road · side road · ramp														
	Bridge type(2)	bridge · viaduct · plank pass														
	Bridge type(3)	5-span continuous PC box girder														
	Total length	330.00 (m)														
	Span	51 + 72 + 84 + 72 + 51 (m)														
	Nos. of span	5 span														
	Width	21.80 (m) / (m)														
	Completion	1985														
Road information	Horizontal	Straight · incli ( $\theta = 1.5^\circ$ ) · Curve ( R m )														
	Gradient	One way ( $\nearrow$ · $\searrow$ ) parabo ( $\square$ · $\square$ )														
	Nearby tunnel	yes · no ( m )														
	Nearby crossing	yes · no ( m )														
	Traffic	Much · Medium · Little

Present state ( 1 / 10 )					
Authority	DOH	Address	Bangkok	Data	24-Oct-09
Bridge	Phra NangKlao Bridge

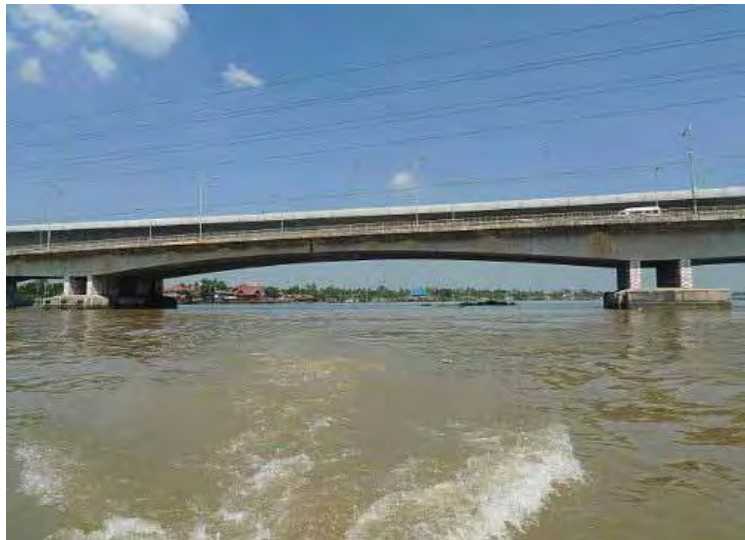
Picture No.	1
Span	1
Member	Side view
<i>*Survey on board, 31-oct</i>

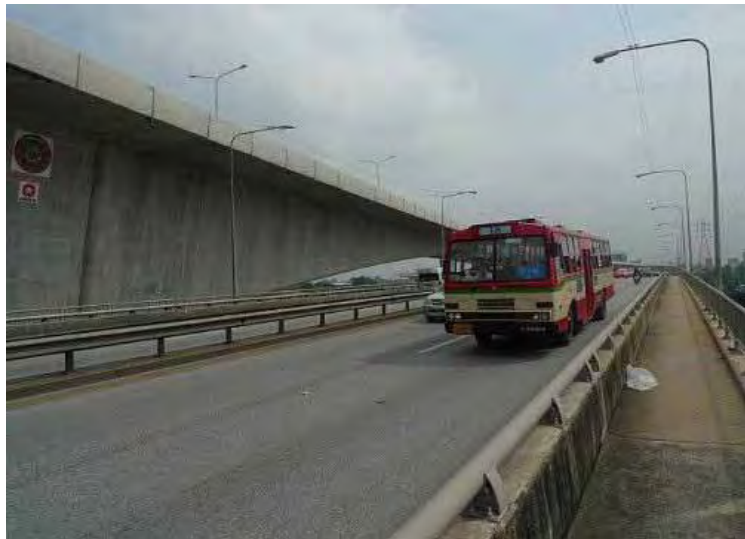
Picture No.	2
Span	2
Member	View on road

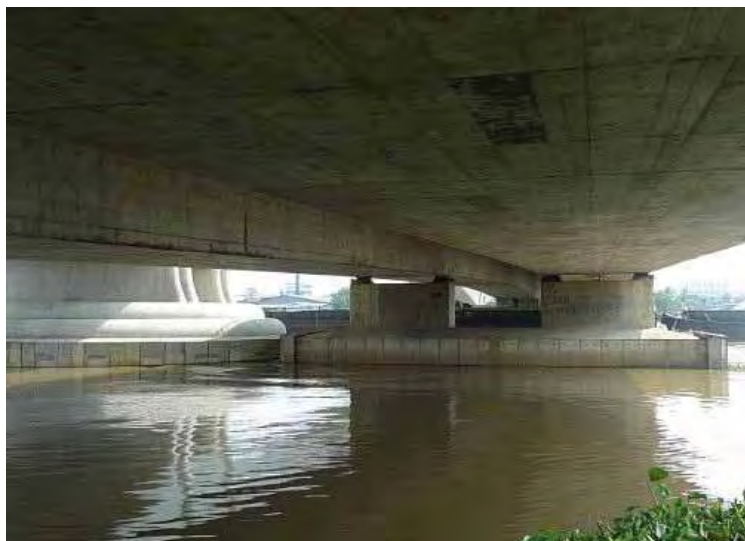
Picture No.	3
Span	1
Member	View under bridge

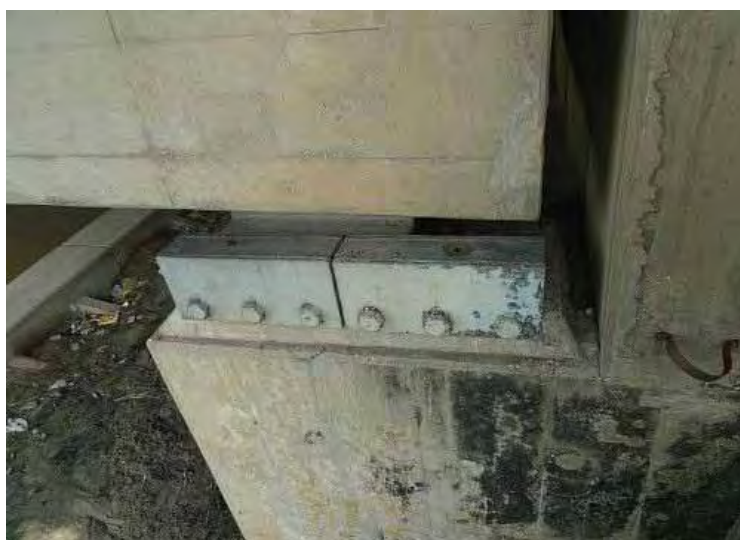
Picture No.	9
Span	1
Member	Bearing
Movement of girder	
Bangkok side is lager than Thonbu

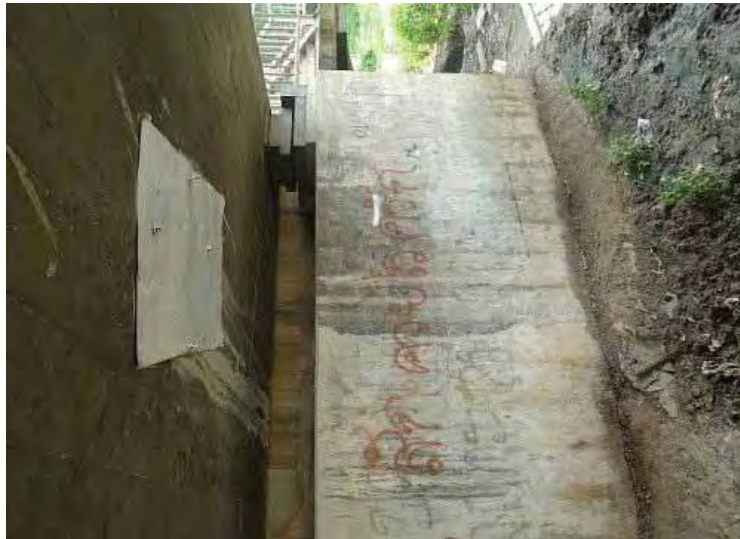
Picture No.	10
Span	1
Member	Manhole
graffiti	
Manhole can be access by ladder

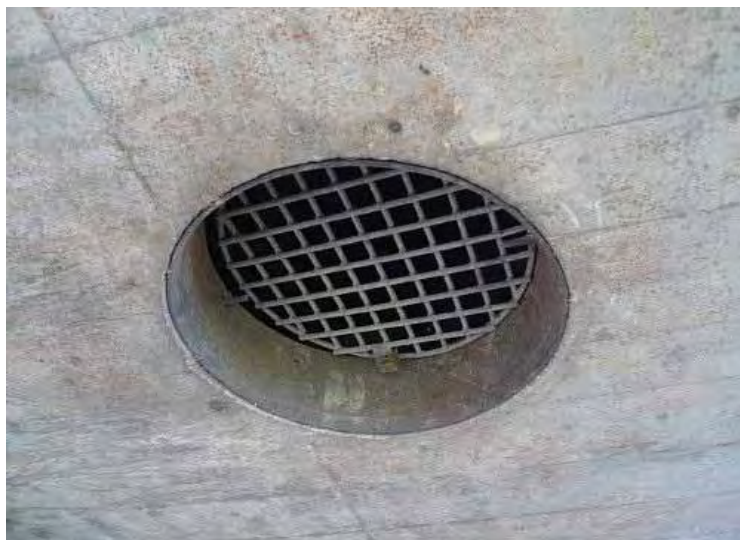
Picture No.	11
Span	1
Member	Manhole
With a key

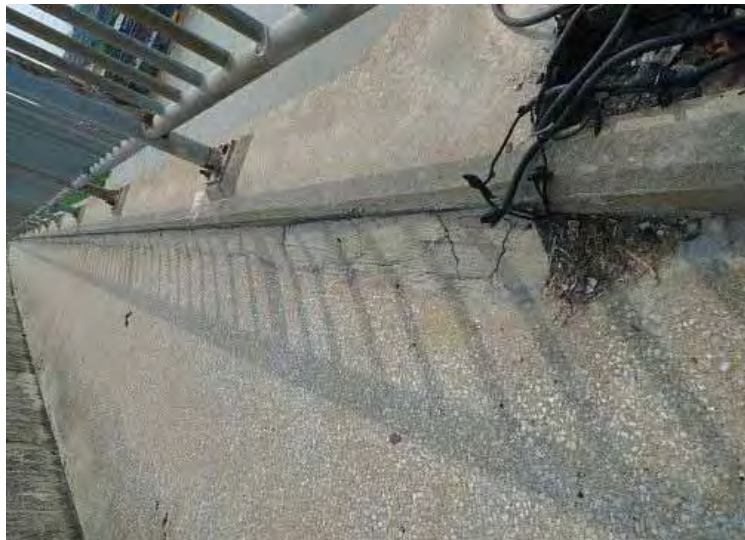
Picture No.	13
Span	1
Member	
Repair of electric cable

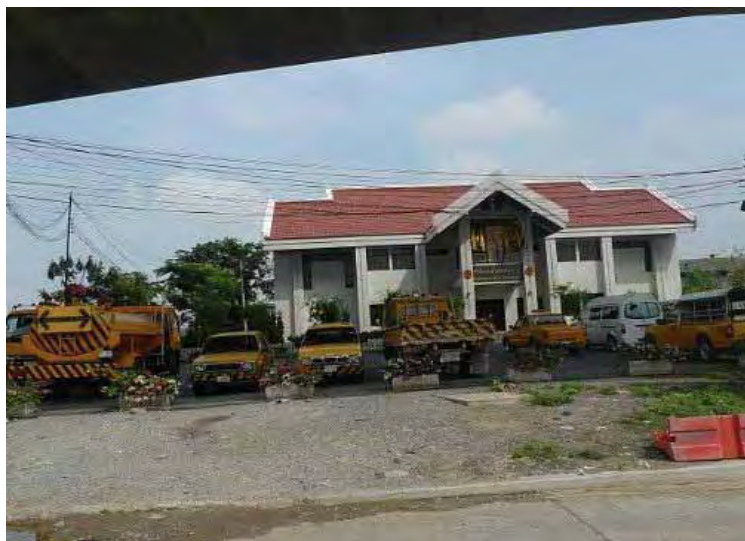
Picture No.	15
Span	1
Member	Management office

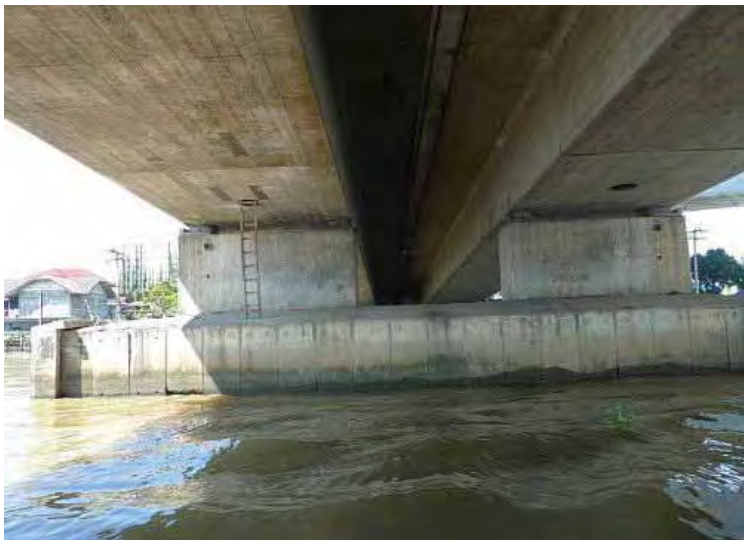
Picture No.	17
	Span	1
	Member	View of footing
	<i>*Survey on board, 31-oct</i>

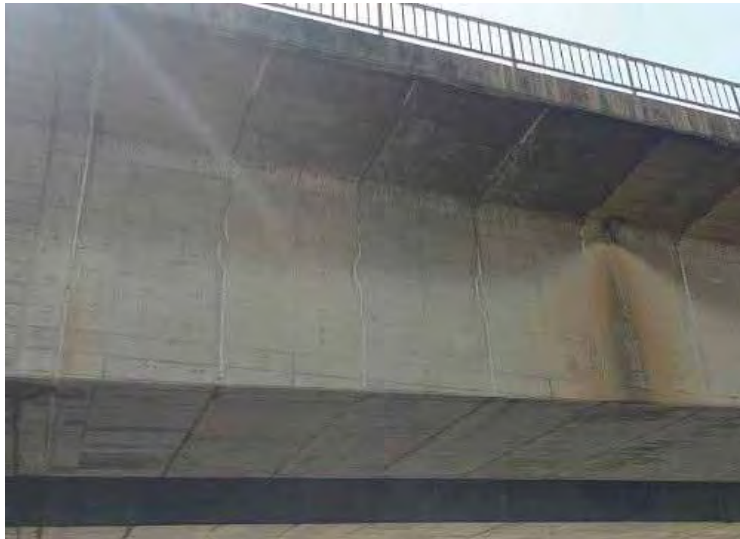
Picture No.	7
Span	1
Member	PC-box
Free lime from construction joint	
<i>*Survey on board, 31-oct</i>

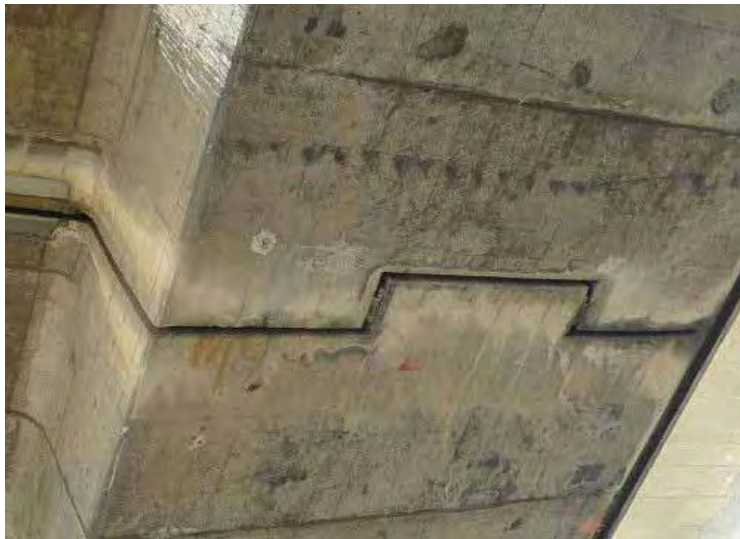
Picture No.	8
Span	1
Member	Hinge
Lack of pin	
Vertical movement is occurred independently	
<i>*Survey on board, 31-oct</i>

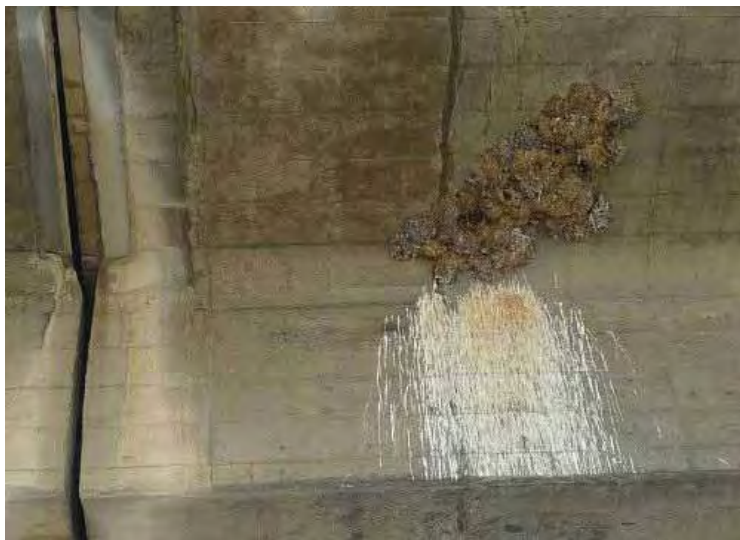
Picture No.	9
Span	1
Member	PC-box
Nest and droppings	
<i>*Survey on board, 31-oct</i>

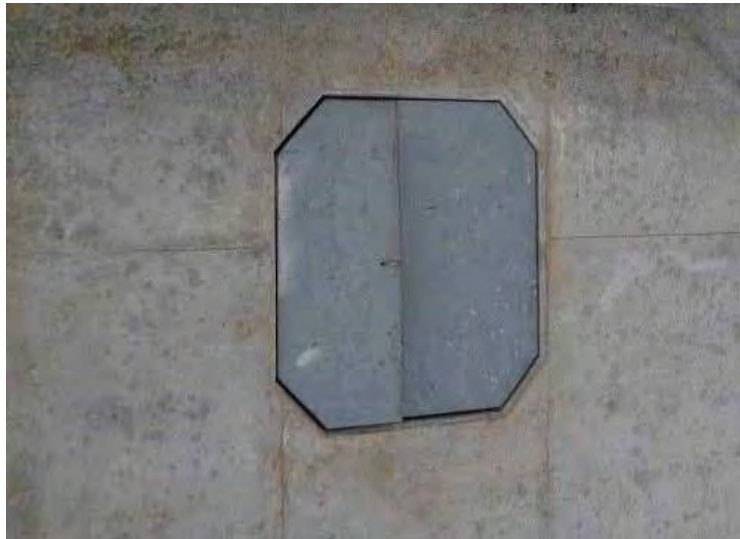
Picture No.	4
Span	1
Member	Manhole
No key

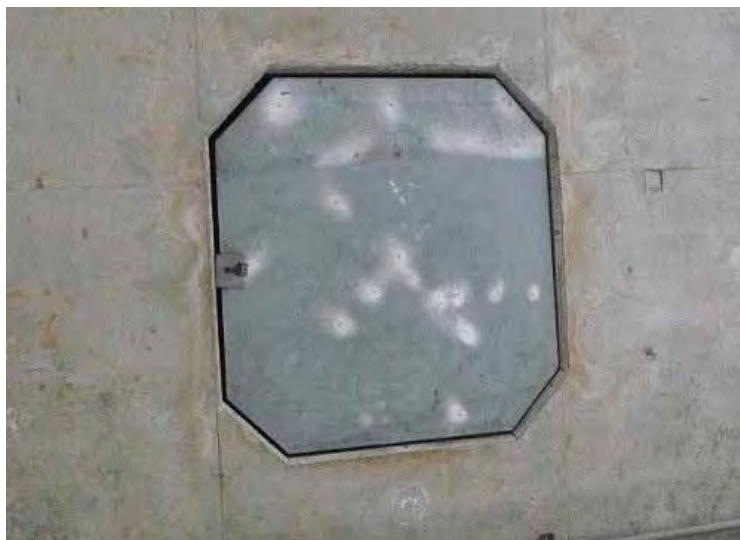
Picture No.	5
Span	1
Member	Manhole (walkway side)
With key

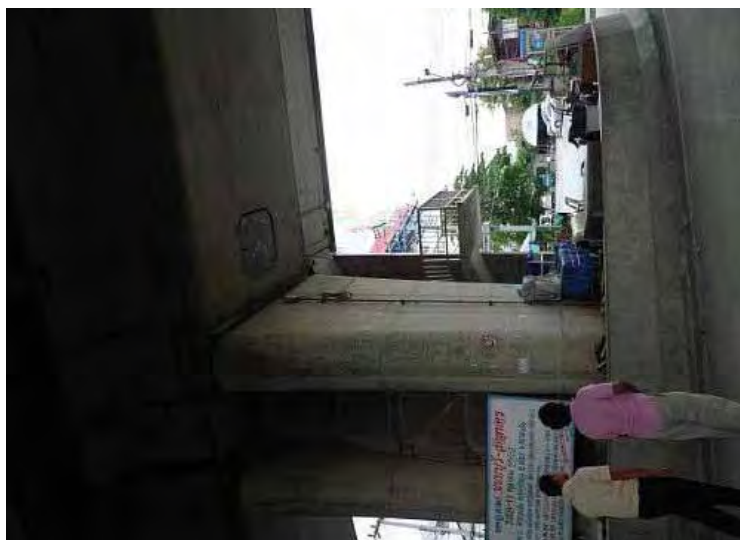
Picture No.	6
Span	1
Member	Manhole
About 6m height	
Lift car or ladder is needed to access

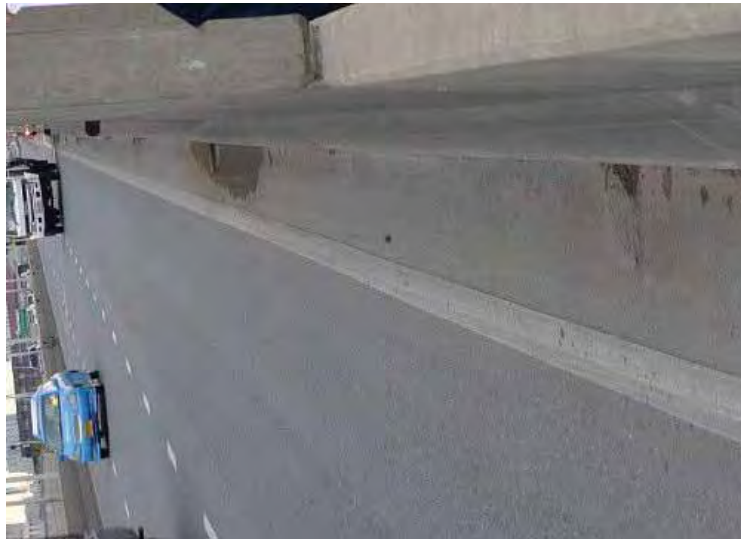
Picture No.	7
Span	1
Member	Catch basin
Blocking	
Part without noise barrier is cleaned and has no blocking

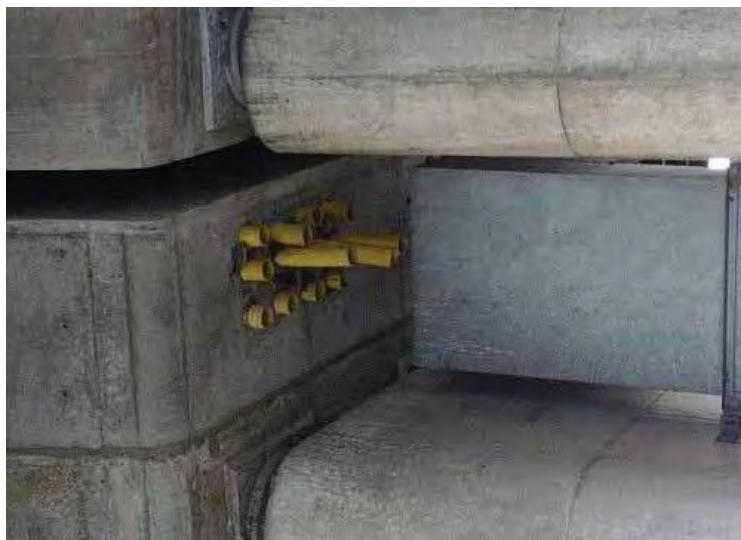
Picture No.	8
Span	1
Member	slab (walkway, roadway)
Electric and communication line

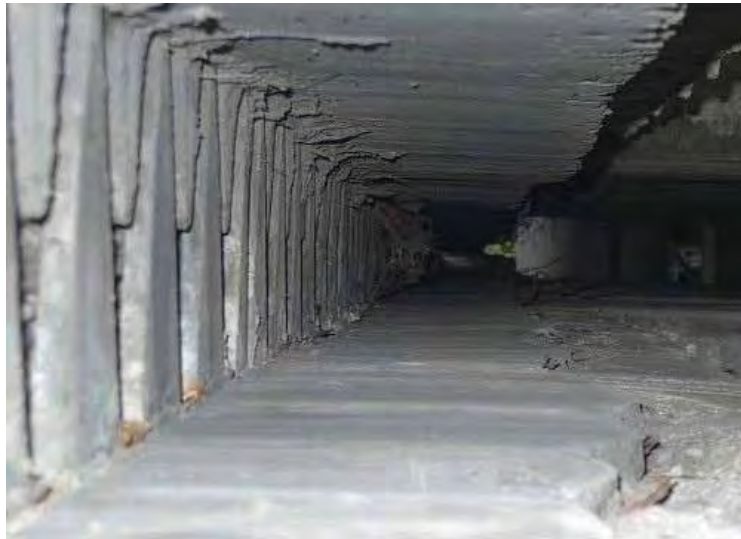
Picture No.	10
Span	1
Member	Expansion joint
Leaving of form work

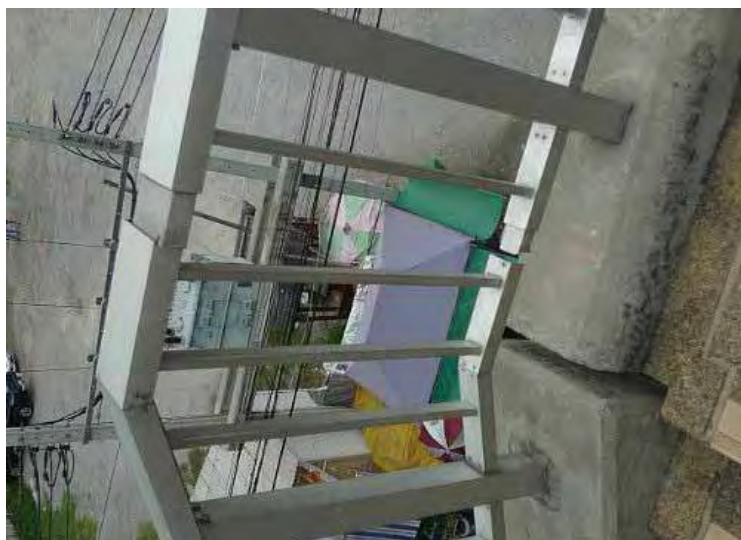
Picture No.	12
Span	1
Member	Handrail
Joint is off by unusual movement

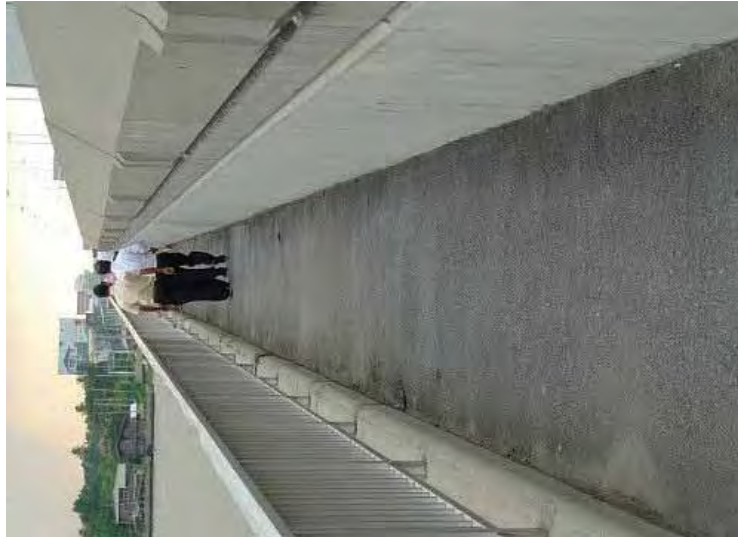
Picture No.	7
Span	1
Member	walkway
Less than 2m	
Inspection vehicle cannot park in walkway

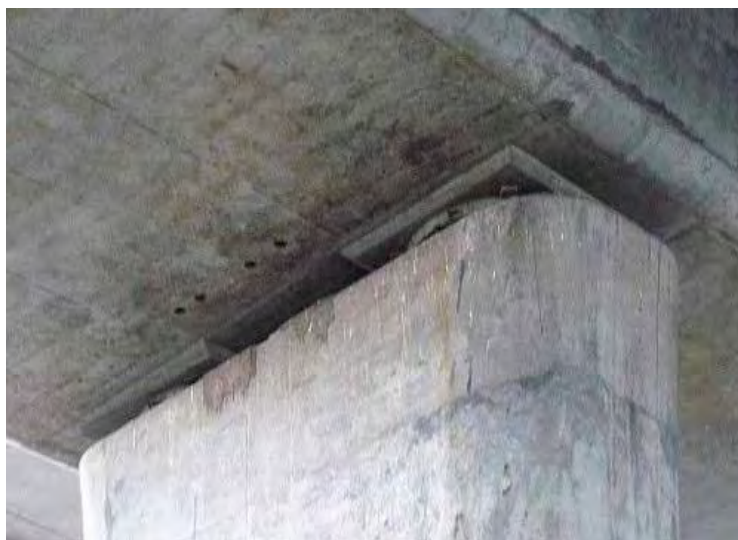
Picture No.	9
Span	1
Member	Pier head
Genellary healthy

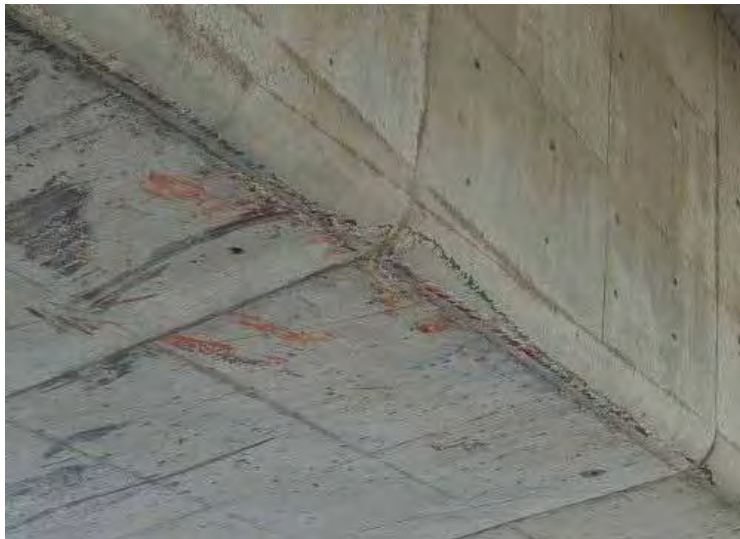
Picture No.	11
Span	1
Member	Girder
Scrach by ship collision	
<i>*Survey on board, 31-oct</i>

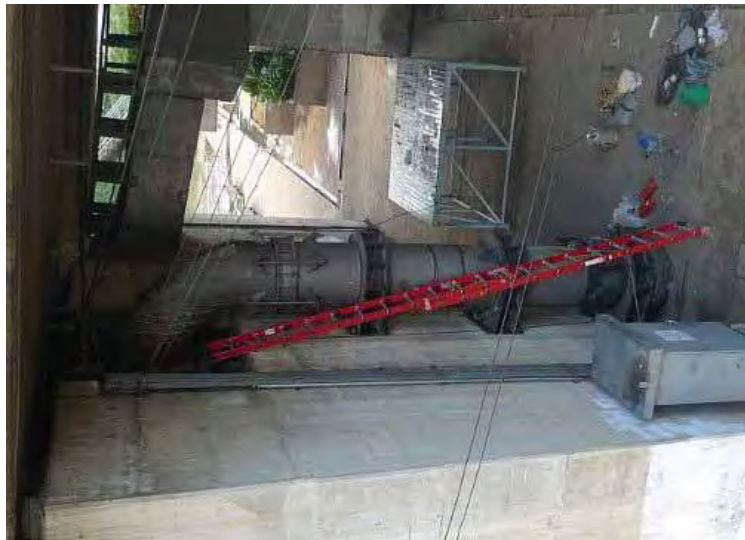
Picture No.	4
Span	1
Member	Water supply

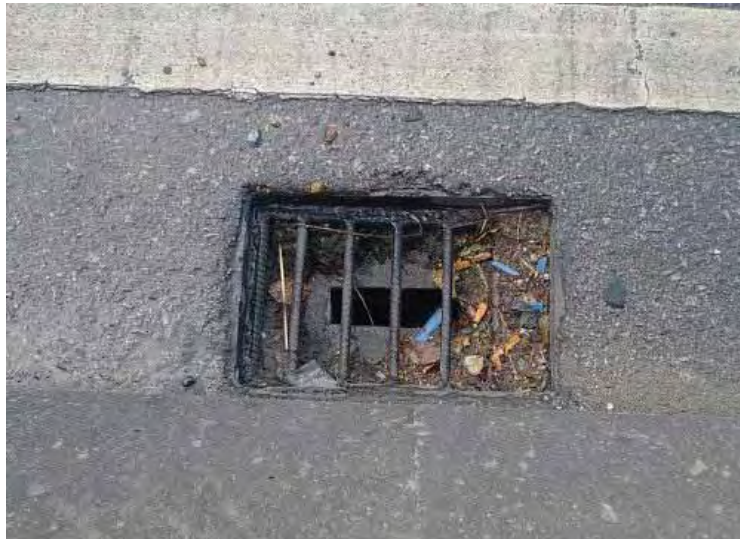
Picture No.	7
Span	1
Member	Catch basin
Partly blocked

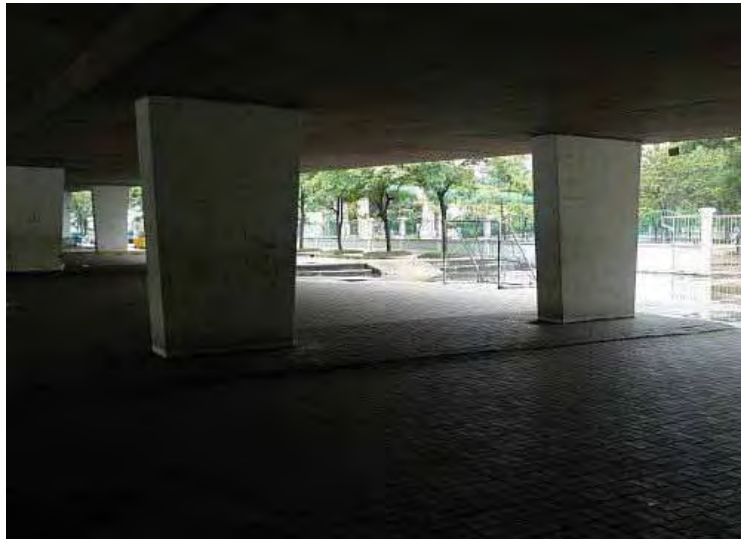
Picture No.	7
Span	1
Member	Approach bridge

Settlement around pier

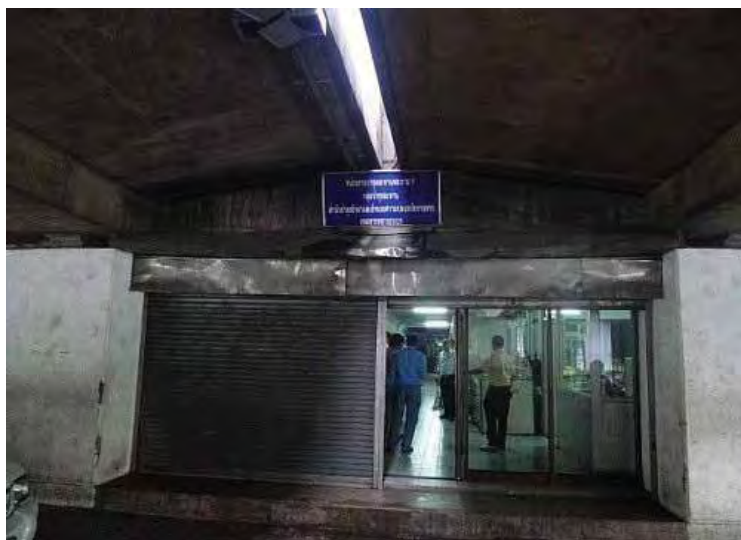
Picture No.	9
Span	1
Member	Site management office

Management office

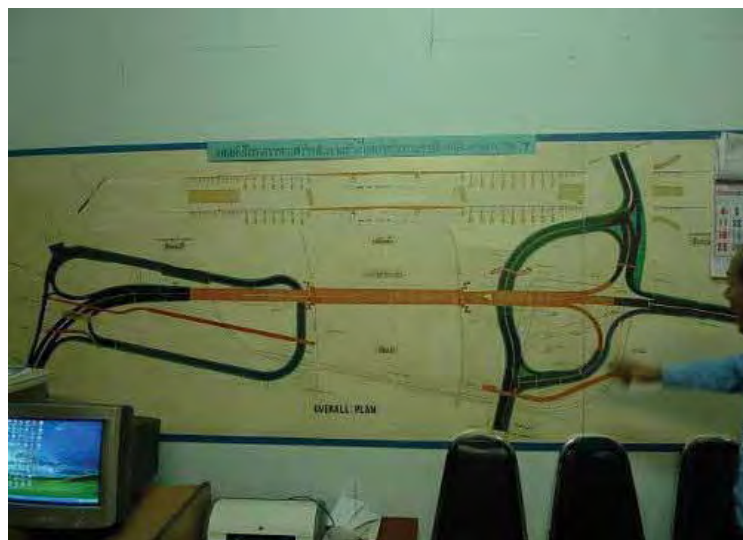
Picture No.	10
Span	1
Member	Site management office

Management area is yellow section

Green section is managed by BMA

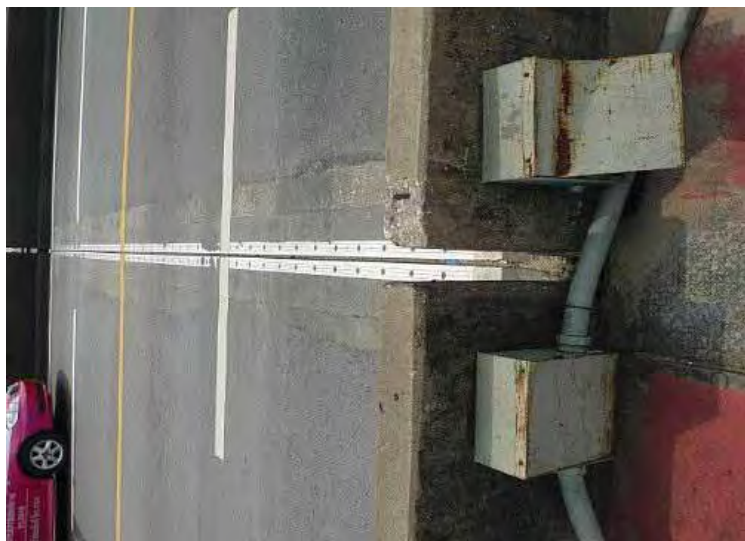
Picture No.	6
Span	1
Member	Expansion joint
Between 1st and 2nd span (Thon Buri side)

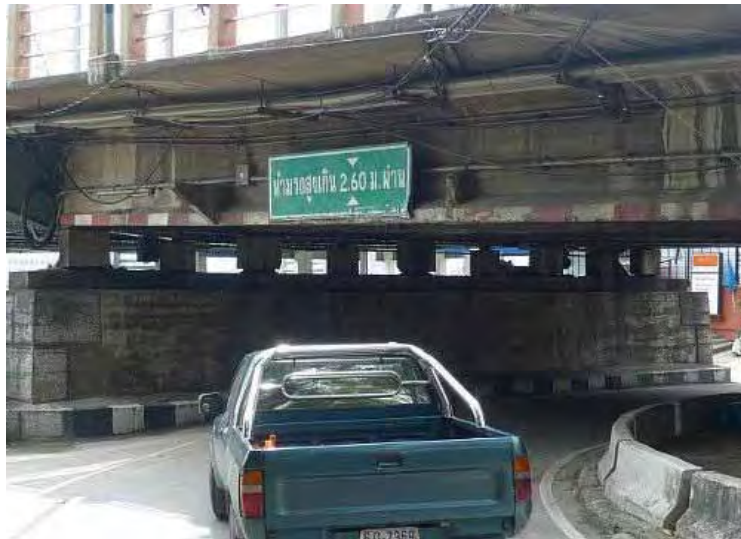
Picture No.	11
Span	1
Member	Approach bridge

Limit of vehicle height	2.6m
(Thon Buri side)

Many scratch
--------------

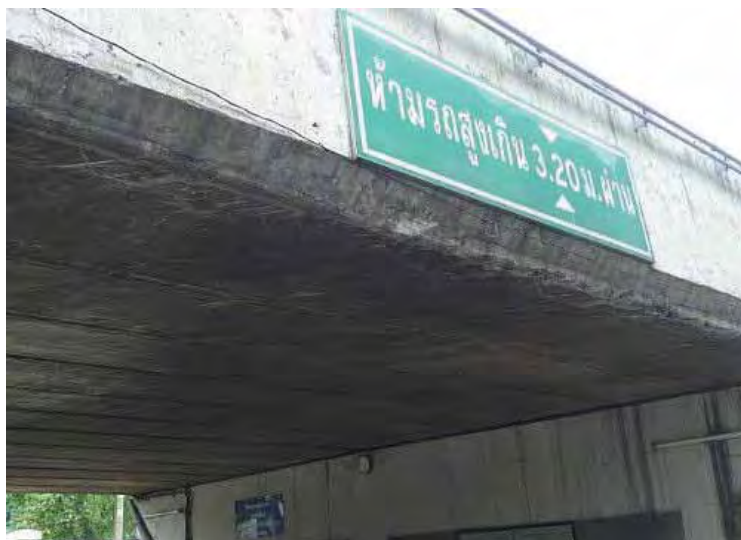
Picture No.	12
Span	1
Member	Approach bridge

Limit of vehicle height 3.2m (Bangkok side)
--

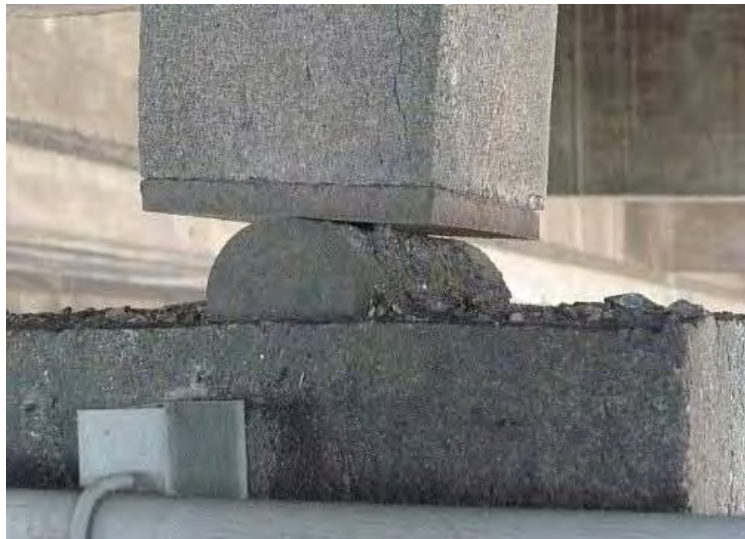
Picture No.	20
Span	1
Member	Bearing
Bearing on cross beam between main girder	
Approach bridge

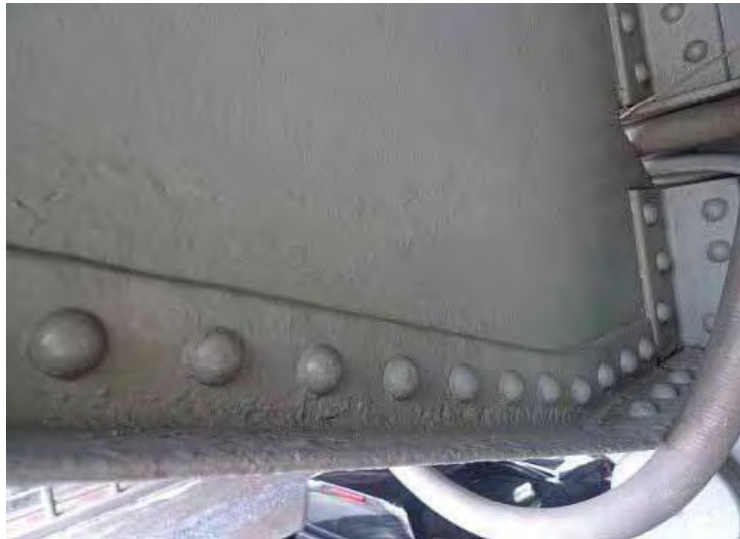
Picture No.	28
Span	1
Member	Bracket
Reduction of plate thickness

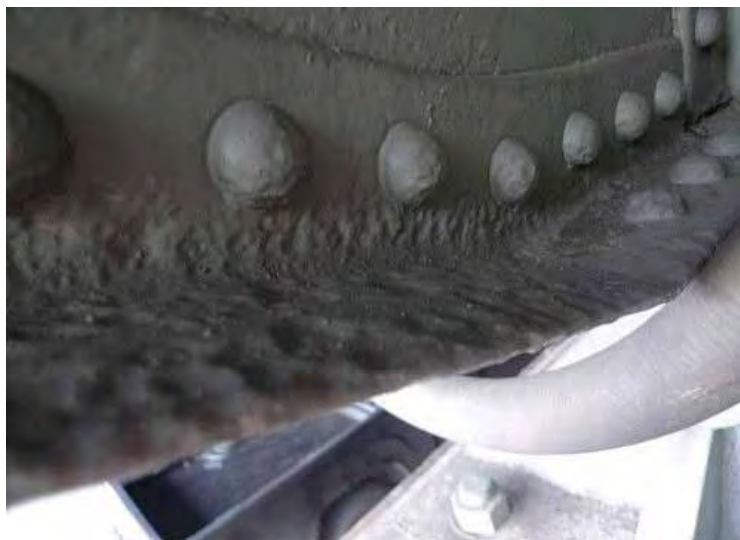
Picture No.	29
Span	1
Member	Bracket
Reduction of plate thickness

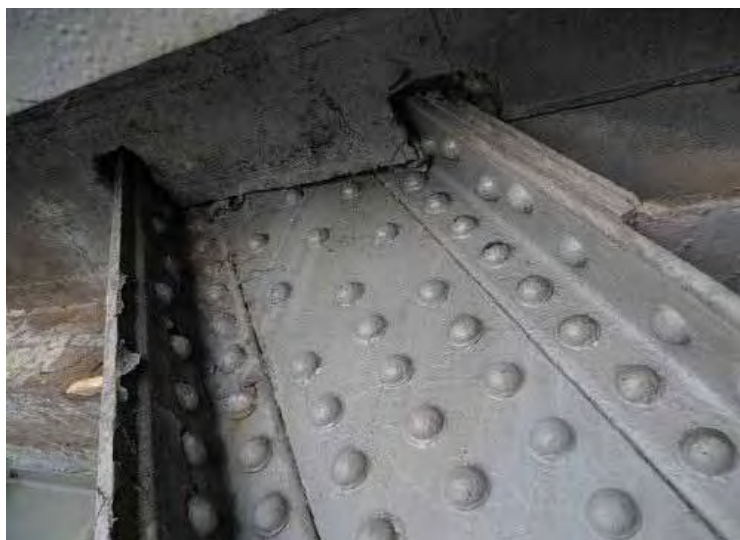
Picture No.	30
Span	1
Member	Chord member
It's not clear the concept of gap Gap width is small.

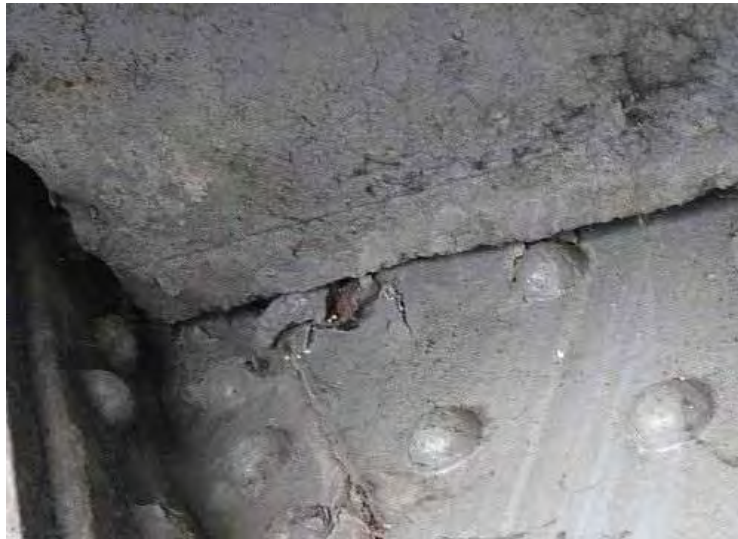
Picture No.	31
Span	1
Member	Stringer
Peeling of paint

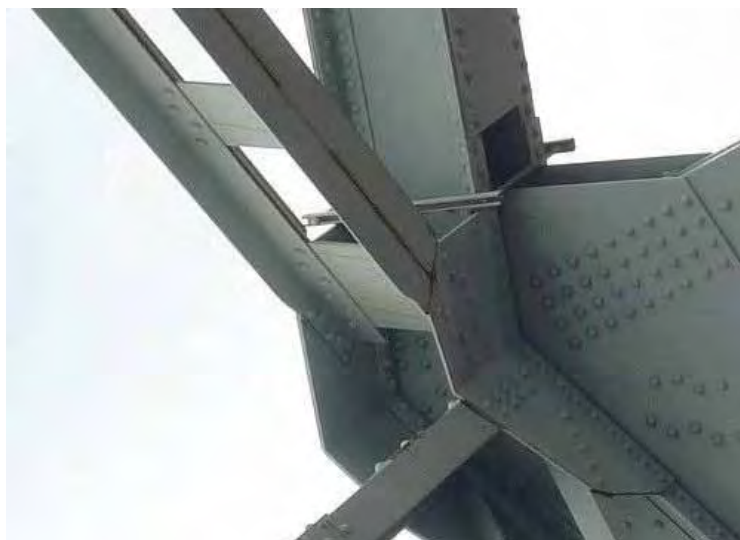
Picture No.	39
Span	1
Member	Cross frame
Deformation at the end of cross frame	
Adjustment of height?

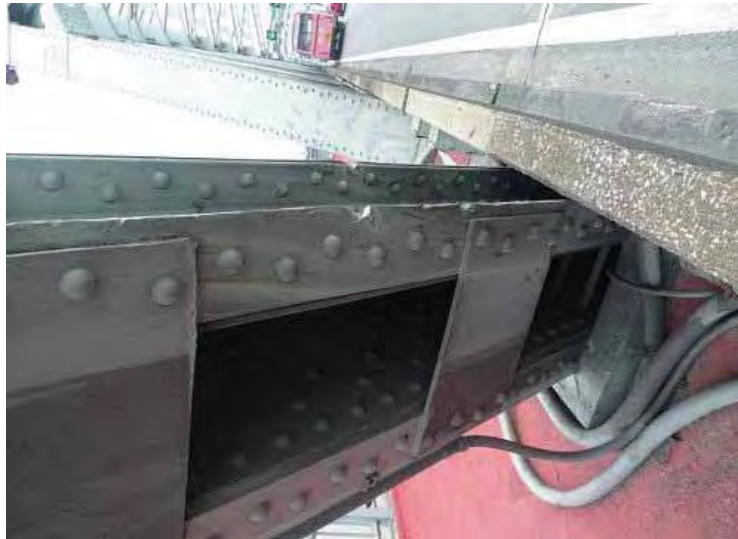
Picture No.	40
Span	1
Member	Chord member
Deformation by vehicle collision

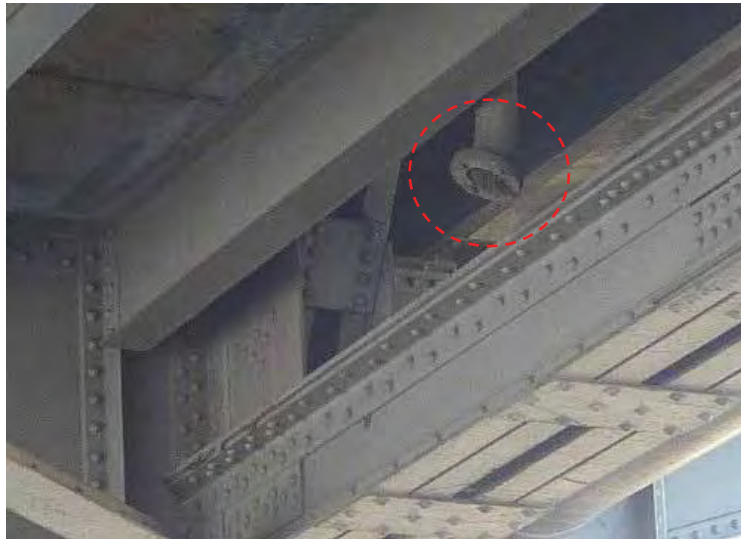
Picture No.	52
Span	1
Member	Slab
Falling of drainage pipe	
<i>*Survey on board, 31-oct</i>
