Inspection sheet of visual survey

Bridge No. 11

Bridge name		RAMA VIII Bridge		Route name		-		Authority		BMA		Code of authority		-		
Place		from Khat Bang Phlat to Khet Phra Nakhon		Distance		from km+ 0 to km+ 0						No.		-		
												Survey date		23-Oct-2009		
Bridge properties	Bridge type(1)	main road · side road · ramp														
	Bridge type(2)	bridge · viaduct · plank pass														
	Bridge type(3)	4-span composite 2 l girder cable stayed bridge														
	Total length	475.00 (m)														
	Span	75 + 50 + 50 + 300 (m)														
	Nos. of span	4 span														
	Width	29.20 (m) / (m)														
	Completion	2002														
Road information	Horizontal	Straight · incli (θ = 2 %) · Curve (R m)														
	Gradient	One way (↗ · ↘) parabo (▽ · ▹)														
	Nearby tunnel	yes · no (m)														
	Nearby crossing	yes · no (ramp way)														
	Traffic	Much · Medium · Little														
	Commercial traffic	Much · Medium · Little

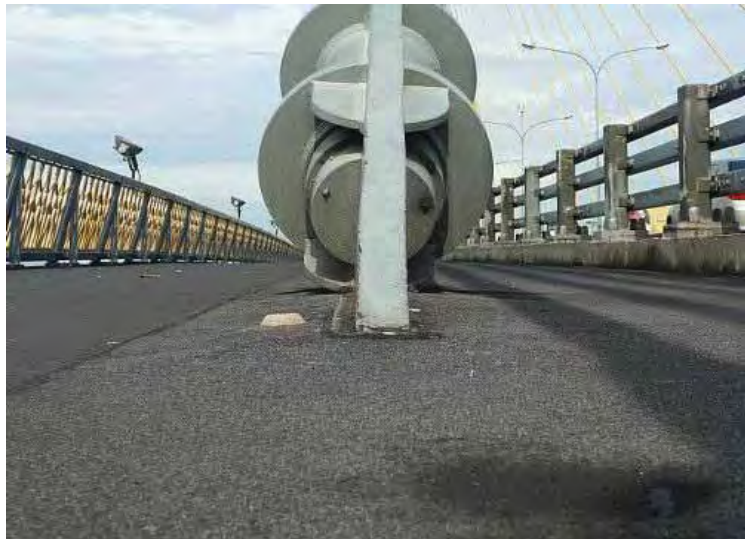
Picture No.	11
Span	1
Member	Cable fixing structure
slab. And mounted up around cable to prevent remaining water.

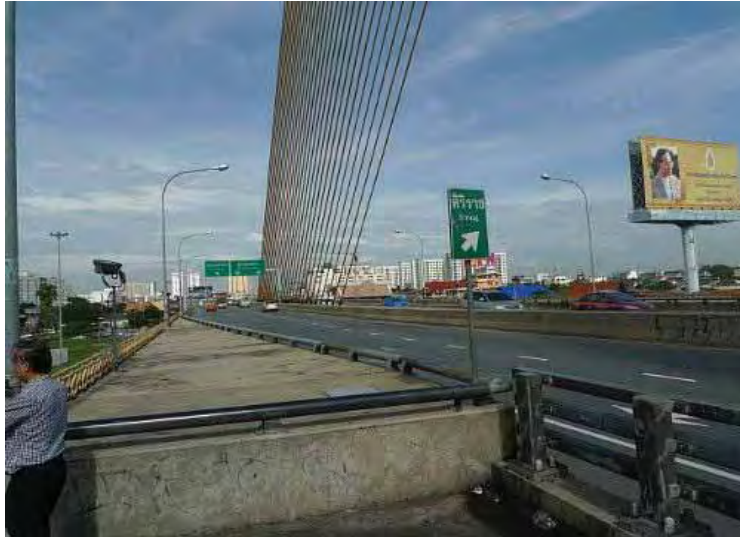
Picture No.	7
Span	1
Member	Side span and approach

side span is 3+2 lane for ramp wa

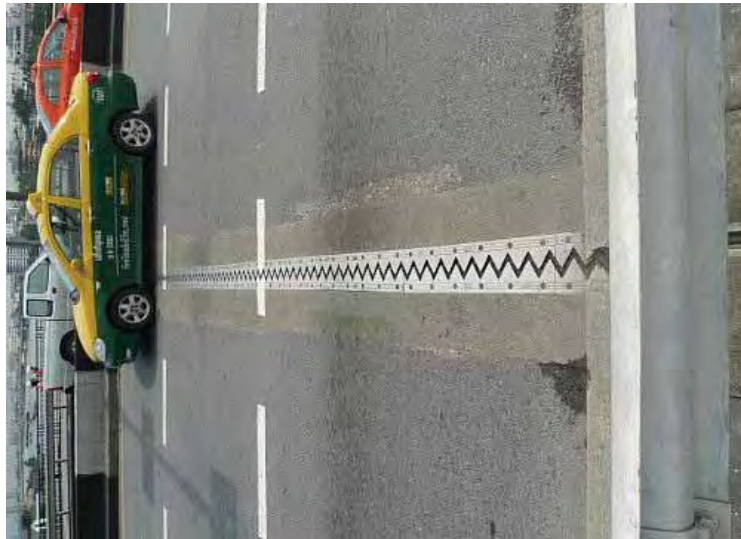
Picture No.	7
Span	1
Member	Expansion joint
Center hinge part

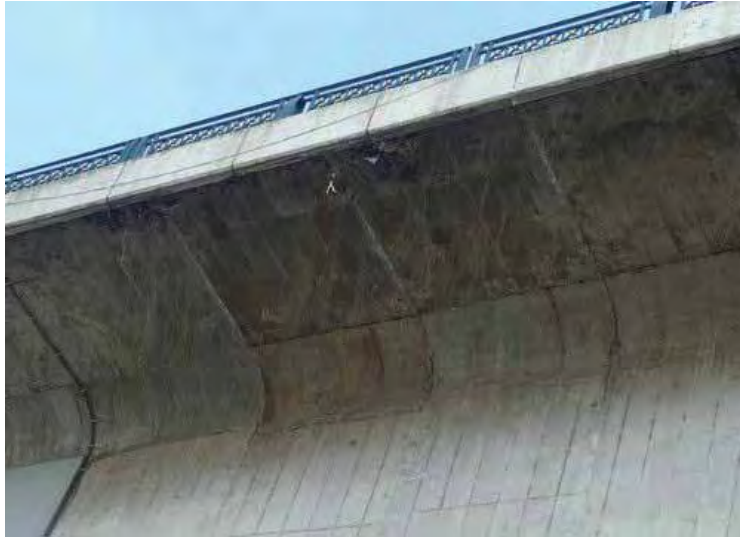
Picture No.	16
Span	1
Member	Slab
Free lime from construction joint	
<i>*Survey on board, 31-oct</i>

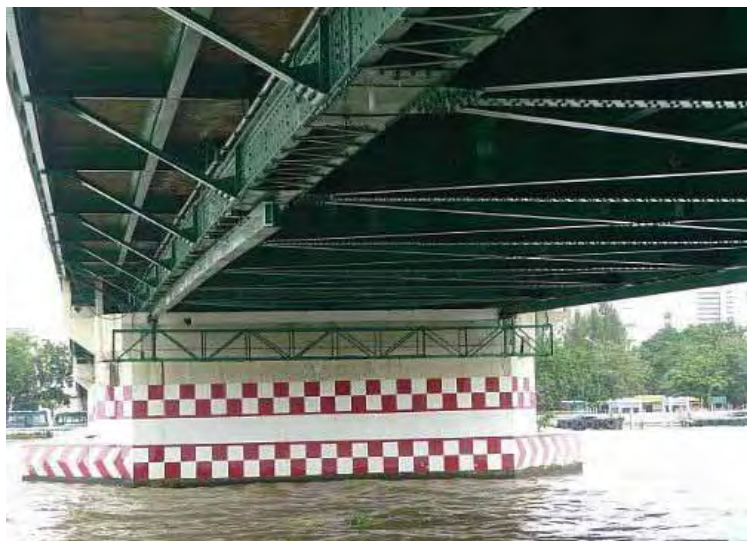
Picture No.	3
	Span	1
	Member	View under girder
	Inspection vehicle of side span.	
	No inspection vehicle in center span

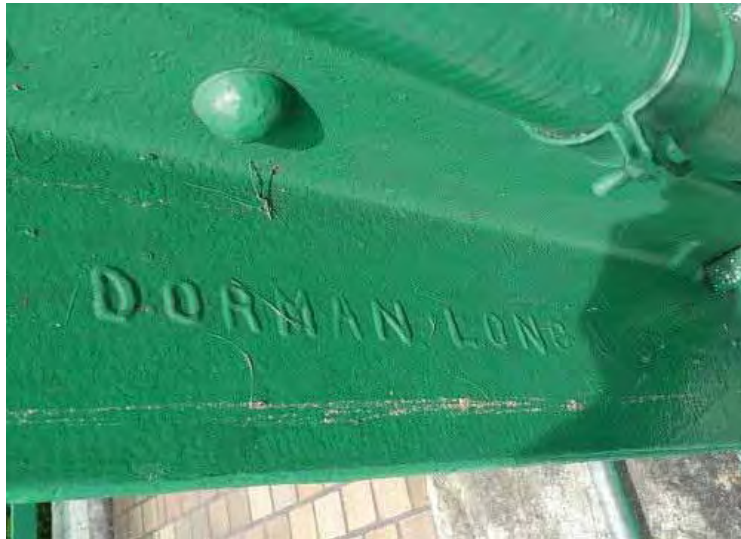
Picture No.	7
Span	1
Member	material

The material made in England

It's seems that same fabricator provide material for repairing work

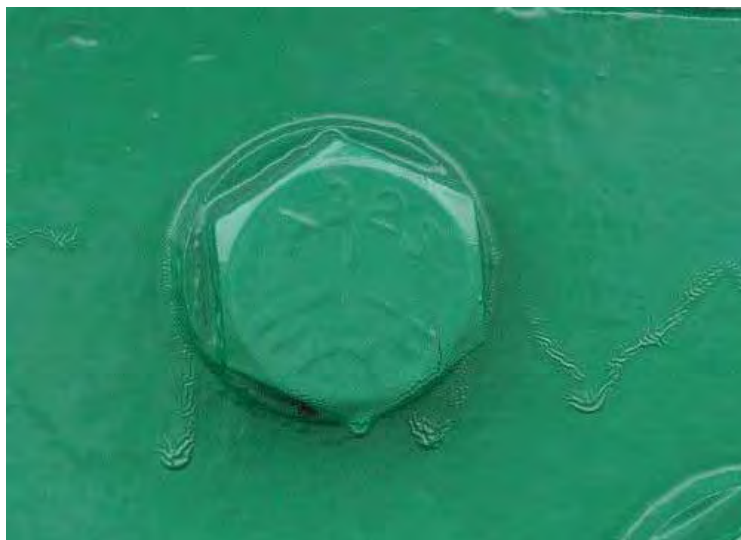
Picture No.	8
Span	1
Member	Material

A325 (ASTM), NYM

High tension bolt produced MISUBOSHI

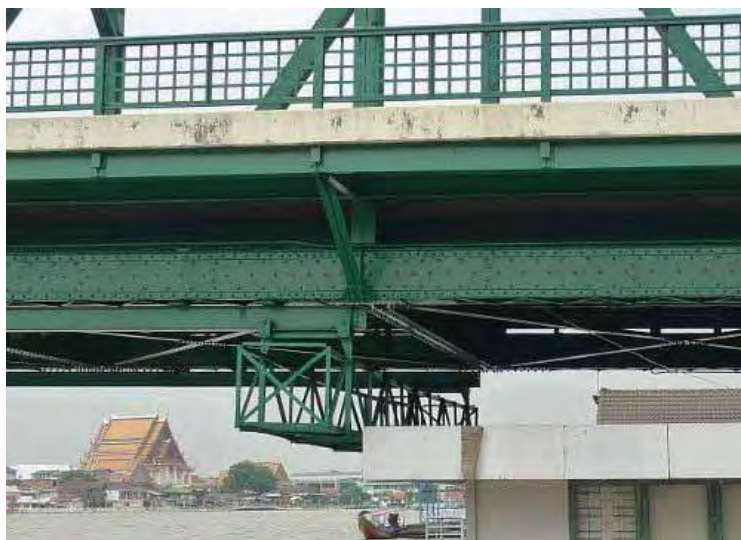
Picture No.	9
Span	1
Member	Inspection vehicle

Han powered inspection vehicle.

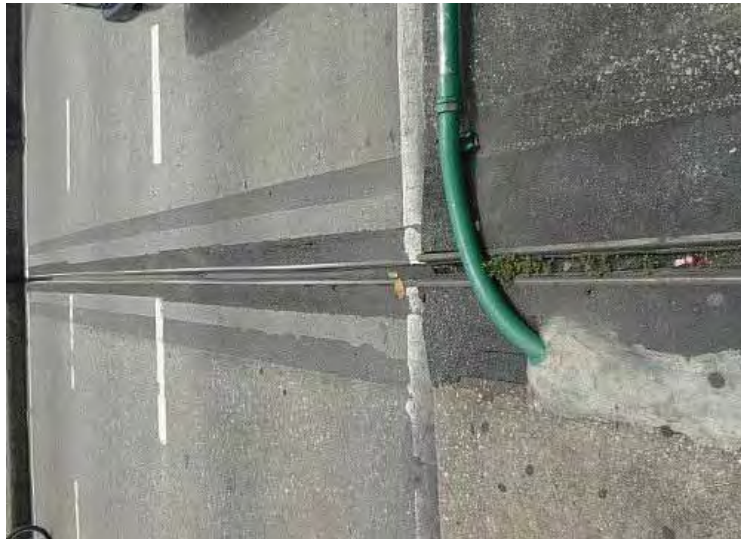
Picture No.	10
Span	1
Member	Expansion joint
Bangkok side

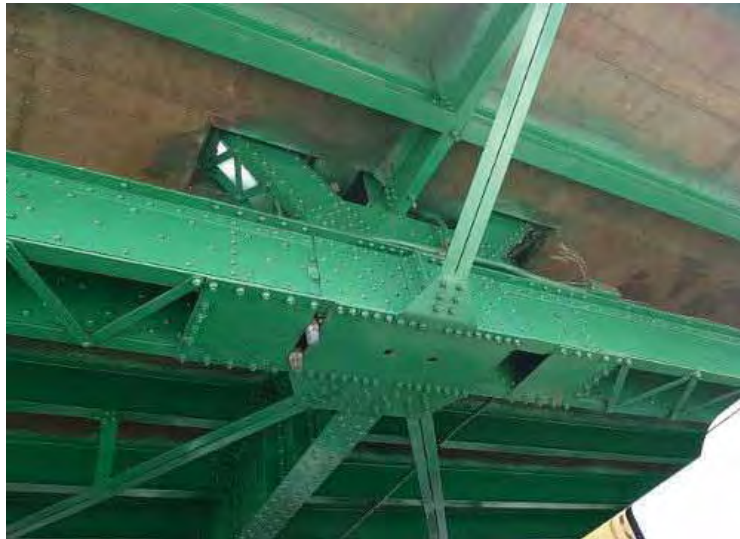
Picture No.	10
Span	1
Member	Stay cable
Connection between steel and slab	
It looks make gap around steel member from bottom side.

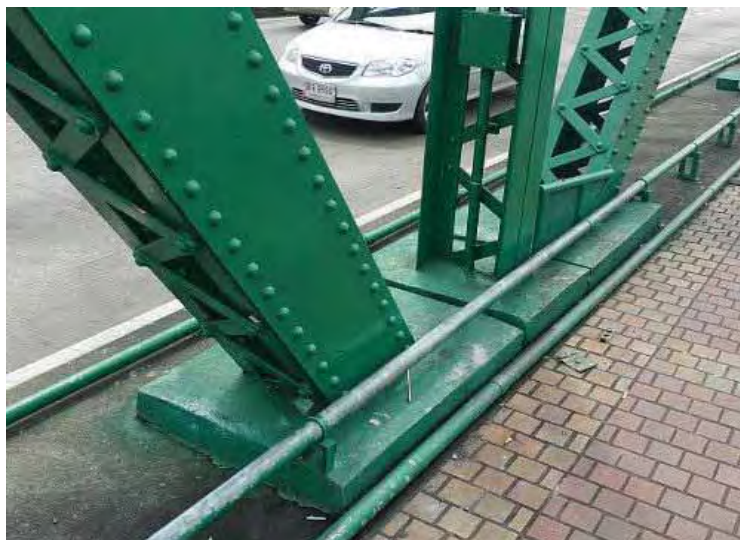
Picture No.	11
Span	1
Member	Inspection vehicle
Mounted up around steel member to prevent remaining water.	
It looks no gap around steel member from top side.

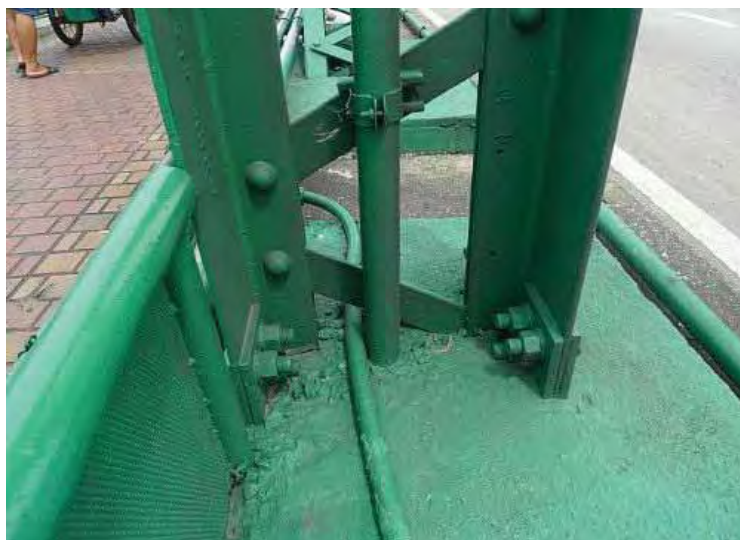
Picture No.	12
Span	1
Member	slab
It looks no gap around steel member from top side.

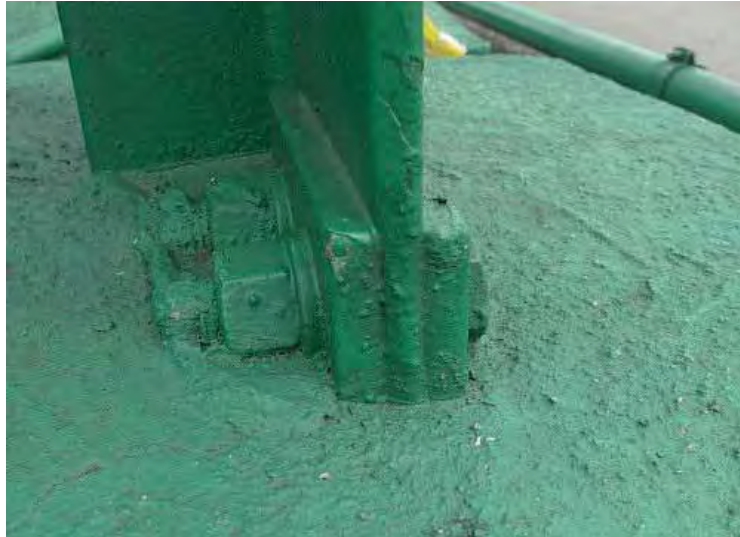
Picture No.	13
Span	1
Member	slab
Reinforcement by additional plate	
Original structure is connected by rivet	
Reinforcement structure is connected by high tension bolt.

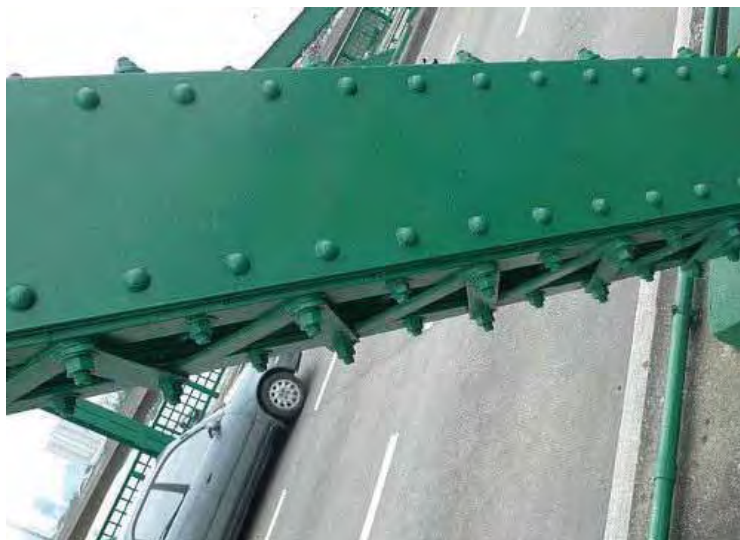
Picture No.	14
Span	1
Member	slab
Reinforcement plate top and bottom of member

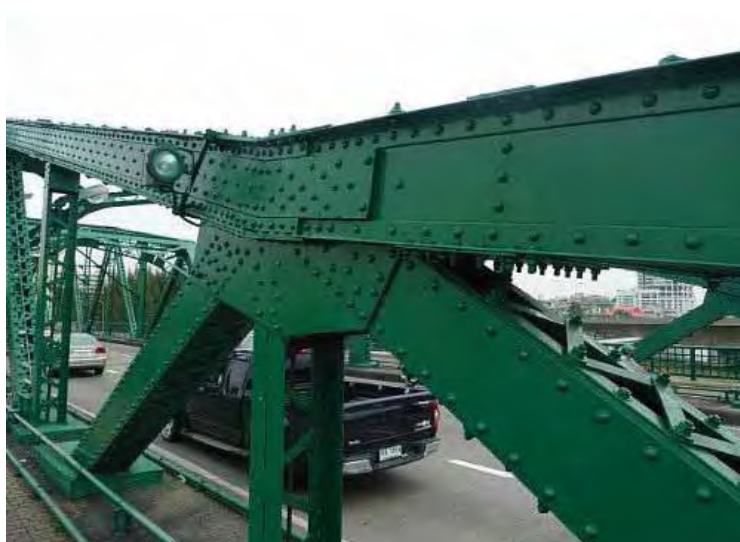
Picture No.	15
Span	1
Member	slab
Remaining water is seen inside of chord member

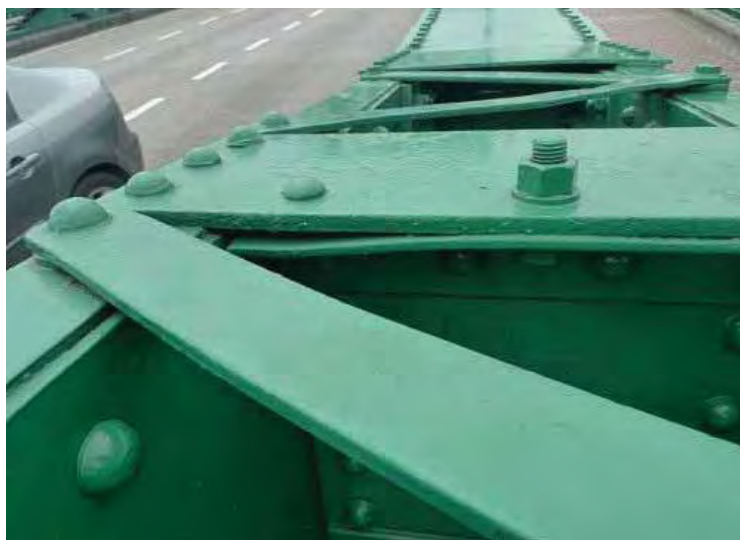
Picture No.	18
Span	1
Member	slab
Rivet is not changed to bolt.	
Reinforcement plate was connected only center by bolt.

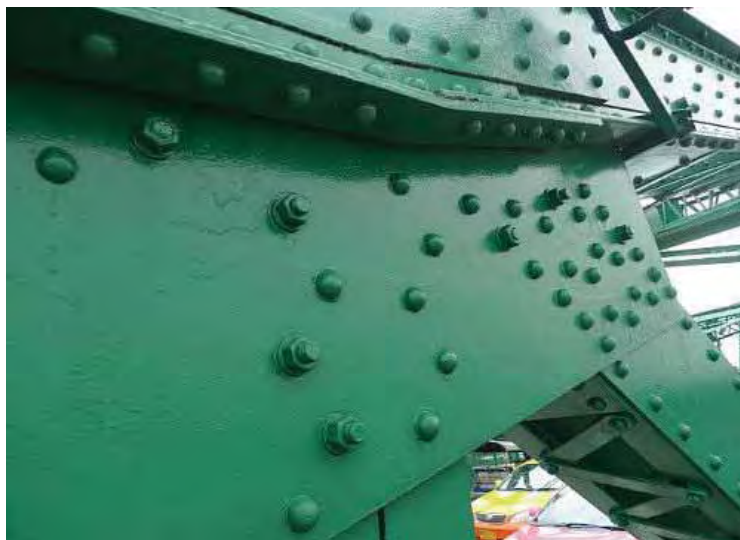
Picture No.	17
Span	1
Member	Bolt
Rivet was replaced by bolt

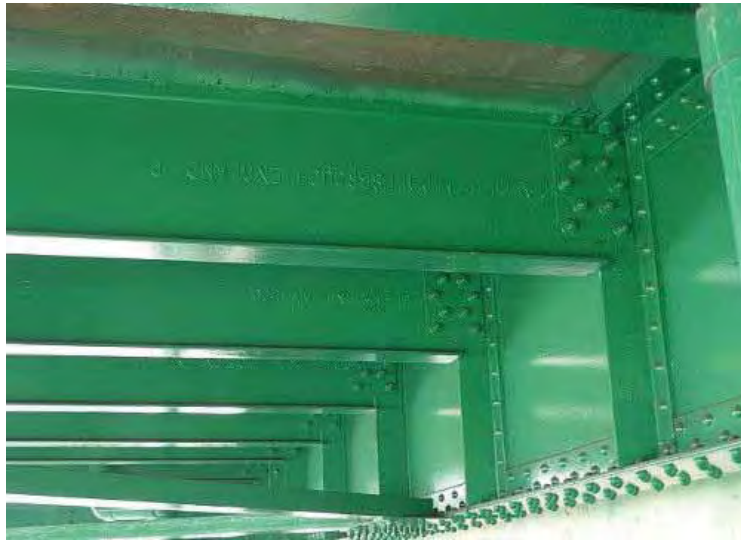
Picture No.	22
Span	1
Member	Stringer
Stringer is connected by high tension bolt.	
All stringer might be replaced at repairing work

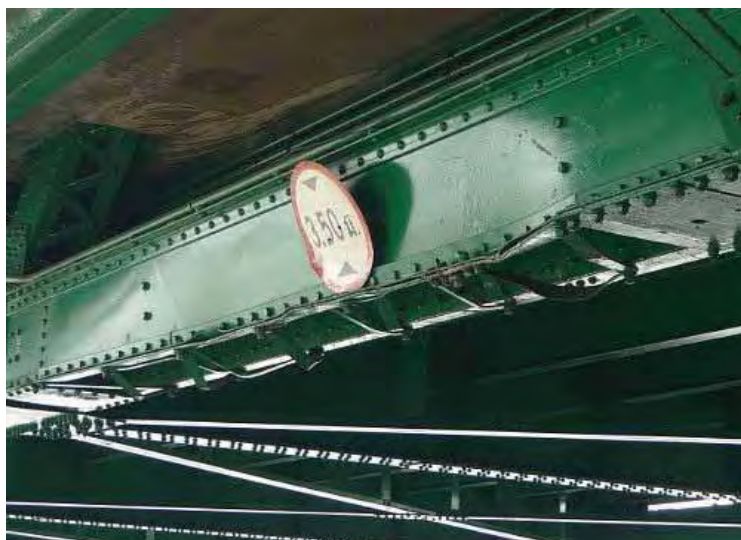
Picture No.	24
Span	1
Member	Bottom chord
Deformation by vehicle collision	
Thon Buri side

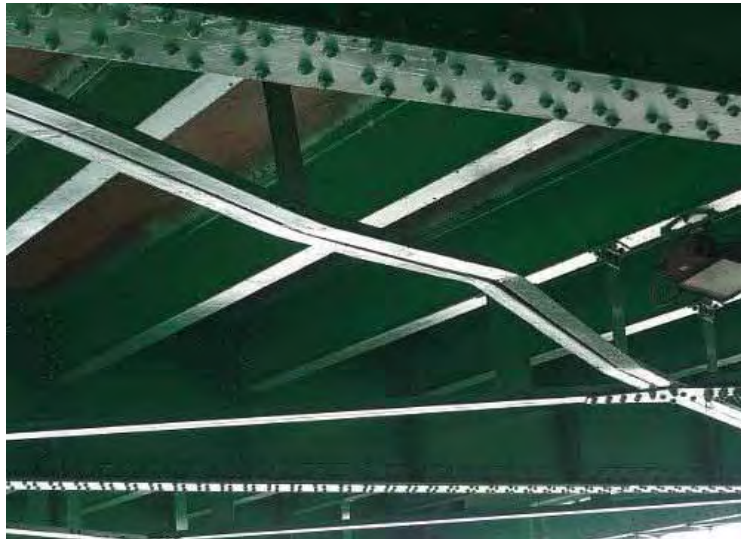
Picture No.	25
Span	1
Member	Cross frame
Thon Buri side	
Buckling by vehicle collision

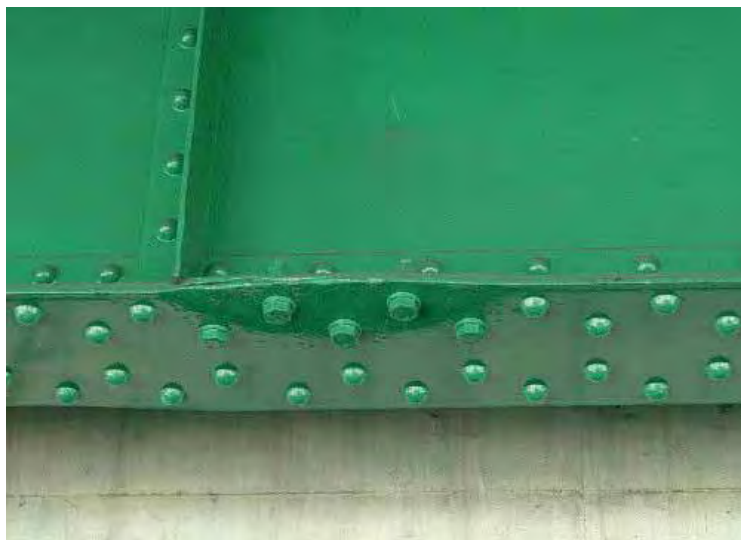
Picture No.	26
Span	1
Member	End cross beam
Deformation

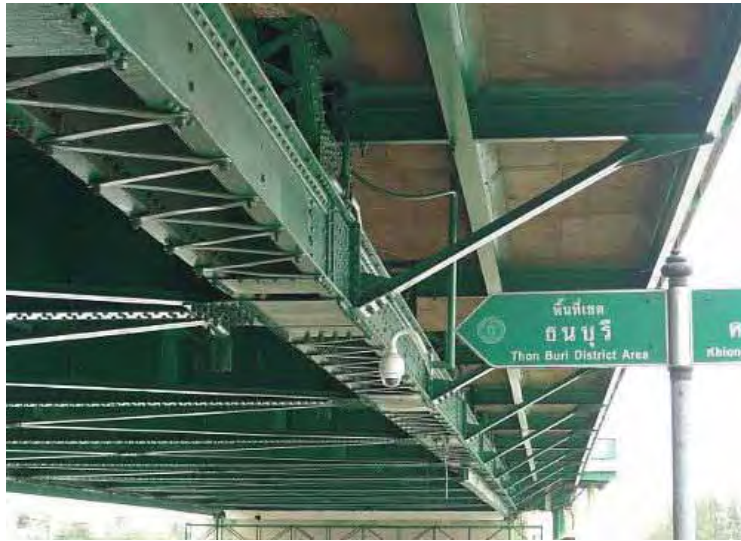
Picture No.	28
Span	1
Member	Monitoring camera

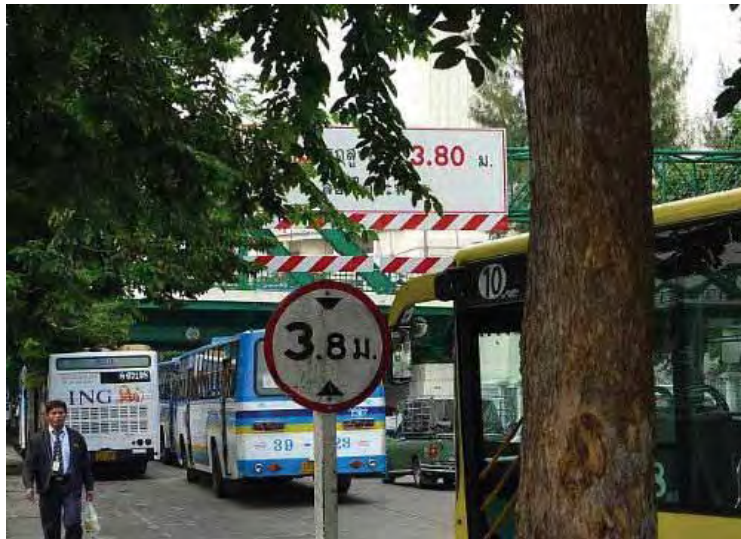
Picture No.	29
Span	1
Member	Worning frame

There is warning frame at Bangkok
side

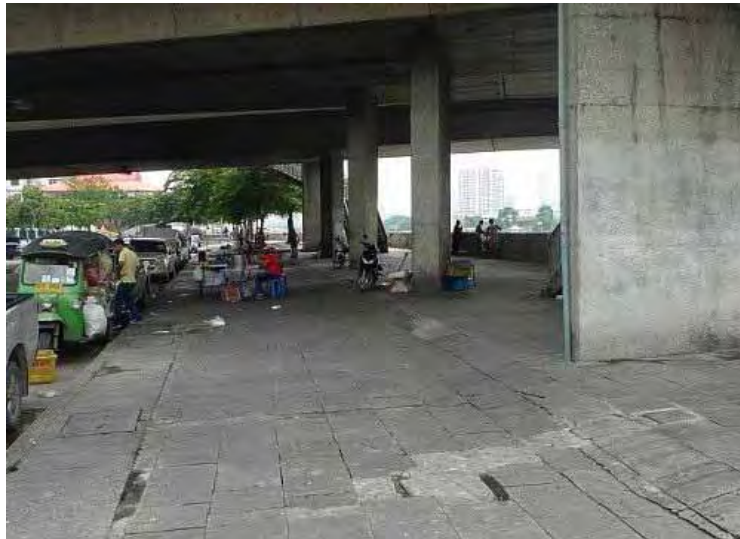
Picture No.	4
Span	1
Member	Approach bridge
Settlement around pier

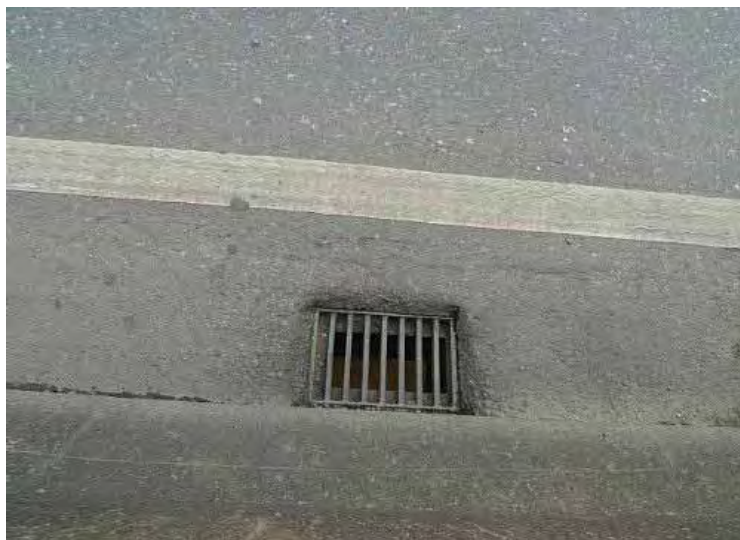
Picture No.	5
Span	1
Member	Catch basin

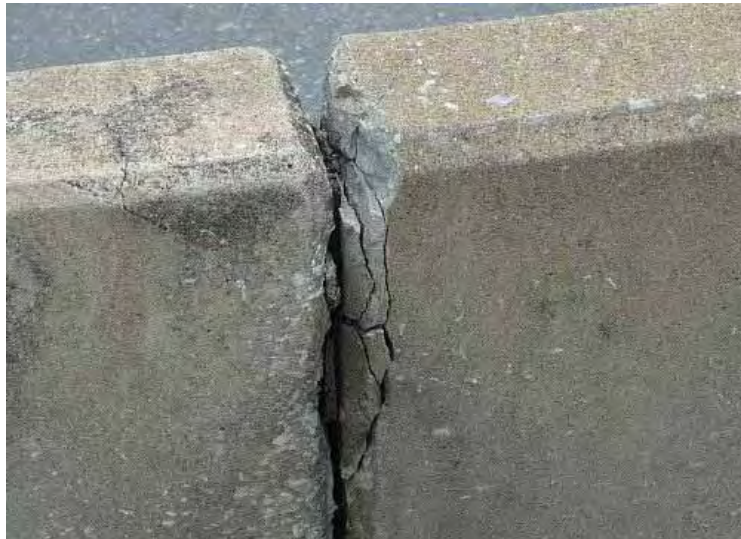
Picture No.	7
Span	1
Member	Side barrier
Exfoliation of concrete

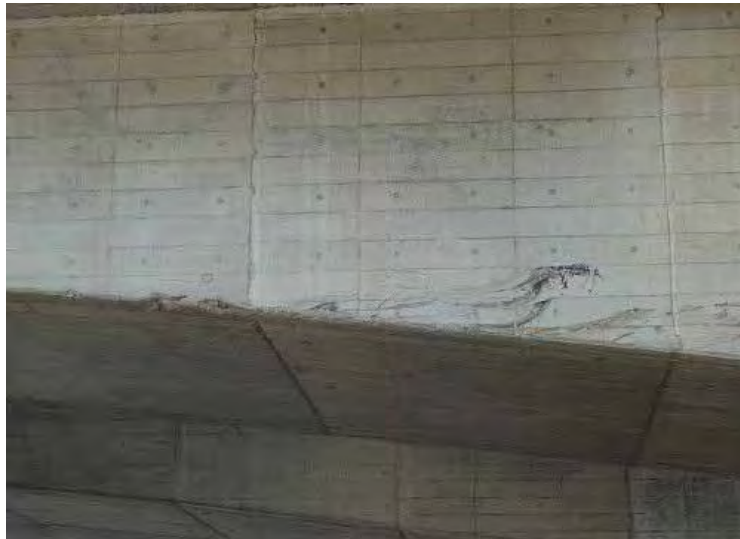
Picture No.	10
Span	1
Member	Drainage
Scratch by ship collision

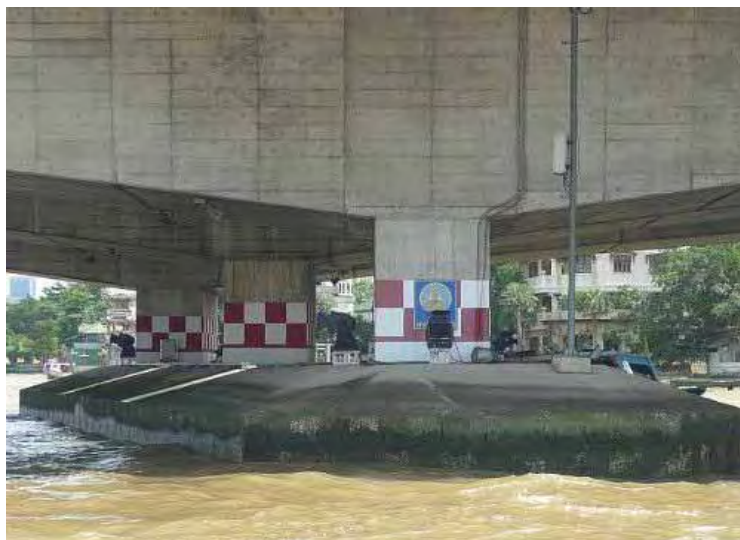
Picture No.	11
Span	1
Member	Substructure

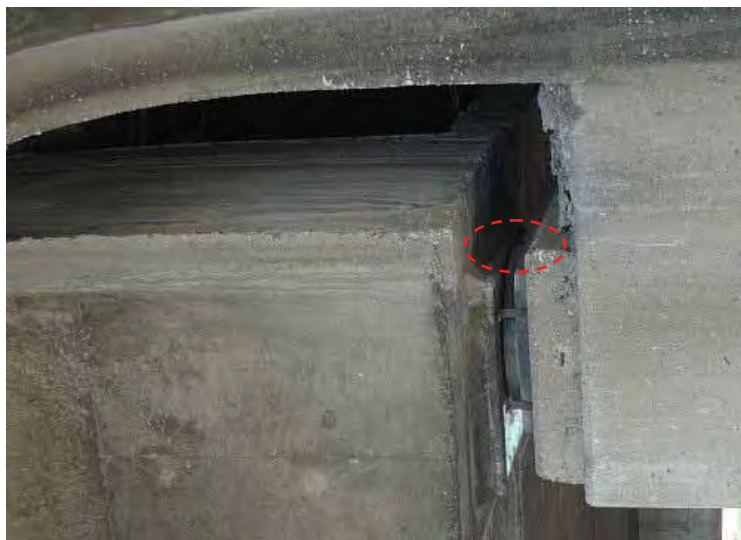
Picture No.	8
Span	1
Member	Bearing
Movement of bearing.	
Bangkok side	
Already reach to end of sliding plate

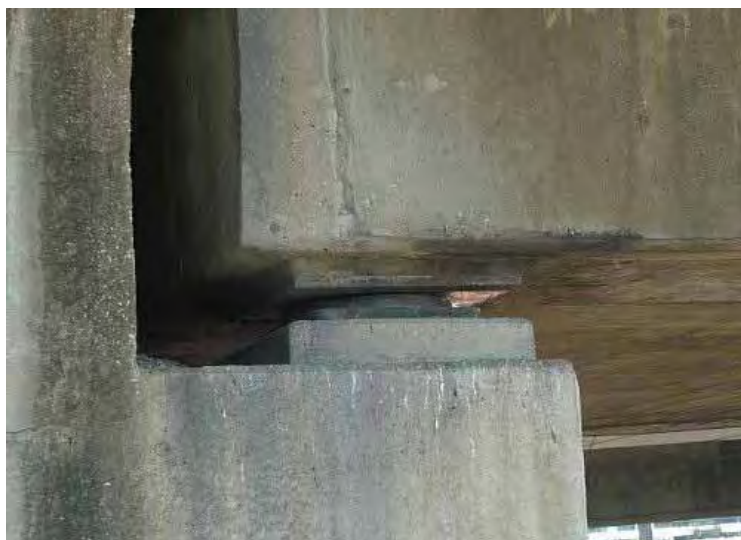
Picture No.	9
Span	1
Member	Bearing
Movement of Thon Buri side is sma

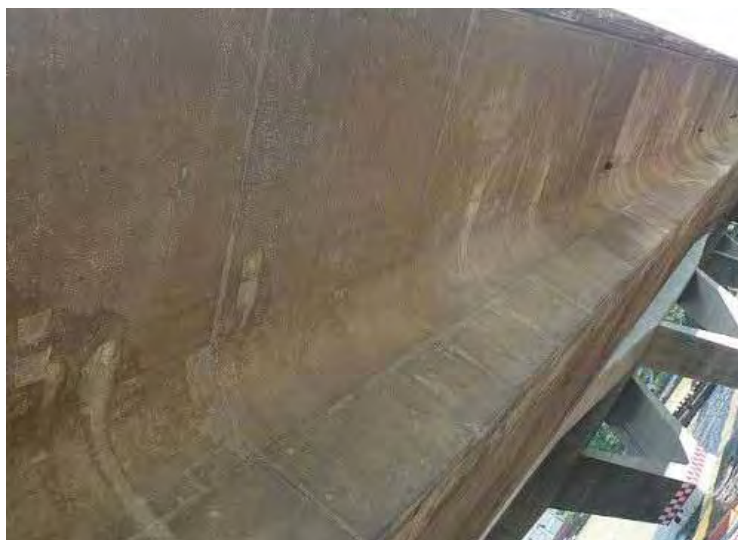
Picture No.	12
Span	1
Member	Slab
Free lime

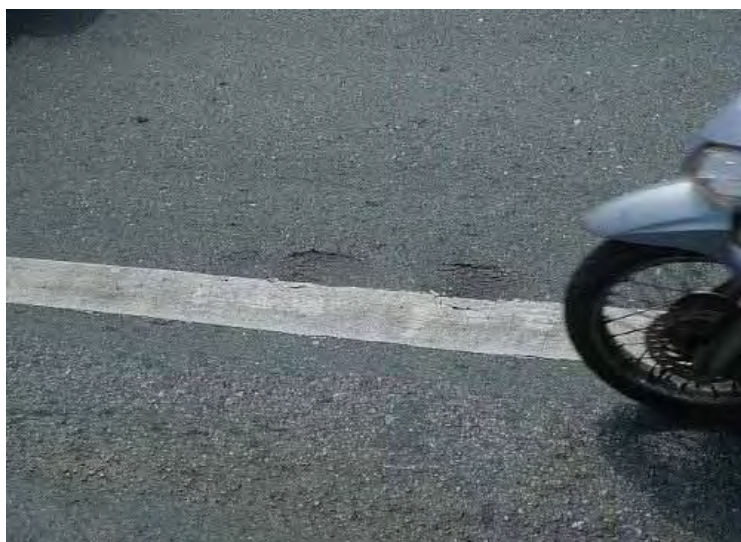
Picture No.	8
Span	1
Member	Pavement
Uneavenness of pavement	
Upstream, Bangkok side

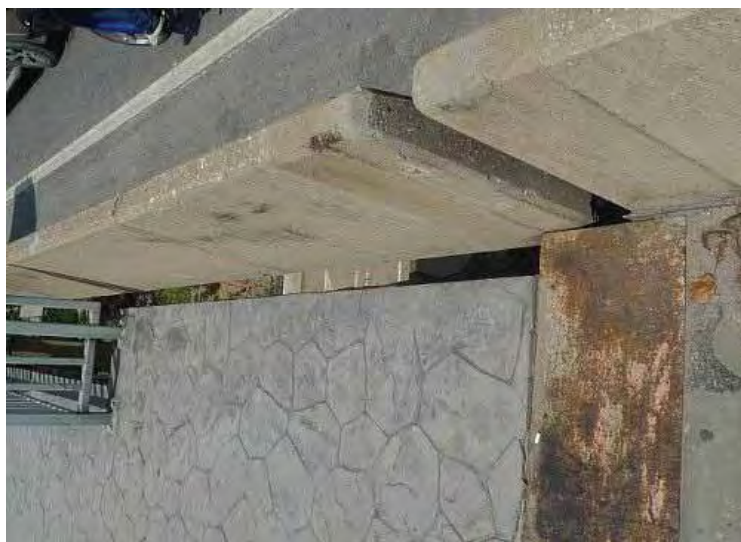
Picture No.	9
Span	1
Member	Walkway
Feeling uneasy due to wide gap

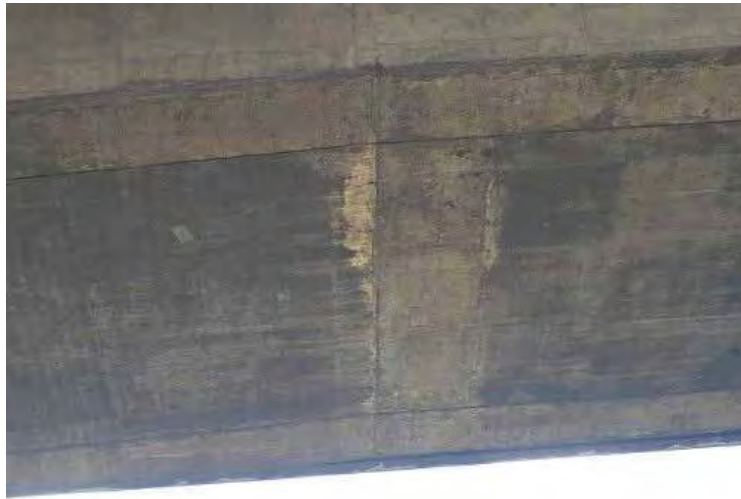
Picture No.	10
Span	1
Member	Girder
Free lime from construction joint

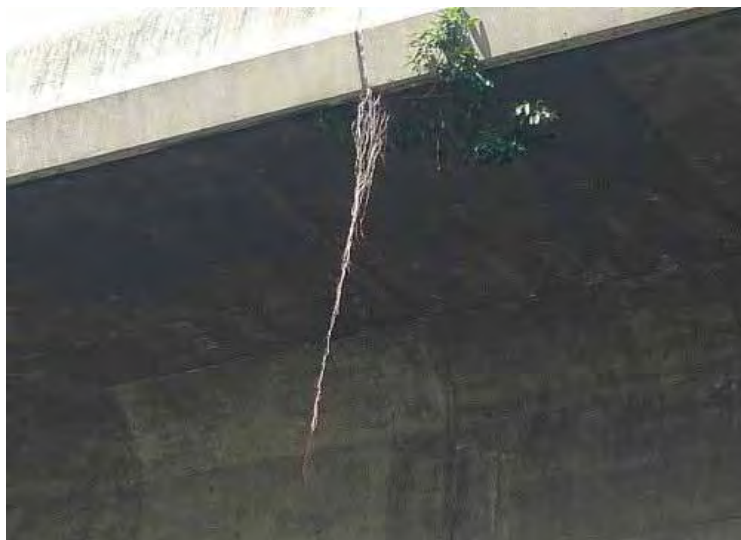
Picture No.	11
Span	1
Member	Girder
Acumuration of soil
