# Inspection sheet of visual survey

Bridge No. 16

Bridge name		RAMA III Bridge		Route name		-		Authority		DRR		Code of authority		-			
Place		from Khet Thon Buri to Khet Bang Kho Leam		Distance		from km+ 0 to km+ 0						No.		-			
												Survey date		2009/10/23			
Bridge properties	Bridge type(1)	main road · side road · ramp															
	Bridge type(2)	bridge · viaduct · plank pass															
	Bridge type(3)	3-span continuous PC box girder															
	Total length	476.00 (m)															
	Span	125 + 226 + 125 (m)															
	Nos. of span	3 span															
	Width	23.00 (m) / (m)															
	Completion	2000															
Road information	Horizontal	Straight · incli ( $\theta =$ ° ) · Curve ( R m )															
	Gradient	One way ( ↗ · ↘ ) parabo ( $\frac{1}{4}$ · $\frac{3}{4}$ )															
	Nearby tunnel	yes · no ( m )															
	Nearby crossing	yes · no ( m )															
	Traffic	Much · Medium · Little

Bridge name		Krung Thep Bridge		Route name		-		Authority		DRR		Code of authority		-			
Place		from Khet Thon Buri to Khet Bang Kho Leam		Distance		from km+ 0 to km+ 0						No.		-			
												Survey date		2009/10/23			
Bridge properties

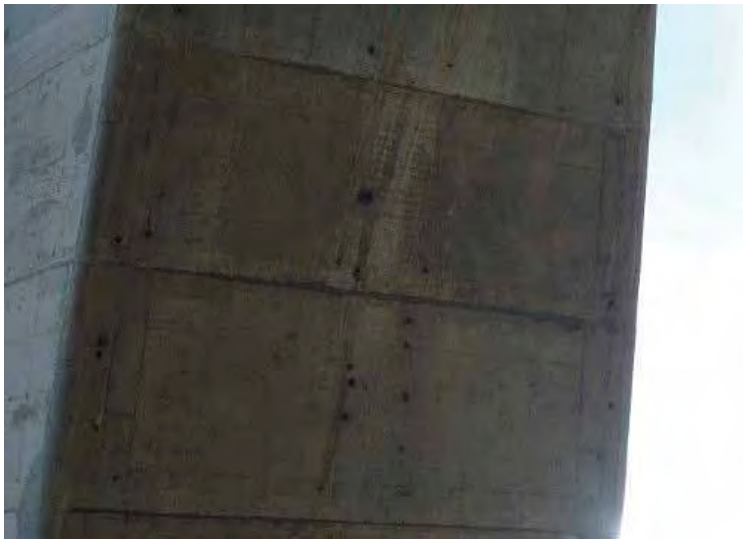
Picture No.	5
	Span	1
	Member	Girder
	Unfilled hole	
	Picture No.	6
	Span	1
	Member

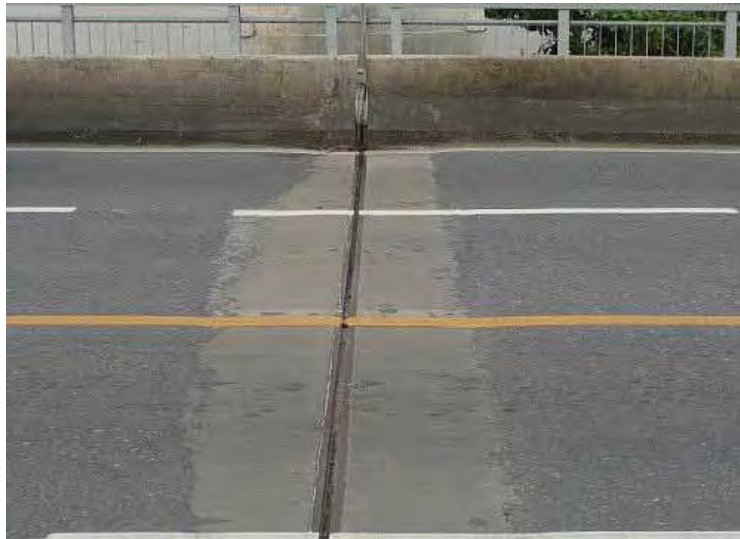
Picture No.	10
Span	1
Member	Expansion joint
Height adjustment around joint

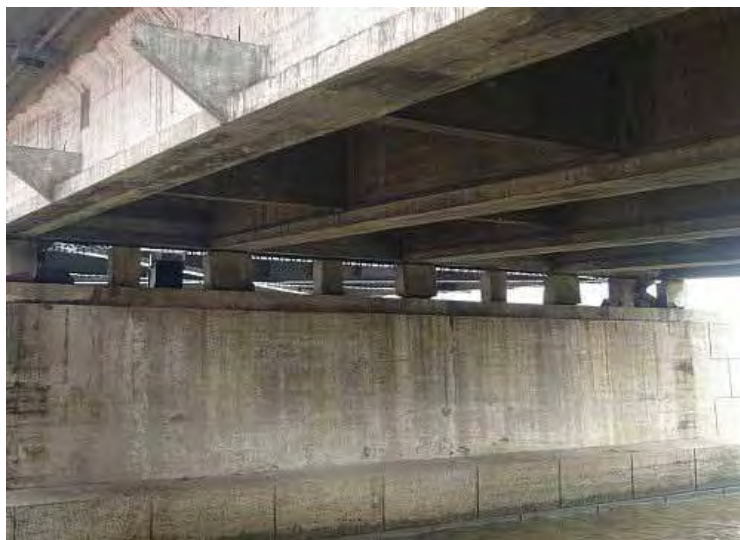
Picture No.	11
Span	1
Member	Bearing
Locker bearing, Approach bridge

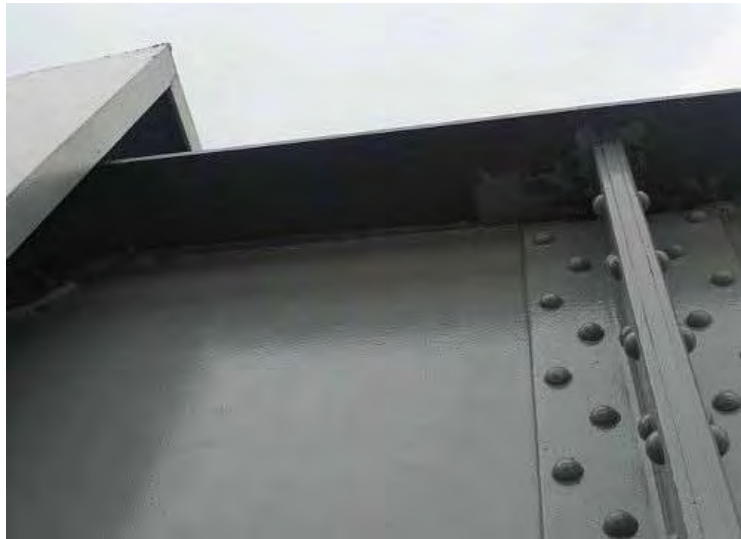
Picture No.	25
Span	1
Member	Center span
Over coating is not painted lower side of flange.

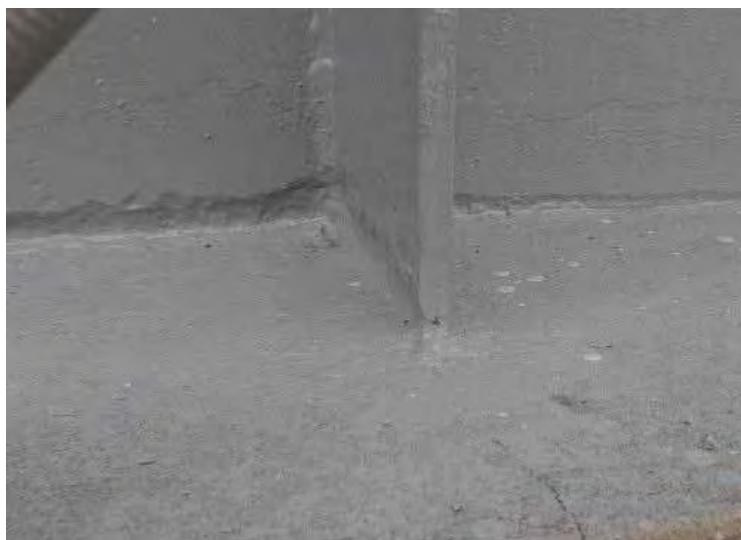
Picture No.	27
Span	1
Member	Center span
Reduction of plate thickness of steel plate.

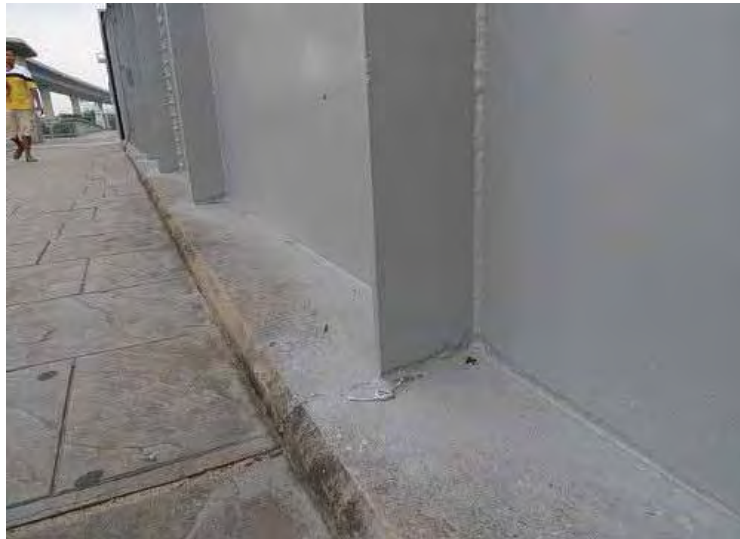
Picture No.	28
Span	1
Member	Center span
Reduction of plate thickness of steel plate.	
There is no remaining water

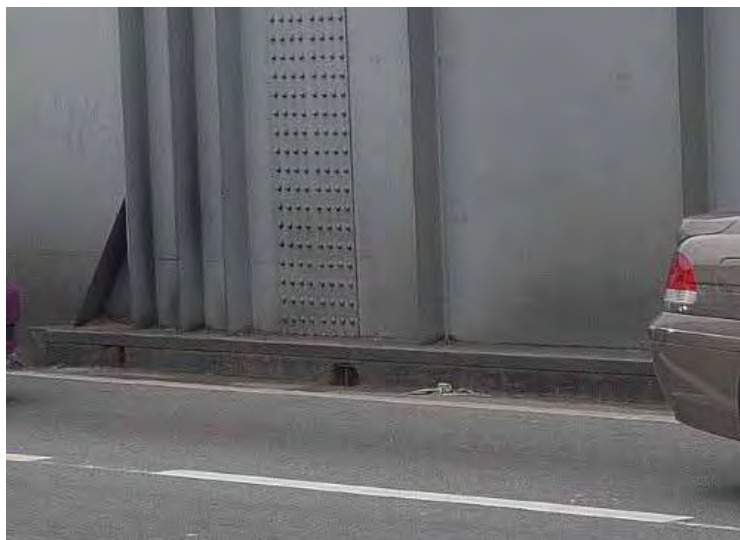
Picture No.	29
Span	1
Member	Center span
Dirt line is seen at bottom of we	
Possibility of remaining water and soil

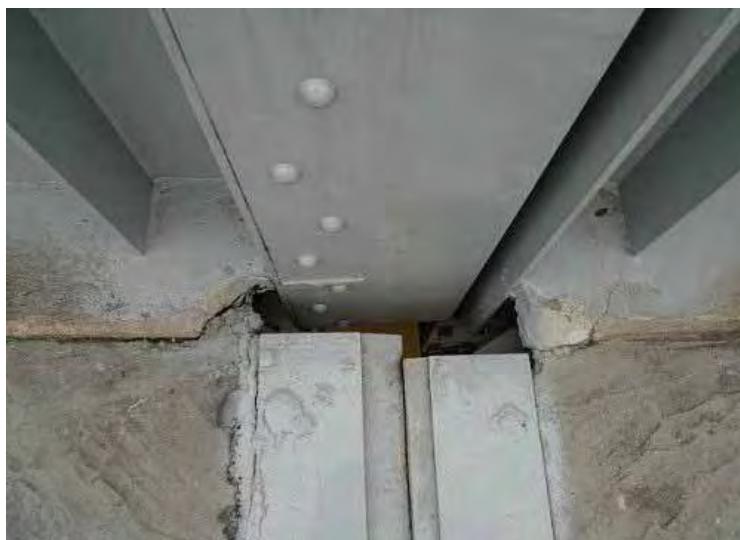
Picture No.	30
Span	1
Member	Center span
Difference at center joint

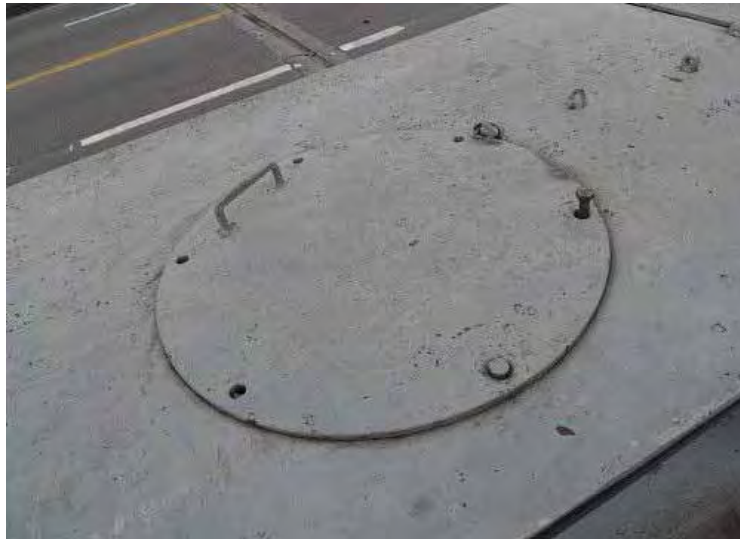
Picture No.	31
Span	1
Member	Center span
Manhole	
Lost of bolt	
No key

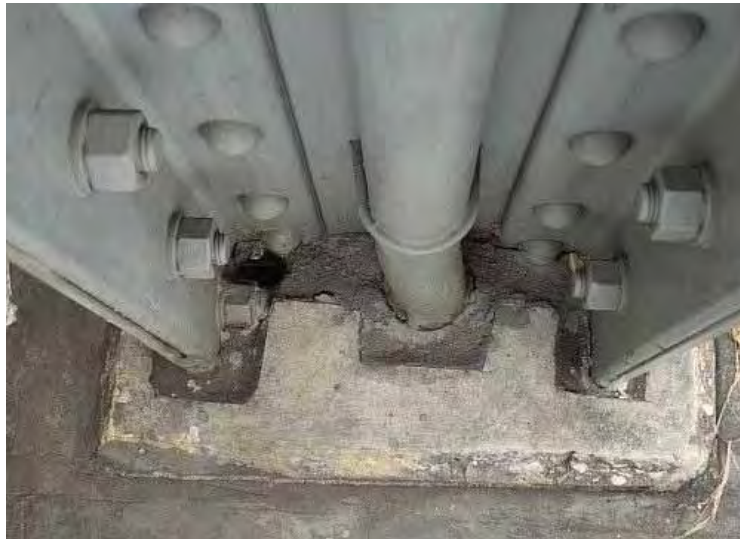
Picture No.	37
Span	1
Member	Vertical member
Reinforcement by additional plate

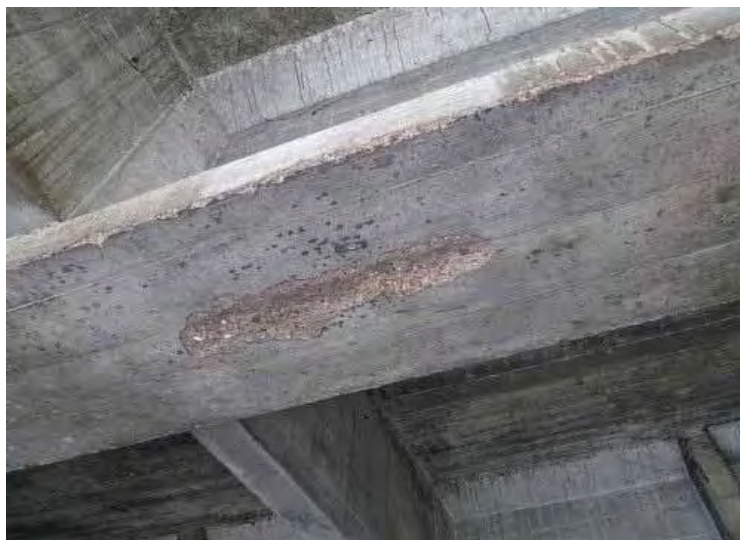
Picture No.	38
Span	1
Member	Approach bridge
Exfoliation

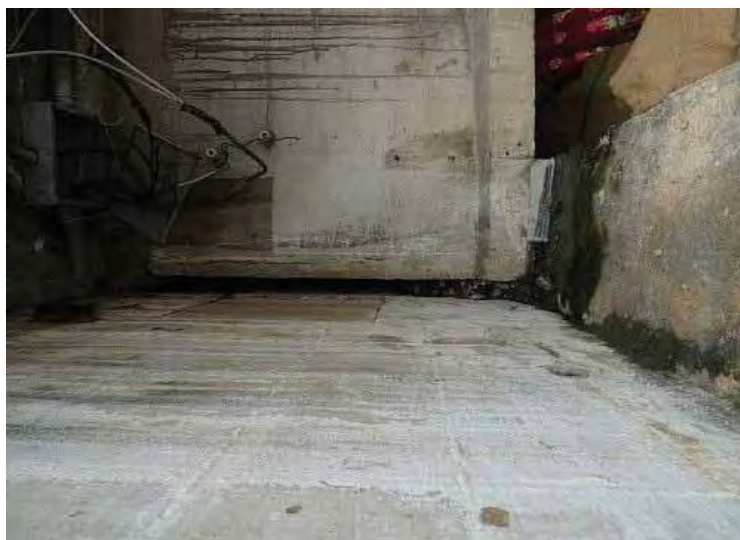
Picture No.	39
Span	1
Member	Approach bridge
Remaining water at shoe

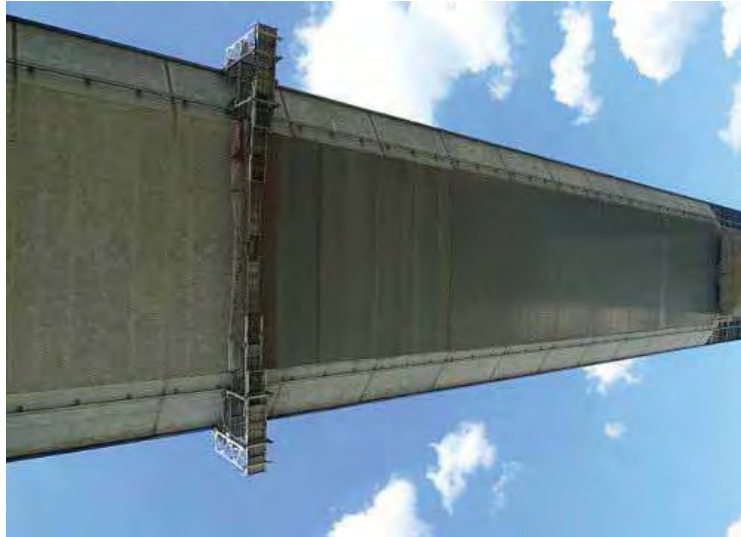
Picture No.	4
Span	1
Member	View under bridge
Under repainting using inspection vehicle	
<i>*Survey on board, 31-oct</i>

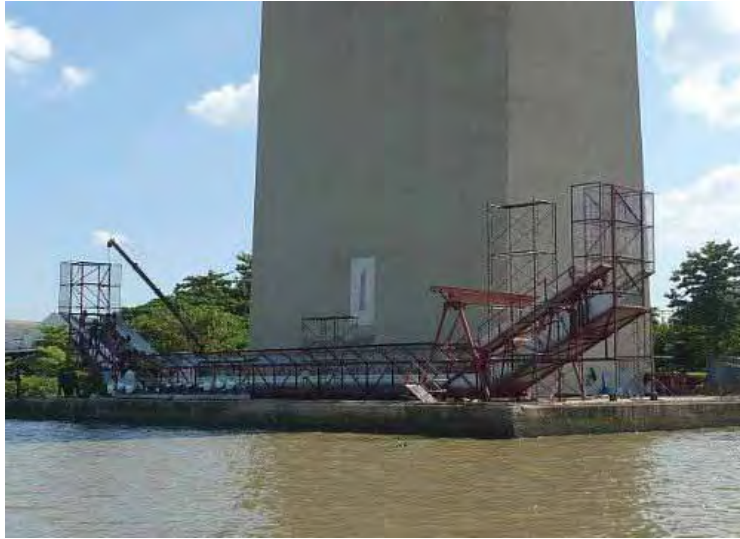
Picture No.	7
Span	1
Member	Inspection vehicle

Preparing work for painting?

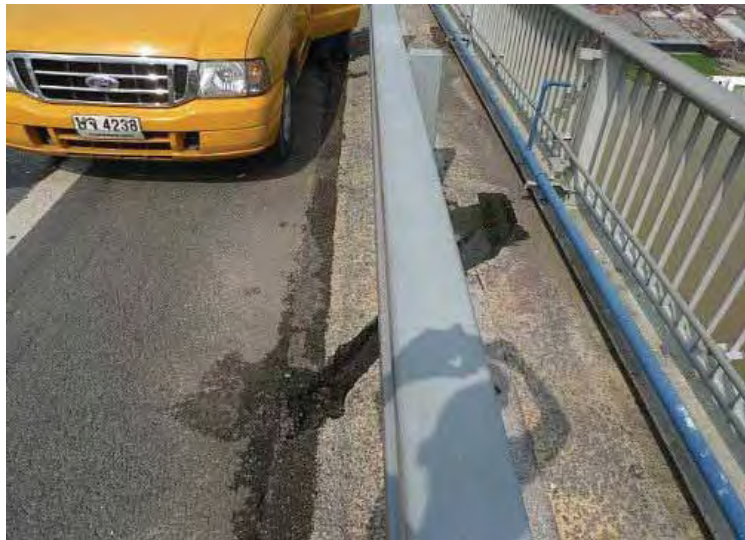
Picture No.	7
Span	1
Member	Drainage
Guide of rain water

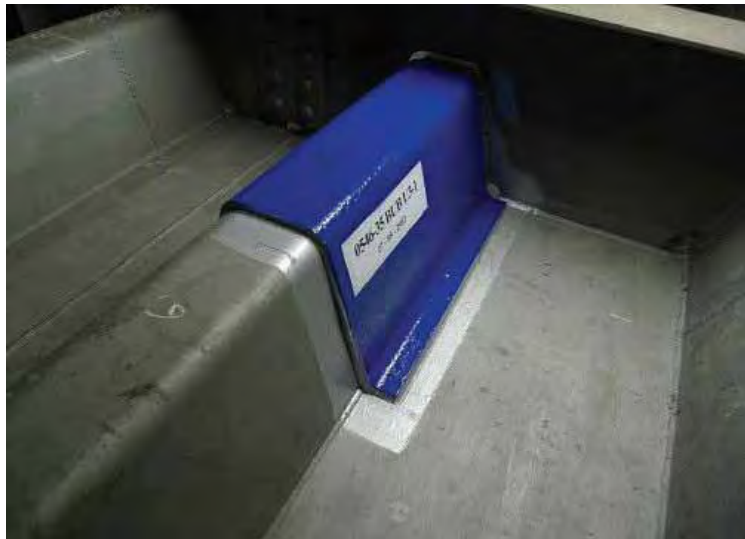
Picture No.	11
Span	1
Member	Bottom flange
Reinforcement by CFRT

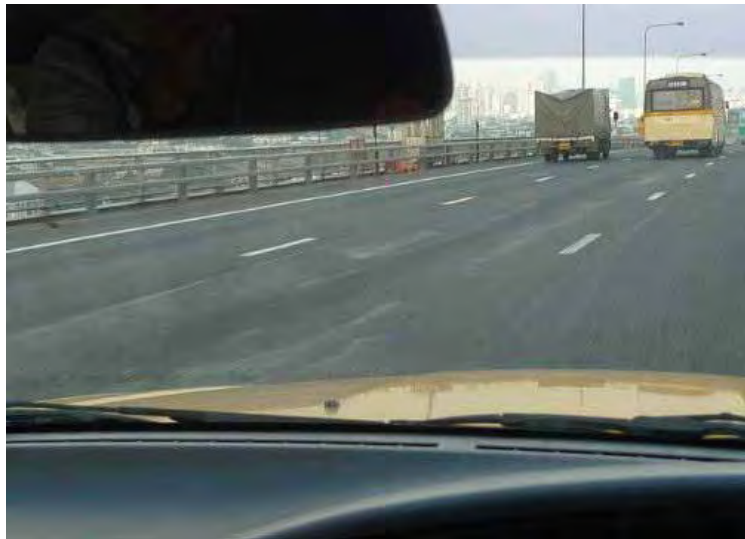
Picture No.	17
				Span	1
				Member	Pavement
				All layer of pavement was replaced at 2005	
				Picture No.	18
				Span	1
				Member	slab

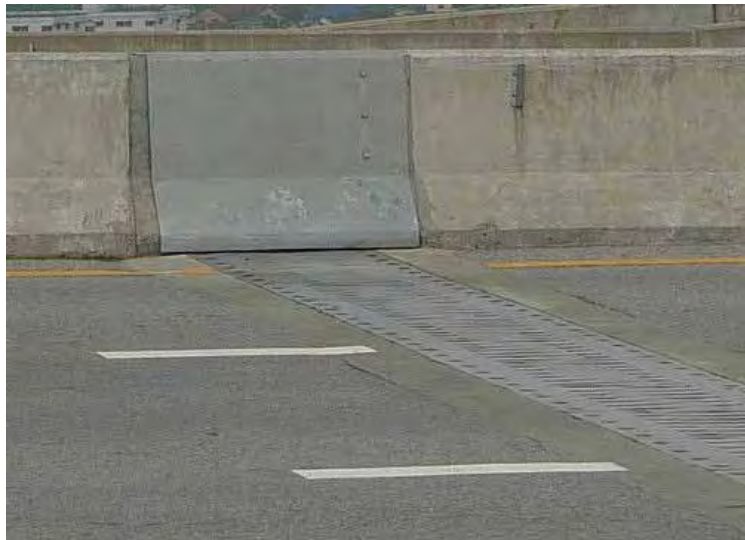
Picture No.	10
Span	1
Member	Expansion joint
South side. Adjustment of difference of grade

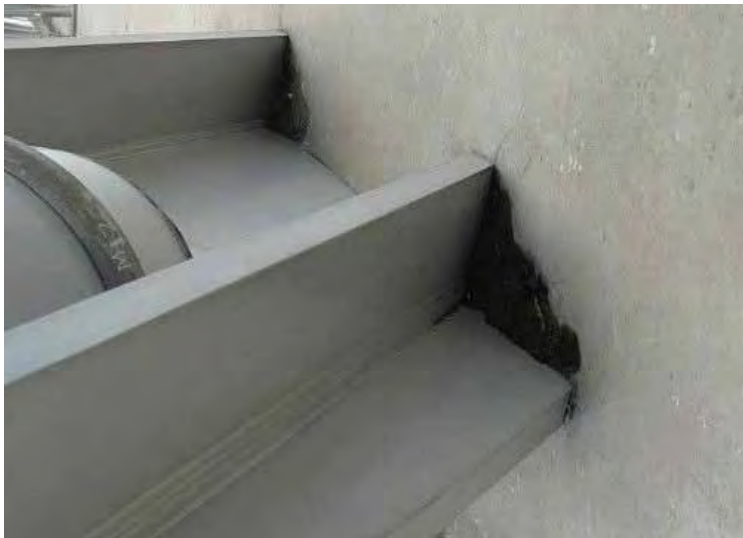
Picture No.	16	
			Span	1	
			Member	slab	
			Accumulaton soil at fixing struct

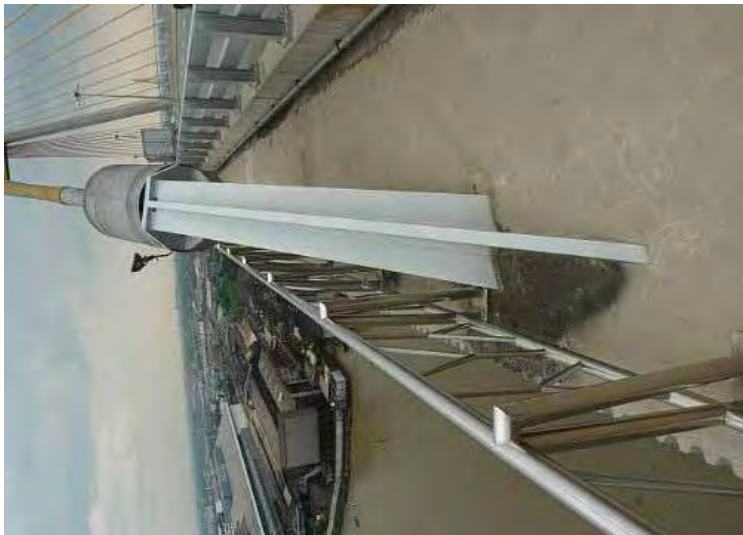
Picture No.	17	
			Span	1	
			Member	slab	
			Accumulaton soil at fixing struct

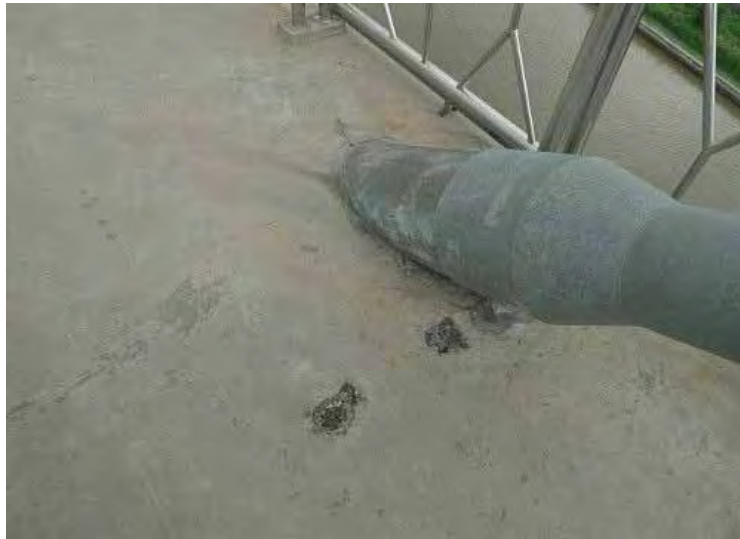
Picture No.	16
Span	1
Member	slab
Peeling of concrete

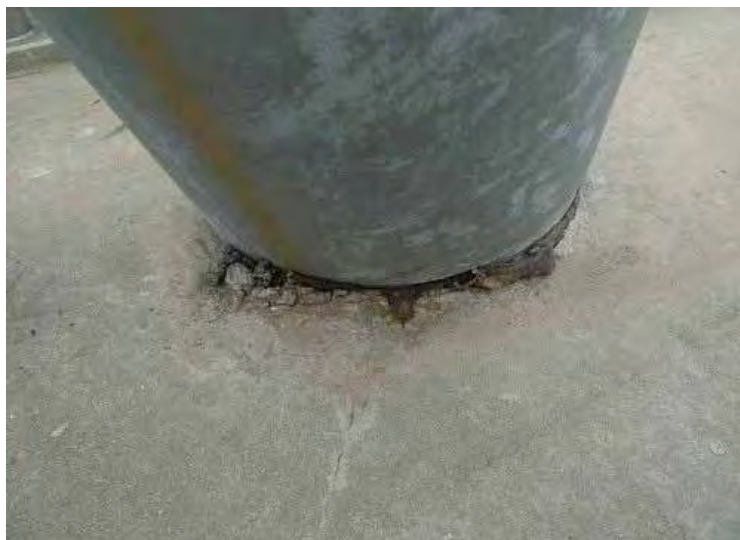
Picture No.	17
Span	1
Member	slab
Fixing structure	
Mold?
