Appendix-6

Bridge Inspection Sheets of Visual Survey

Inspection sheet of visual survey

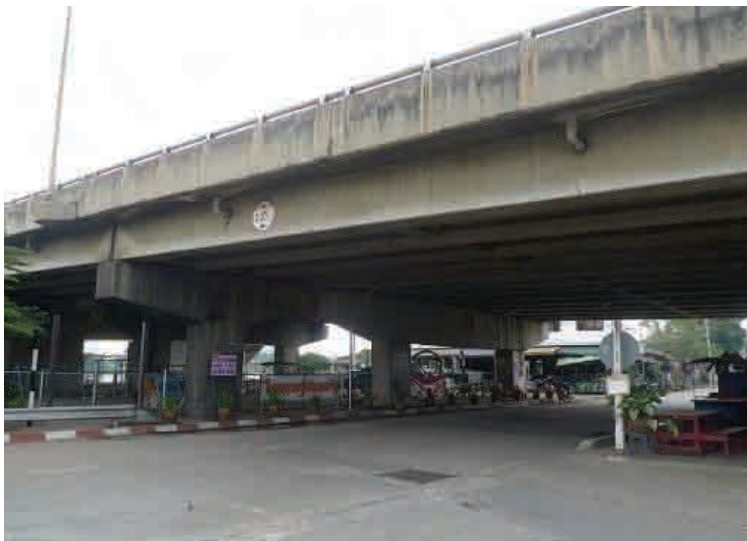
Picture No.	6
	Span	1
	Member	Approach bridge
	Limit of vehicle height, 3.5m

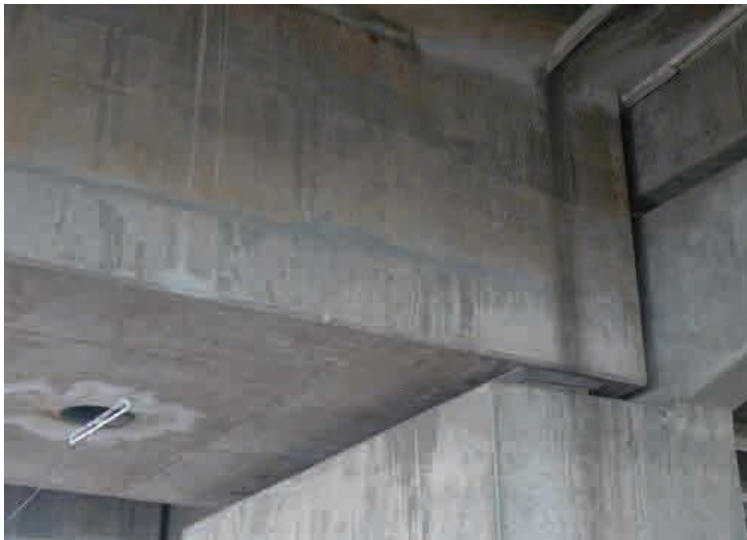
Picture No.	7
	Span	1
	Member	manhole
	About 5m.

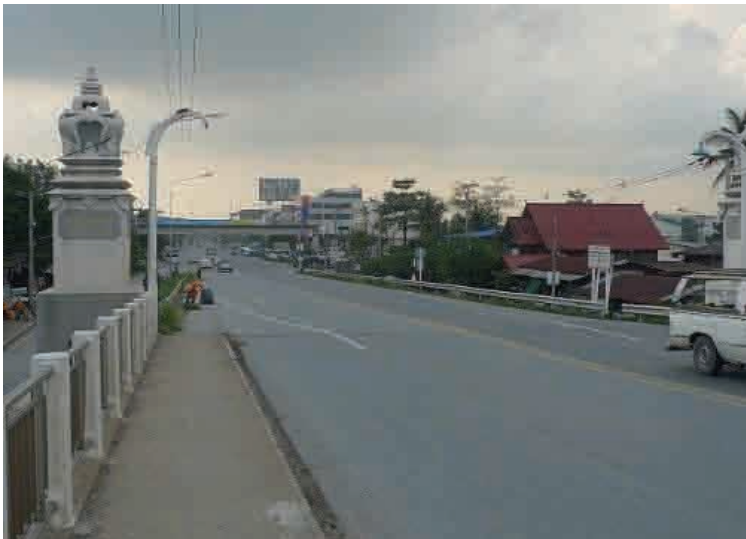
Picture No.	7
	Span	1
	Member	Approach road
	Approach road is 4 lane	
	Main bridge is 2 lane	
	Approach road of Thon Buri side is under widening.

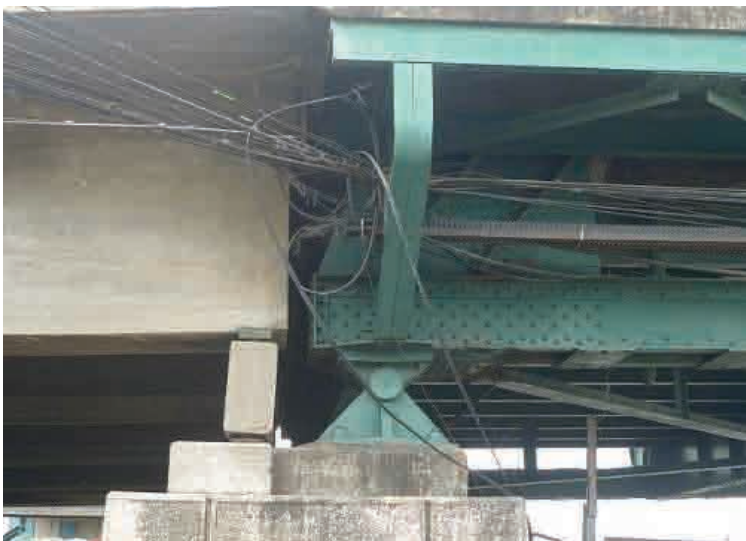
Picture No.	8
	Span	1
	Member	Bearing
	Structure around bearing

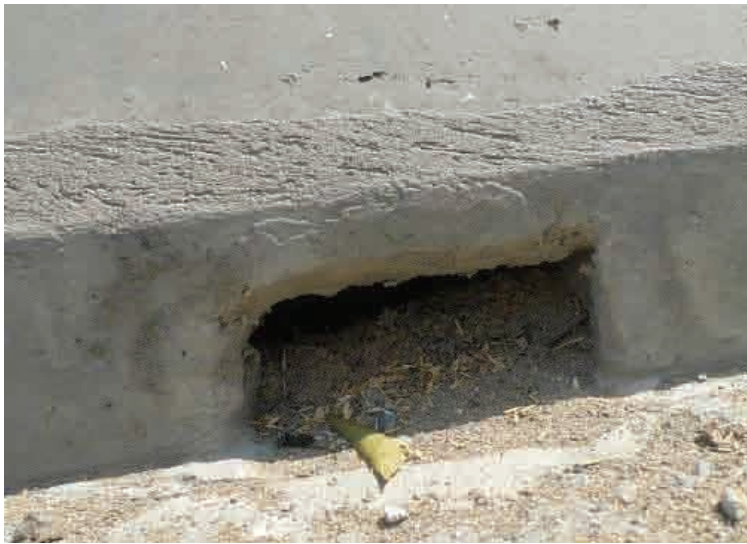
Picture No.	25
	Span	1
	Member	Drainage
	Drainage under barrier
