Inspection sheet of visual survey

Bridge No. 6

Bridge name		Pra Nangklaio Bridge		Route name		-		Authority		DOH		Code of authority		-	
Place		from Anphoe Bang Bua Thong		Distance		from km+ 0						No.		-	
		to Anphoe mueang Nonthaburi				to km+ 0						Survey date		24-oct-2009	
Bridge properties	Bridge type(1)	main road · side road · ramp													
	Bridge type(2)	bridge · viaduct · plank pass													
	Bridge type(3)	5-span continuous PC box girder													
	Total length	330.00 (m)													
	Span	51 + 72 + 84 + 72 + 51 (m)													
	Nos. of span	5 span													
	Width	21.80 (m) / (m)													
	Completion	1985													
Road information	Horizontal	Straight · incli(= 1.5 °) · Curve (R m)													
	Gradient	One way (·) parabo (▽ · ▽)													
	Nearby tunnel	yes · no (m)													
	Nearby crossing	yes · no (m)													
	Traffic	Much · Medium · Little													
	Commercial traffic	Much · Medium · Little

Authority	DOH	Address	Bangkok	Data	24-Oct-09
Bridge	Phra NangKlao Bridge

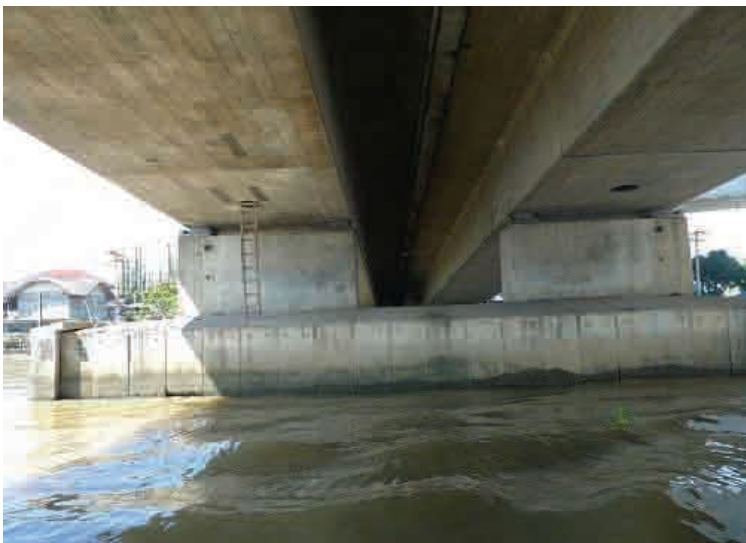
Picture No.	17
	Span	1
	Member	View of footing

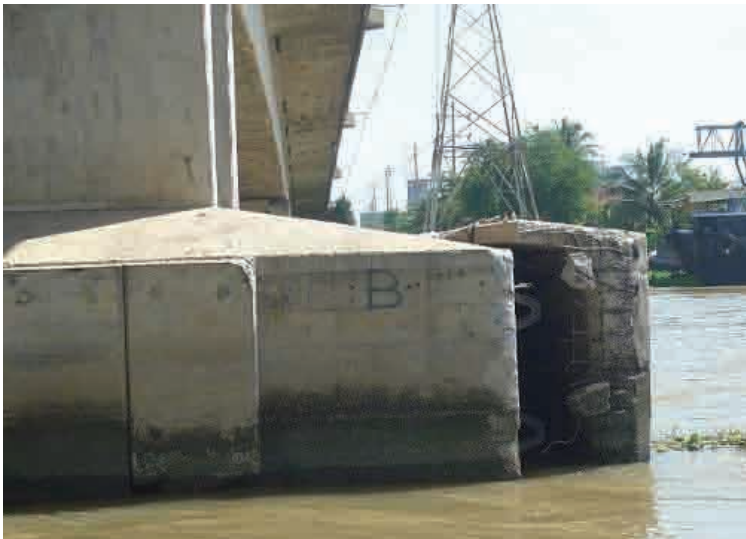
Picture No.	10
	Span	1
	Member	Footing
	Breaking and movement	
	<i>*Survey on board, 31-oct</i>	
	Picture No.	11
	Span	1
	Member	
	Picture No.	12
	Span	1
	Member

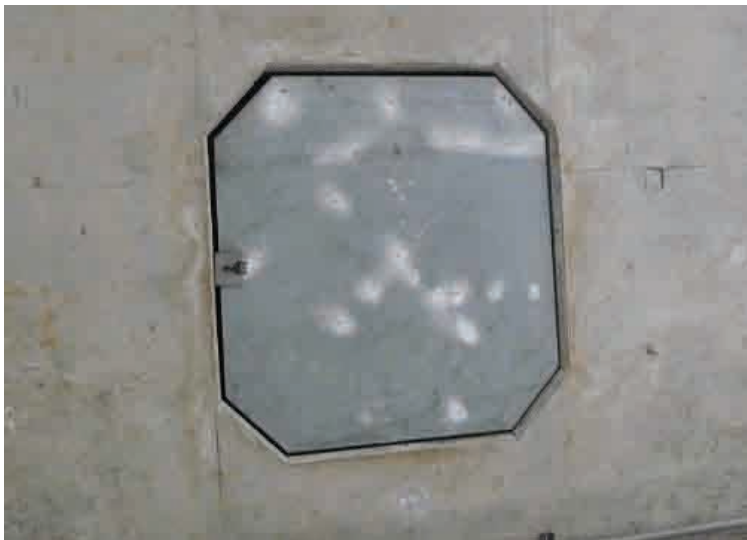
Picture No.	5
	Span	1
	Member	Manhole (walkway side)
	With key

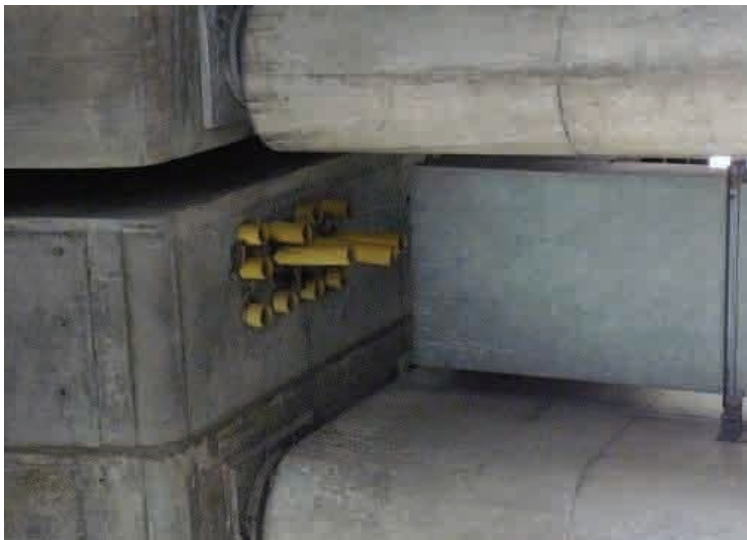
Picture No.	8
	Span	1
	Member	slab (walkway, roadway)
	Electric and communication line

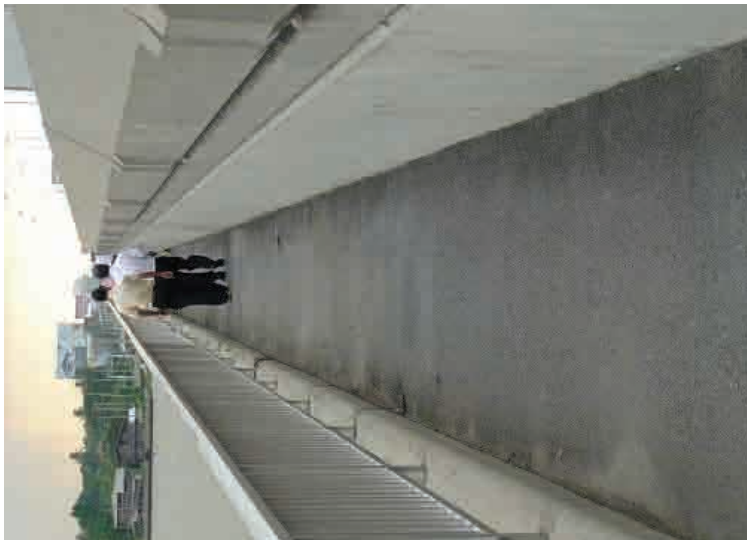
Picture No.	7
	Span	1
	Member	walkway
	Less than 2m	
	Inspection vehicle cannot park in walkway	
 	Picture No.	8
	Span	1
	Member	Handrail
	Stolen of stainless handrail	
 	Picture No.	9
	Span	1
	Member	Pier head
	Genellary healthy

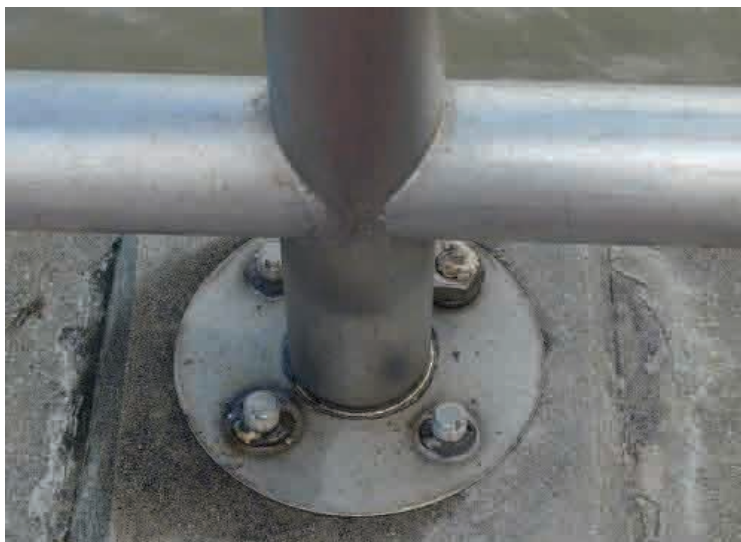
Picture No.	5
Span	1
Member	Handrail
Antitheft welding

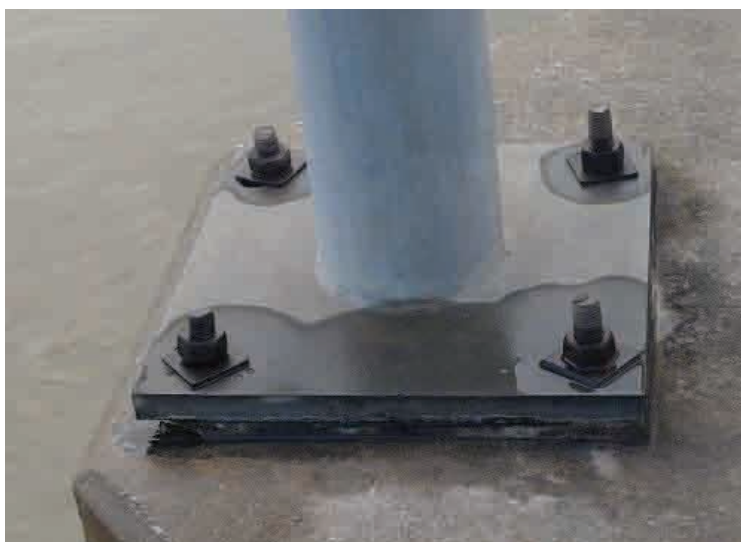
Picture No.	6
Span	1
Member	Lighting pole
Deformation of bolt

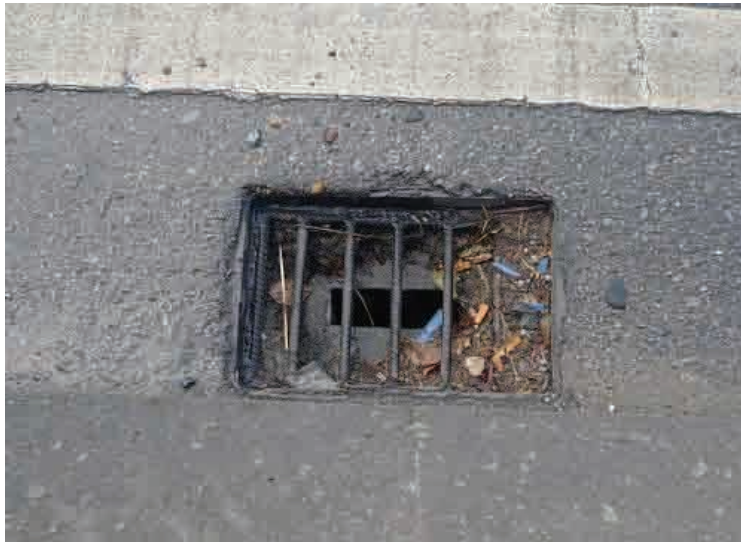
Picture No.	7
Span	1
Member	Catch basin
Partly blocked

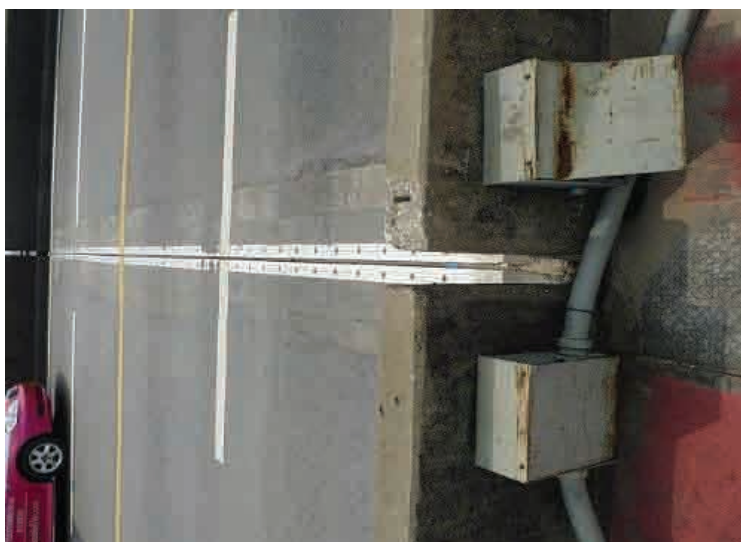
Picture No.	6
Span	1
Member	Expansion joint

Between 1st and 2nd span (Thon Buri side)
--

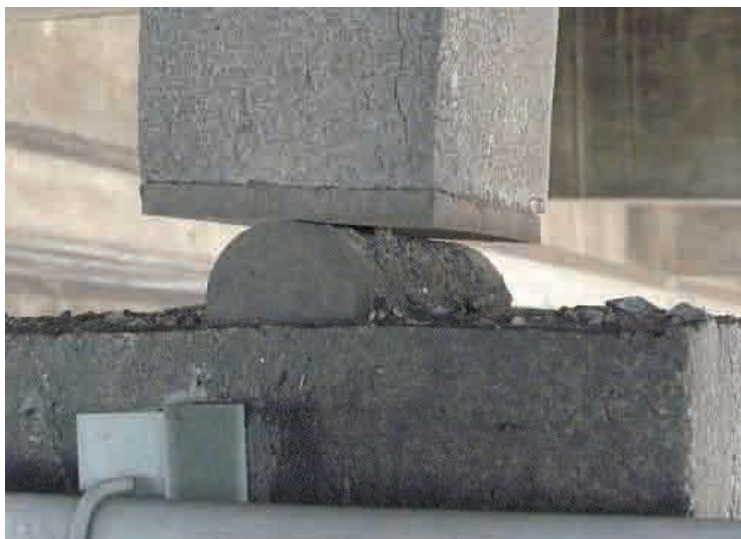
Picture No.	20
Span	1
Member	Bearing
Bearing on cross beam between main girder	
Approach bridge

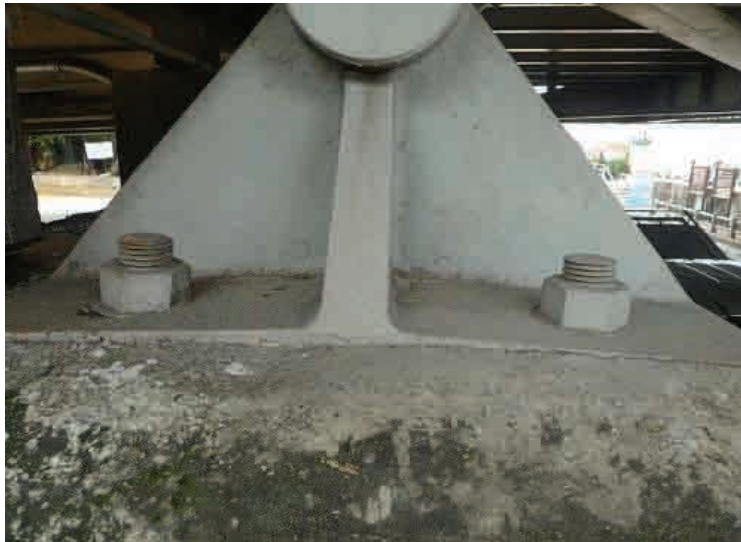
Picture No.	22
Span	1
Member	Bearing
Deformation of base plate

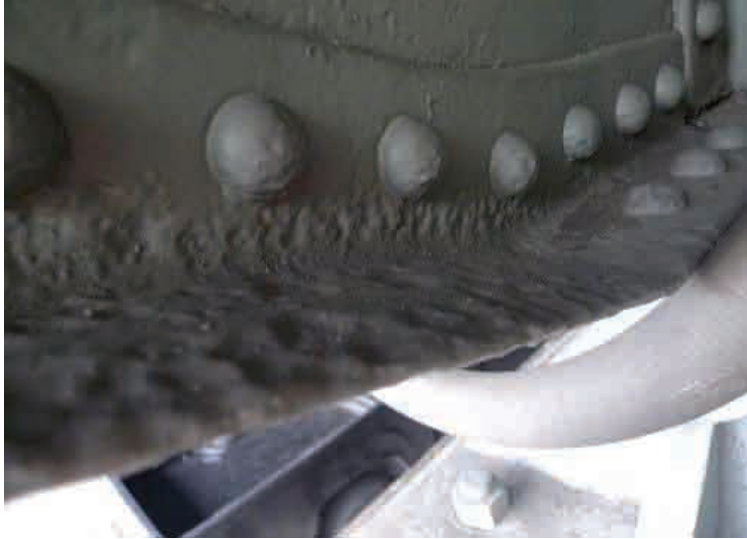
Picture No.	29
	Span	1
	Member	Bracket
	Reduction of plate thickness

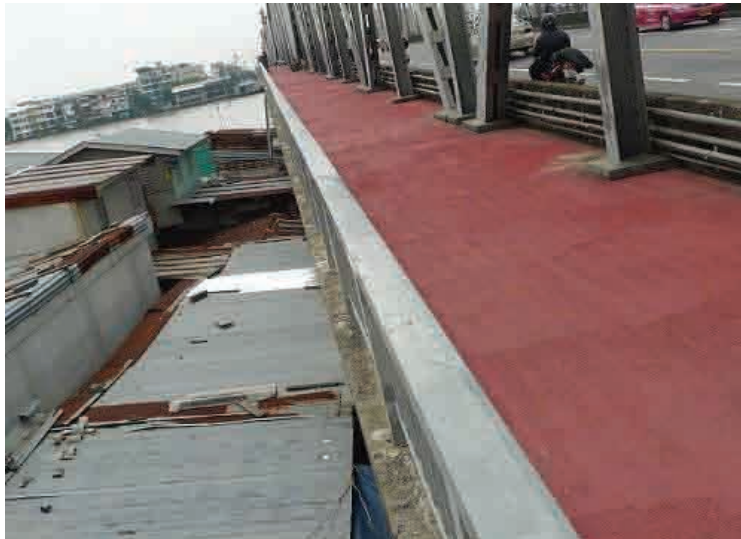
Picture No.	49
Span	1
Member	Under bridge
Residence under bridge	
Bangkok side

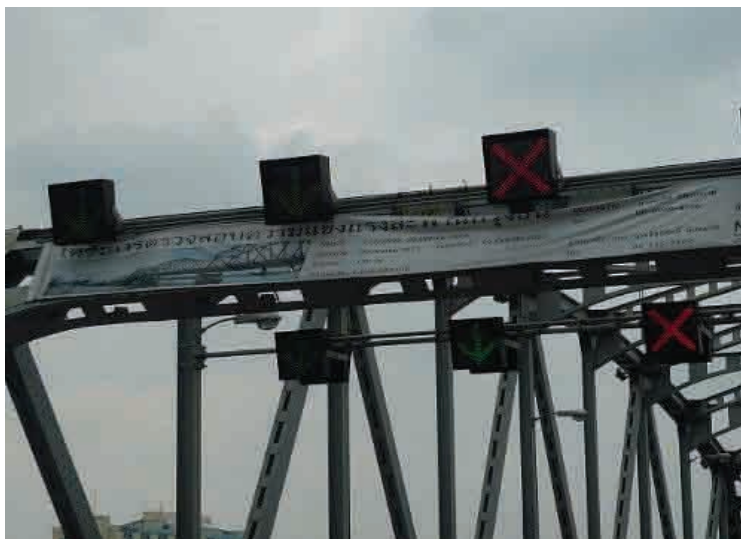
Picture No.	50
Span	1
Member	Slab
Signboard of inspection and repairing work	
150days from 2009.Feb	
Consultant is Norconsultant

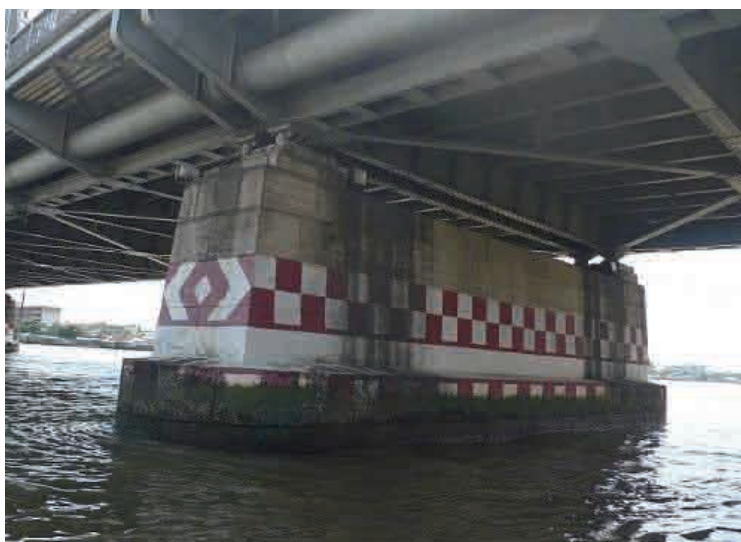
Picture No.	51
Span	1
Member	Substructure
<i>*Survey on board, 31-oct</i>
