Inspection sheet of visual survey

Bridge name		RAMA VIII Bridge		Route name		-		Authority		BMA		Code of authority		-		
Place		from Khat Bang Phlat to Khet Phra Nakhon		Distance		from km+ 0 to km+ 0						No.		-		
												Survey date		23-Oct-2009		
Bridge properties	Bridge type(1)	main road · side road · ramp														
	Bridge type(2)	bridge · viaduct · plank pass														
	Bridge type(3)	4-span composite 2 l girder cable stayed bridge														
	Total length	475.00 (m)														
	Span	75 + 50 + 50 + 300 (m)														
	Nos. of span	4 span														
	Width	29.20 (m) / (m)														
	Completion	2002														
Road information	Horizontal	Straight · incli(= 2 %) · Curve (R m)														
	Gradient	One way (·) parab (▽ · ▽)														
	Nearby tunnel	yes · no (m)														
	Nearby crossing	yes · no (ramp way)														
	Traffic	Much · Medium · Little														
	Commercial traffic	Much · Medium · Little

Appendices

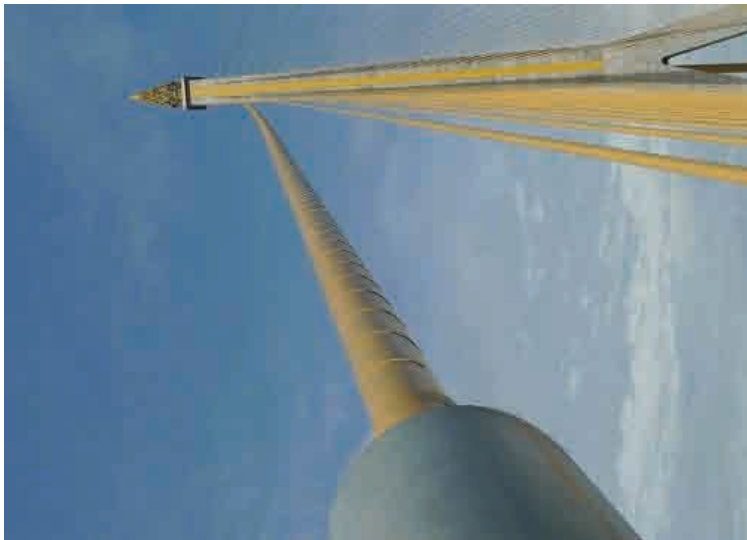
Picture No.	7
	Span	1
	Member	View of cable
	Helical type wind resistance

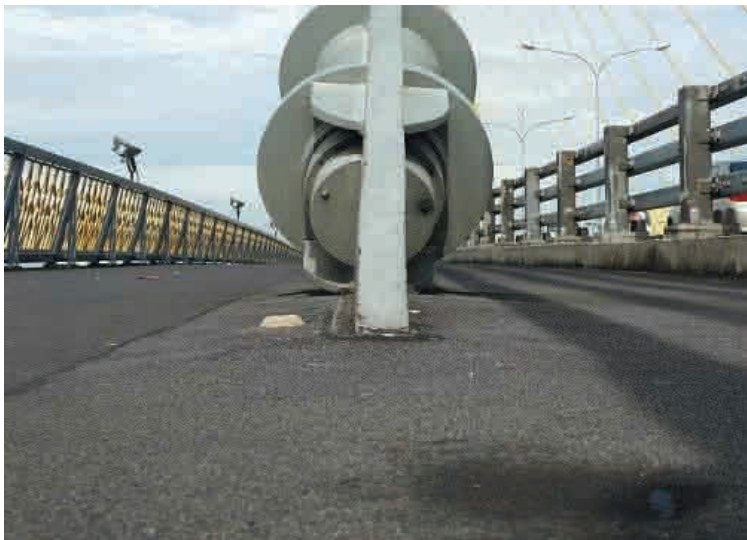
Picture No.	11
	Span	1
	Member	Cable fixing structure
	slab. And mounted up around cable to prevent remaining water.

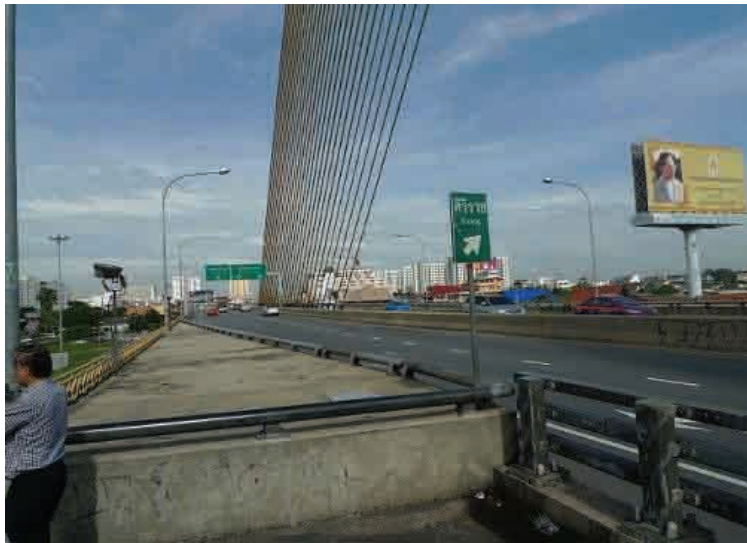
Picture No.	7
Span	1
Member	Side span and approach
side span is 3+2 lane for ramp wa

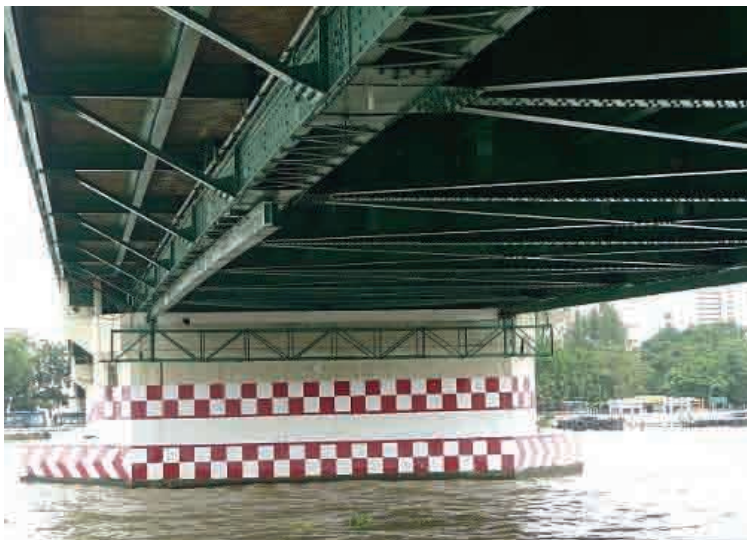
Picture No.	3
	Span	1
	Member	View under girder
	Inspection vehicle of side span.	
	No inspection vehicle in center span

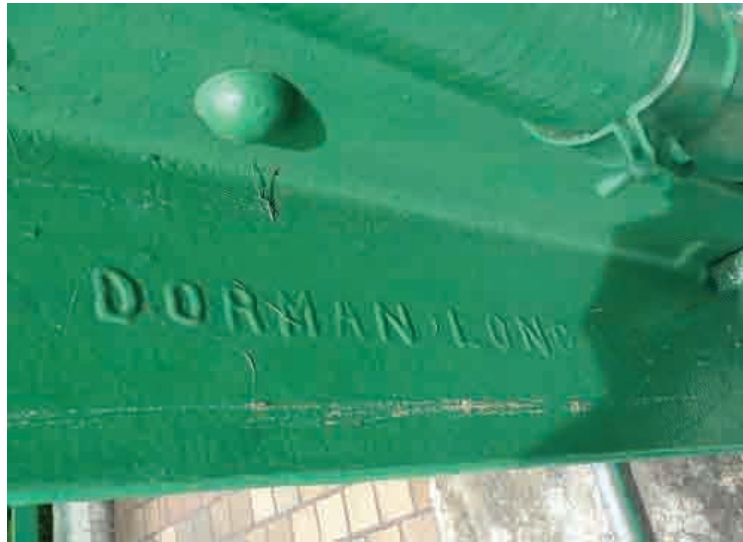
Picture No.	7
Span	1
Member	material
The material made in England	
It's seems that same fabricator provide material for repairing wo

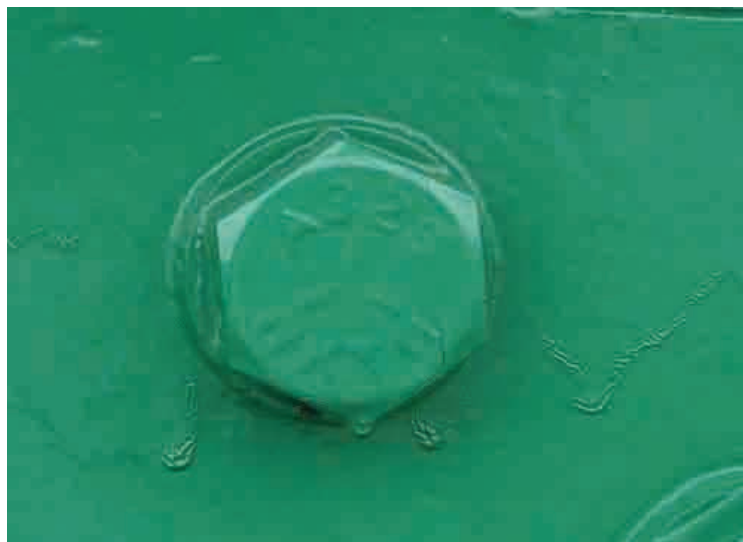
Picture No.	8
Span	1
Member	Material
A325 (ASTM), NKYM	
High tension bolt produced MISUBOSHI

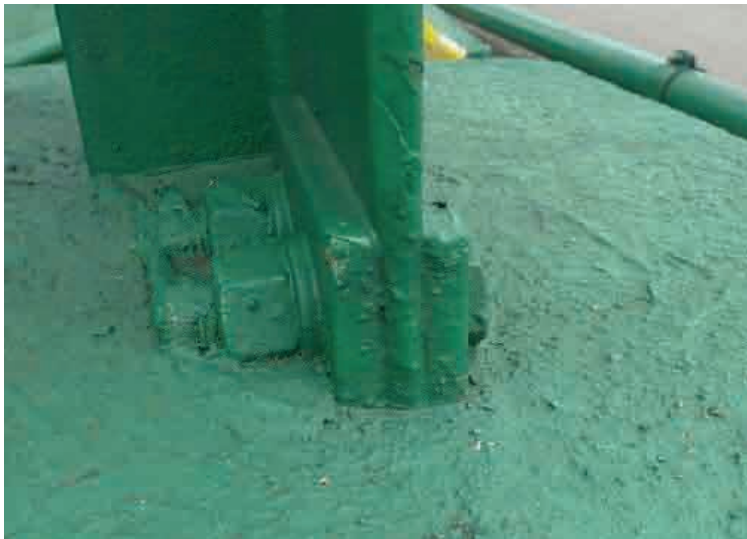
Picture No.	13
	Span	1
	Member	slab
	Reinforcement by additional plate	
	Original structure is connected by rivet	
	Reinforcement structure is connected by high tension bolt.

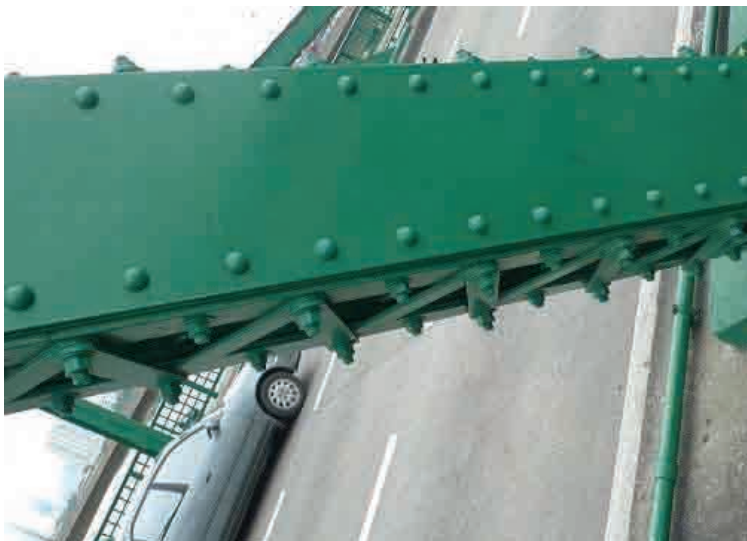
Picture No.	14
	Span	1
	Member	slab
	Reinforcement plate top and bottom of member

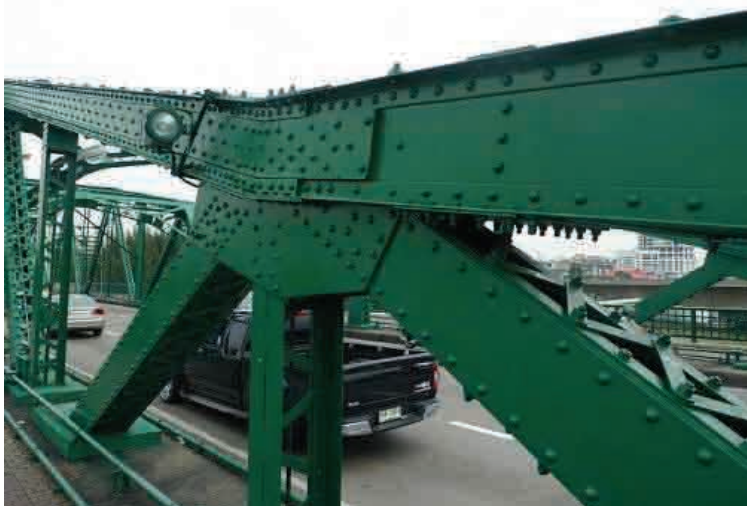
Picture No.	15
	Span	1
	Member	slab
	Remaining water is seen inside of chord member

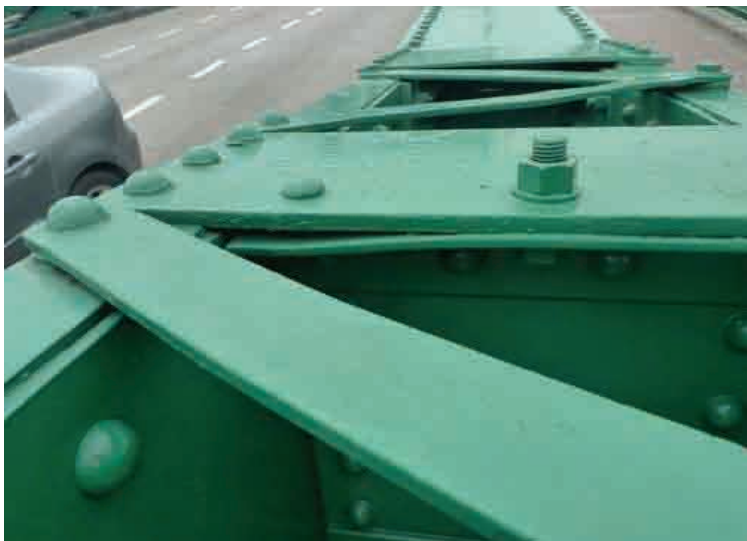
Picture No.	18
	Span	1
	Member	slab
	Rivet is not changed to bolt.	
	Reinforcement plate was connected only center by bolt.

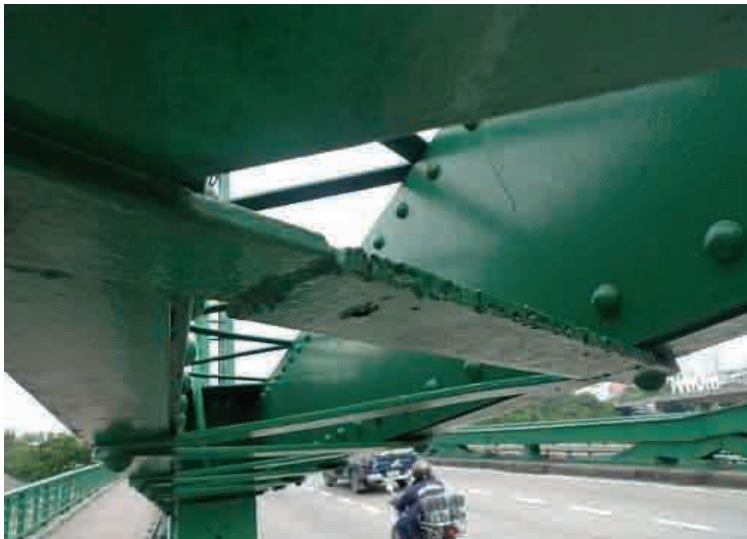
Picture No.	16
	Span	1
	Member	Chord member
	Repaired member

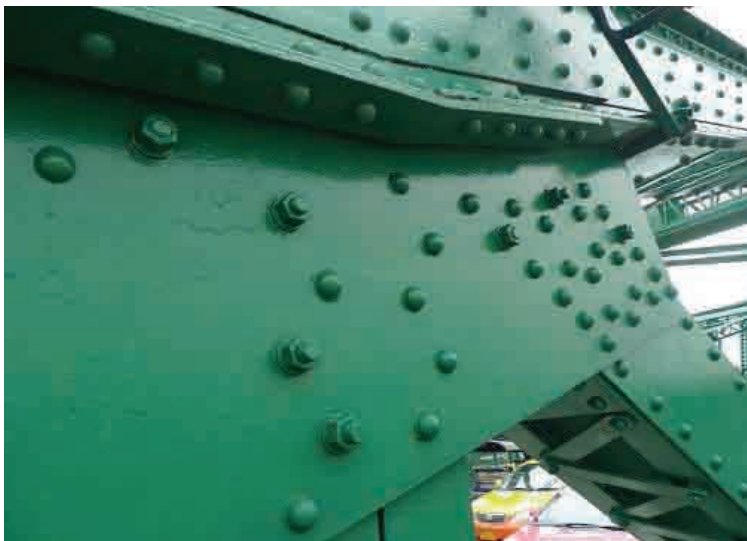
Picture No.	17
	Span	1
	Member	Bolt
	Rivet was replaced by bolt

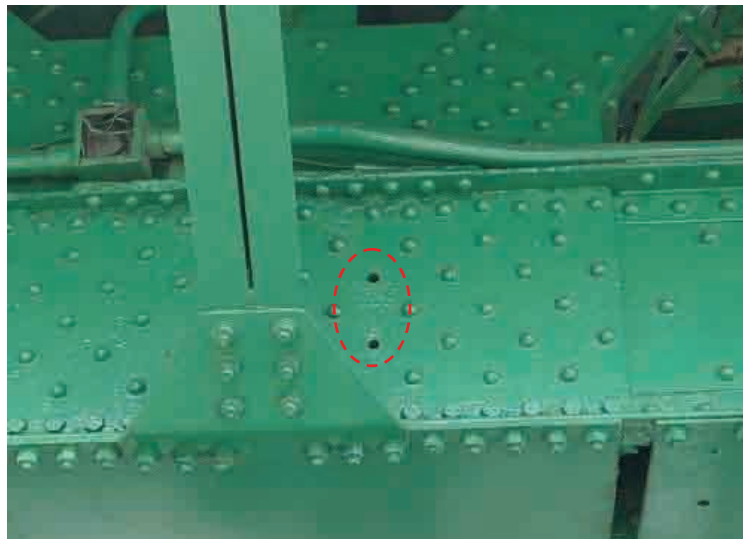
Picture No.	19
Span	1
Member	Bolt
Falling of rivet

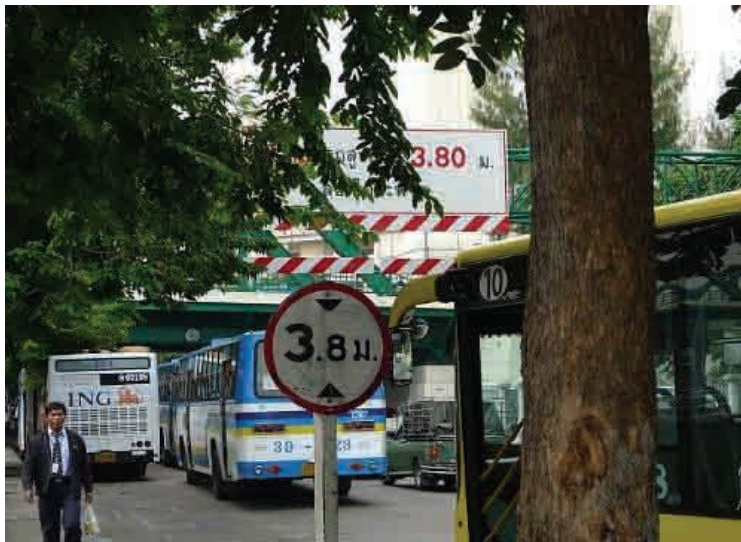
Picture No.	29
Span	1
Member	Warning frame

There is warning frame at Bangkok side

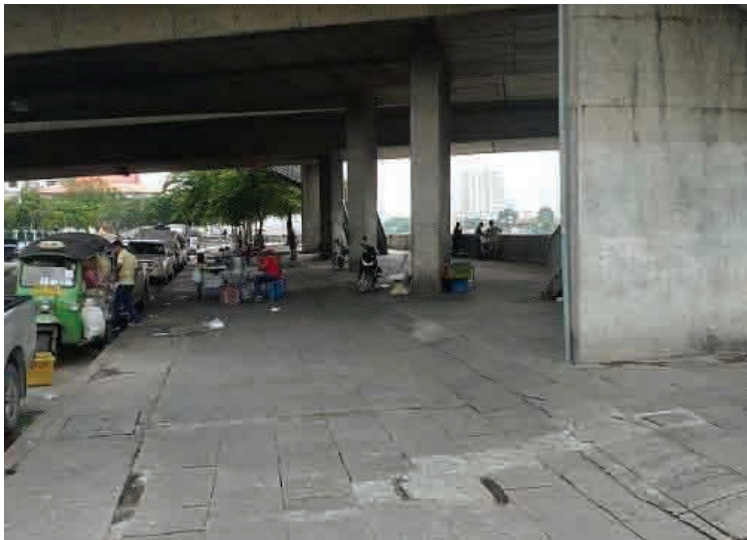
Picture No.	4
	Span	1
	Member	Approach bridge
	Settlement around pier

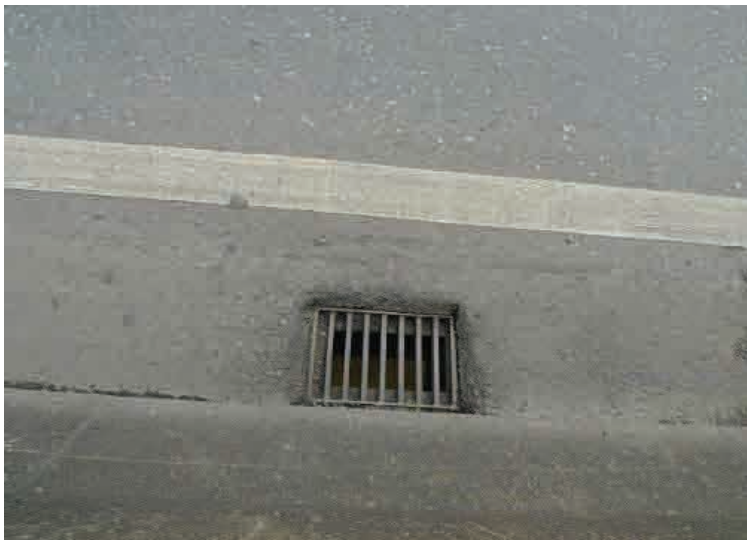
Picture No.	5
	Span	1
	Member	Catch basin

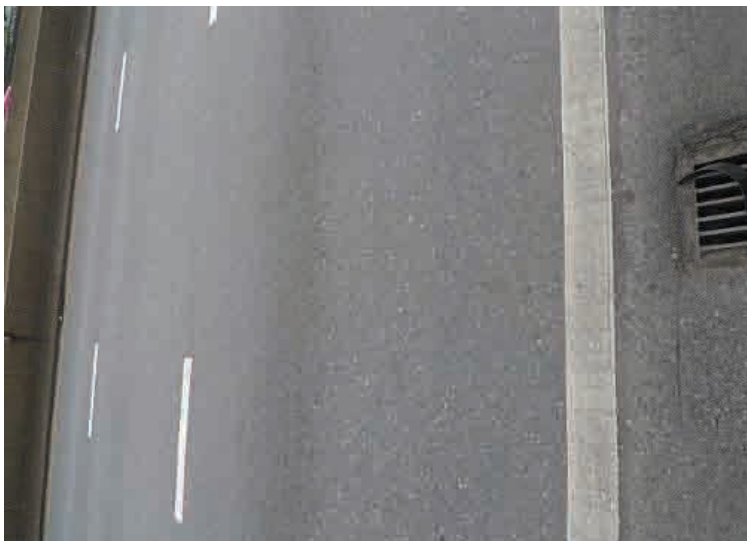
Picture No.	6
	Span	1
	Member	Catch basin
	Cross fall is parabola?	
	Catch basin is installed at both side

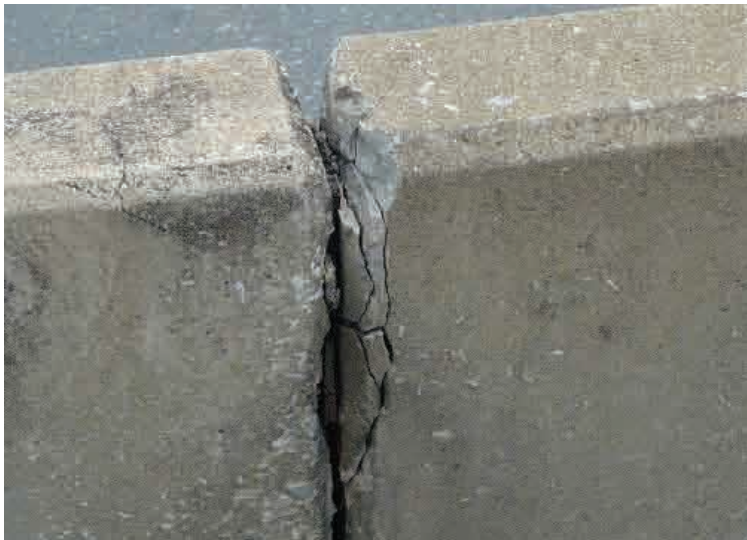
Picture No.	7
	Span	1
	Member	Side barrier
	Exfoliation of concrete

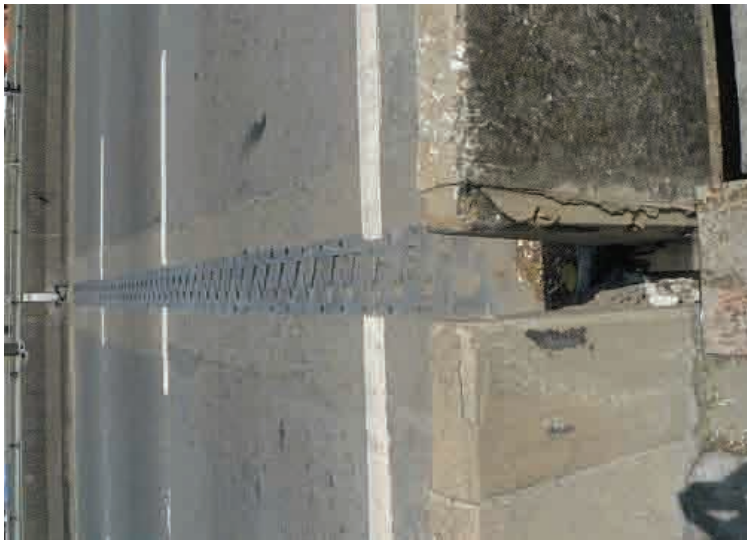
Picture No.	4
	Span	1
	Member	Expansion Joint
	Replaced expansion joint

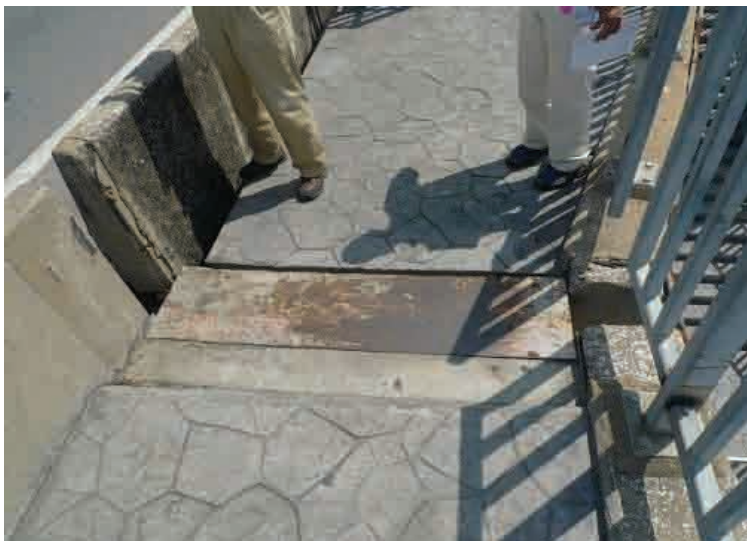
· Movement to center span was seen at Bangkok side bearing. It is recommended watching continuously.												
	· Cover of barrier and railing was disappear on expansion joint.												
History of repair	History of repair ; Repaint ; - yy - mm												
	Surveyor ; Mr.Chujo, Mr.Kudo												
Diagnosis	Deterioration of bridge deficient · fair · good												
	Noticeable point												
	· Crack or cold joint on web												
	· Longitudinal move of girder

Picture No.	6
	Span	1
	Member	Expansion joint
	Lack of cover of barrier and curv

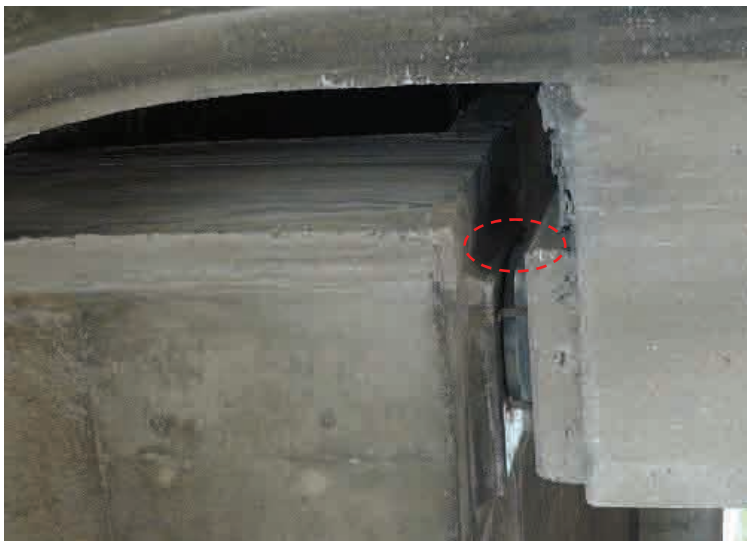
Picture No.	8
	Span	1
	Member	Bearing
	Movement of bearing.	
	Bangkok side	
	Already reach to end of sliding plate

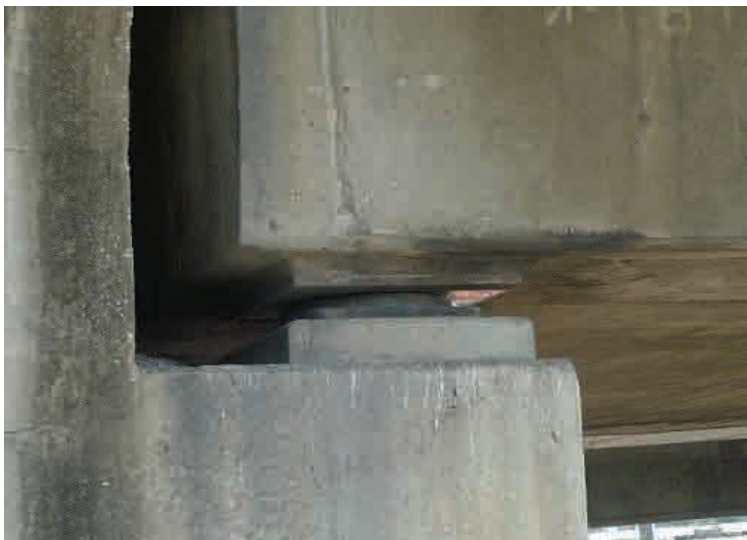
Picture No.	9
	Span	1
	Member	Bearing
	Movement of Thon Buri side is sma

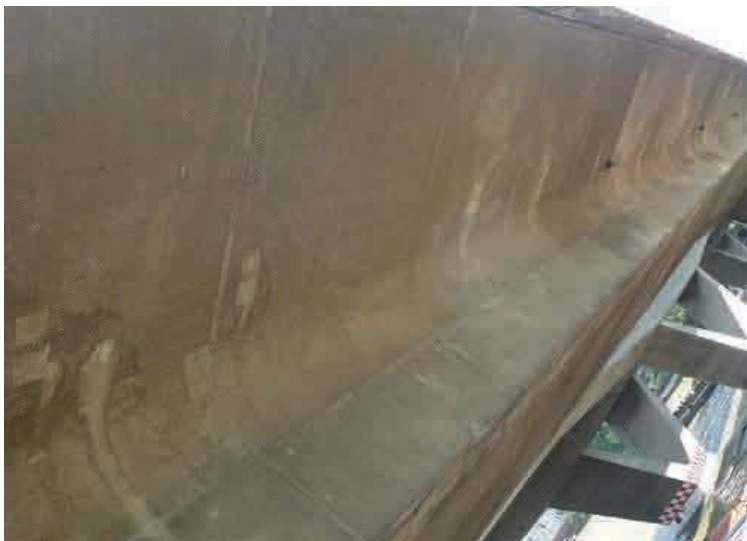
Picture No.	12
	Span	1
	Member	Slab
	Free lime

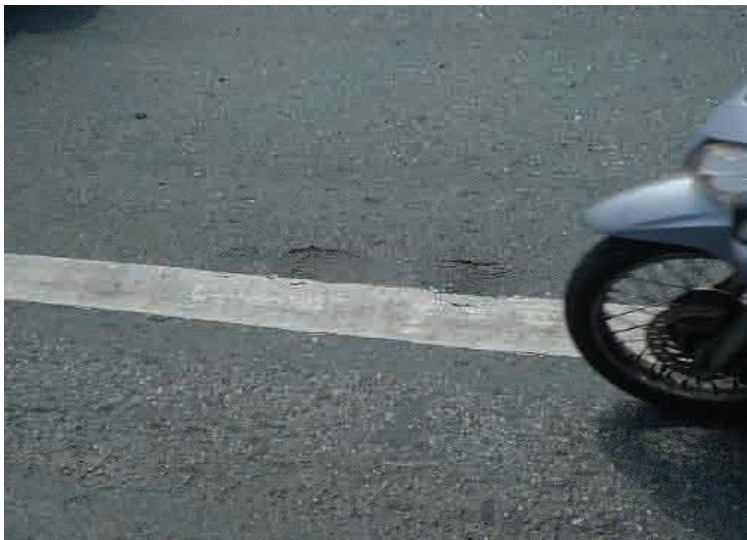
Picture No.	8
	Span	1
	Member	Pavement
	Uneavenness of pavement	
	Upstream, Bangkok side

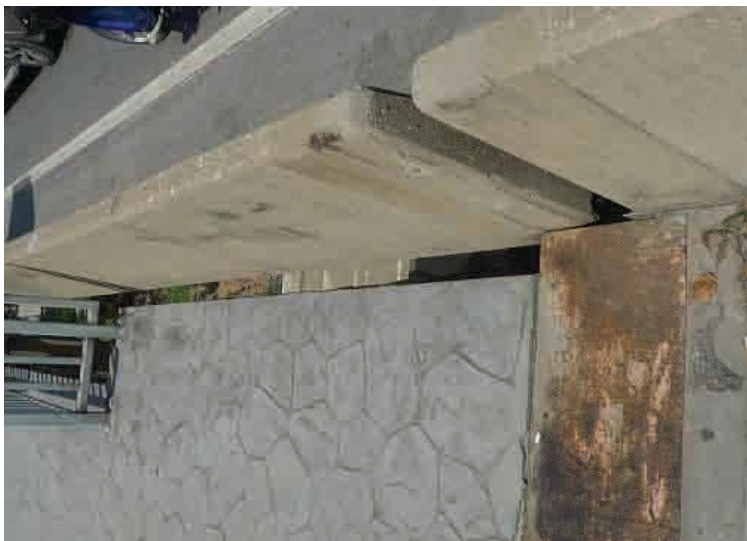
Picture No.	9
	Span	1
	Member	Walkway
	Feeling uneasy due to wide gap

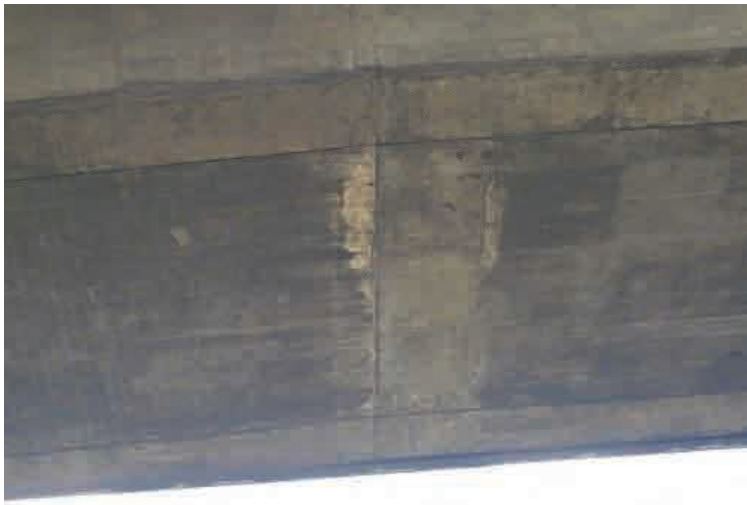
Picture No.	10
	Span	1
	Member	Girder
	Free lime from construction joint

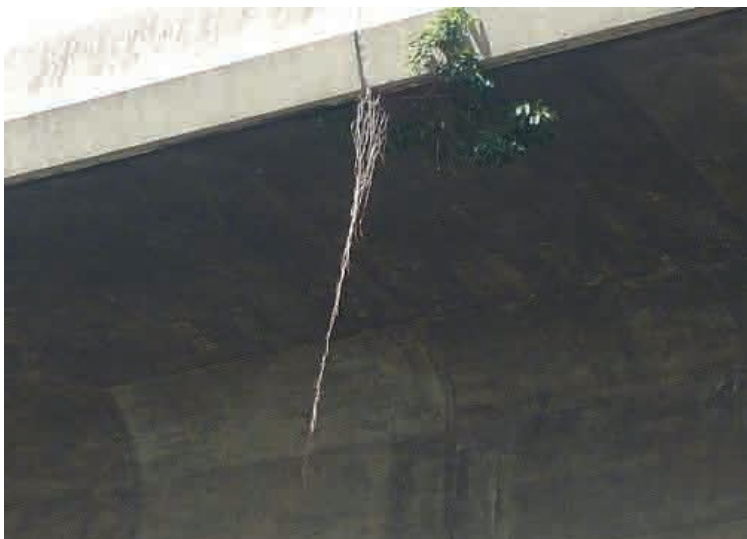
Picture No.	11
	Span	1
	Member	Girder
	Acumuration of soil
