Inspection sheet of visual survey

Bridge No. 10

Bridge name		Krung Thon Bridge		Route name	-		Authority	Code of authority	-		
Place		from Khat Bang Phlat to Khet Dusit		Distance	from	km+	0	No.	-		
					to	km+	0	Survey date	2009/10/24		
Bridge properties	Bridge type(1)	<input checked="" type="checkbox"/> main road · <input type="checkbox"/> side road · <input type="checkbox"/> ramp		Camber deform	yes · <input checked="" type="checkbox"/> no		Outline of damage	Item	Type	State	
	Bridge type(2)	<input checked="" type="checkbox"/> bridge · <input type="checkbox"/> viaduct · <input type="checkbox"/> plank pass		Difference in grade	yes · <input checked="" type="checkbox"/> no			Main girder	Truss	Corrosion, Deterioration of proofing, deformation by collision	
	Bridge type(3)	6-span steel truss		Continuous of barrier	<input checked="" type="checkbox"/> yes · <input type="checkbox"/> no			Cross beam	I section steel	-	
	Total length	360.00 (m)		Continuous of curve	<input checked="" type="checkbox"/> yes · <input type="checkbox"/> no			Stringer	I section steel	Deterioration of proofing

Present state (7 / 19)					
Authority	DRR	Address	Bangkok	Data	24-Oct-09
Bridge	Krung Thon Bridge

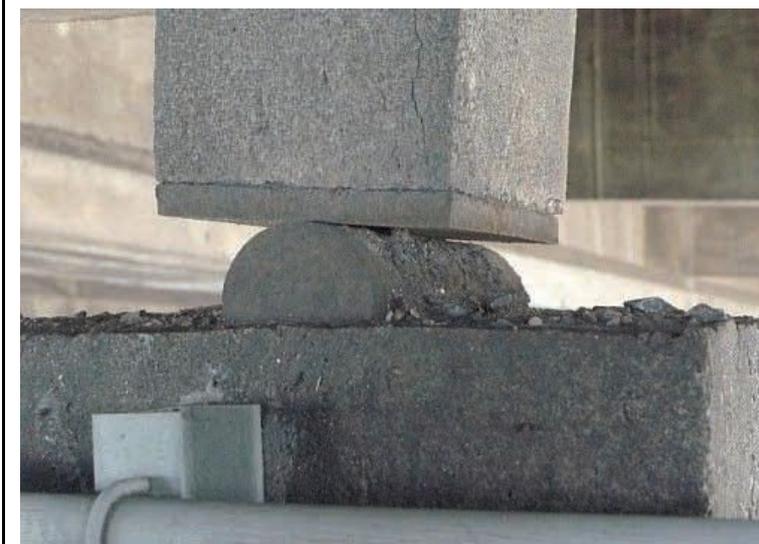
Picture No.	20
Span	1
Member	Bearing
Bearing on cross beam between main girder	
Approach bridge

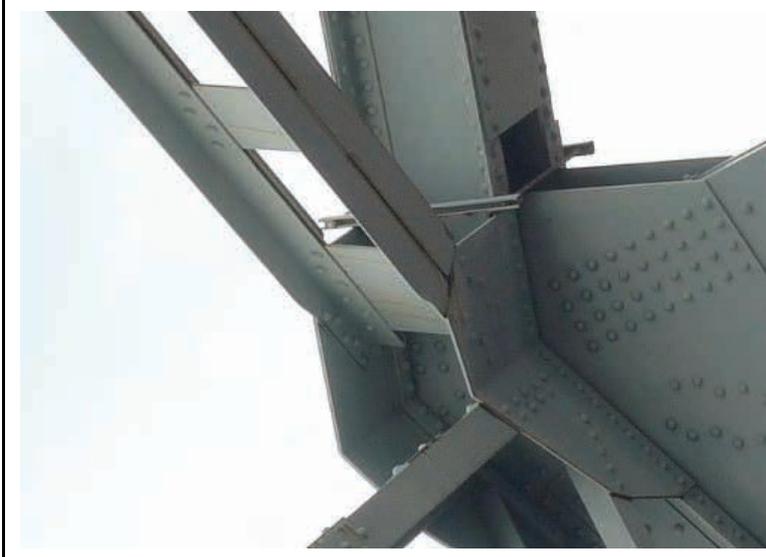
Picture No.	39
Span	1
Member	Cross frame
Deformation at the end of cross frame	
Adjustment of height?

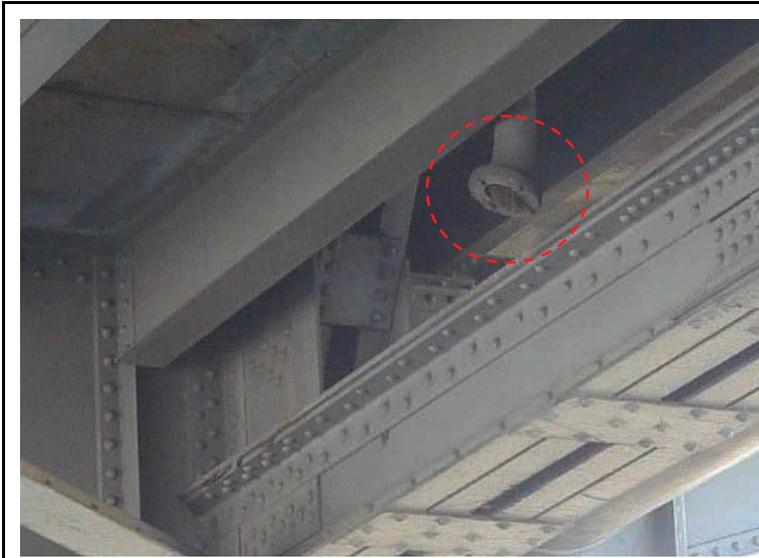
Picture No.	52
Span	1
Member	Slab
Falling of drainage pipe	
*Survey on board, 31-oct

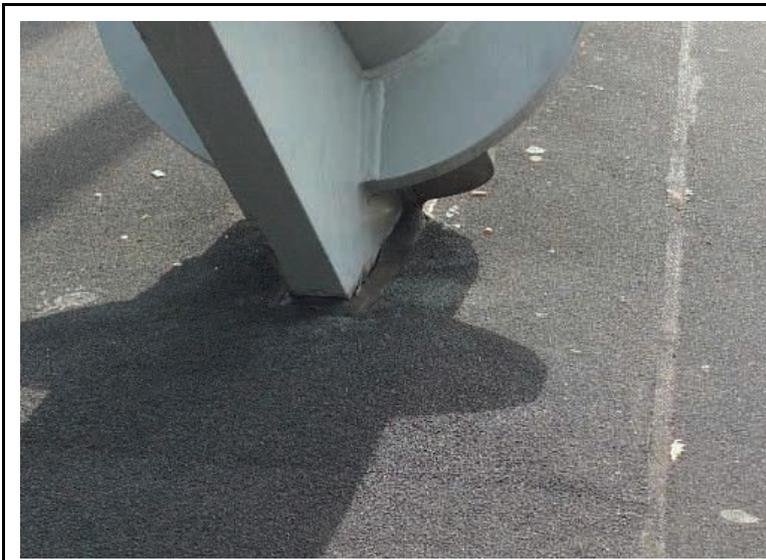
Picture No.	10
Span	1
Member	Cable fixing structure
Gap and calking between cable and slab. And mounted up around cable to prevent remaining water.

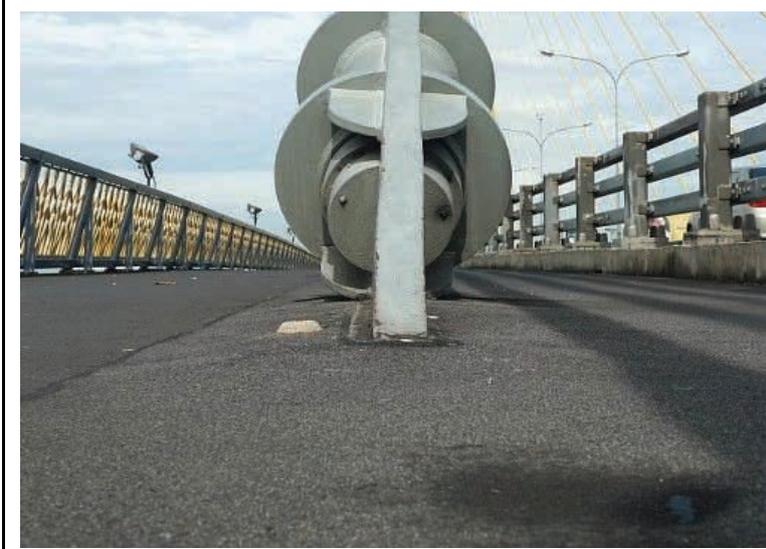
Picture No.	11
Span	1
Member	Cable fixing structure
slab. And mounted up around cable to prevent remaining water.

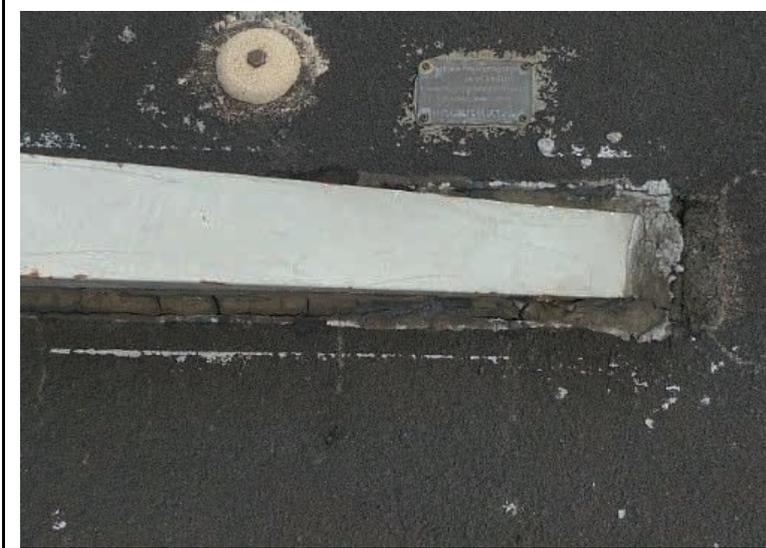
Picture No.	12
Span	1
Member	Cable fixing structure
Calking and name plate of cable	
well maintained but aging

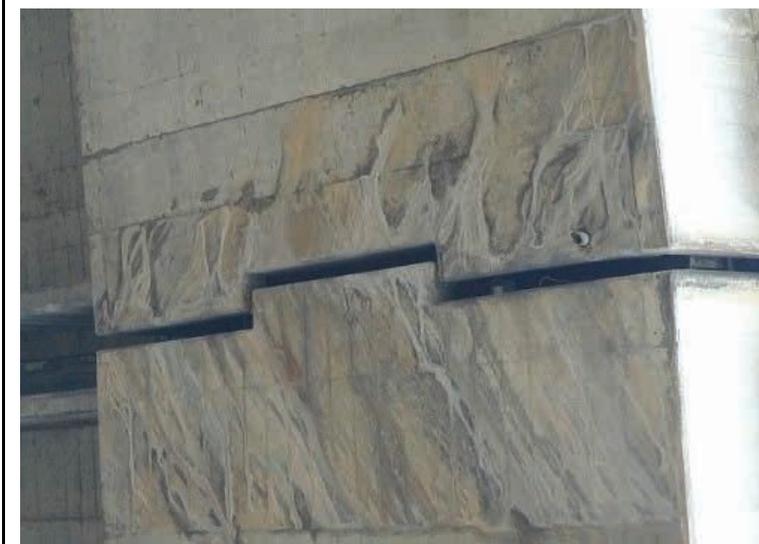
Picture No.	17
Span	1
Member	Hinge
Leakage	
*Survey on board, 31-oct

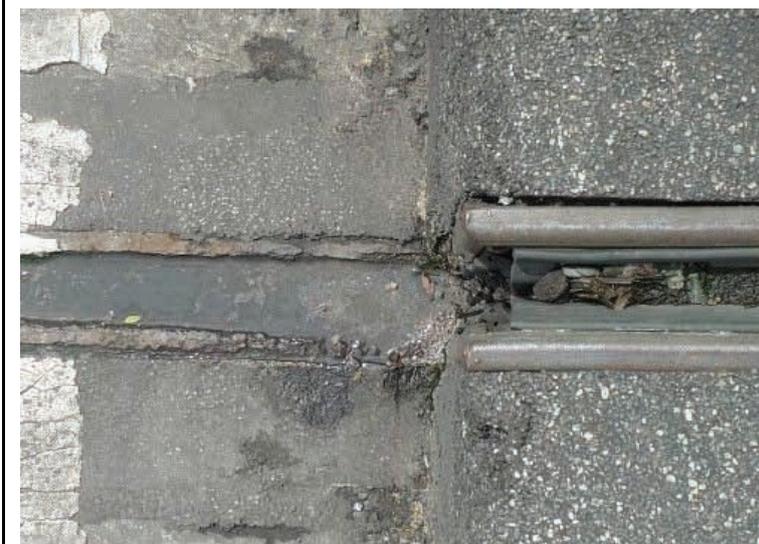
Picture No.	11
Span	1
Member	Expansion joint
Bangkok side	
Deterioration of corrosion proofing

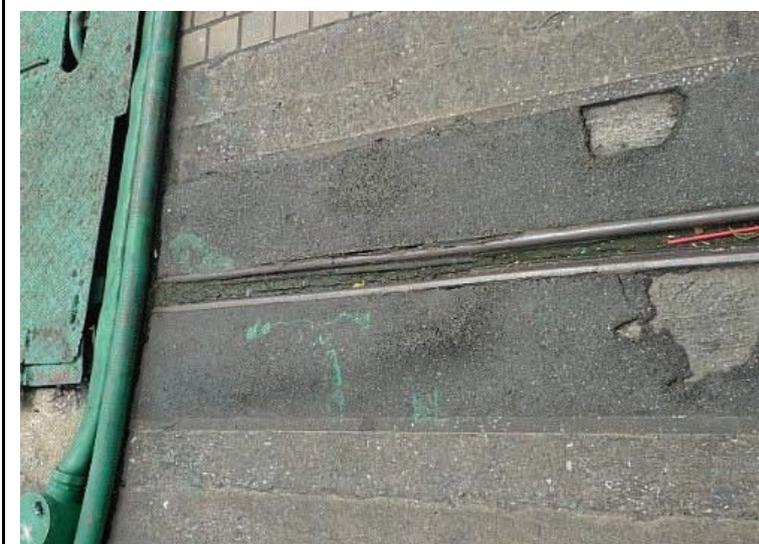
Picture No.	12
Span	1
Member	Expansion joint
between side span and center span	
Peeling of surface layer

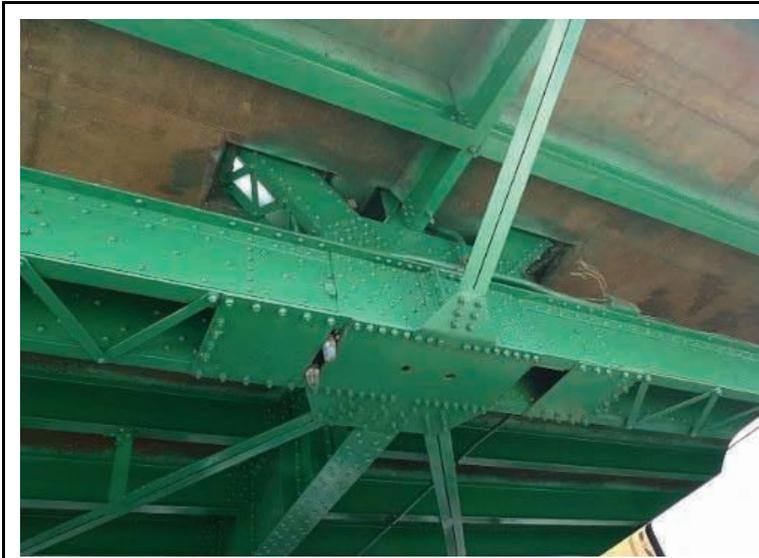
Picture No.	10
Span	1
Member	Stay cable
Connection between steel and slab	
It looks make gap around steel member from bottom side.

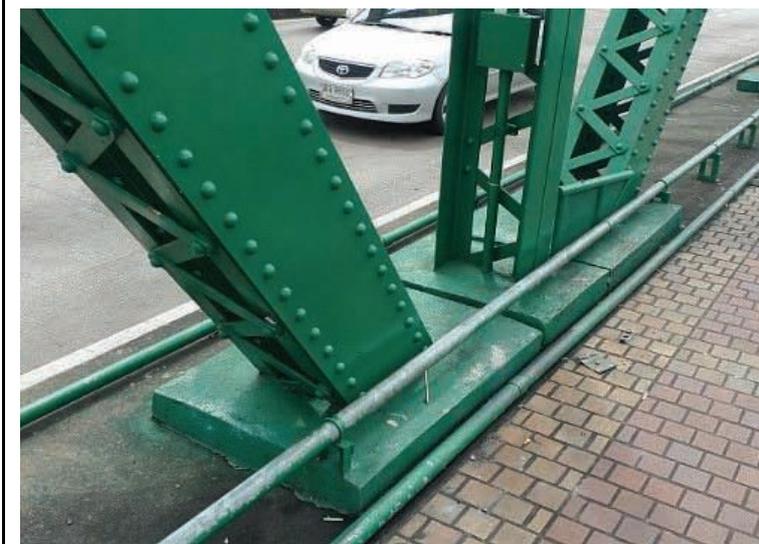
Picture No.	11
Span	1
Member	Inspection vehicle
Mounted up around steel member to prevent remaining water.	
It looks no gap around steel member from top side.

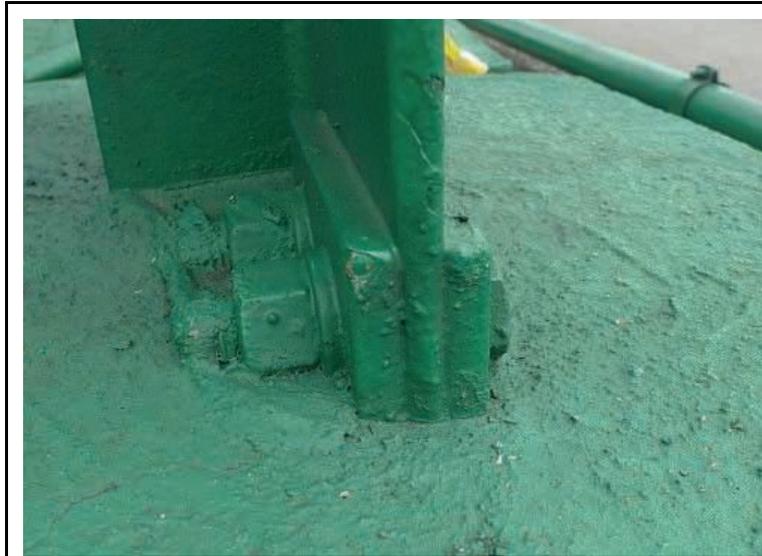
Picture No.	13
Span	1
Member	slab
Reinforcement by additional plate	
Original structure is connected by rivet	
Reinforcement structure is connected by high tension bolt.

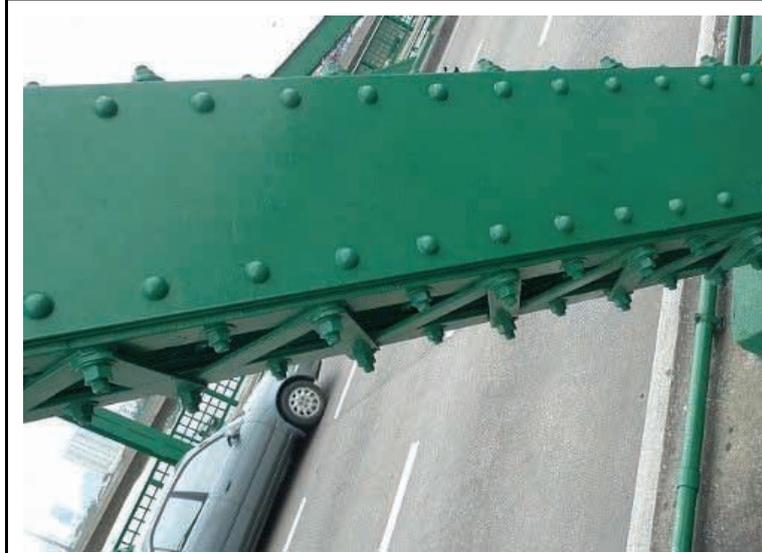
Picture No.	14
Span	1
Member	slab
Reinforcement plate top and bottom of member

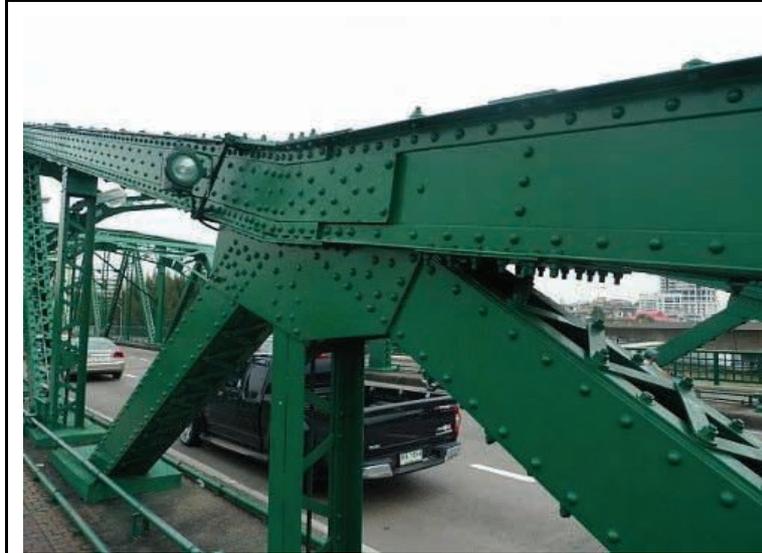
Picture No.	15
Span	1
Member	slab
Remaining water is seen inside of chord member

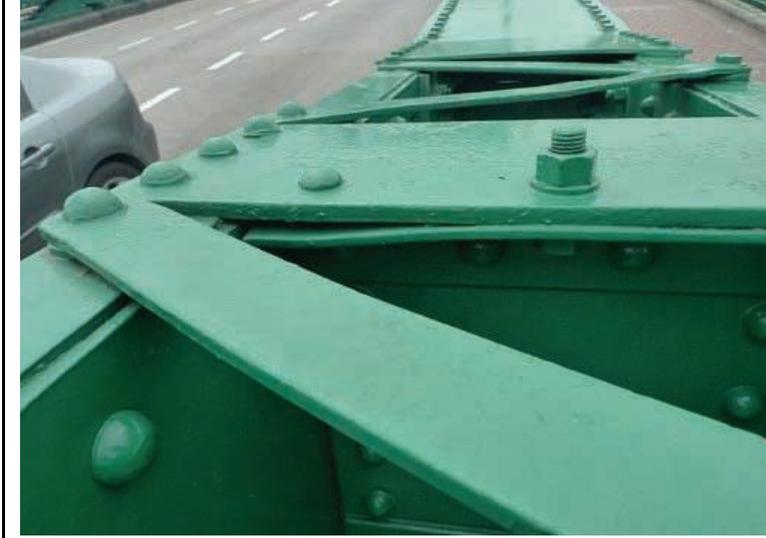
Picture No.	18
Span	1
Member	slab
Rivet is not changed to bolt.	
Reinforcement plate was connected only center by bolt.

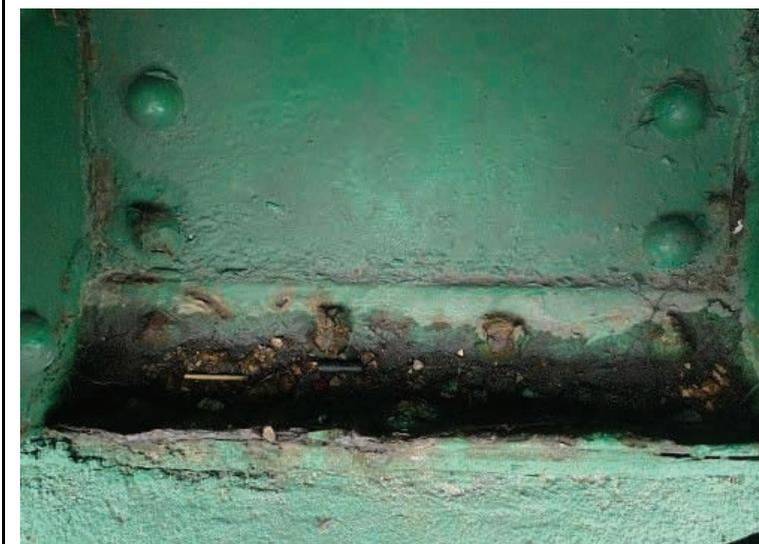
Picture No.	14
Span	1
Member	slab
Corrosion of diaphragm	
Accumulation of soil

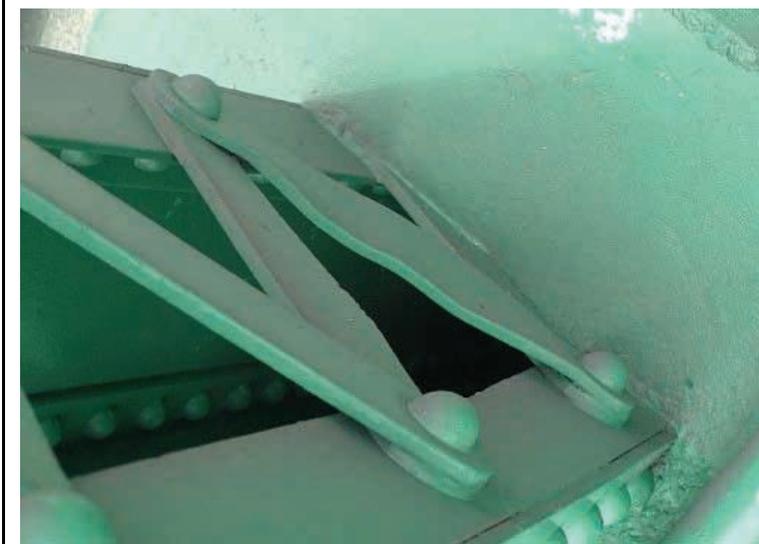
Picture No.	20
Span	1
Member	Upper chord
Deformation

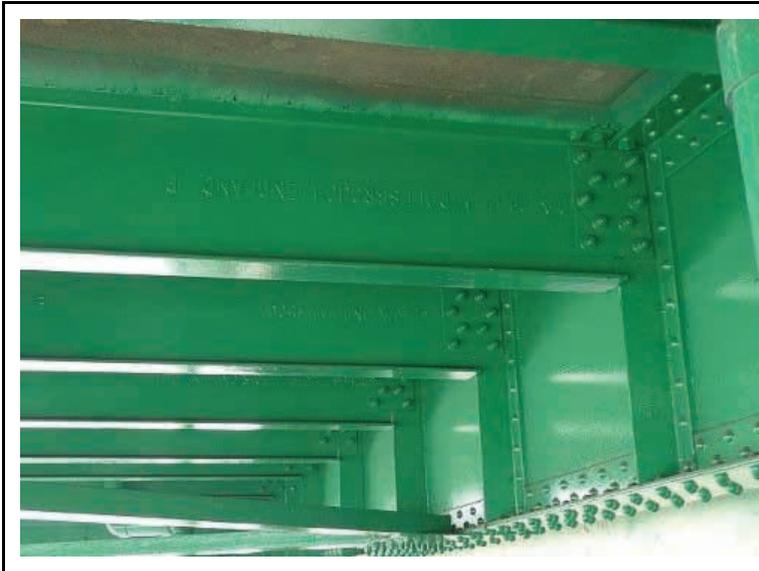
Picture No.	22
Span	1
Member	Stringer
Stringer is connected by high tension bolt.	
All stringer might be replaced at repairing work

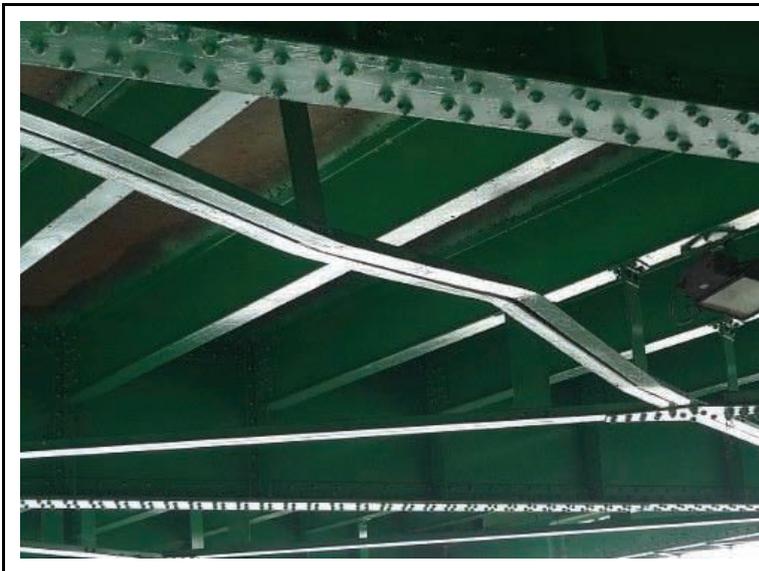
Picture No.	25
Span	1
Member	Cross frame
Thon Buri side	
Buckling by vehicle collision

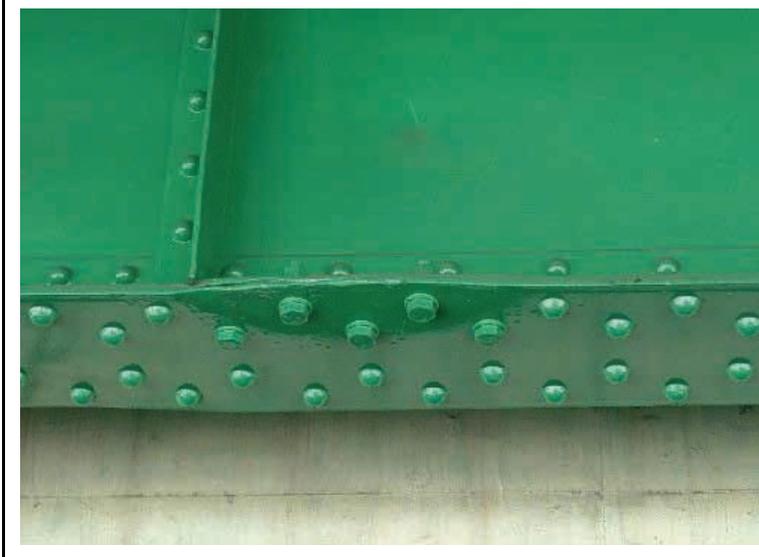
Picture No.	26
Span	1
Member	End cross beam
Deformation

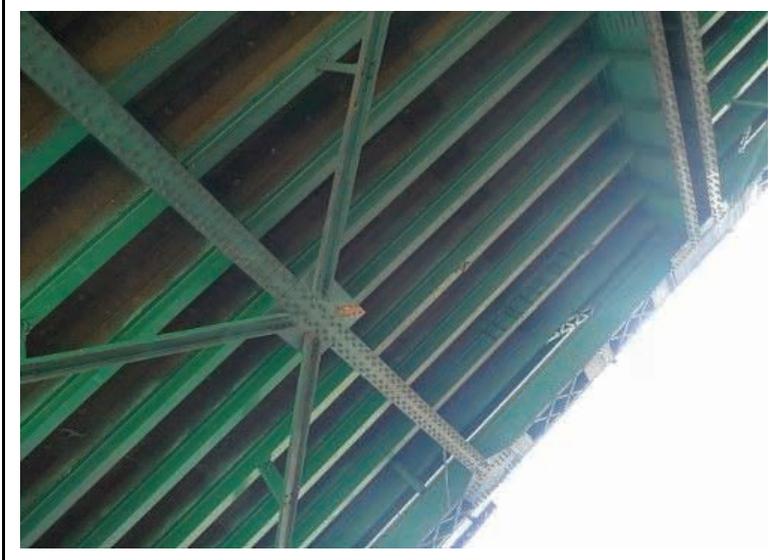
Picture No.	39
Span	1
Member	Cross frame
Drop off 1 member by ship collision	
*Survey on board, 31-oct

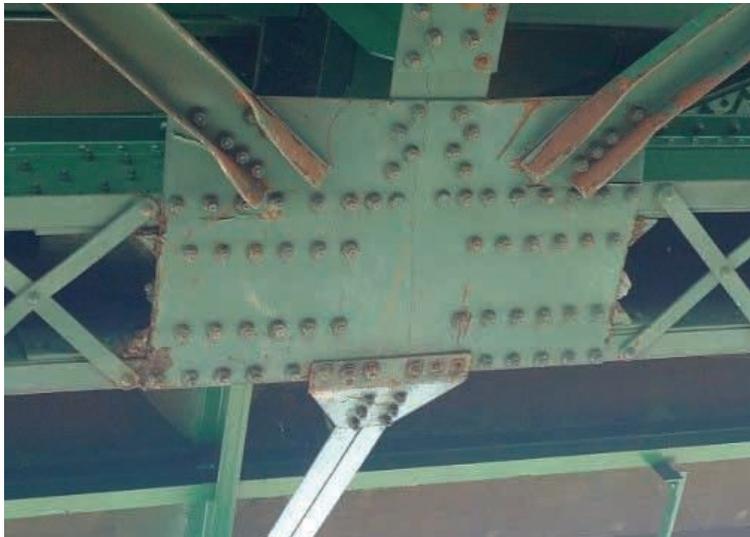
Picture No.	40
	Span	1
	Member	Gusset plate
	Damage by ship collision	
	*Survey on board, 31-oct

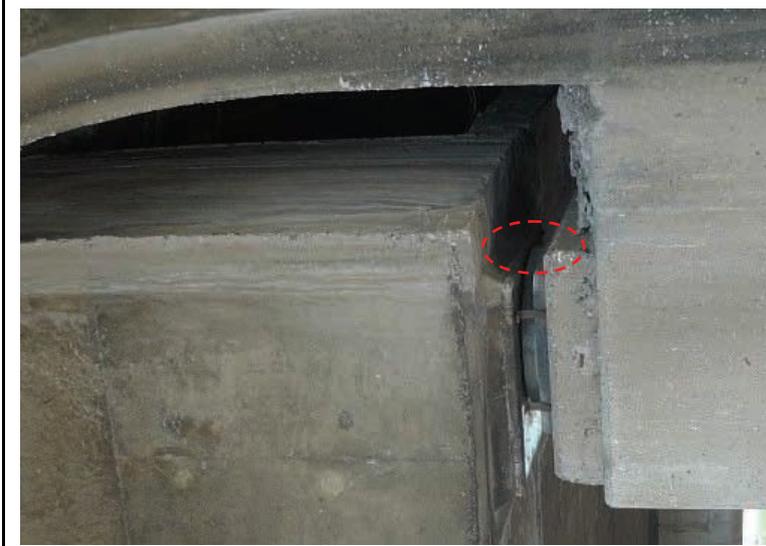
Picture No.	8
Span	1
Member	Bearing
Movement of bearing.	
Bangkok side	
Already reach to end of sliding plate

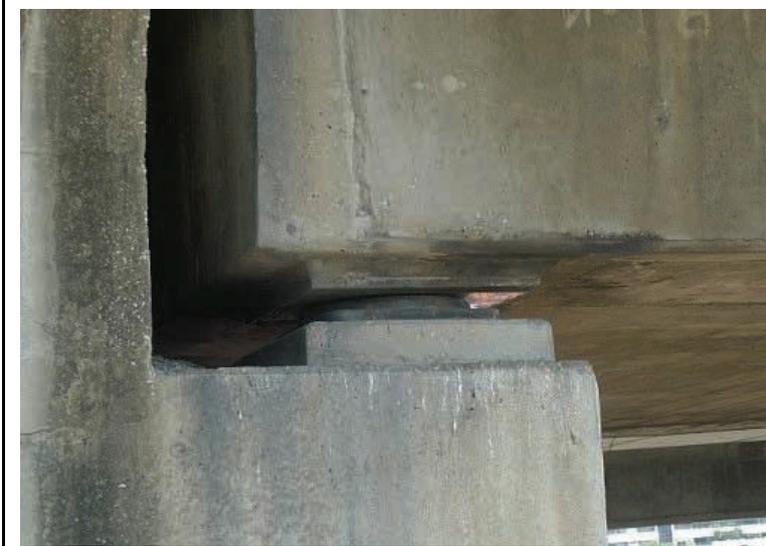
Picture No.	9
Span	1
Member	Bearing
Movement of Thon Buri side is sma

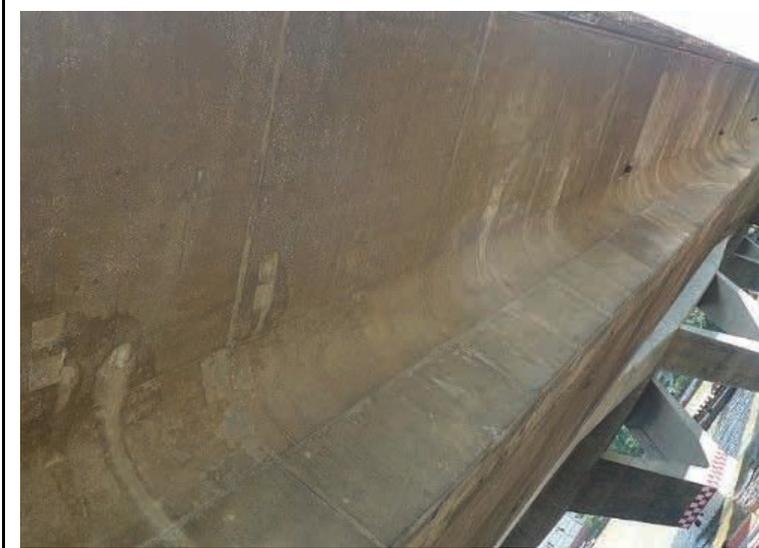
Picture No.	12
Span	1
Member	Slab
Free lime

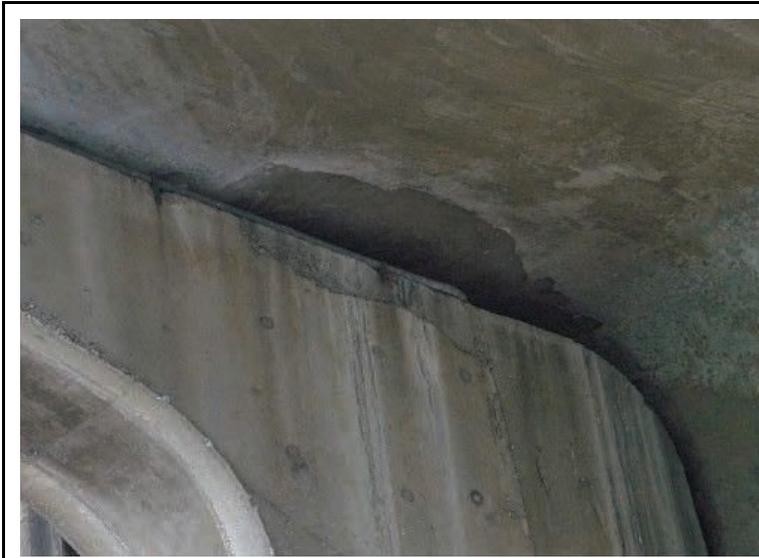
Picture No.	10
Span	1
Member	Slab
Mark of repair

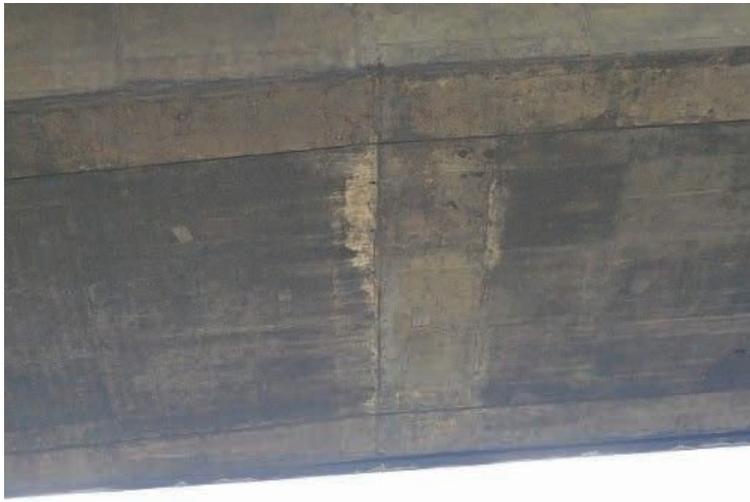
Picture No.	10
	Span	1
	Member	Girder
	Free lime from construction joint

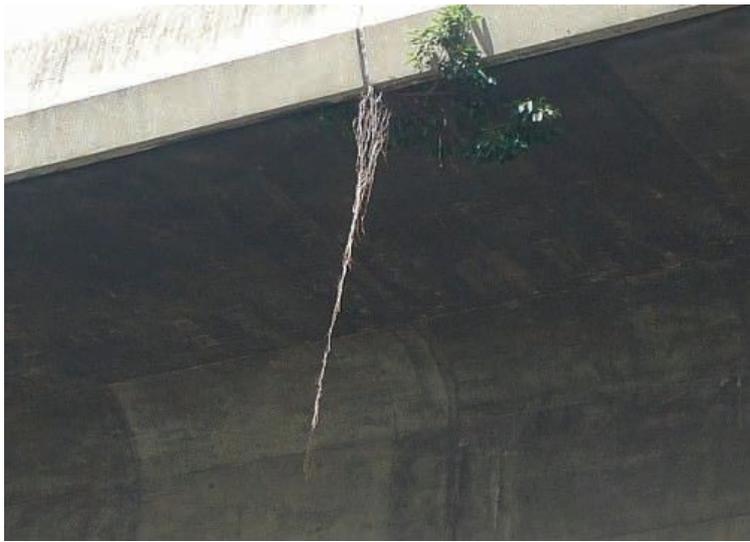
Picture No.	11
	Span	1
	Member	Girder
	Acumuration of soil

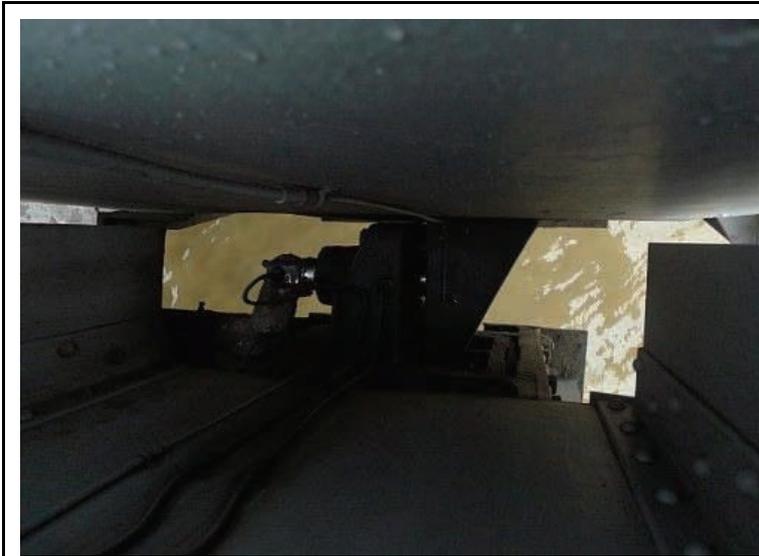
Picture No.	16
Span	1
Member	Stay cable
Hinge of drawbridge	
Mechanical parts is replaced every 2 years.

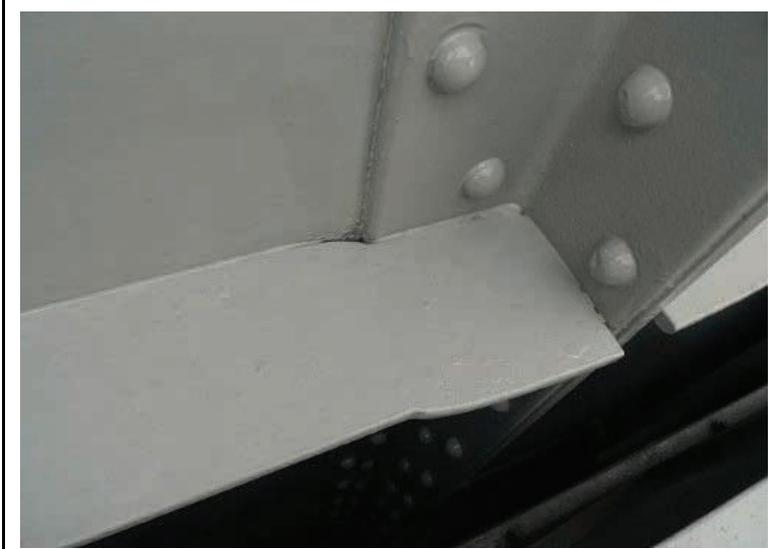
Picture No.	23
Span	1
Member	Center span
Manufactured by plasticity deformation

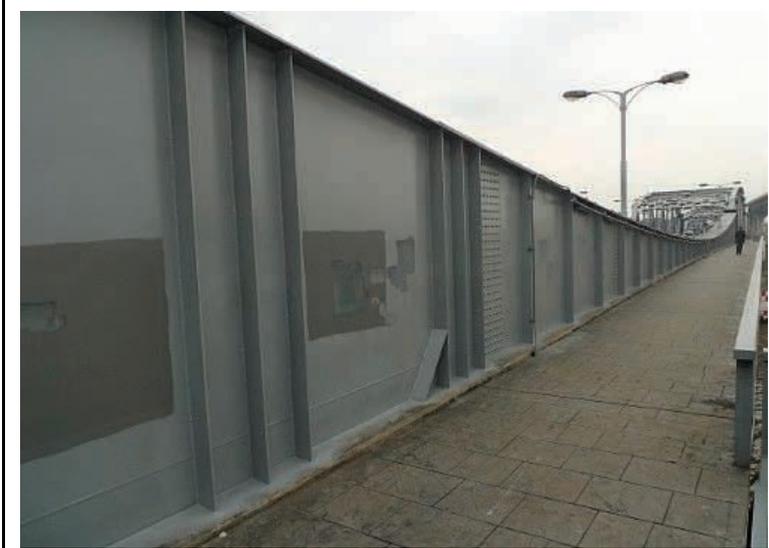
Picture No.	24
Span	1
Member	Center span
Continuous vibration	
Painting is not	
塗装が完全ではない

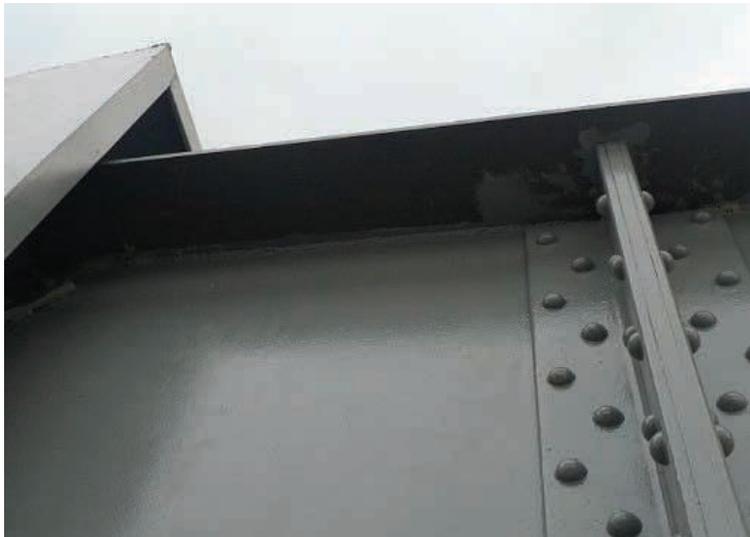
Picture No.	25
	Span	1
	Member	Center span
	Over coating is not painted lower side of flange.

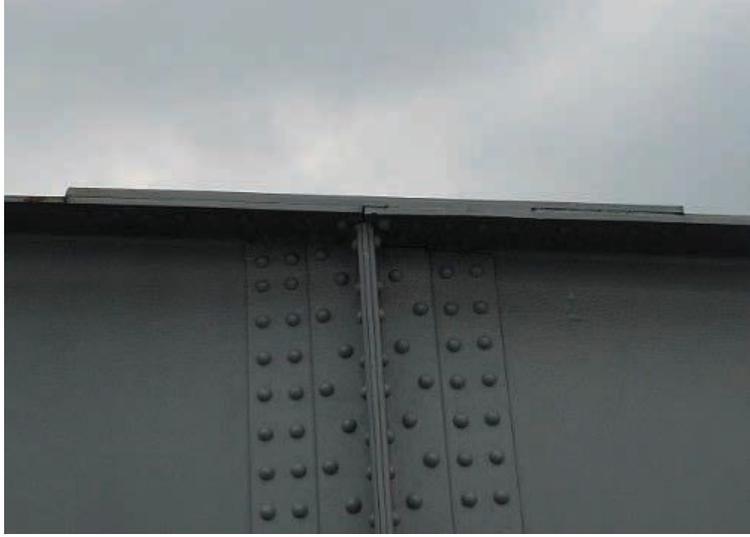
Picture No.	26
	Span	1
	Member	Center span
	Middle splice plate is divided in 2 plate.

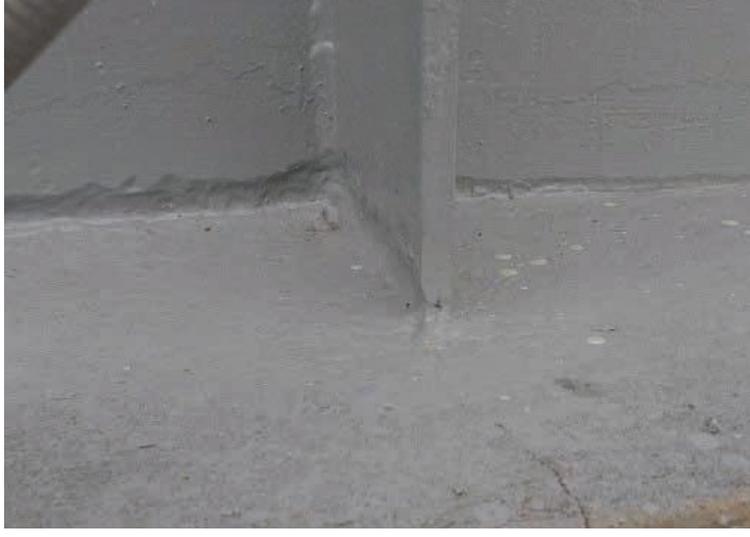
Picture No.	27
	Span	1
	Member	Center span
	Reduction of plate thickness of steel plate.

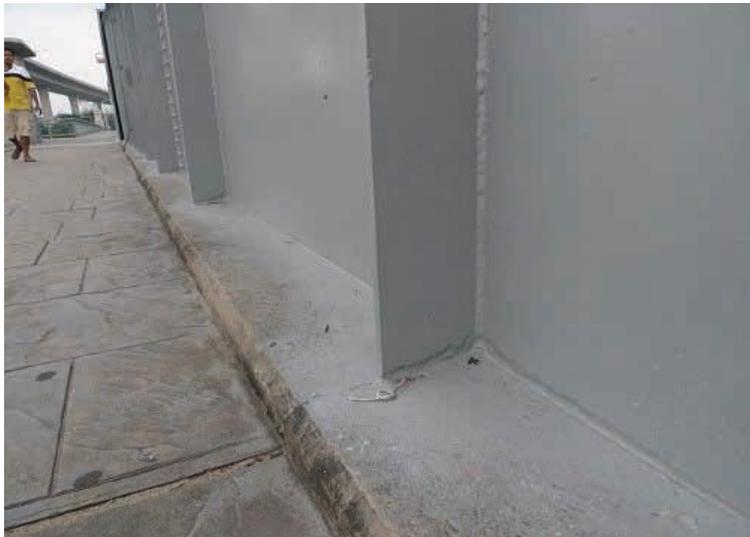
Picture No.	28
	Span	1
	Member	Center span
	Reduction of plate thickness of steel plate.	
	There is no remaining water

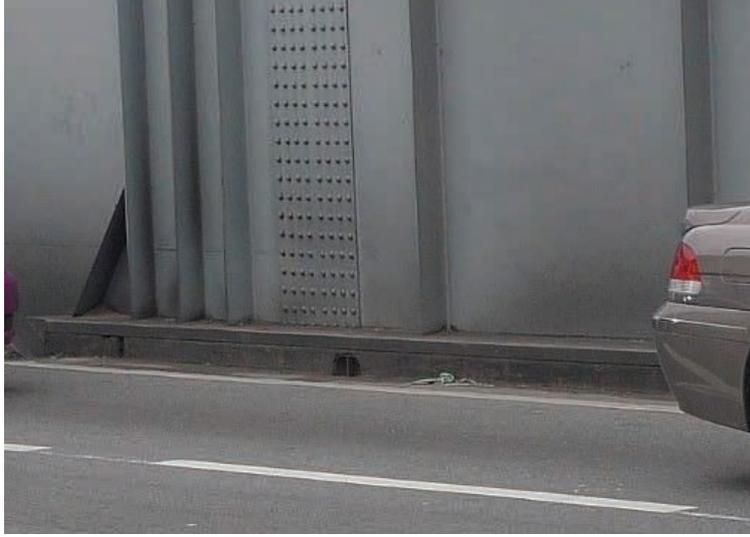
Picture No.	29
	Span	1
	Member	Center span
	Dirt line is seen at bottom of web	
	Possibility of remaining water and soil

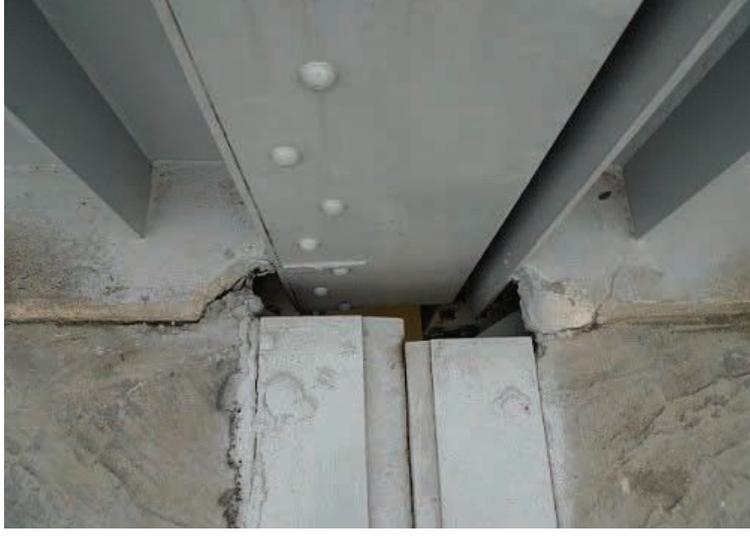
Picture No.	30
	Span	1
	Member	Center span
	Difference at center joint

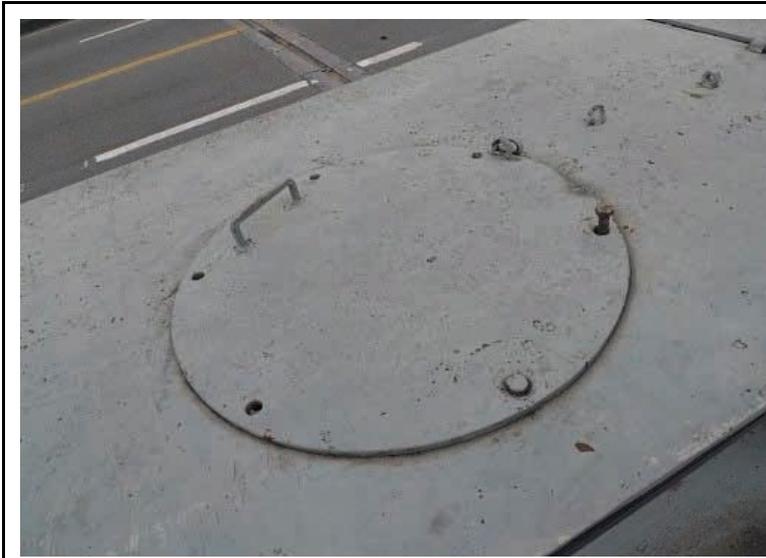
Picture No.	31
Span	1
Member	Center span
Manhole	
Lost of bolt	
No key

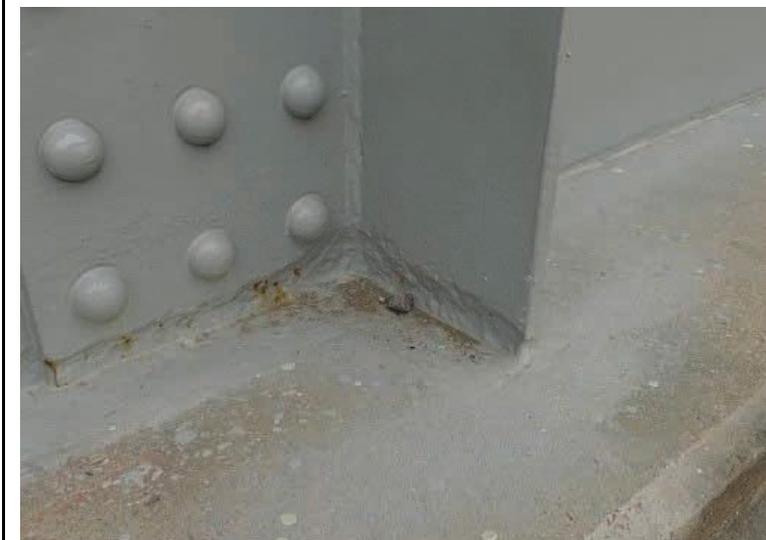
Picture No.	33
Span	1
Member	Center span
Rust from painting part	
Possibility of insufficient of scraping before painting

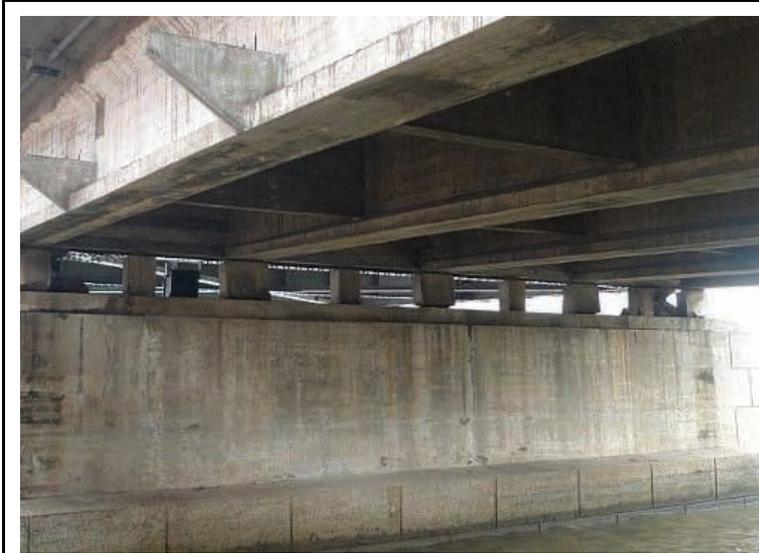
Picture No.	36
Span	1
Member	Center span
Inclination of locker bearing Bangkok side

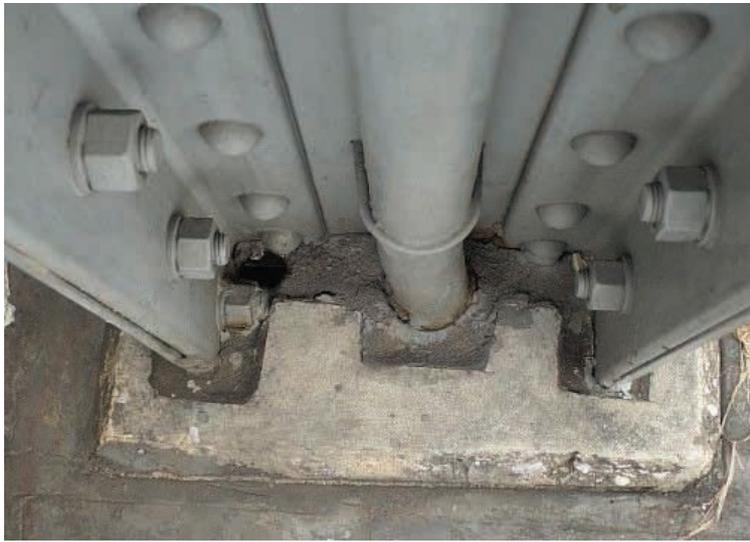
Picture No.	37
	Span	1
	Member	Vertical member
	Reinforcement by additional plate

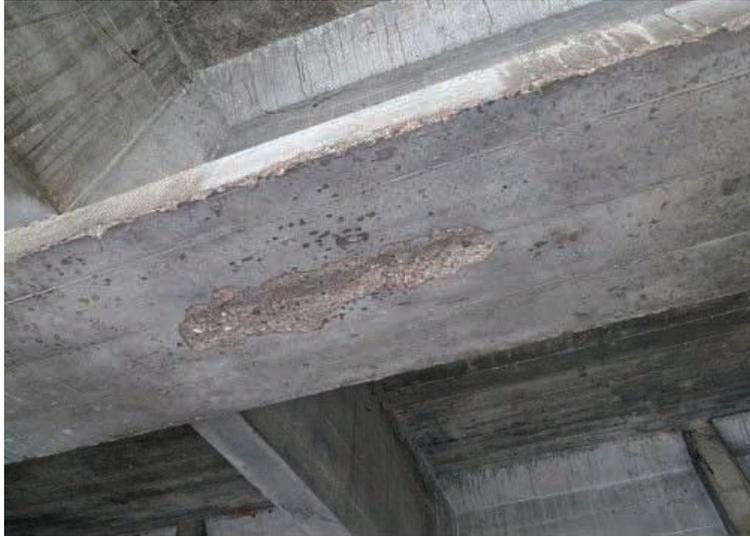
Picture No.	38
	Span	1
	Member	Approach bridge
	Exfoliation

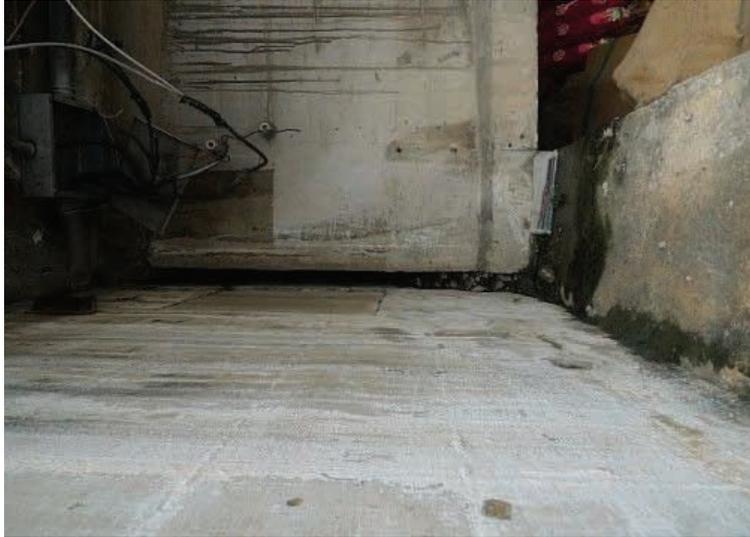
Picture No.	39
	Span	1
	Member	Approach bridge
	Remaining water at shoe

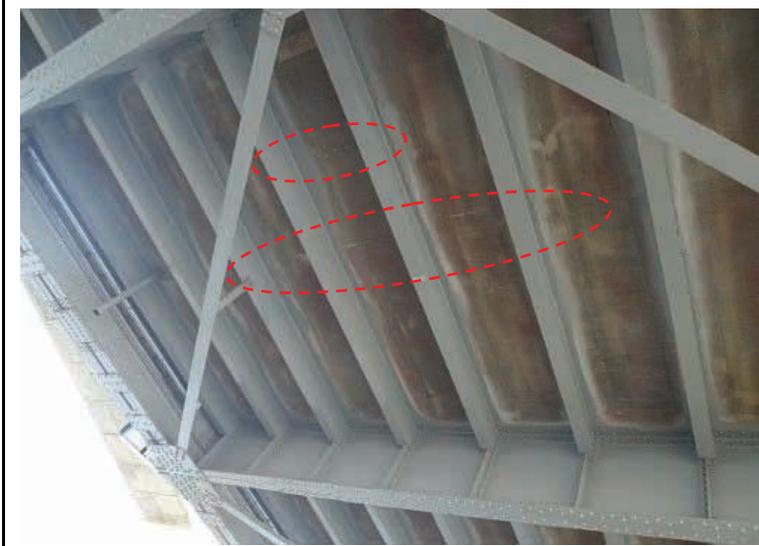
Picture No.	44
Span	4
Member	Slab
Crack	
Free lime	
*Survey on board, 31-oct

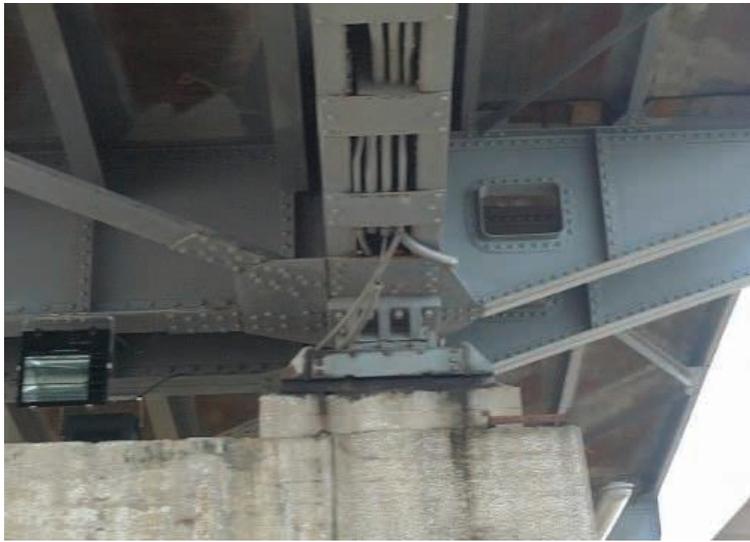
Picture No.	46
	Span	1
	Member	Bearing
	Deterioration of corrosion proof i	
	<i>*Survey on board, 31-oct</i>

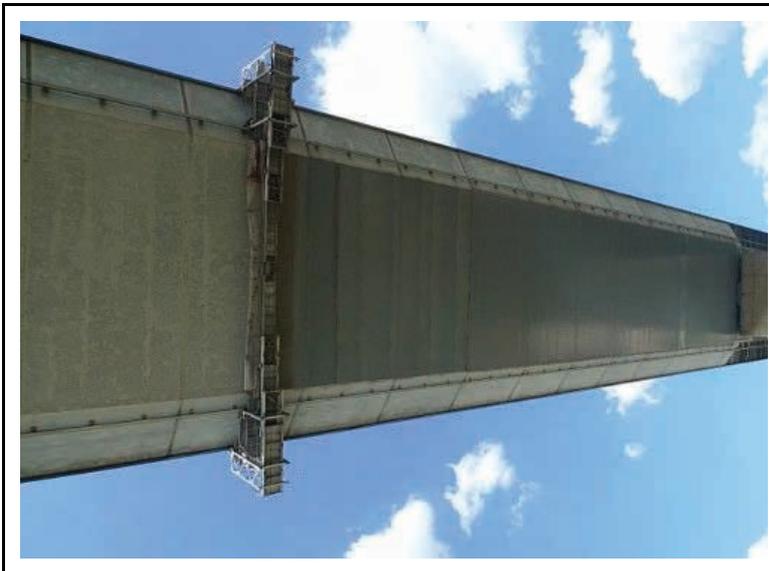
Picture No.	4
Span	1
Member	View under bridge
Under repainting using inspection vehicle	
*Survey on board, 31-oct

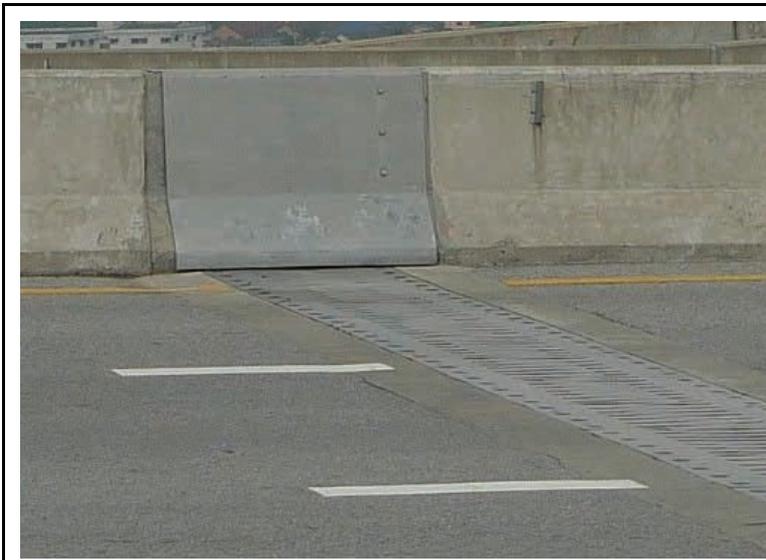
Picture No.	10
Span	1
Member	Expansion joint
South side. Adjustment of difference of grade

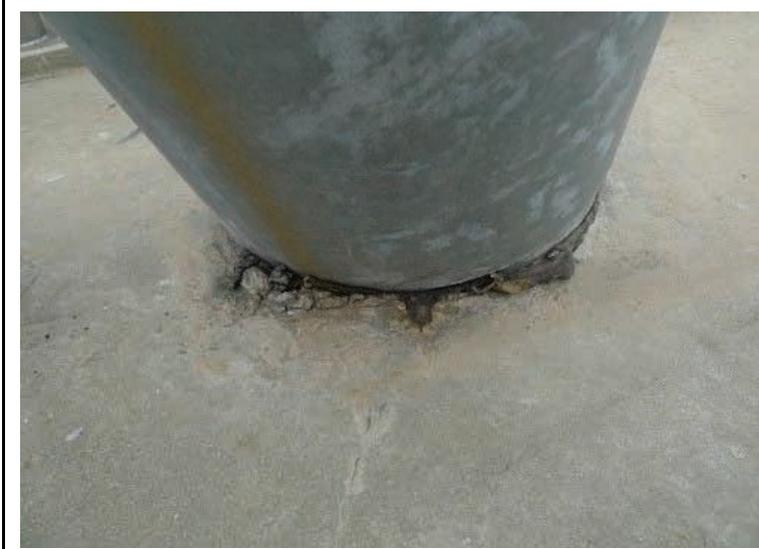
Picture No.	17
Span	1
Member	slab
Fixing structure	
Mold?

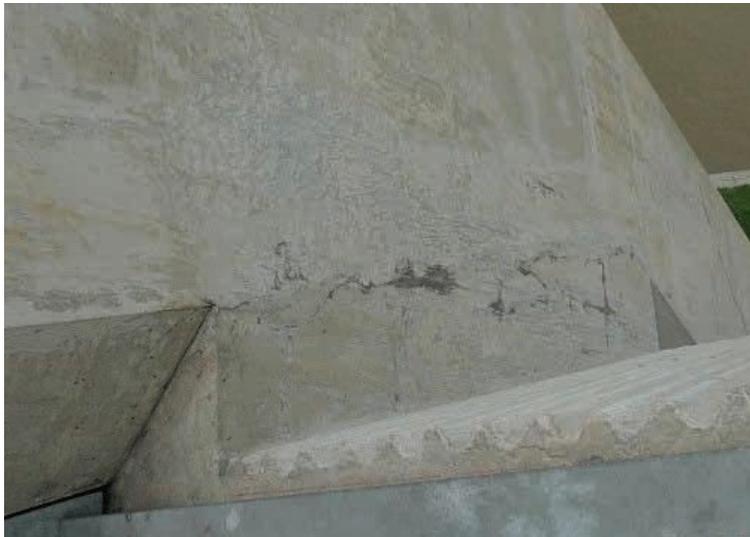
Picture No.	19
	Span	1
	Member	Pylon
	crack around cross beam end

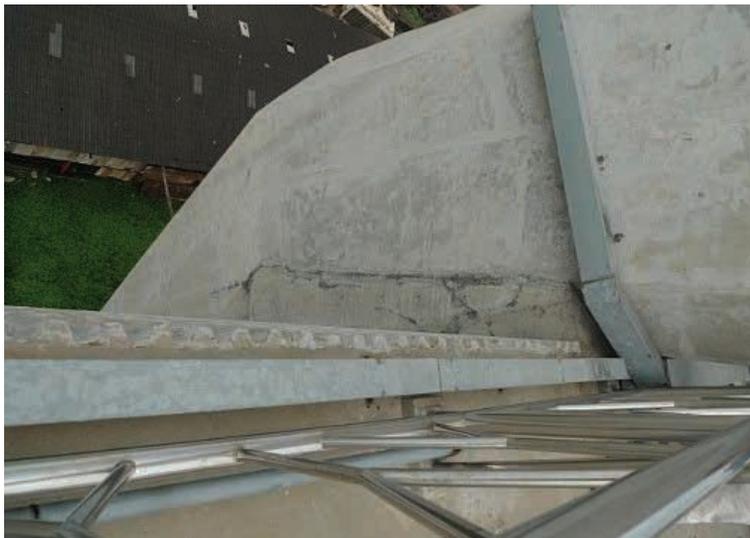
Picture No.	20
	Span	1
	Member	Pylon
	crack around cross beam end

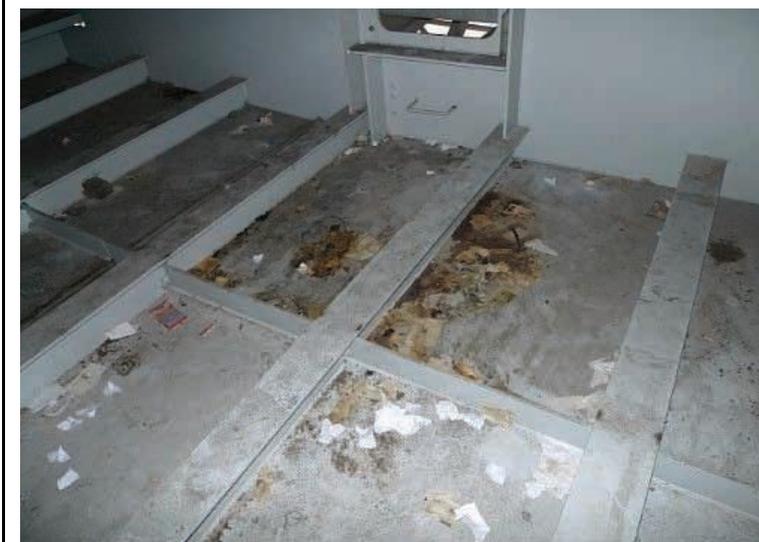
Picture No.	11
Span	1
Member	Connection girder
Inside of connection girder	
Harm of bird

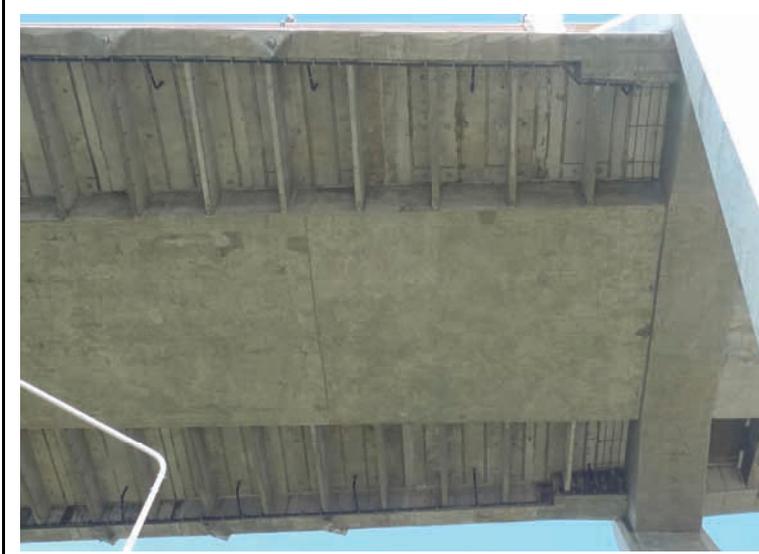
Picture No.	9
Span	1
Member	PC girder
<i>*Survey on board, 31-oct</i>
