## Inspection at Unchahar #2

Boiler residual life assessment was carried out as one of the activities to improve the efficiency of coal-fired thermal power plants in NTPC-India and transfer to counterpart the technology.

Feroze Gandhi Unchahar Thermal Power Station #2 unit

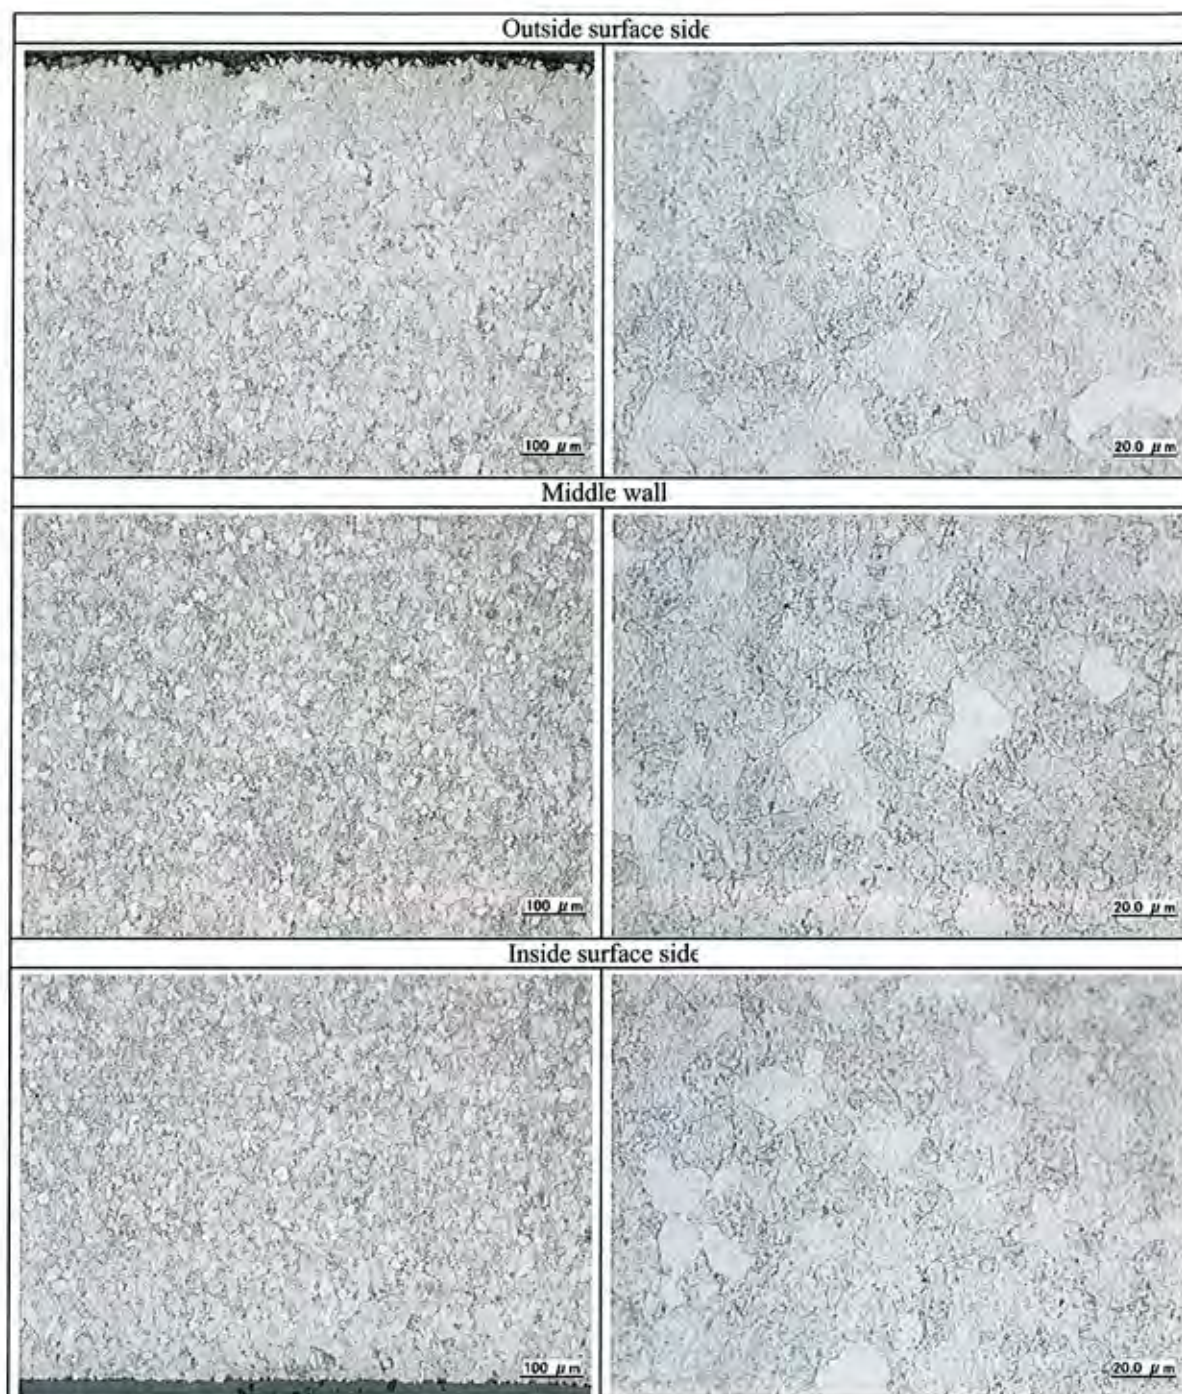
Photo I -25 Microstructure observation at cross section of sample tube  
[RH-Furnace (left side, Base Metal) ]

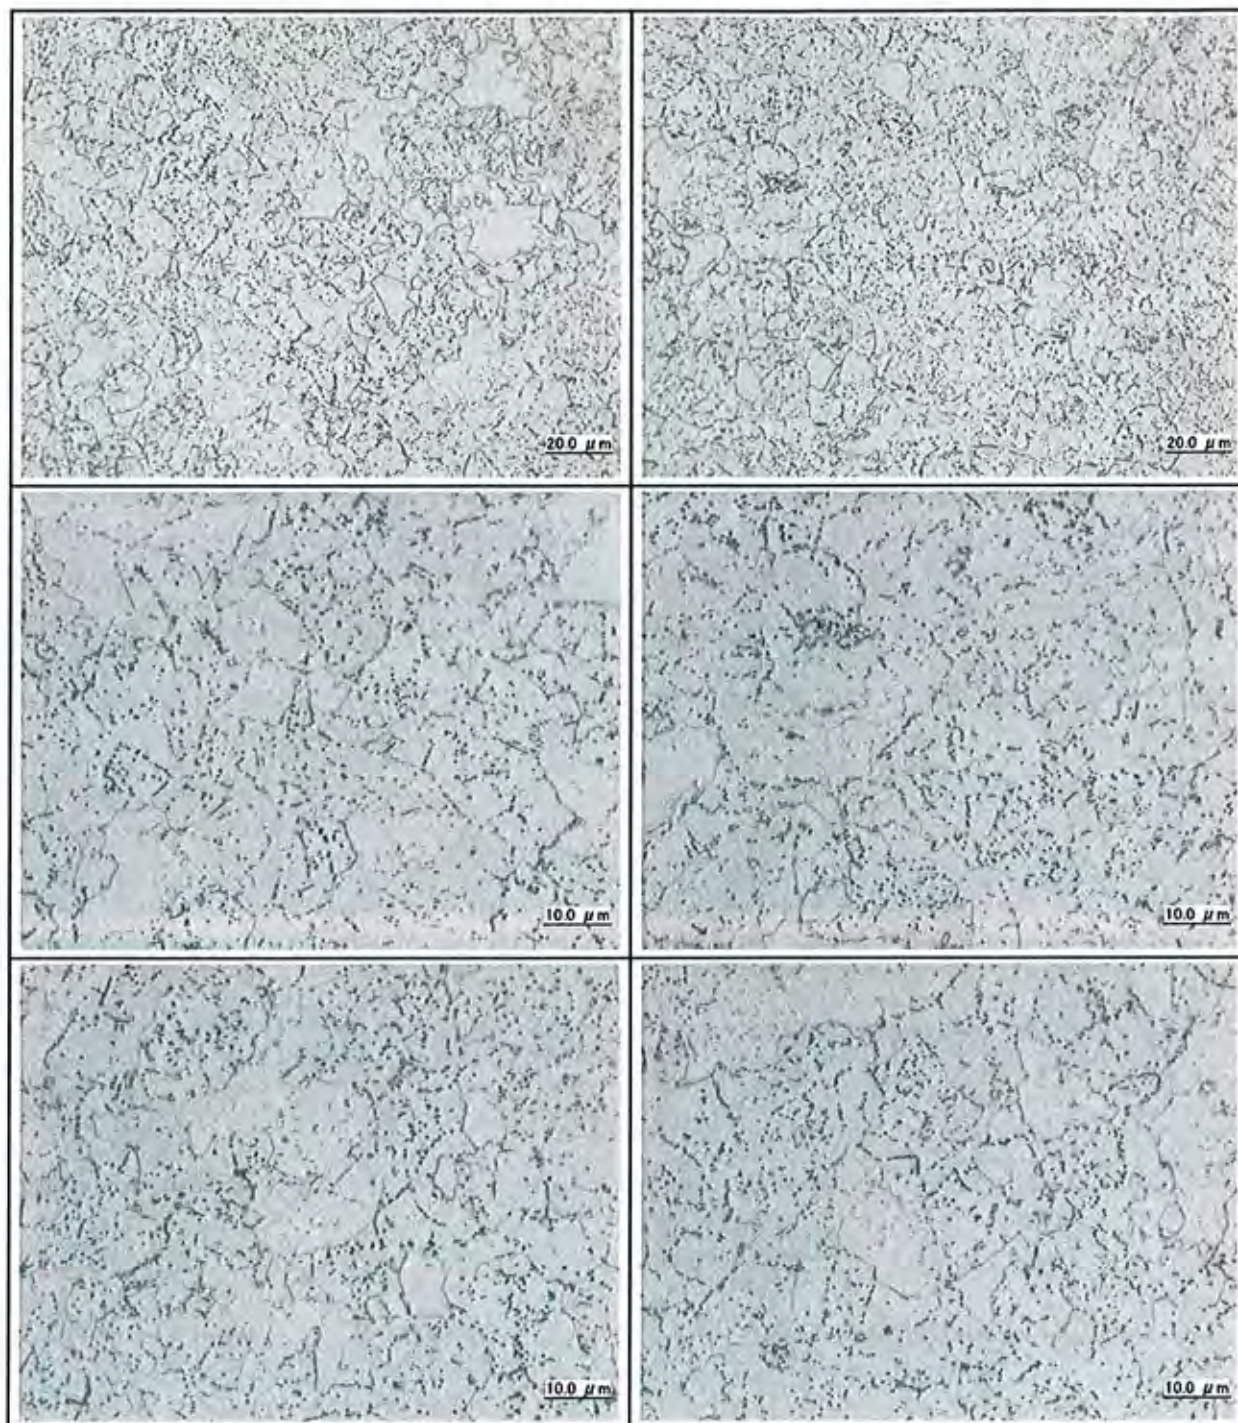
Photo I -39 Microstructure observation at cross section of sample tube  
[RH-Penthouse (Fine Grain HAZ) ]

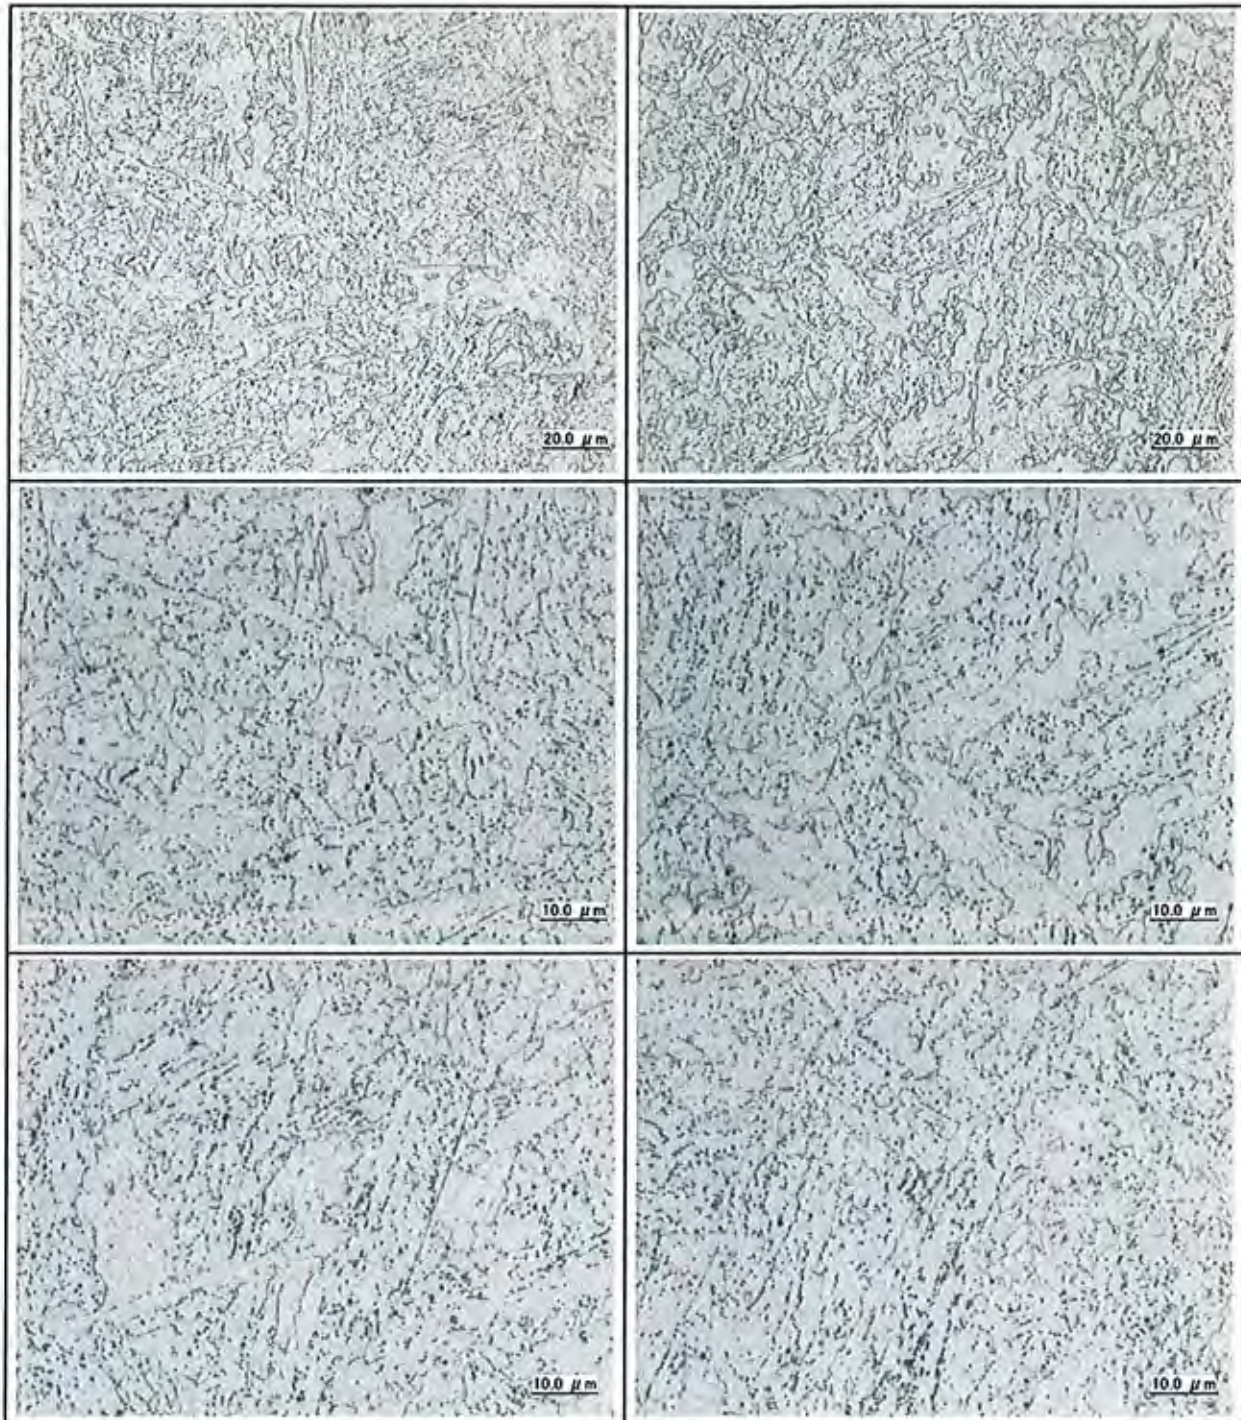
Photo I -41 Microstructure observation at cross section of sample tube  
[RH-Penthouse (Weld Metal) ]
