Characteristics of PSPP Potential Site

Site Name		No.19
Location (River name)		Upper Dam / Reservoir : Burdur Bucak Kocayer (Curukini River) Lower Dam / Reservoir : Burdur Bucak (Karacaoren II Lake)
Profile	Installed Capacity P (MW)	1,000
	Design Discharge Q (m ³ /s)	249
	Effective Head H (m)	507
	Peak Duration Hour (hrs)	7
Geography / Geology	General Geology	<ul style="list-style-type: none"> - The regional geology belongs to the upper Miocene series. Only geology of right bank of Existing Karacaoren II lake is Cretaceous system, and they lay from the west to the east sequentially, Karpuzcay formation (Tmkp) of upper Burdigalian to Serravallian age, Aksu formation (Tma) of Tortonian to Serravallian age. - Karpuzcay formation (Tmkp) consists of sandstone, claystone, siltstone, and conglomerate. Aksu formation (Tma) consists of conglomerate. - N50W/30NE strike and dip was measured at a conglomerate outcrop where southern part of Karacaoren II dam site which geology belongs to Karpuzcay formation. On the other hand, N15W/35NE strike and dip was measured at a calcilutite outcrop on the slope of northern national road, and a fossil of bivalve was found in the outcrop.

Appendix 5-5

R

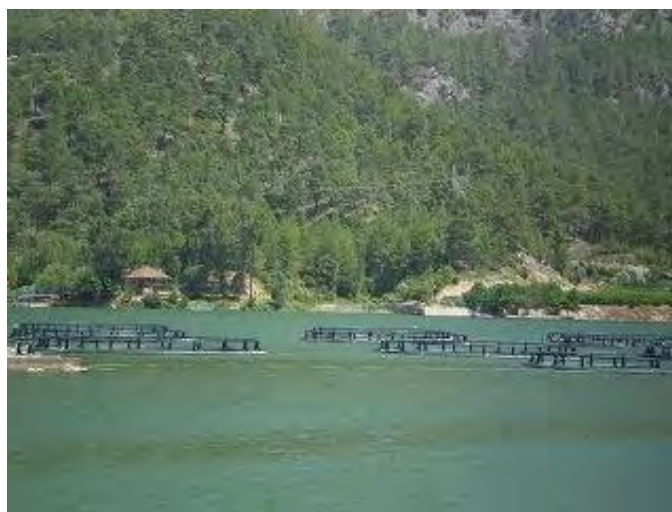
Photo 6 Outlet site (There are a house and fish cages.)

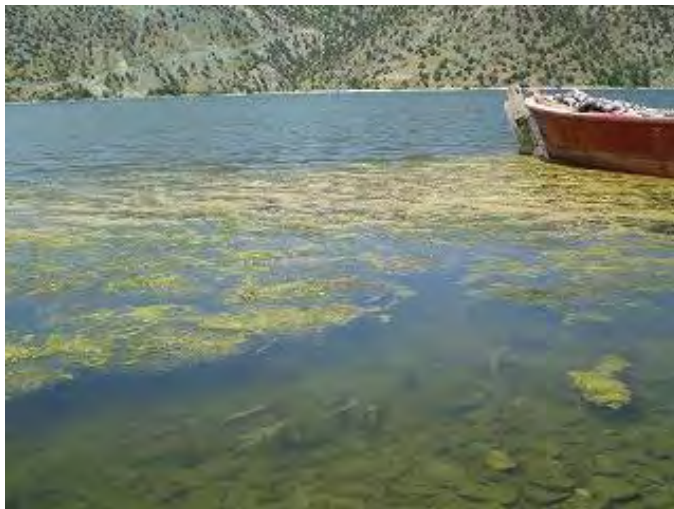
Photo 9 Gökçekaya reservoir, which water quality is relatively bad.

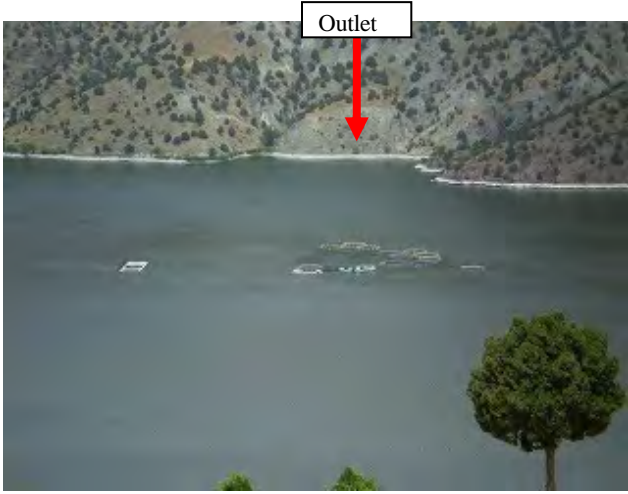
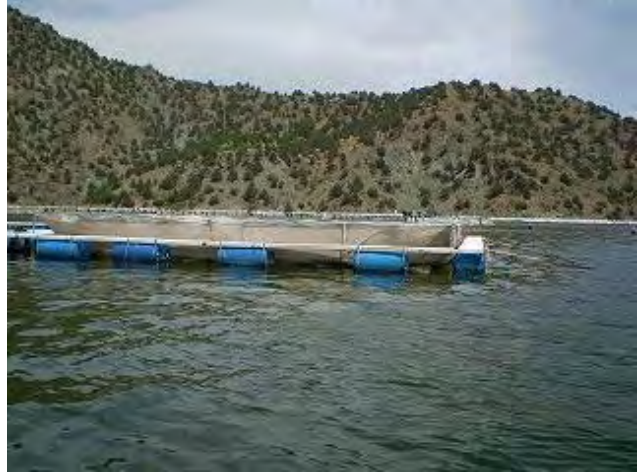
Photo 10 Fish cages in front of the outlet in the Gökçekaya reservoir

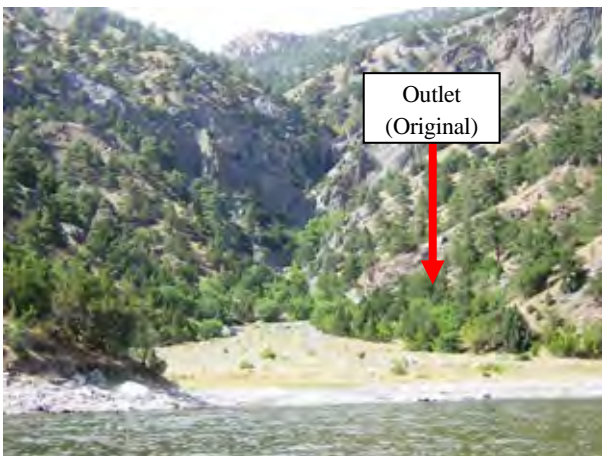
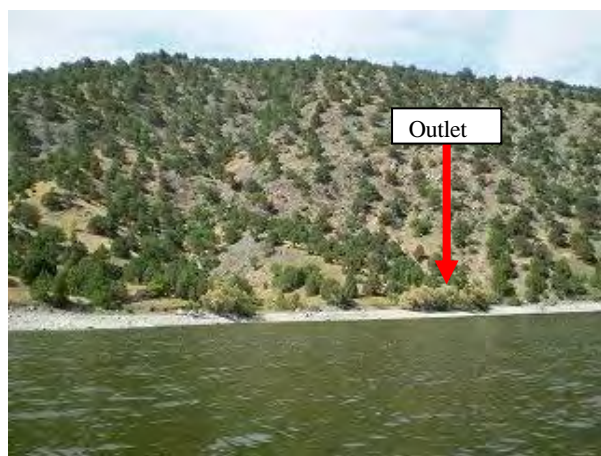
Photo 12 Outlet site

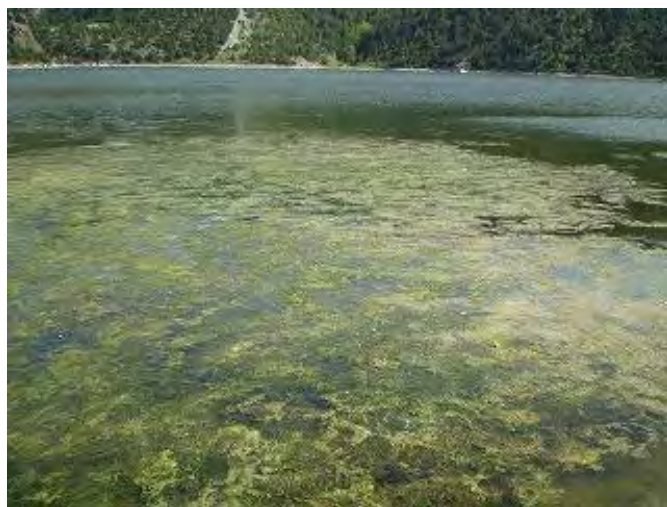
Photo 15 Gökçekaya Reservoir, which water quality is relatively bad.

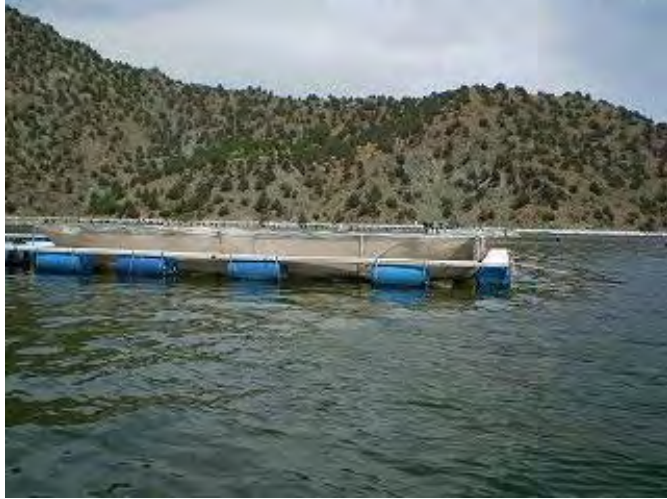
Photo 16 Fish cages in the Gökçekaya reservoir

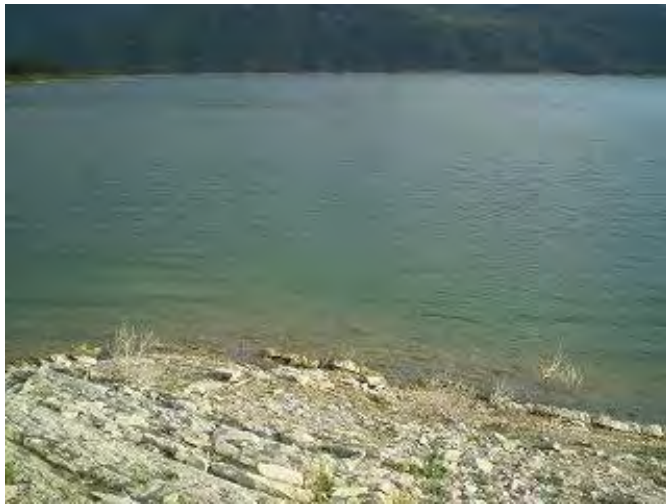
Photo 11 The reservoir of Altinkaya Dam, which water is relatively clean

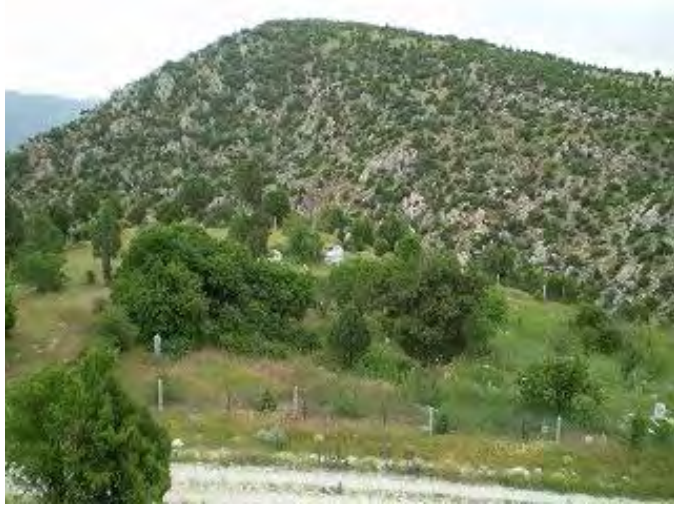
Photo 4 Original upper dam site (There are tombs at the dam axis.)

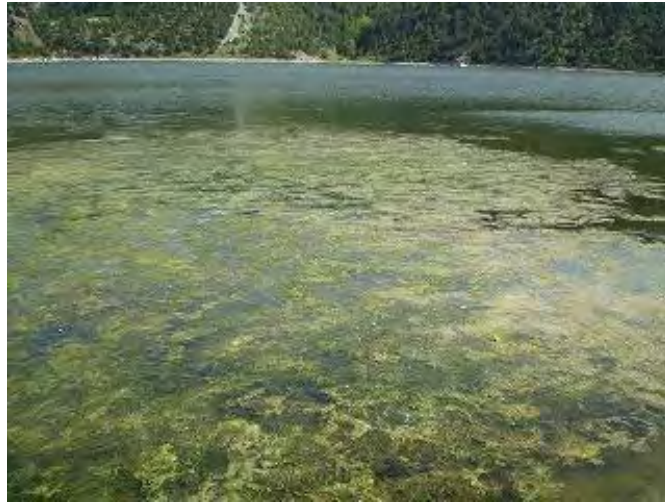
Photo 11 Gökçekaya Reservoir, which water quality is relatively bad

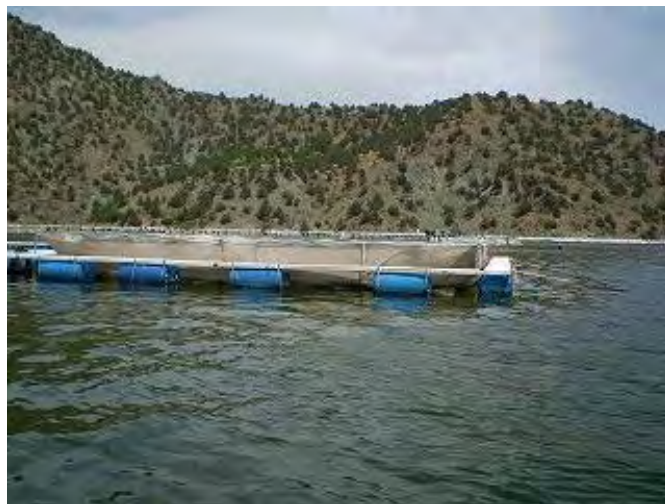
Photo 12 Fish cages in the Gökçekaya reservoir
