4. Existing Facility Survey

SURVEY REPORT – MANHOLE PICK UP

Survey Report: Manhole Pickup

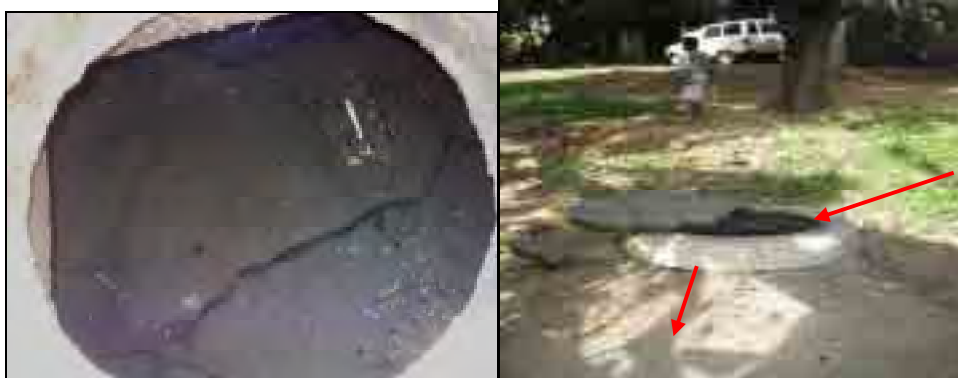
M85264 – GL = +12.071m

“BOP BLOCKED”

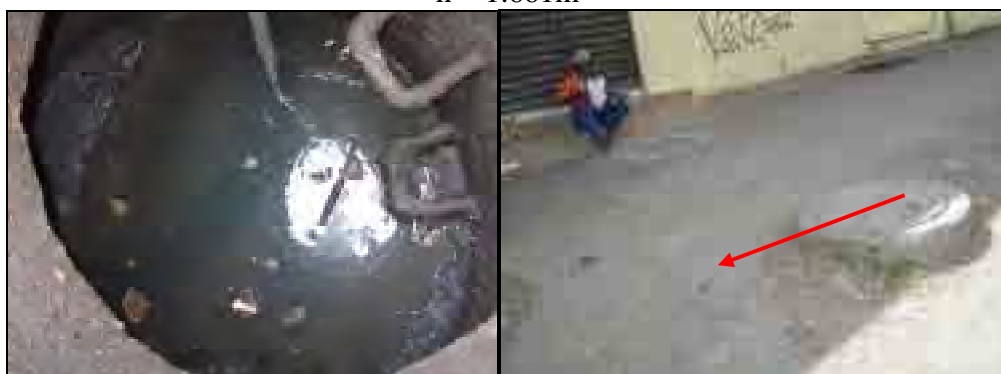
M85268 – GL = 7.817m
BOP = +4.322m
h = 3.495m

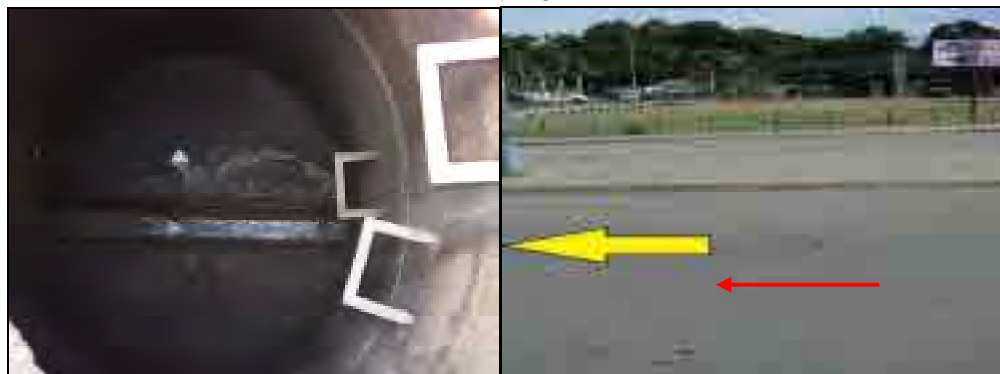
M95231 – GL = +12.701m
BOP = +10.575m
h = 2.126m

* Yellow arrow indicates the location of M95231 from M95227..

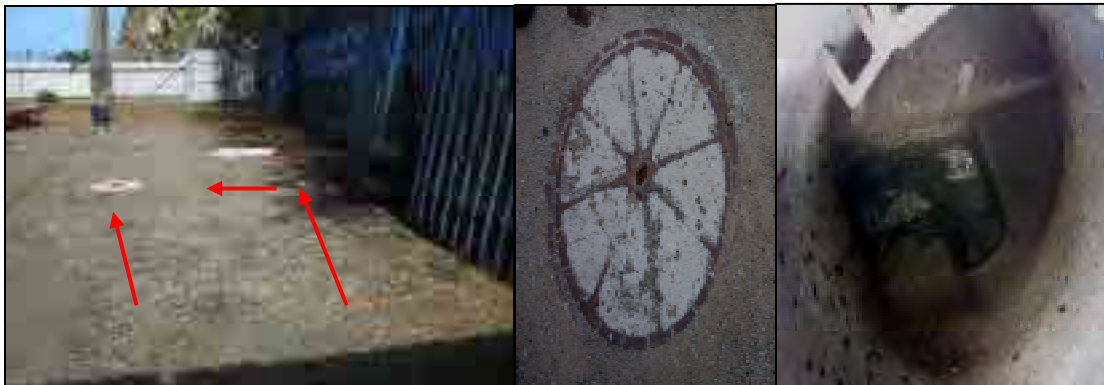
M65143 – GL = +1.482m & M65131 – GL = +1.498m

M65143 is cemented

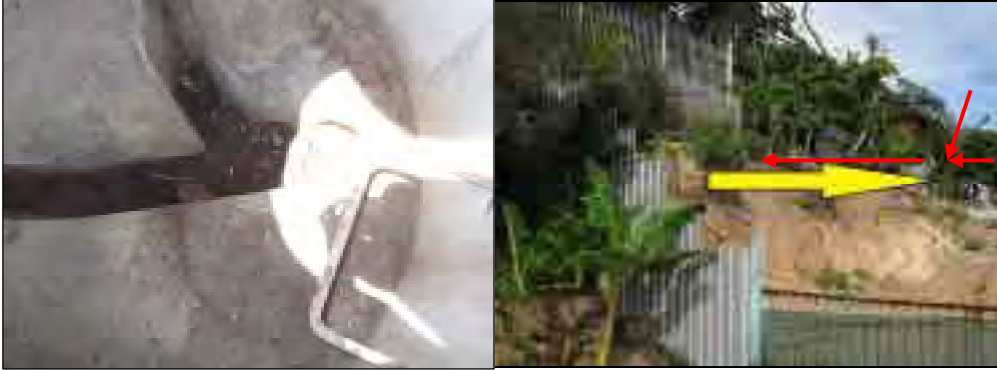
* Yellow arrow indicates location of upper manhole..

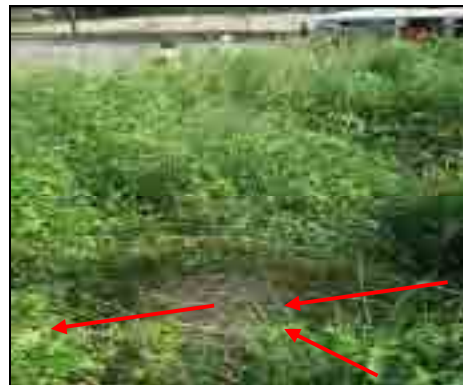
M05103 – GL = +17.749m

* Blocked..

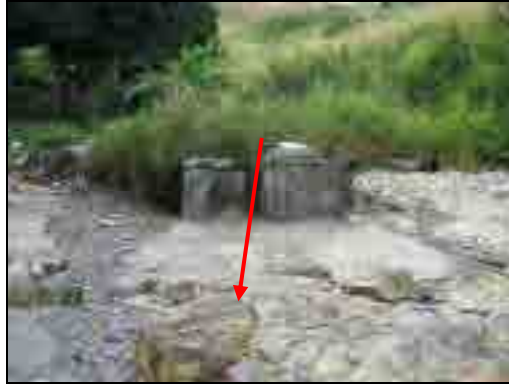
M***** (Middle) – GL = +0.915m
 BOP = -0.520m
 h = 1.435m

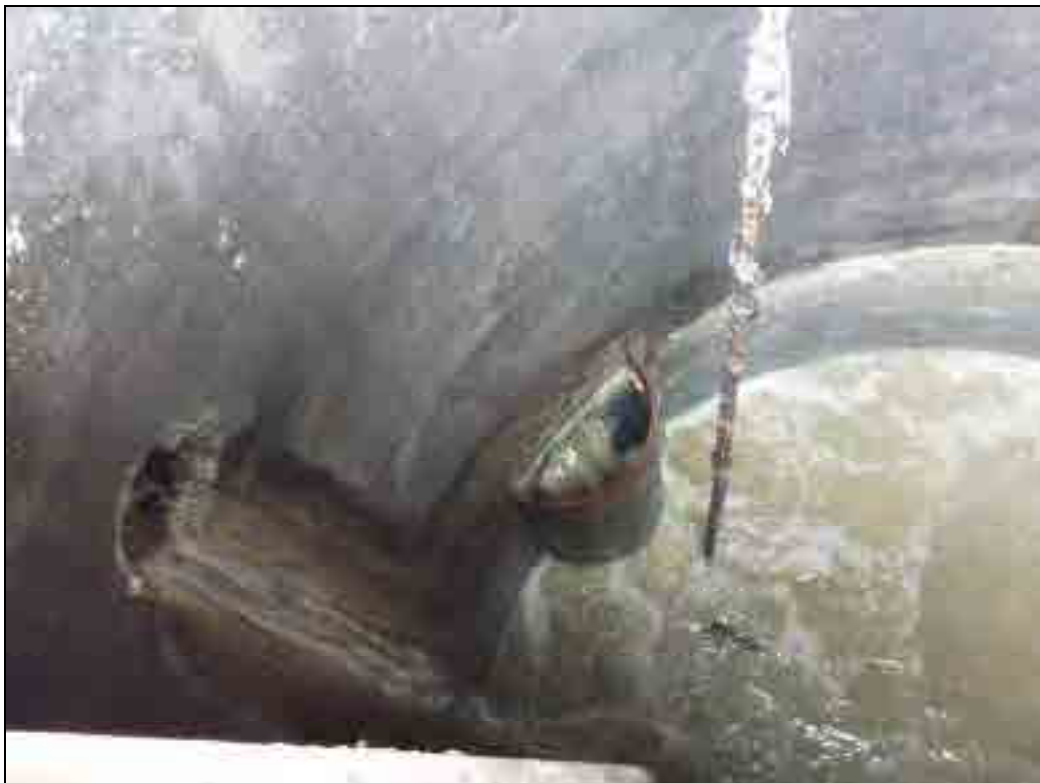
3a. Inflow Pipe 1 Top, PVC; Inflow Pipe 2 Bottom, Steel

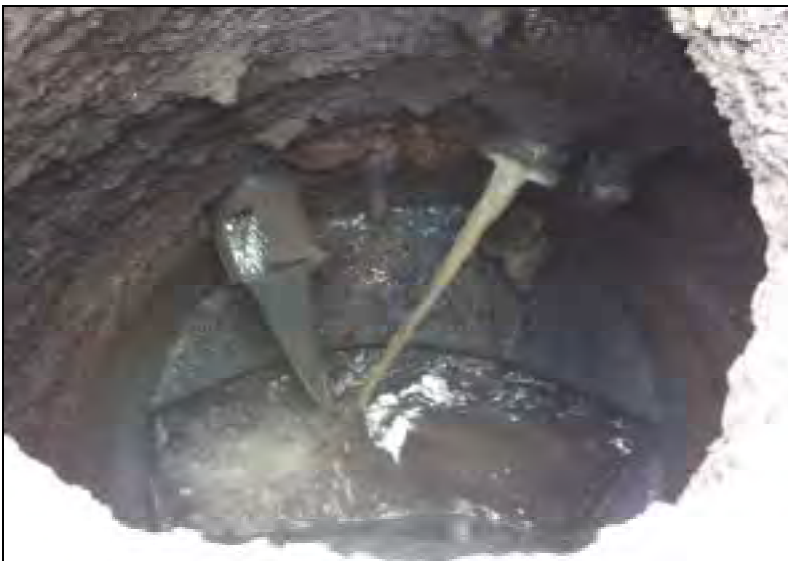
5a. Manhole 1, Inflow manhole

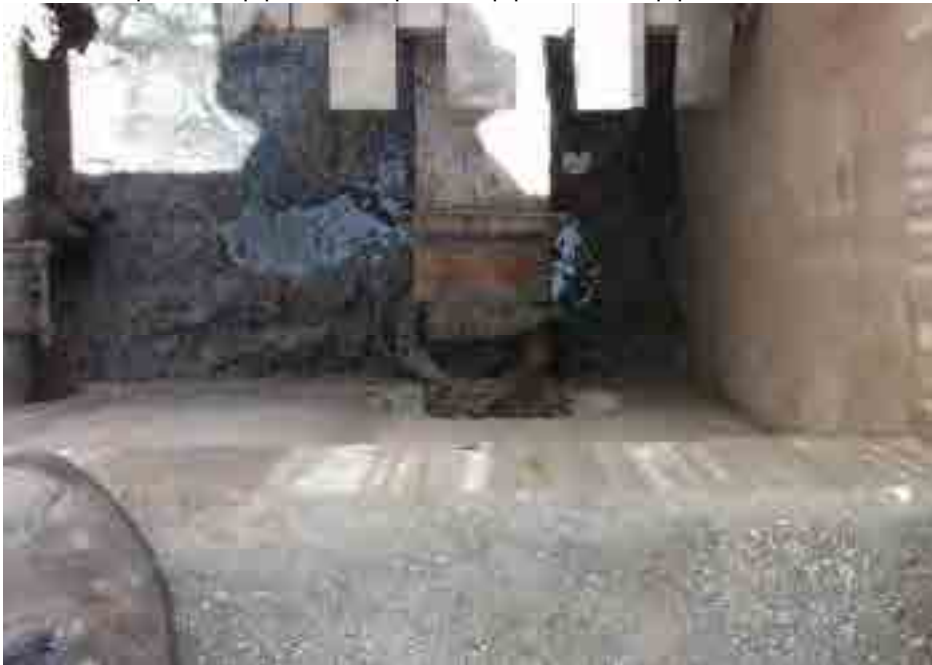
2b. Broken pressure pipe in valve pit. This pipe is the 3rd pipe from left.

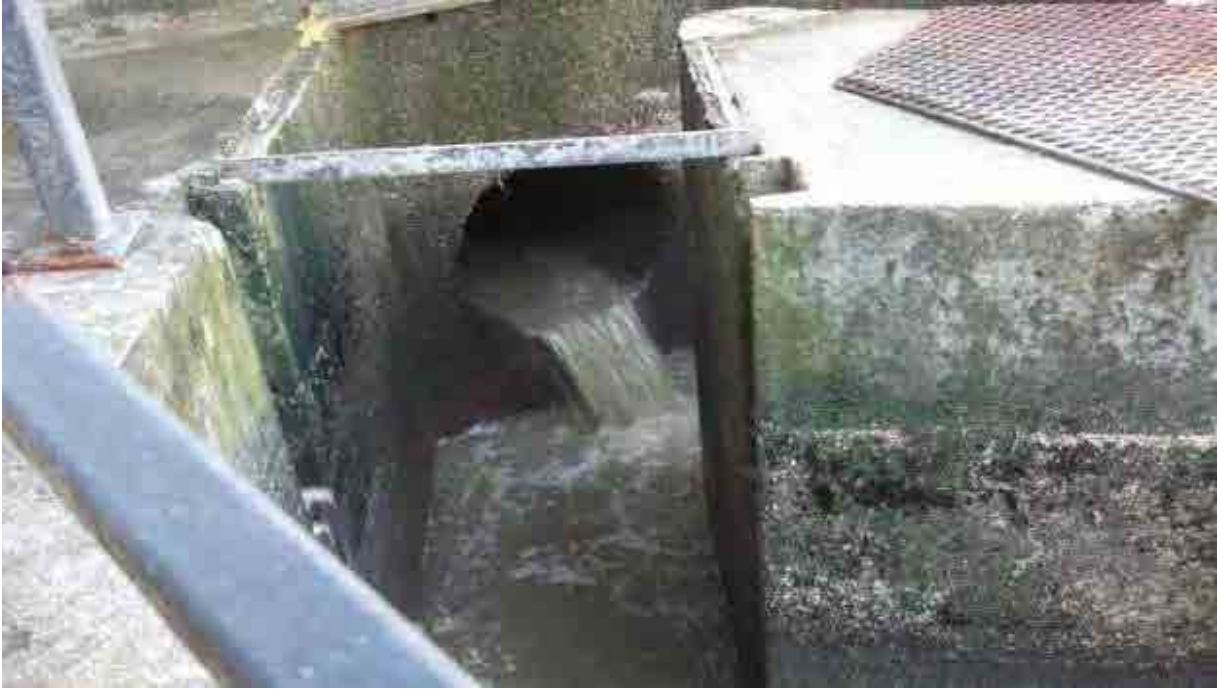
3a. Inflow Pipe (600mm
Diameter)

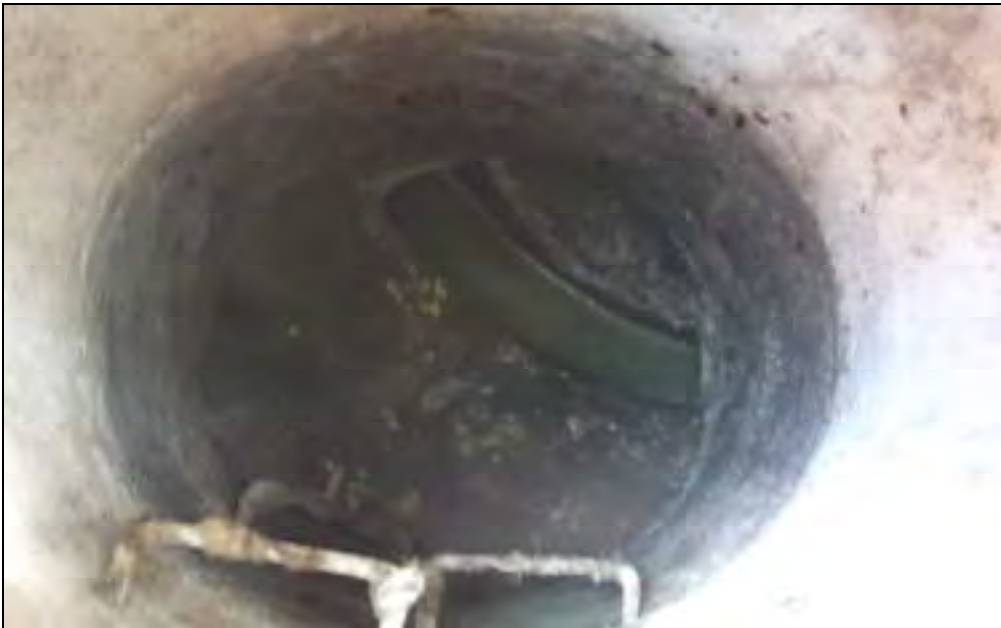
5a. Manhole 1; Inflow Manhole

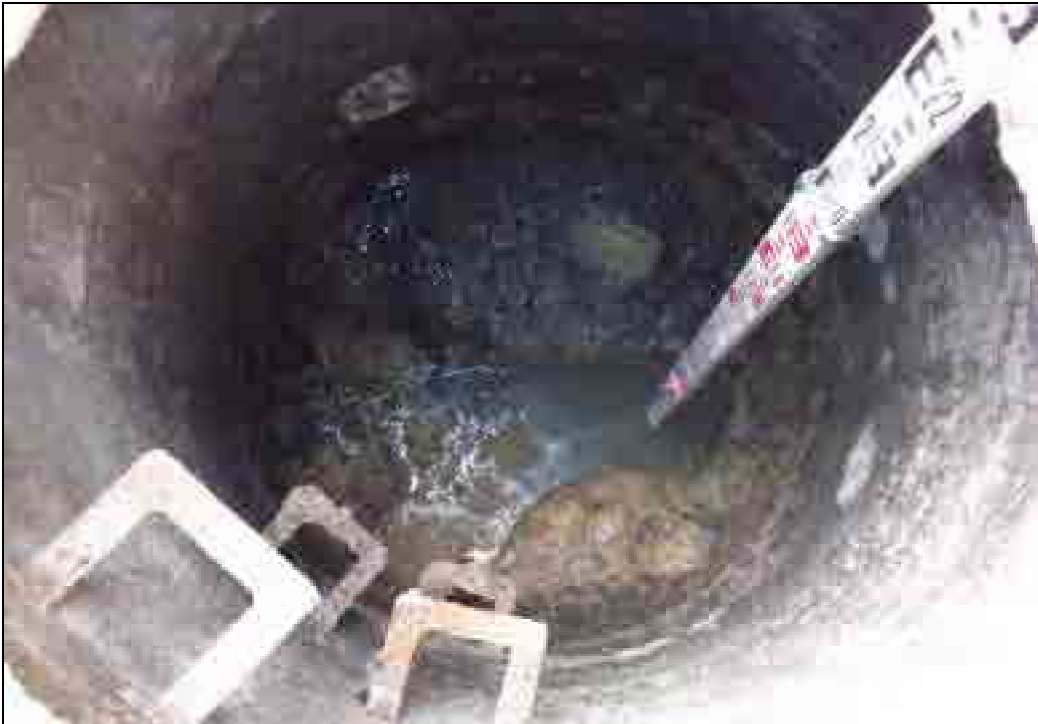
5b. Manhole 2; Inflow Manhole

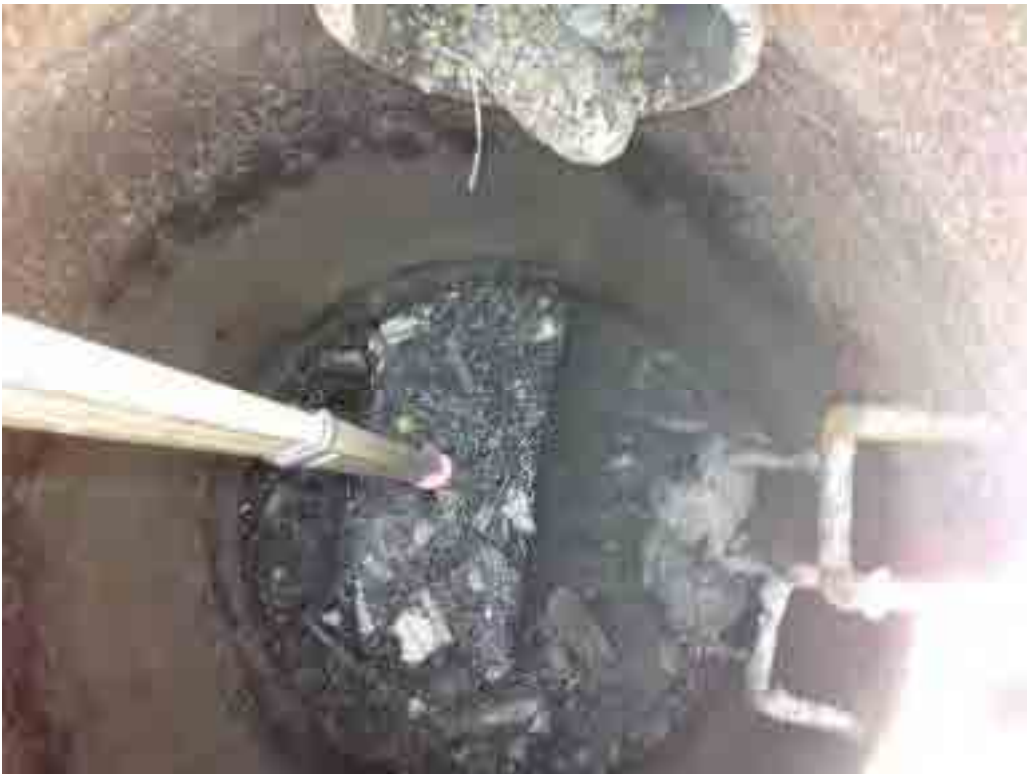
5c. Manhole 3; Outflow Manhole

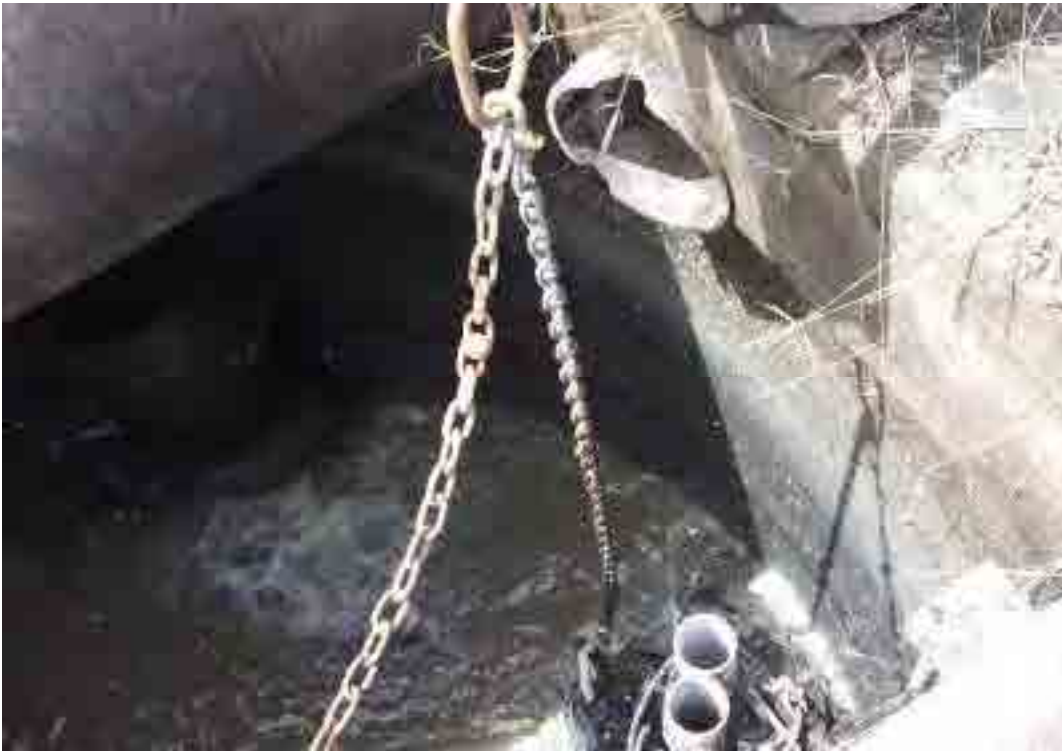
3a. Inflow Pipe 1 is to the left and Outflow Pipe is at top right corner

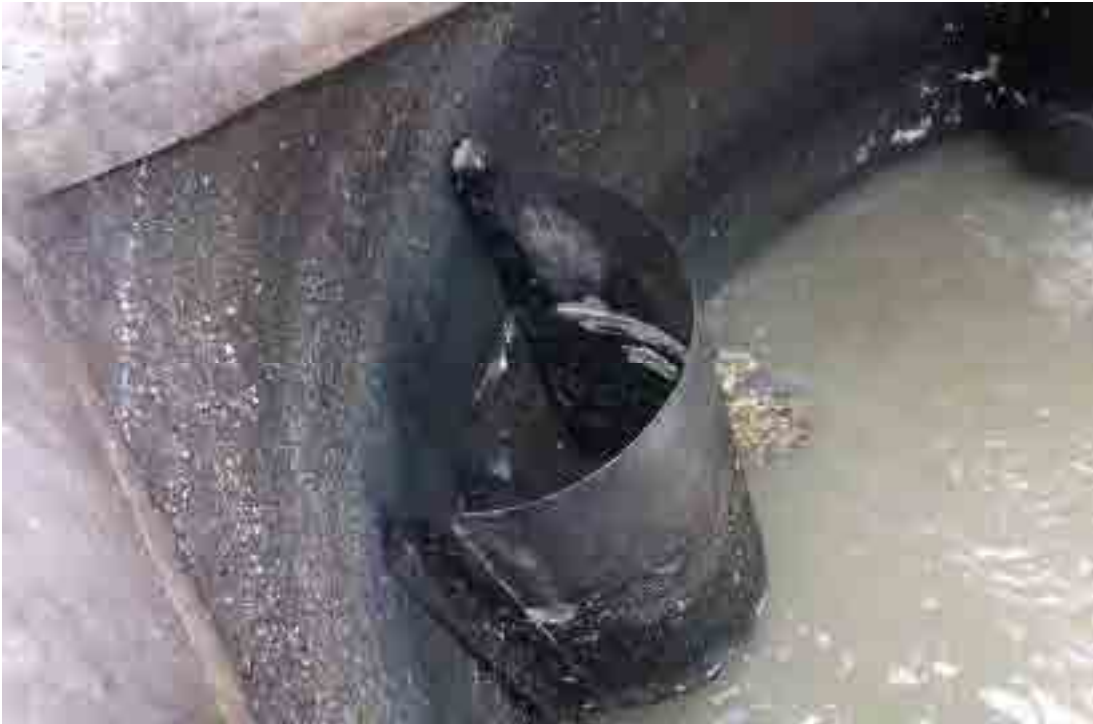
3b. Inflow Pipe 2, (Inflow Pipe 1 is at the top right corner)

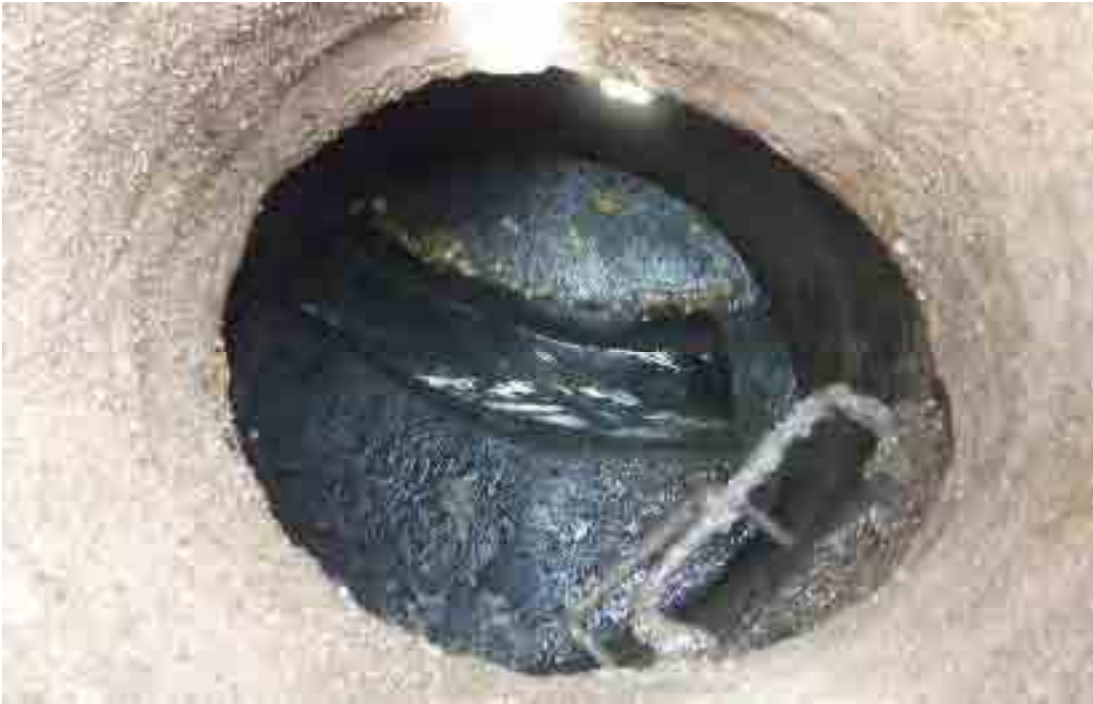
5a. Manhole 1, Inflow Manhole

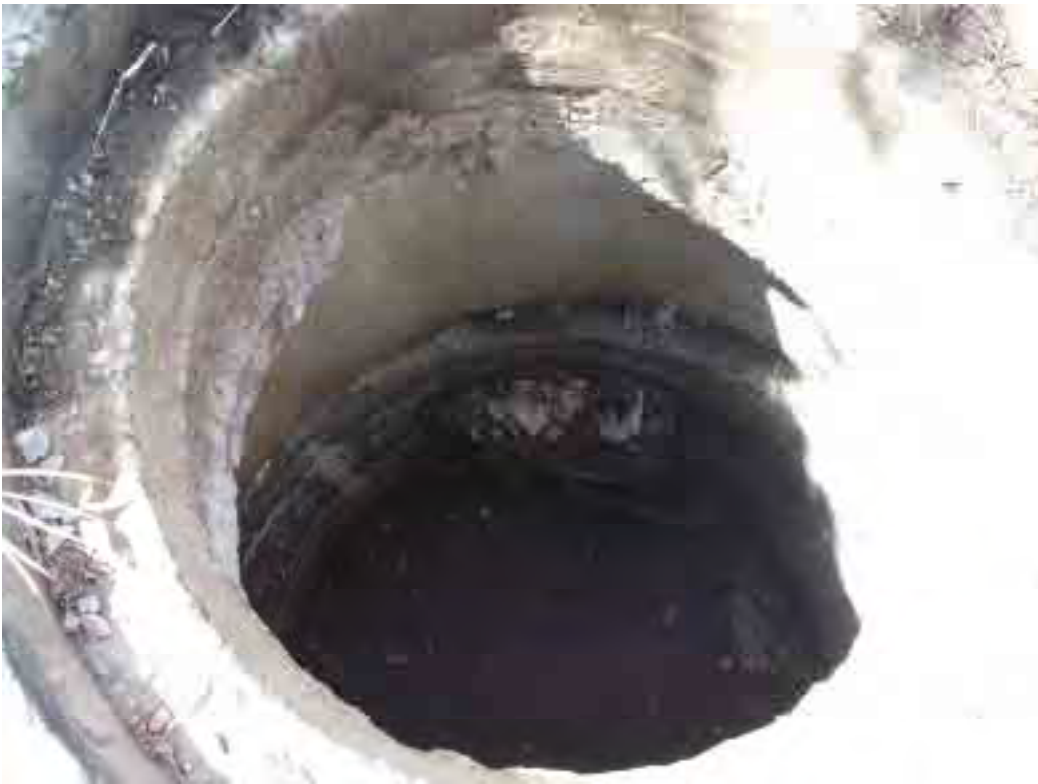
5b. Manhole 2, Inflow Manhole

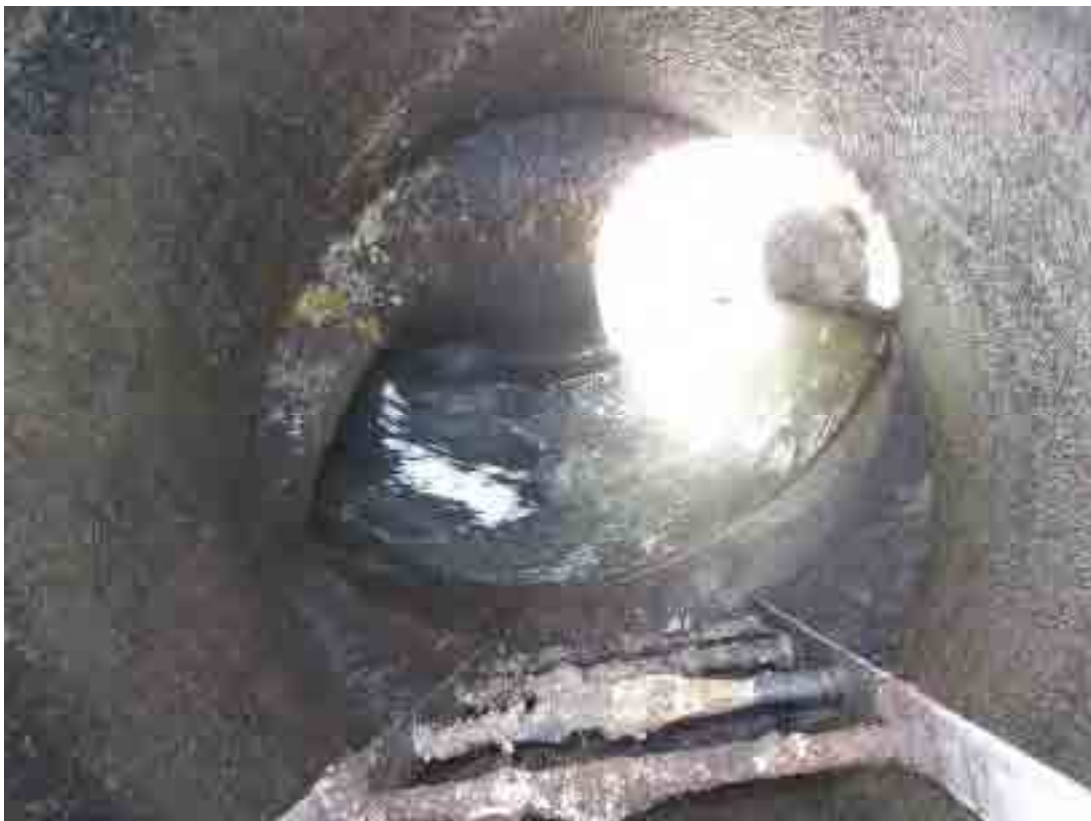
5a. Manhole 1, Inflow Manhole

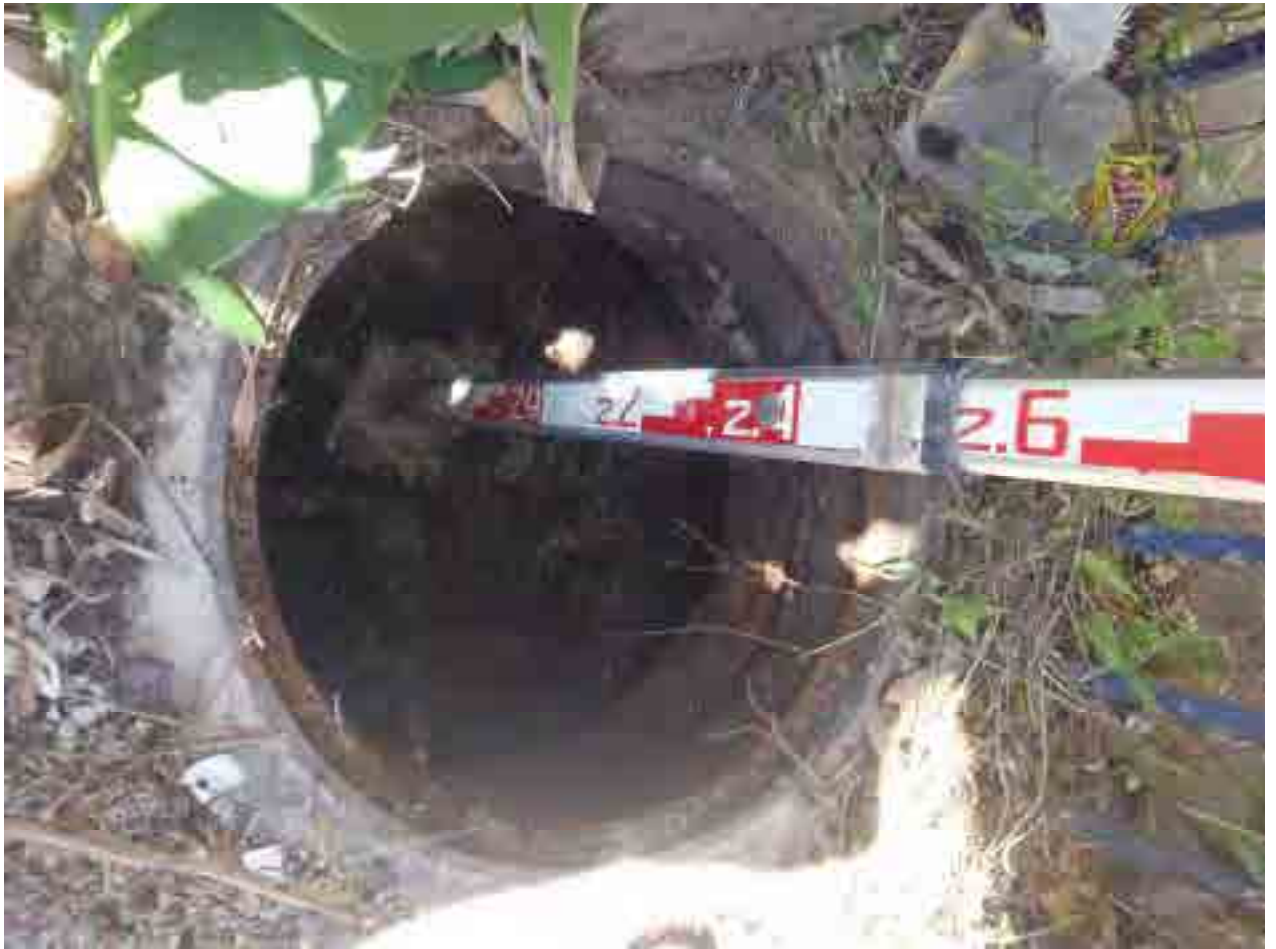
5b. Manhole 2, Inflow Manhole

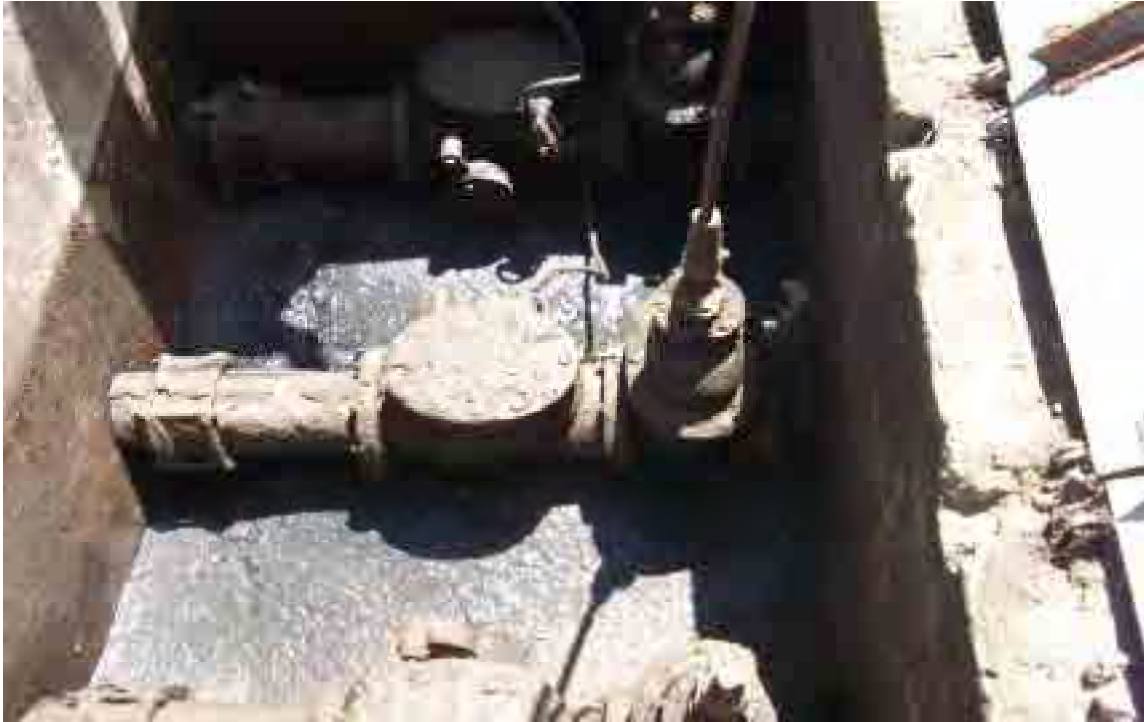
3a. Inflow Pipe; 600mm diameter

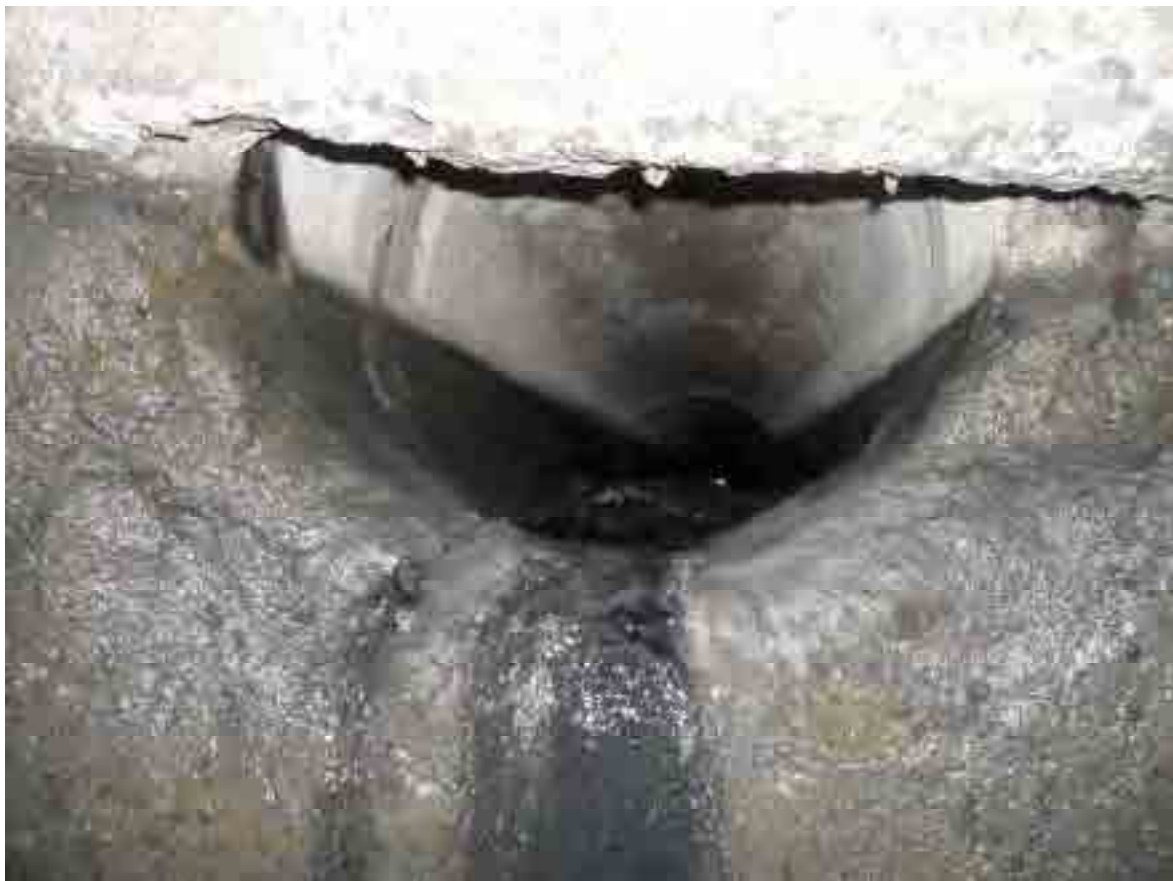
5a. Inflow Manhole

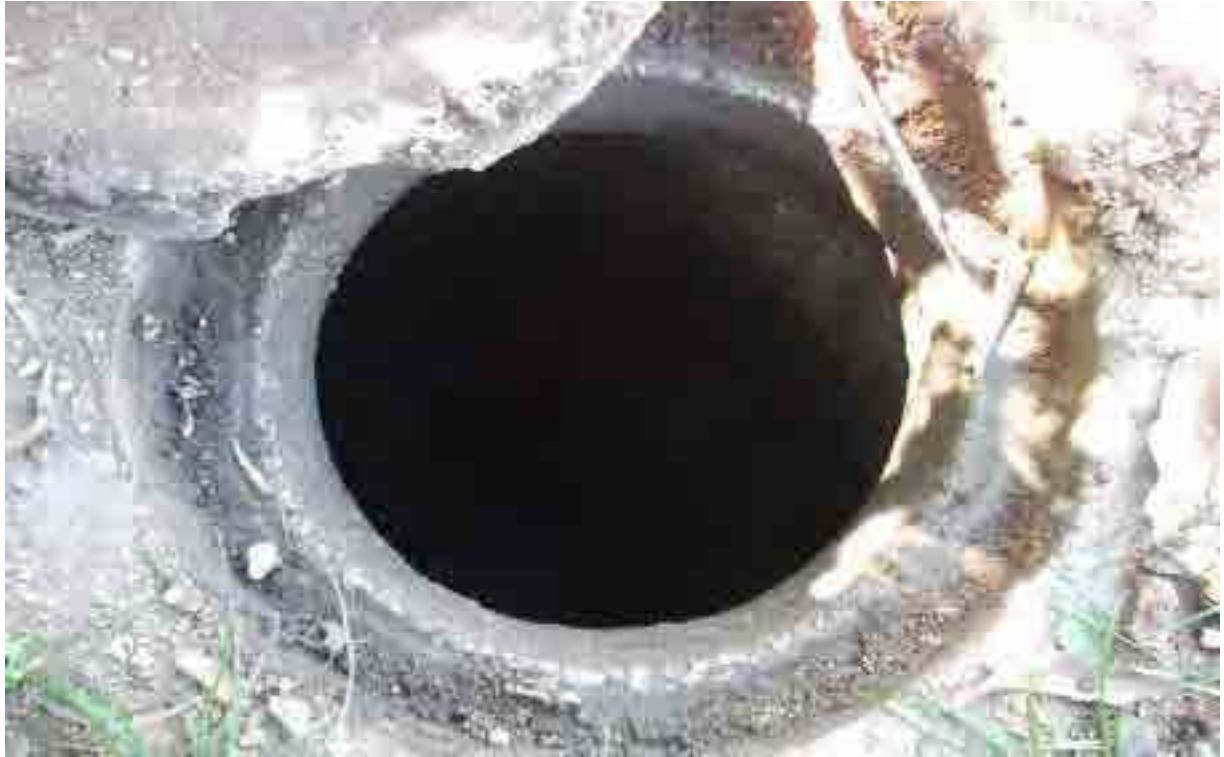
5b. Inflow Manhole

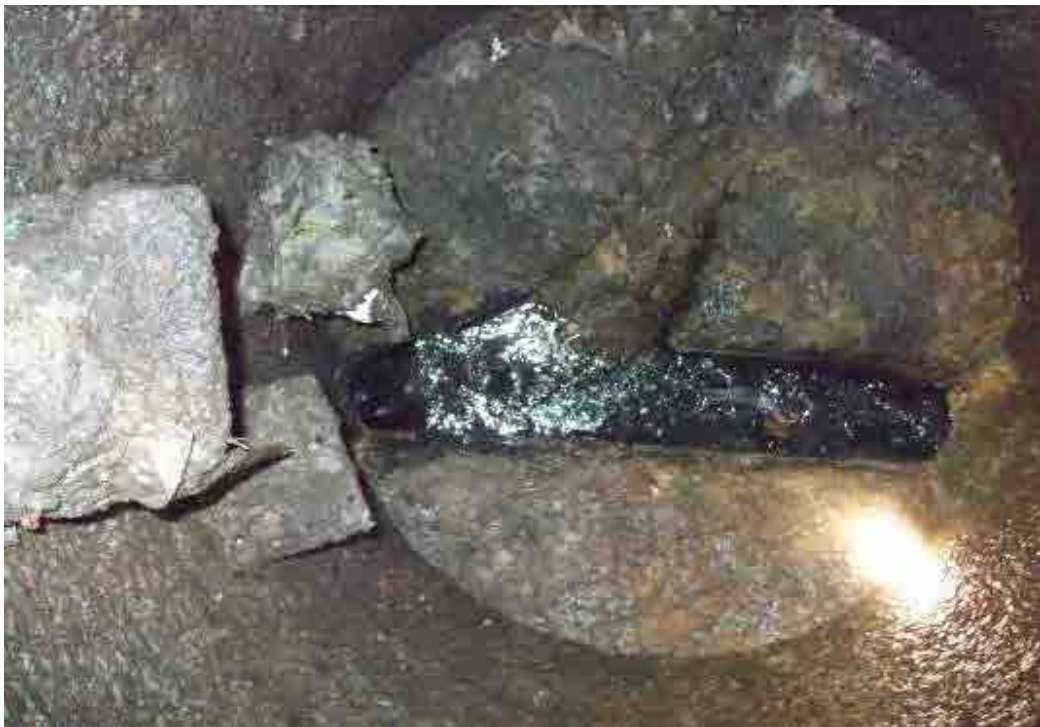
3a. Inflow Manhole 1

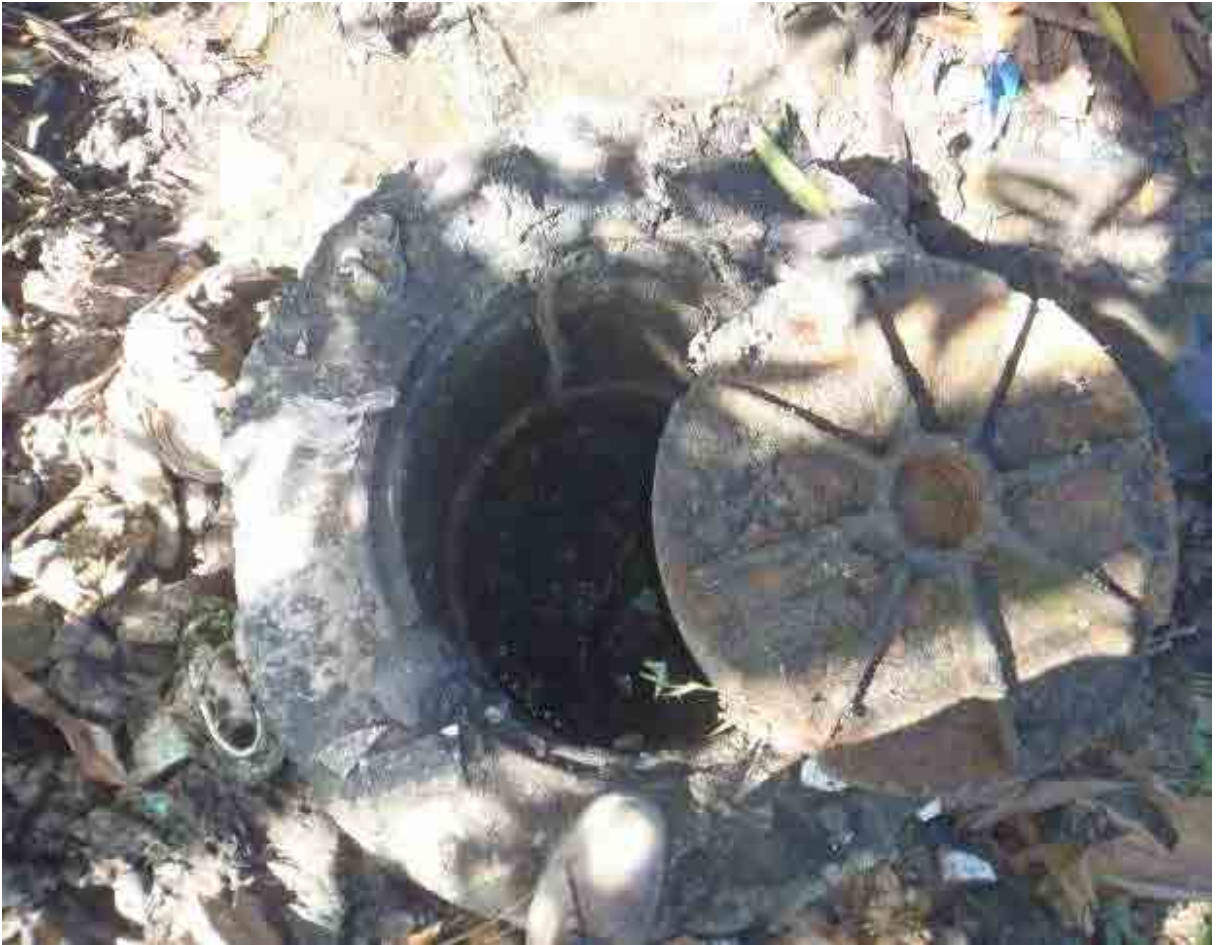
3b. Inflow Manhole 2
