4.2 Meghna Bridge

4.2.1 Crack, water leakage, isolated lime

4.3 Gumti Bridge

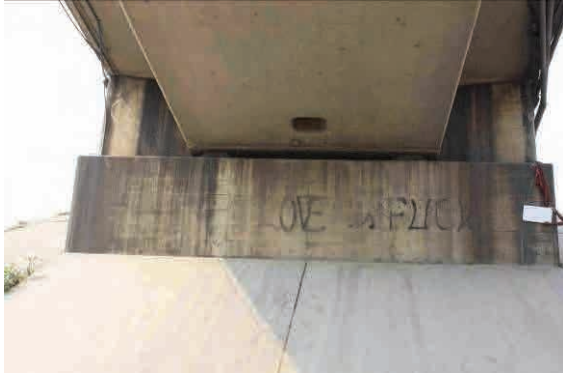
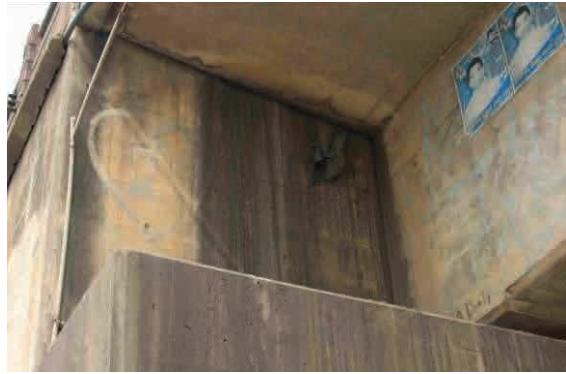
Abutment 01	
Damage: a	Damage: a

No crack	No crack

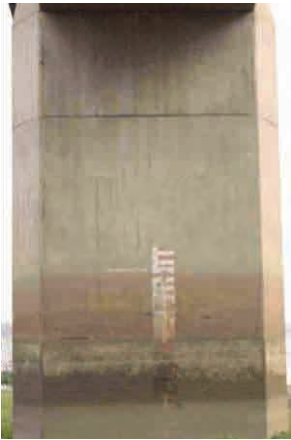
Pier 01	
Damage: a	Damage: c

No crack	Crack width over 0.2mm

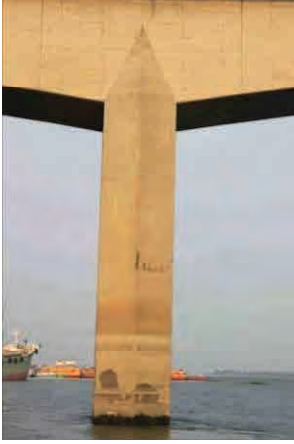
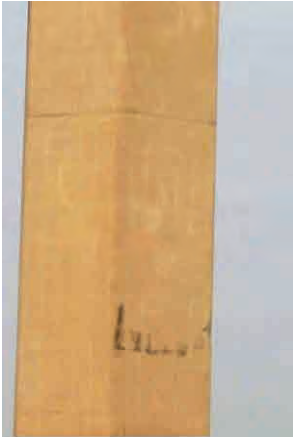
Pier 02	
Damage: a	Damage: a

No crack	No crack

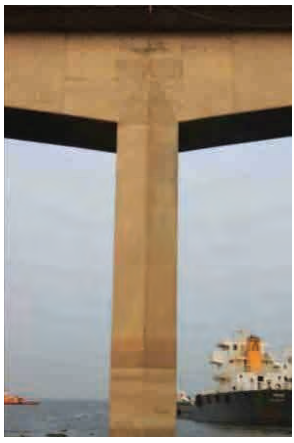
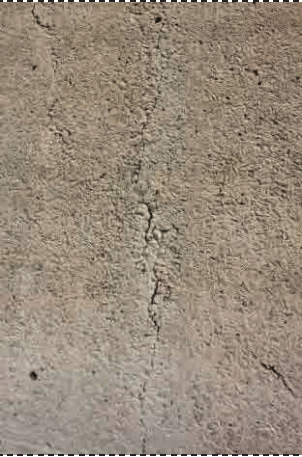
Pier 03	
Damage: a	Damage: c

No crack	Crack width over 0.2mm

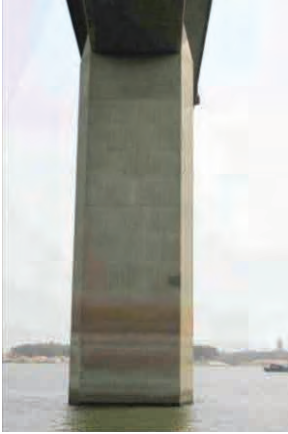
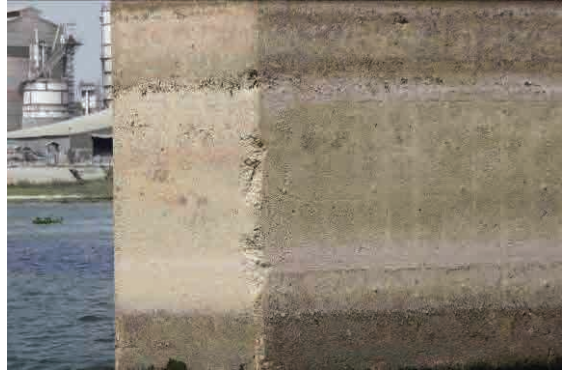
Pier 04	
Damage: a	Damage: a

No crack	No crack

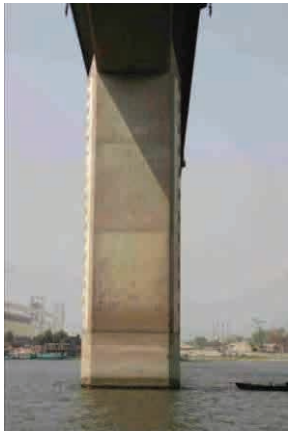
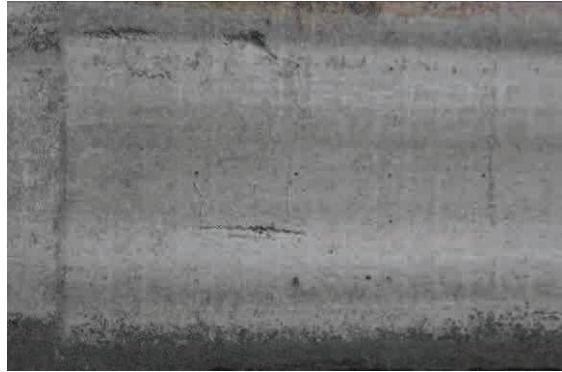
Pier 05	
Damage: a	Damage: a

No crack	No crack

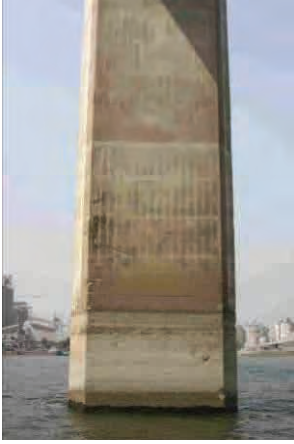
Pier 06	
Damage: a	Damage: c

No crack	Crack width over 0.2mm

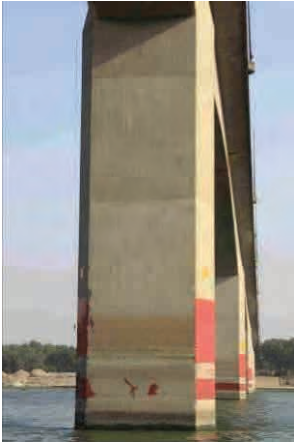
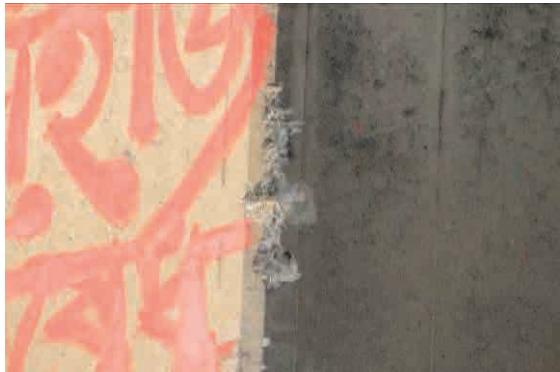
Pier 07	
Damage: a	Damage: a

No crack	No crack

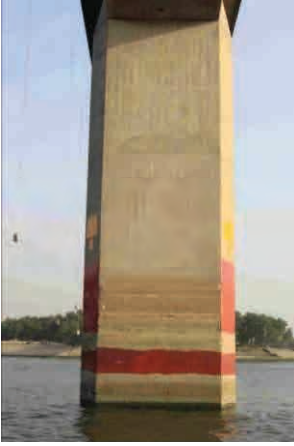
Pier 08	
Damage: a	Damage: c

No crack	Crack width over 0.2mm

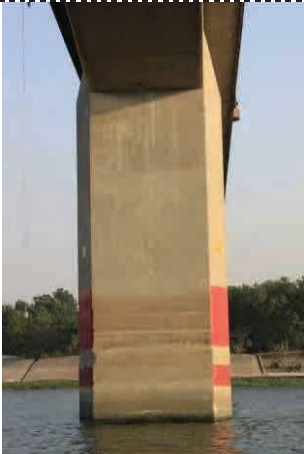
Pier 09	
Damage: a	Damage: c

No crack	Crack width over 0.2mm

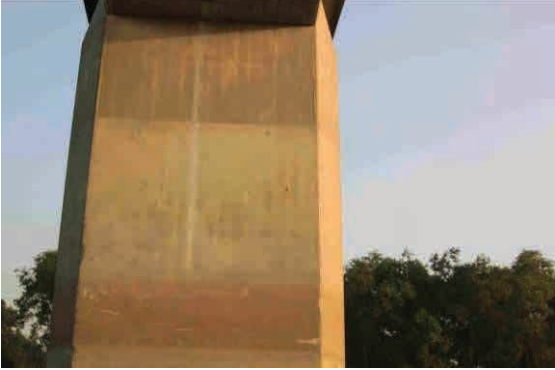
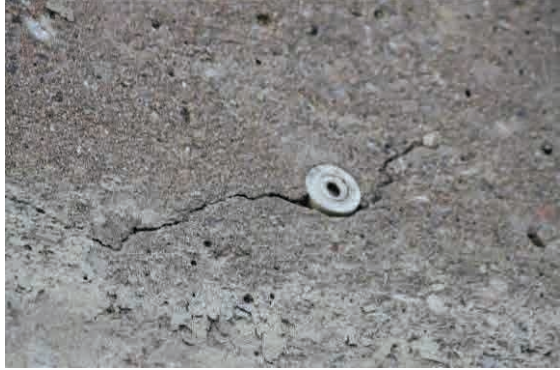
Pier 10	
Damage: a	Damage: c

No crack	Crack width over 0.2mm

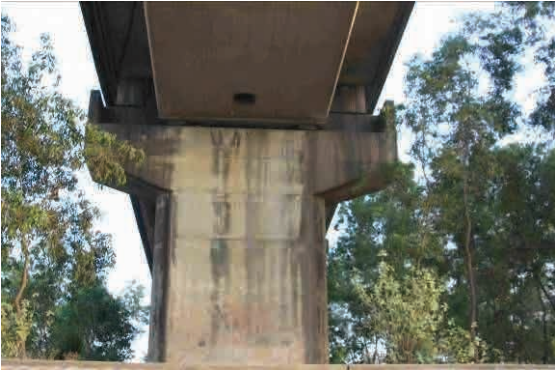
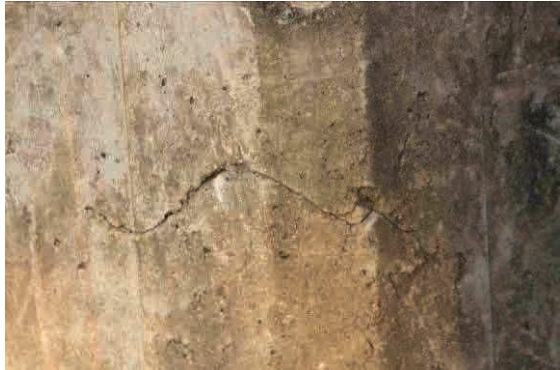
Pier 11	
Damage: a	Damage: c

No crack	Crack width over 0.2mm

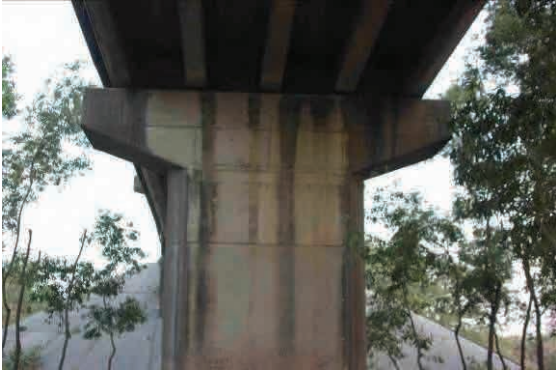
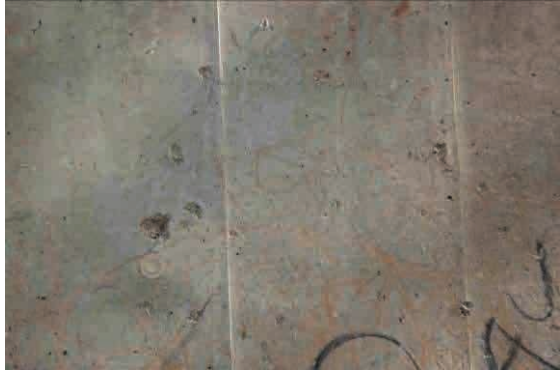
Pier 12	
Damage: a	Damage: a

No crack	No crack

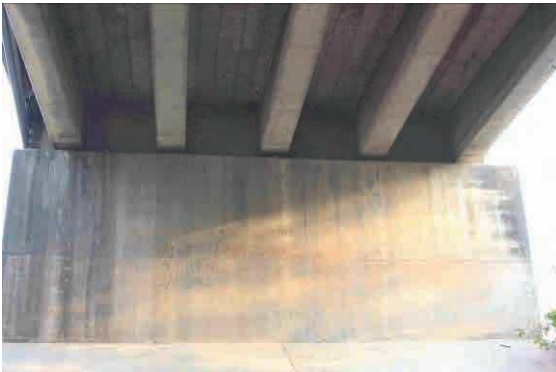
Abutment 02	
Damage: a	Damage: c

No crack	Crack width over 0.2mm

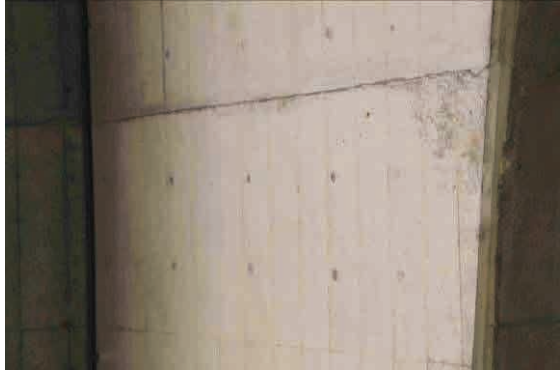
Superstructure P1	
Damage: a	Damage: a

No crack	No crack

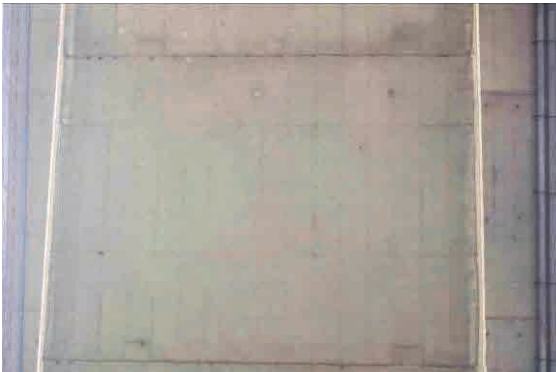
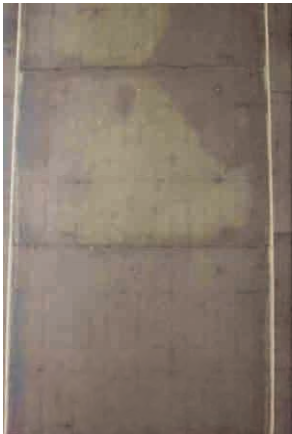
Superstructure P2	
Damage: a	Damage: a

No crack	No crack

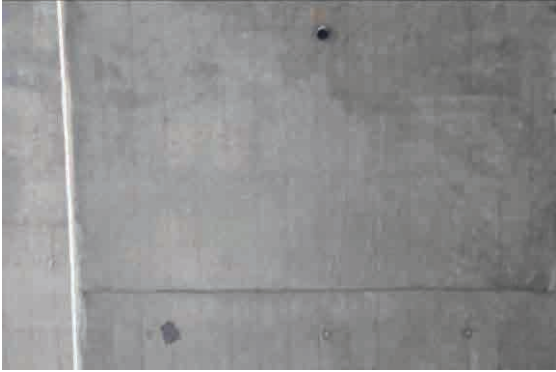
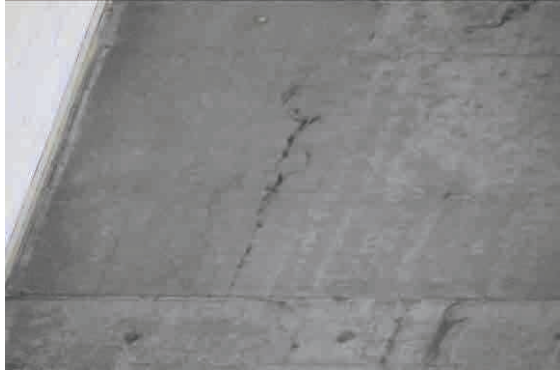
Superstructure P3	
Damage: a	Damage: a

No crack	No crack

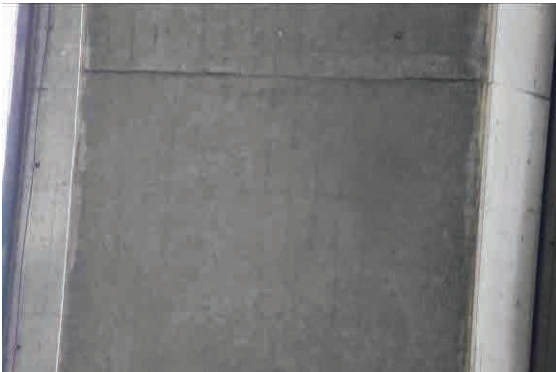
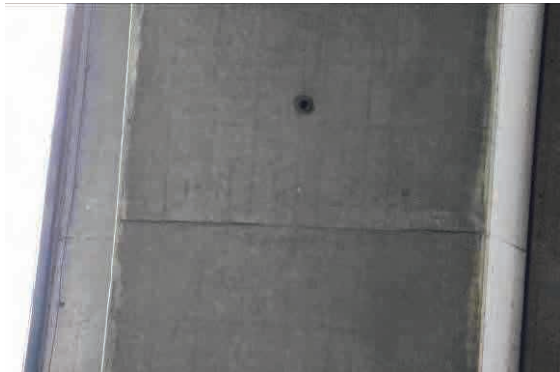
Superstructure P4	
Damage: a	Damage: a

No crack	No crack

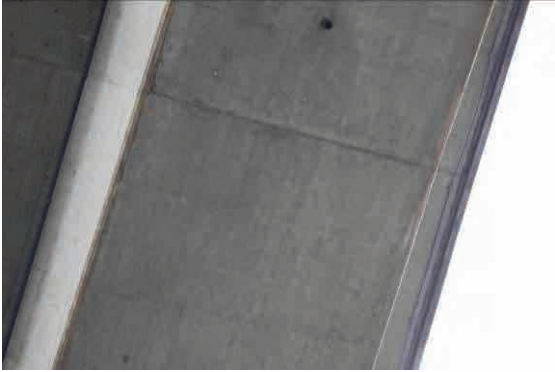
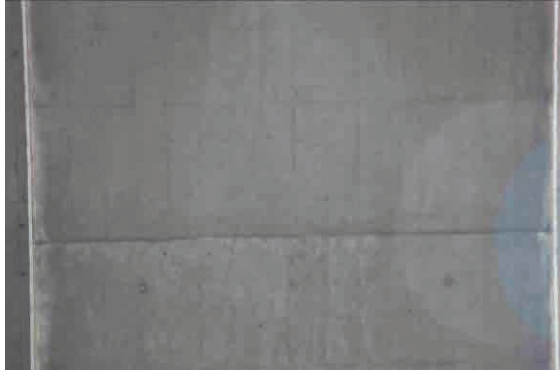
Superstructure P5	
Damage: a	Damage: a

No crack	No crack

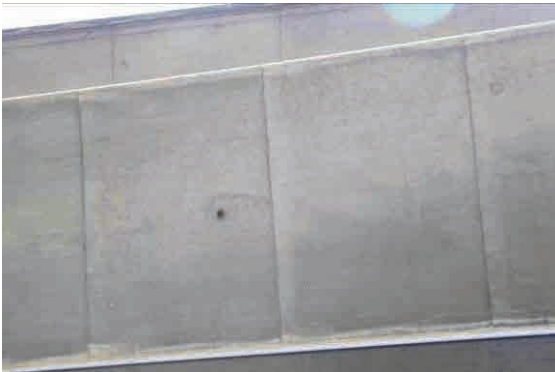
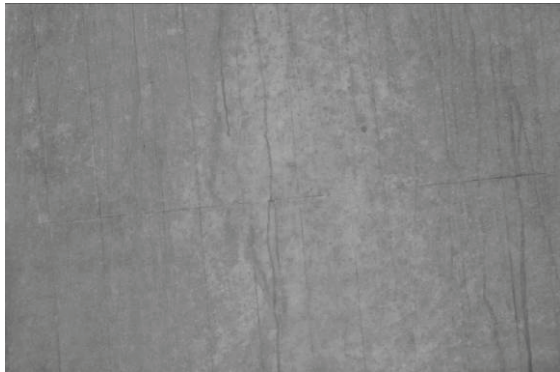
Superstructure P6	
Damage: a	Damage: a

No crack	No crack

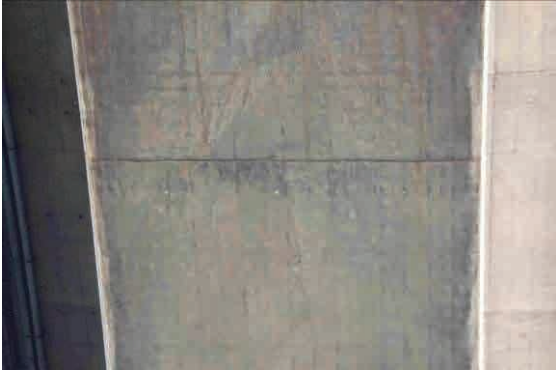
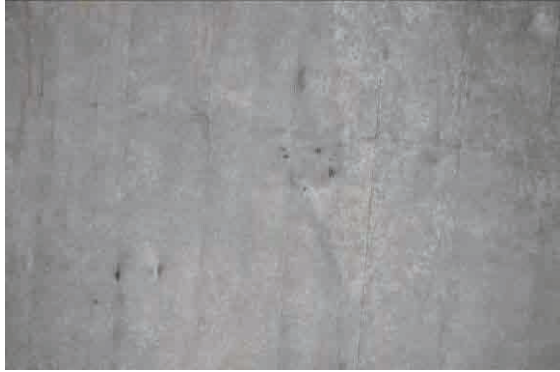
Superstructure P7	
Damage: a	Damage: a

No crack	No crack

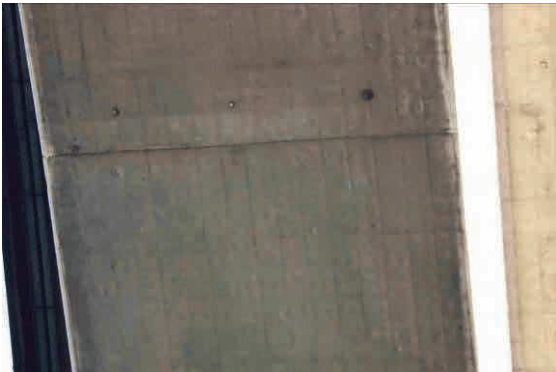
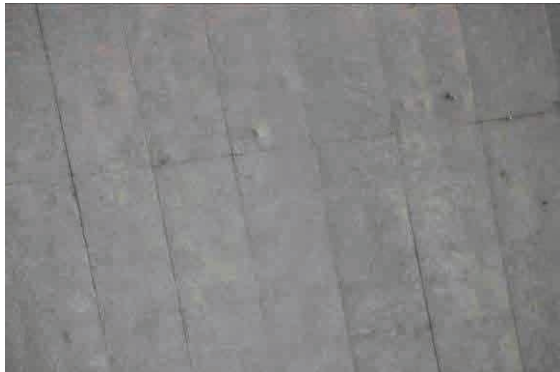
Superstructure P8	
Damage: a	Damage: a

No crack	No crack

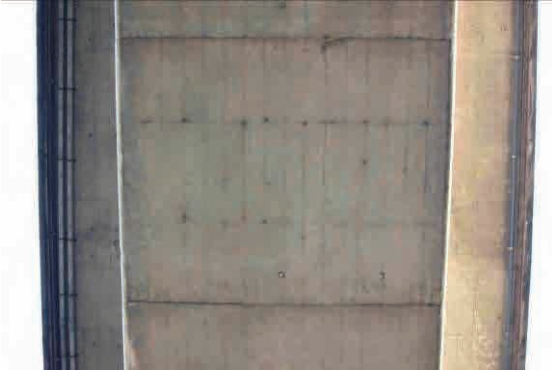
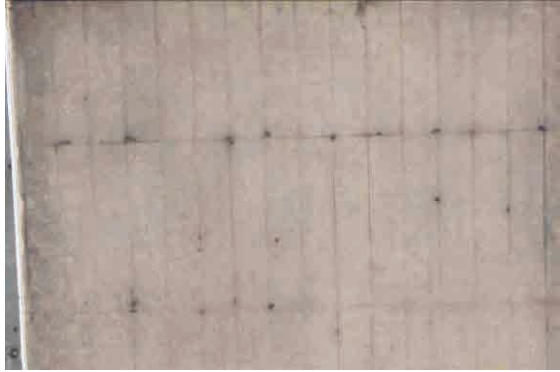
Superstructure P10	
Damage: a	Damage: a

No crack	No crack

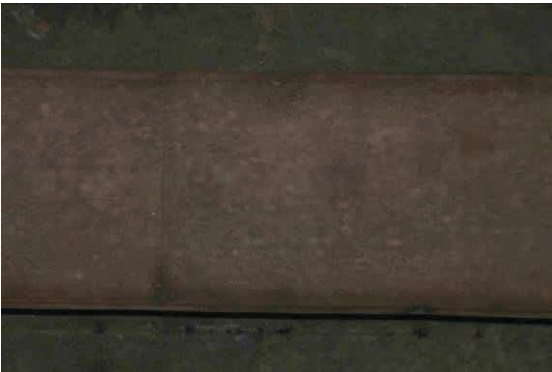
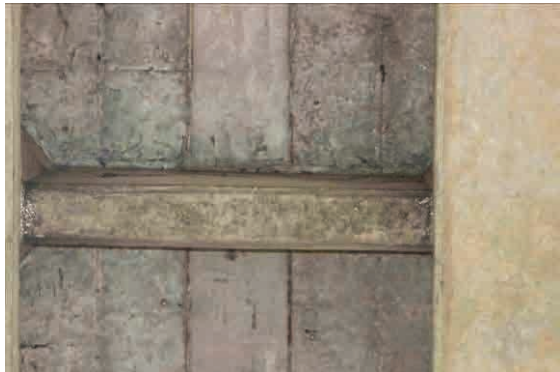
Superstructure P11-P12	
Damage: a	Damage: a

No crack	No crack

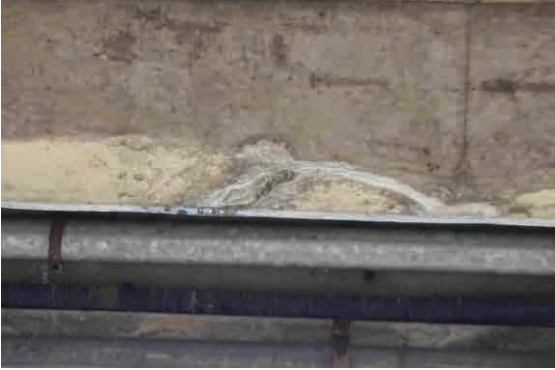
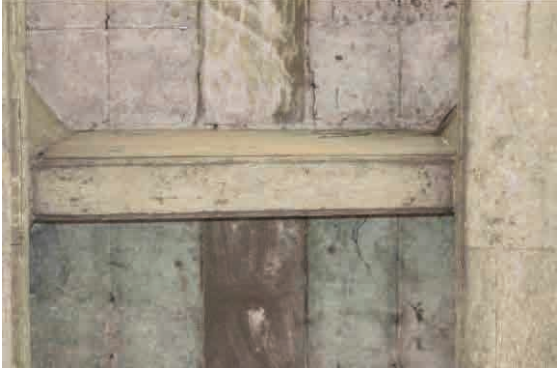
Superstructure P12-A2	
Damage: d	Damage: a

<p>Crack width over 0.2mm Small isolated lime</p>	<p>No crack</p>

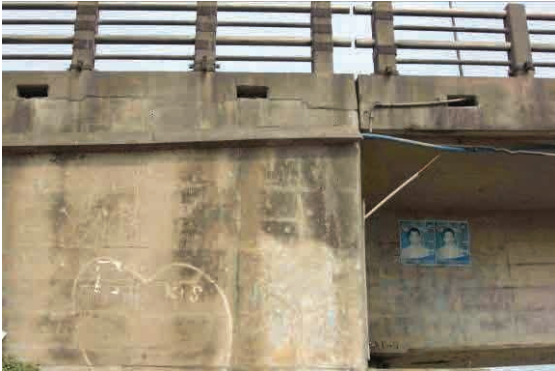
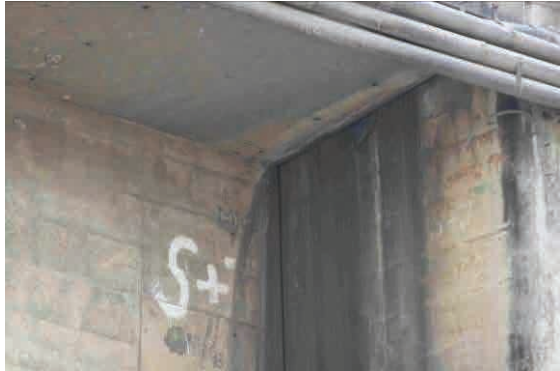
Abutment 01	
Damage: Not exist	Damage: Not exist

No damage	No damage

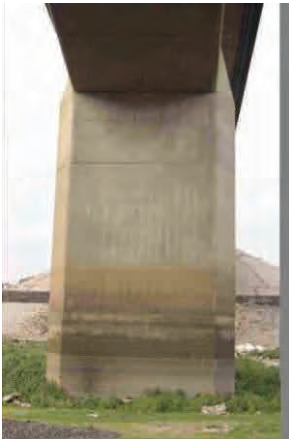
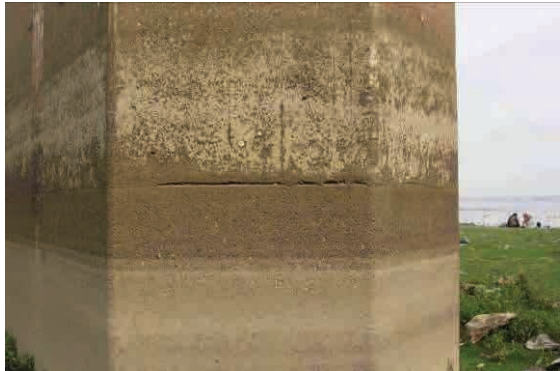
Pier 01	
Damage: Not exist	Damage: Not exist

No damage	No damage in reinforcement

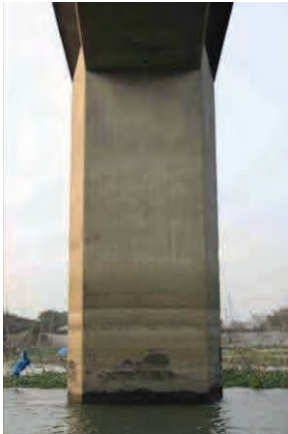
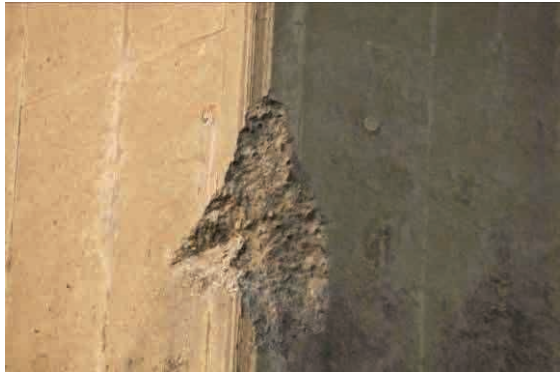
Pier 02	
Damage: Not exist	Damage: Not exist

No damage	No damage in reinforcement

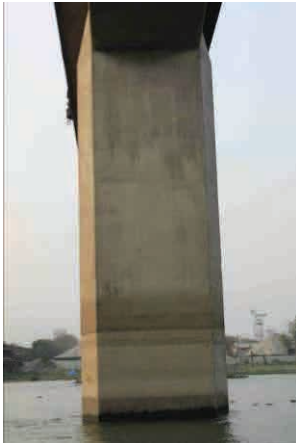
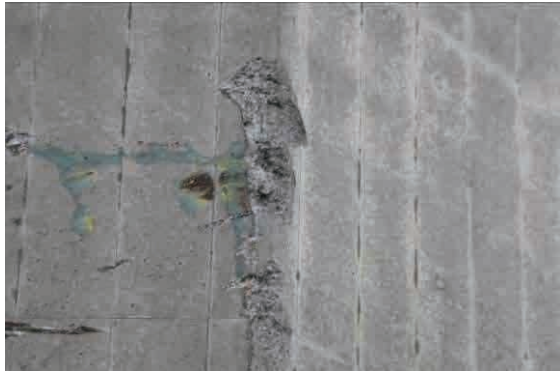
Pier 03	
Damage: Not exist	Damage: Not exist

No damage	No damage in reinforcement

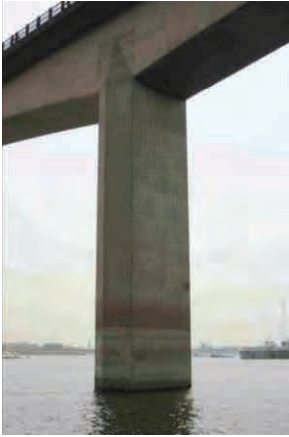
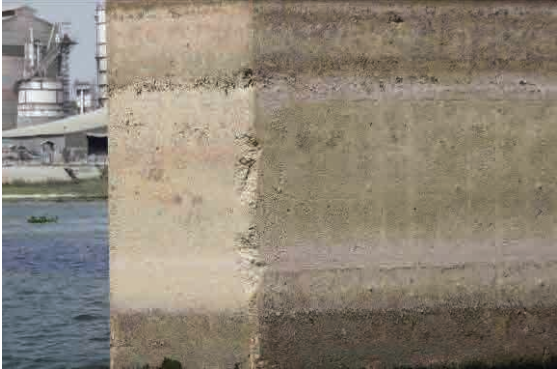
Pier 04	
Damage: Not exist	Damage: Not exist

A close-up photograph of the concrete surface of Pier 04, showing the texture and color of the concrete. There is no visible reinforcement damage.
No damage	No damage in reinforcement

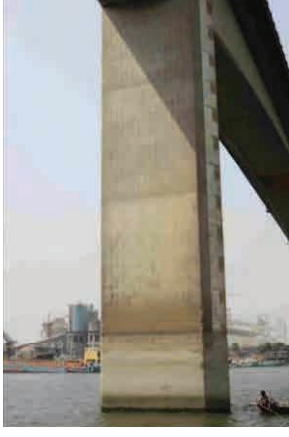
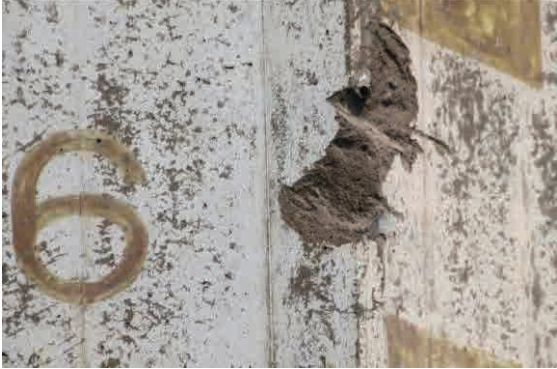
Pier 05	
Damage: Not exist	Damage: Not exist

A close-up photograph of the concrete surface of Pier 05, showing a circular mark and some surface texture. There is no visible reinforcement damage.
No damage	No damage in reinforcement

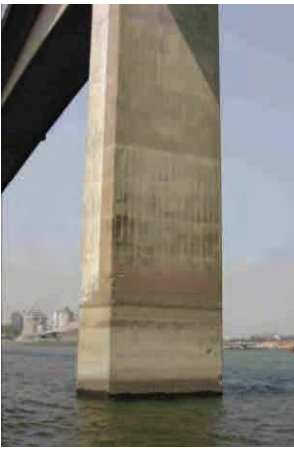
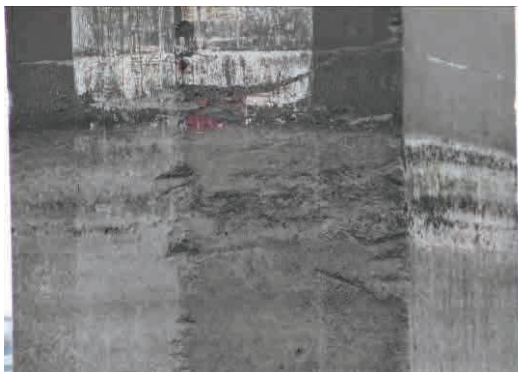
Pier 06	
Damage: Not exist	Damage: Not exist

No damage	No damage in reinforcement

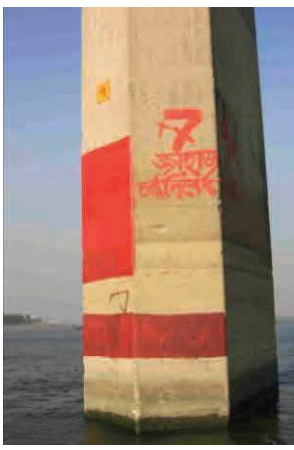
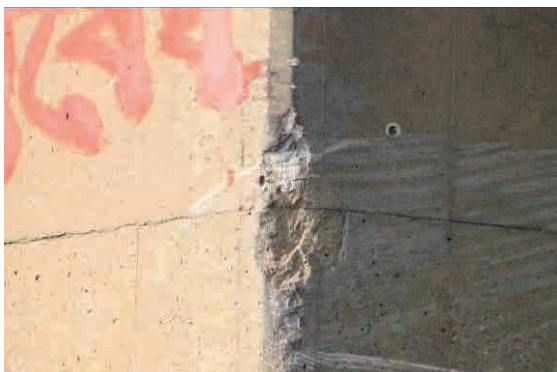
Pier 07	
Damage: Not exist	Damage: Not exist

No damage	No damage in reinforcement

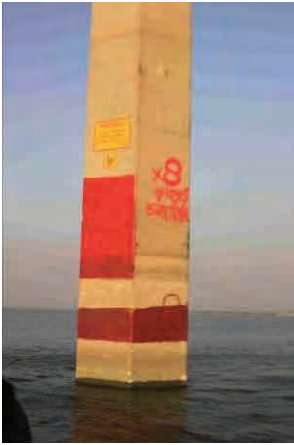
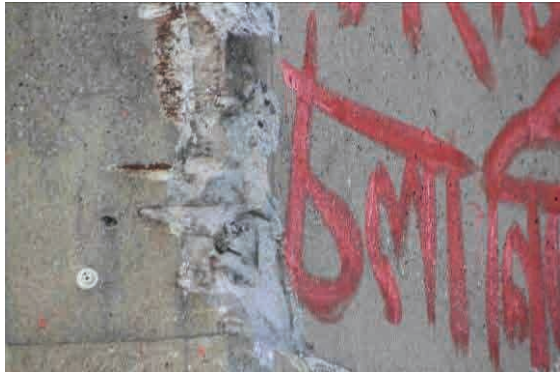
Pier 08	
Damage: Not exist	Damage: Not exist

No damage	No damage in reinforcement

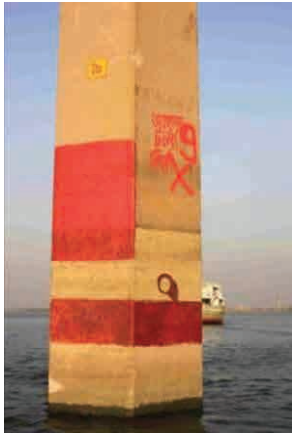
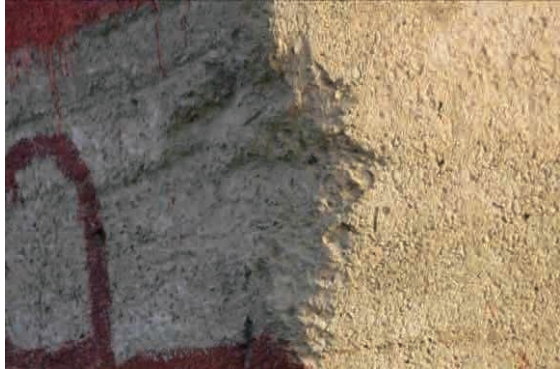
Pier 09	
Damage: Not exist	Damage: Not exist

No damage	No damage in reinforcement

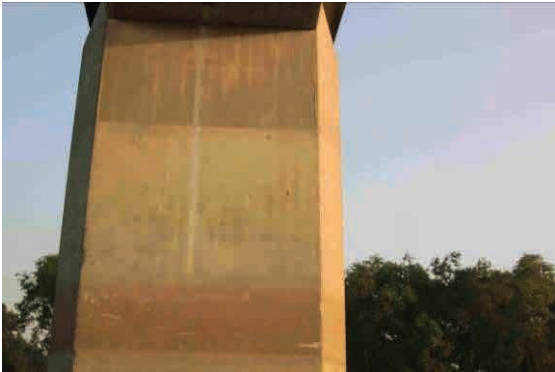
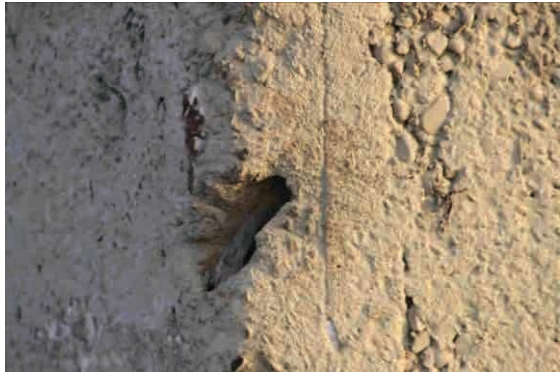
Pier 10	
Damage: Not exist	Damage: Not exist

No damage	No damage in reinforcement

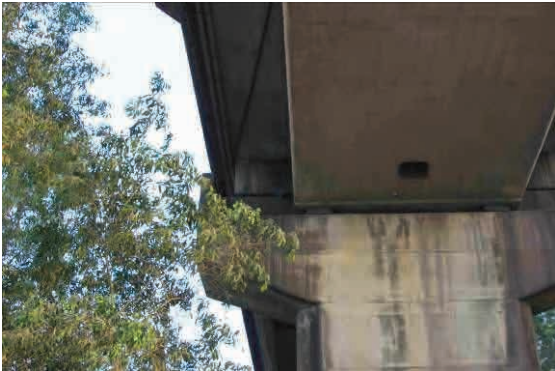
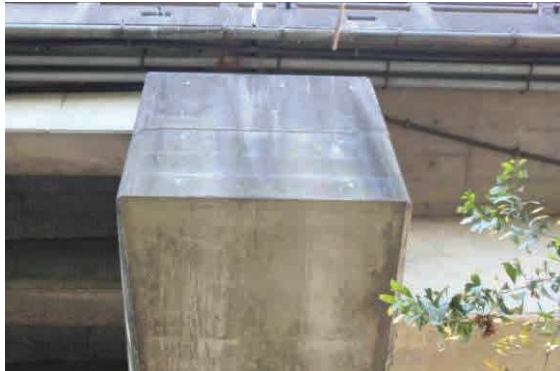
Pier 11	
Damage: Not exist	Damage: Not exist

No damage	No damage

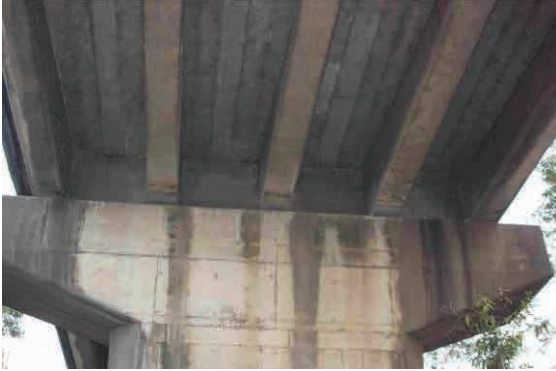
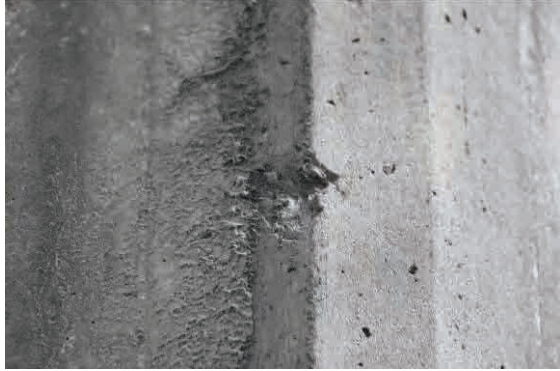
Pier 12	
Damage: Not exist	Damage: Not exist

No damage	No damage in reinforcement

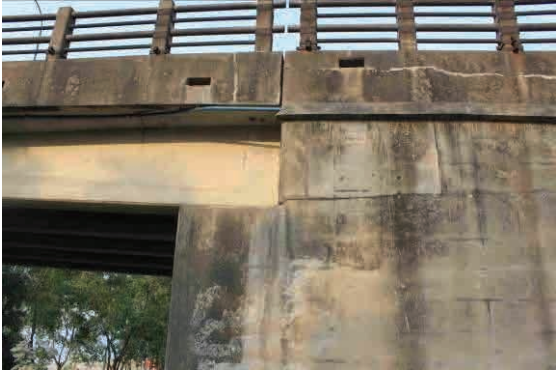
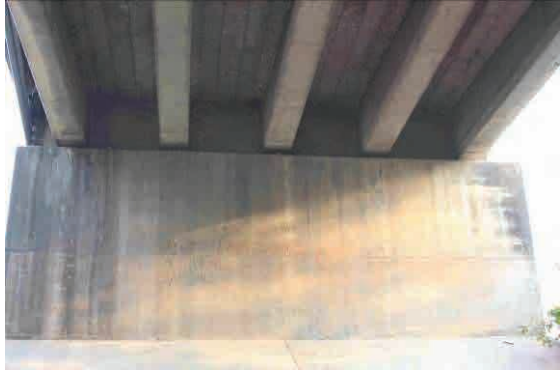
Abutment 02	
Damage: Not exist	Damage: Not exist

No damage	No damage

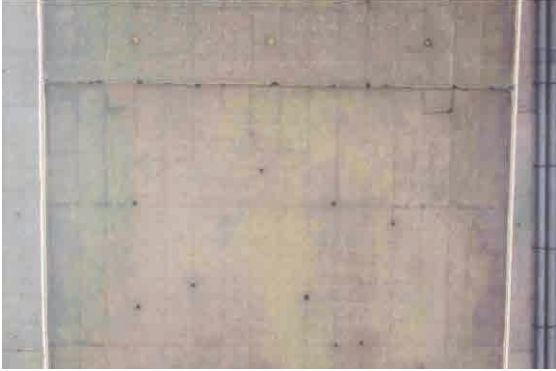
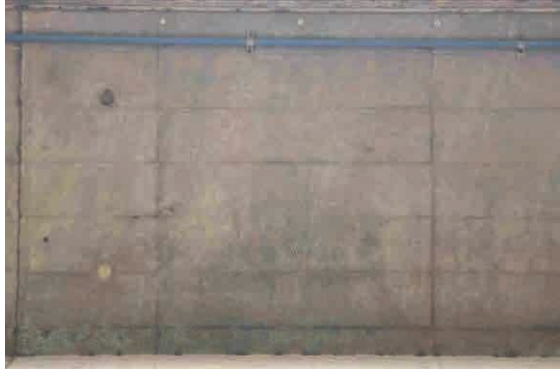
Superstructure P1	
Damage: Not exist	Damage: Not exist

No damage	No damage

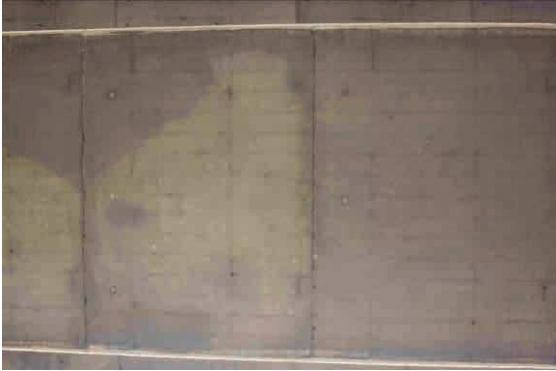
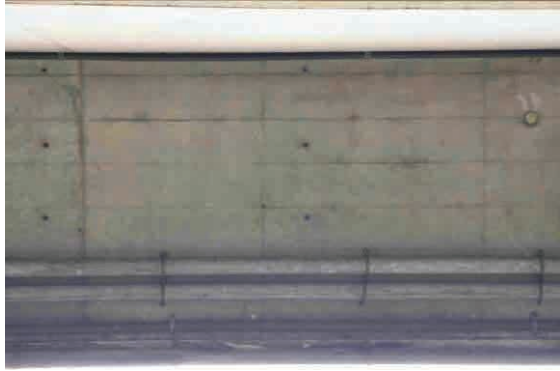
Superstructure P2	
Damage: Not exist	Damage: Not exist

No damage	No damage

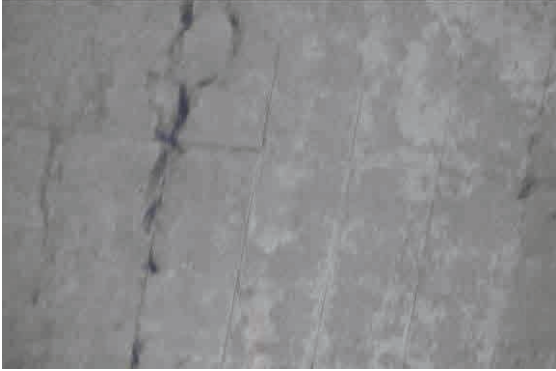
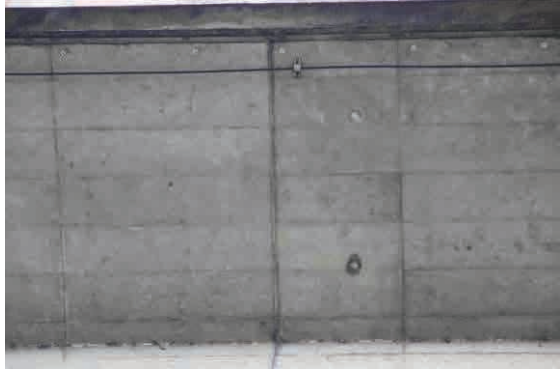
Superstructure P3	
Damage: Not exist	Damage: Not exist

No damage	No damage

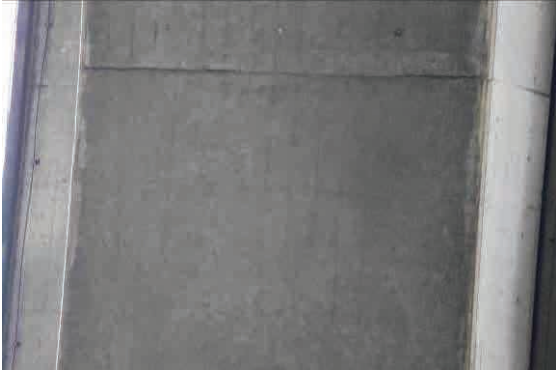
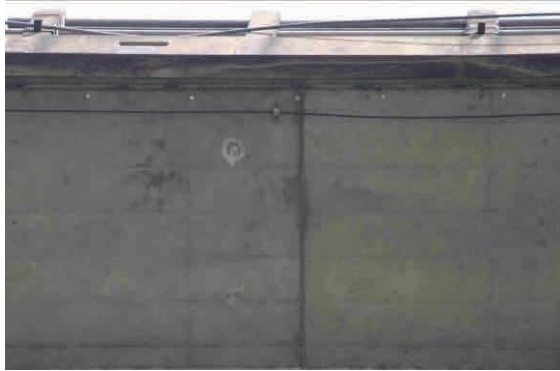
Superstructure P4	
Damage: Not exist	Damage: Not exist

No damage	No damage

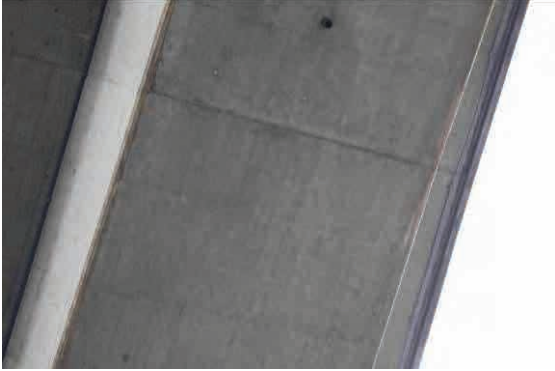
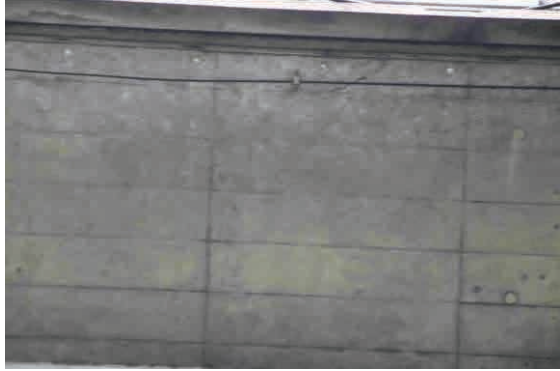
Superstructure P5	
Damage: Not exist	Damage: Not exist

No damage	No damage

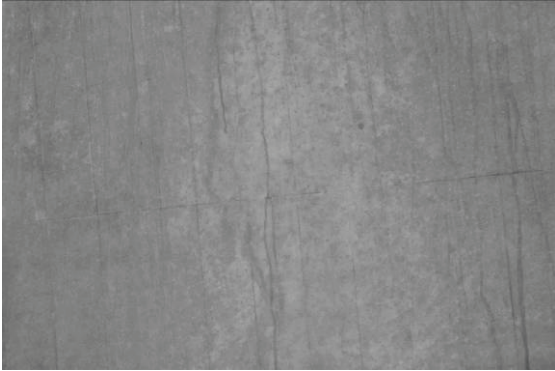
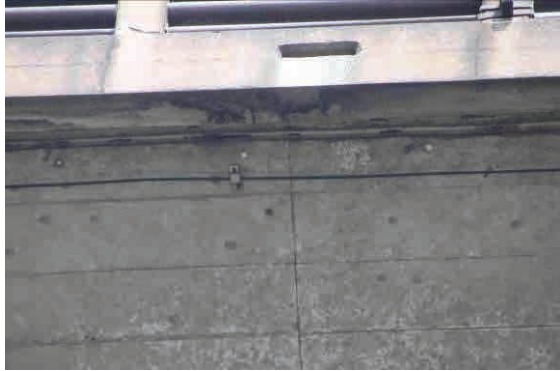
Superstructure P6	
Damage: Not exist	Damage: Not exist

No damage	No damage

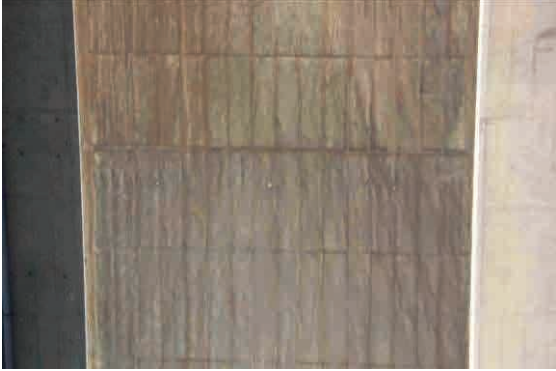
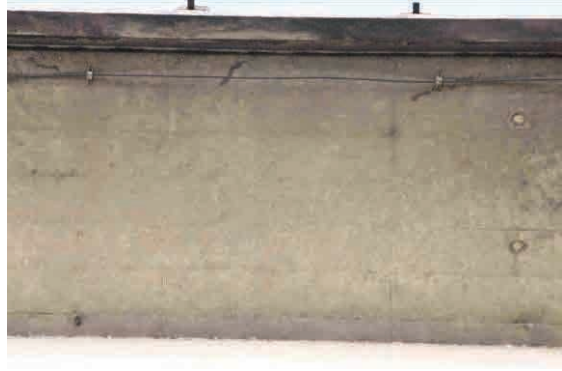
Superstructure P7	
Damage: Not exist	Damage: Not exist

No damage	No damage

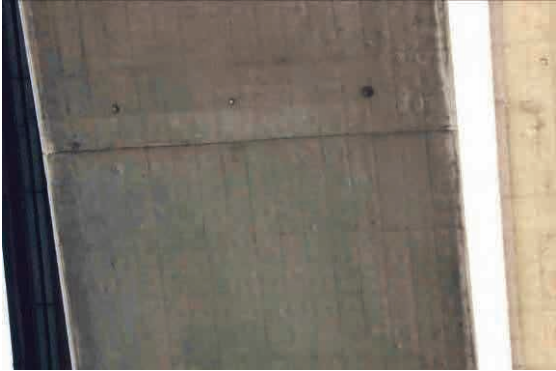
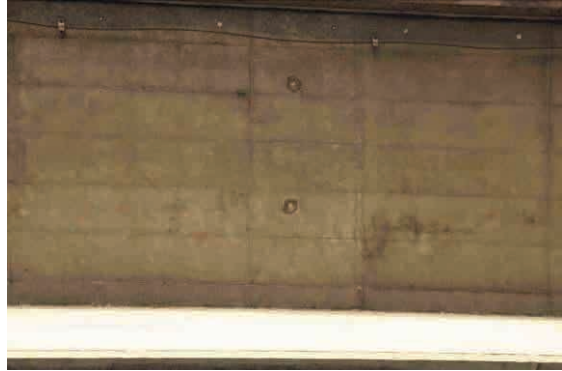
Superstructure P8	
Damage: Not exist	Damage: Not exist

No damage	No damage

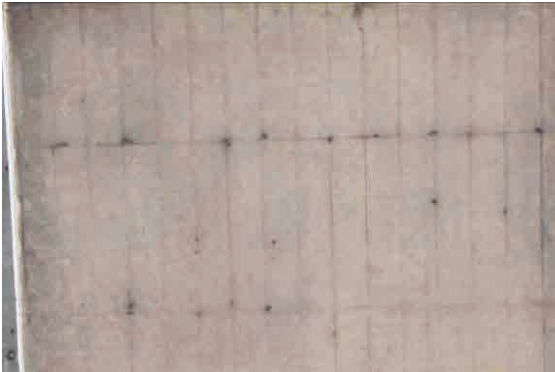
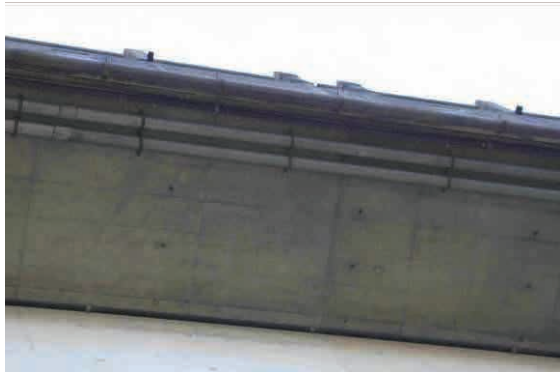
Superstructure P10	
Damage: Not exist	Damage: Not exist

No damage	No damage

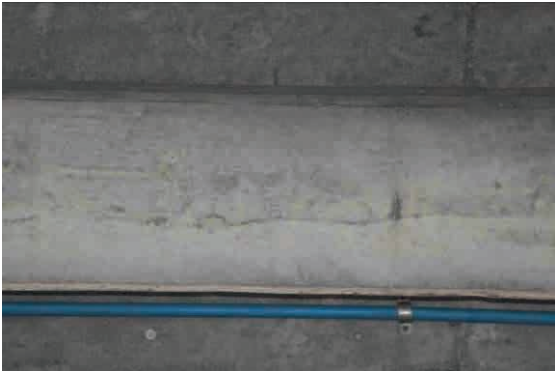
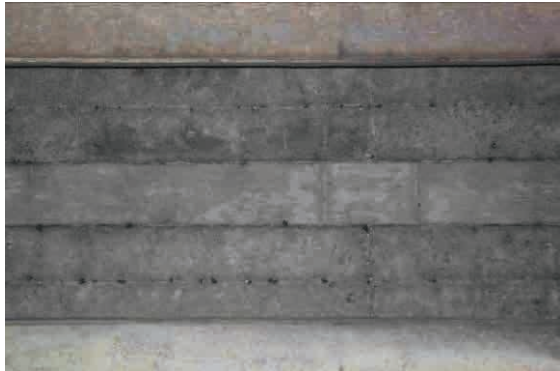
Superstructure P11-P12	
Damage: Not exist	Damage: Not exist

No damage	No damage

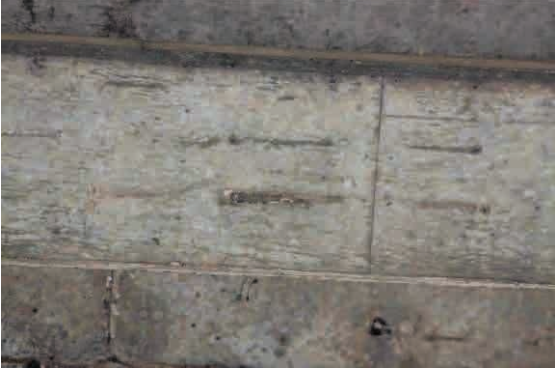
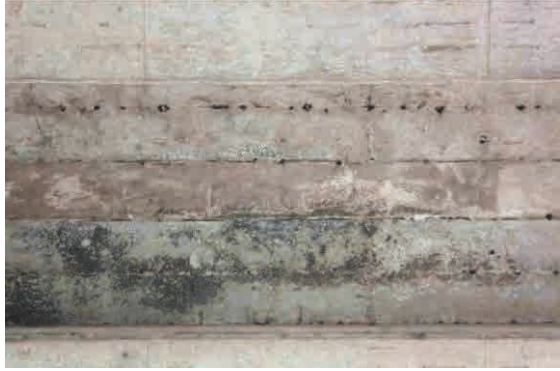
Superstructure P12-A2	
Damage: Exist	Damage: Not exist

<p>Small area Corrosion in reinforcement</p>	<p>No damage</p>

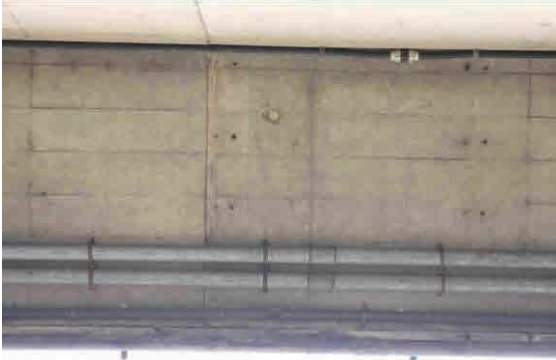
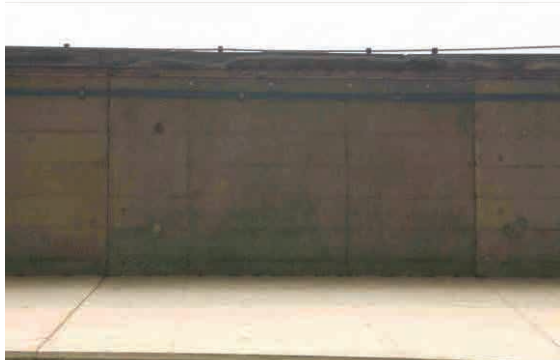
Slab P1	
Damage: Not exist	Damage: a

No damage	No crack

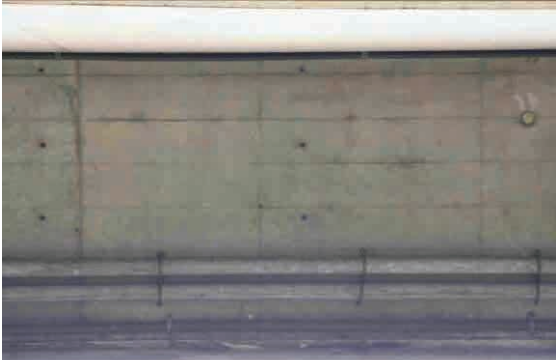
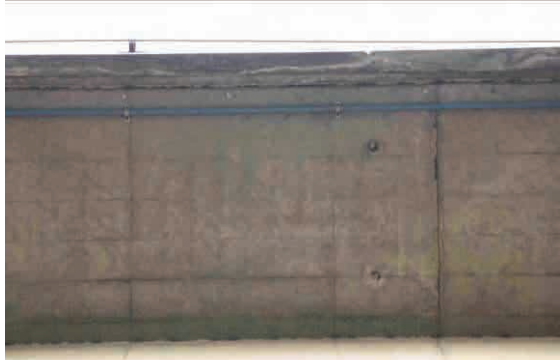
Slab P2	
Damage: Not exist	Damage: a

No damage	No crack

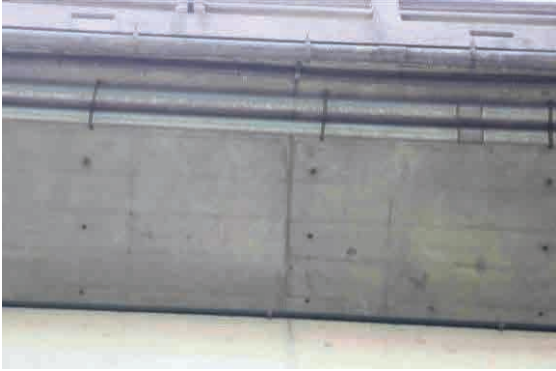
Slab P3	
Damage: Not exist	Damage: a

No damage	No crack

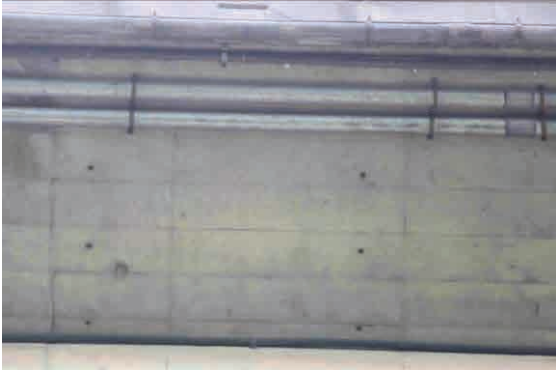
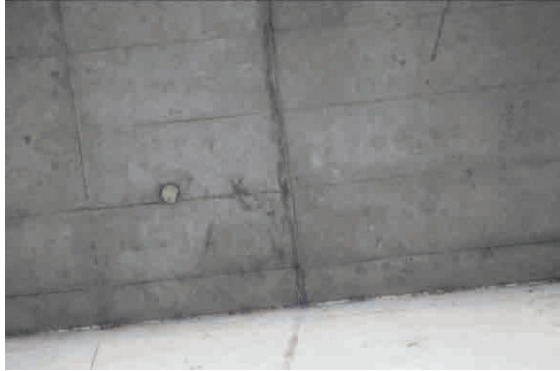
Slab P4	
Damage: Not exist	Damage: a

No damage	No crack

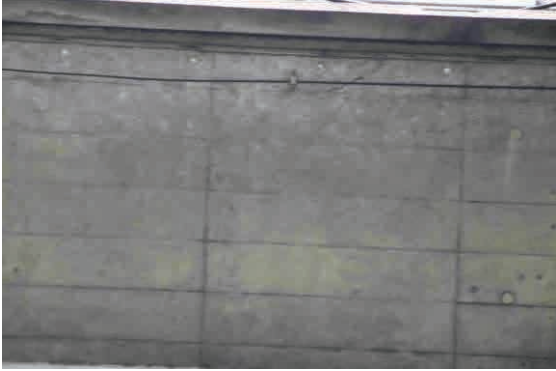
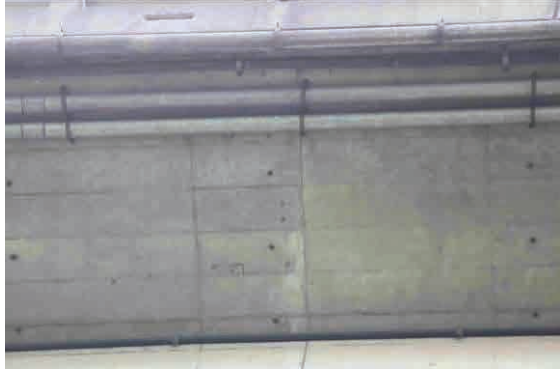
Slab P5	
Damage: Not exist	Damage: a

No damage	No crack

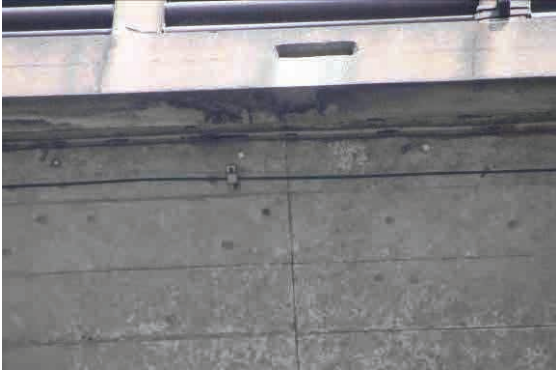
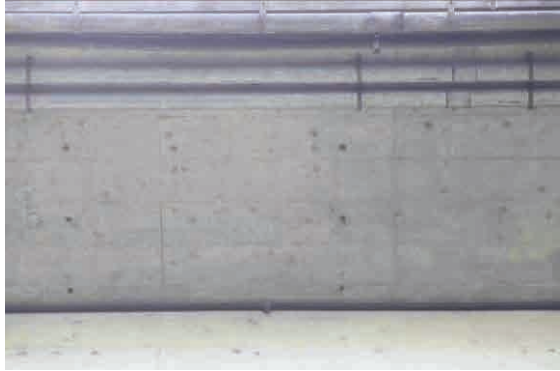
Slab P6	
Damage: Not exist	Damage: a

No damage	No crack

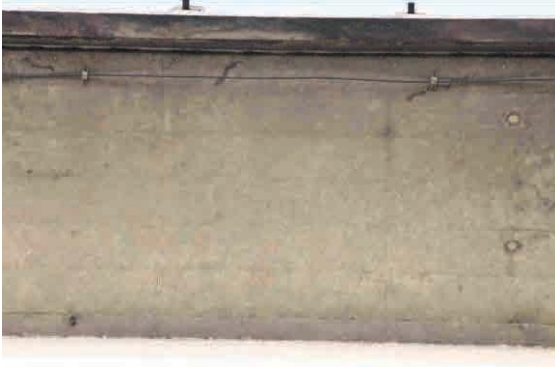
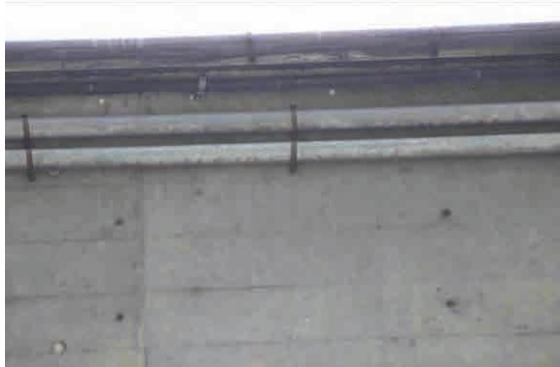
Slab P7	
Damage: Not exist	Damage: a

No damage	No crack

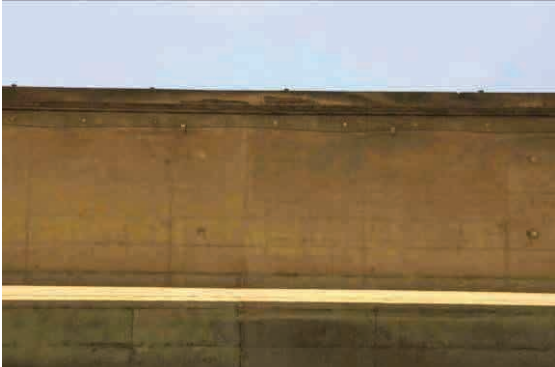
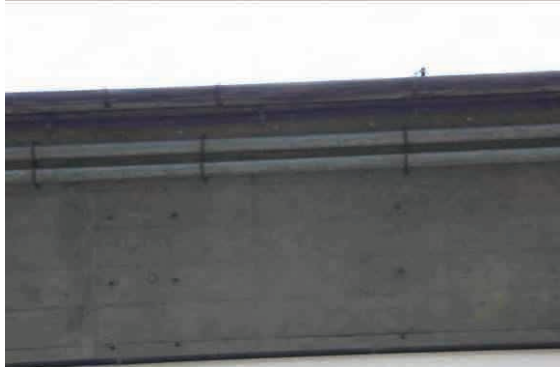
Slab P8	
Damage: Not exist	Damage: a

No damage	No crack

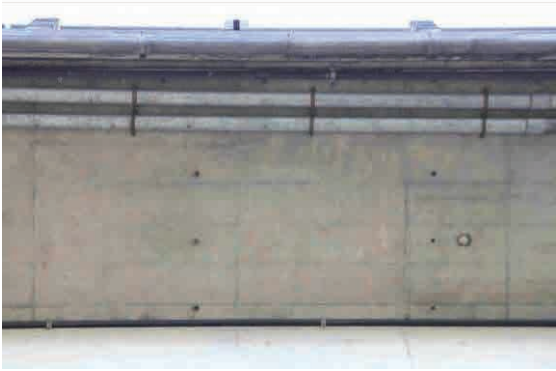
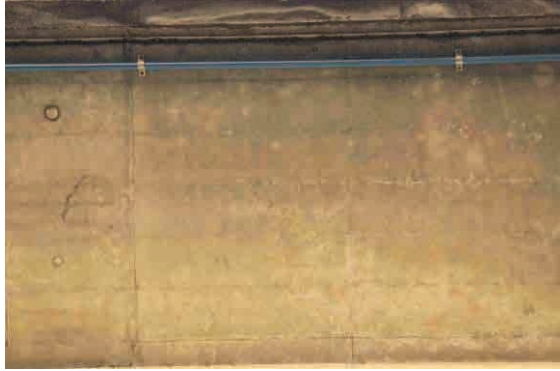
Slab P10	
Damage: Not exist	Damage: a

No damage	No crack

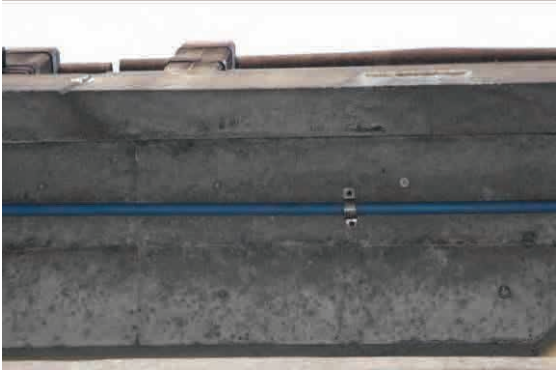
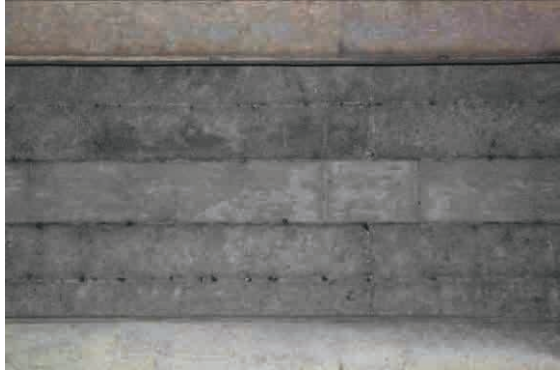
Slab P11-P12	
Damage: Not exist	Damage: a

No damage	No crack

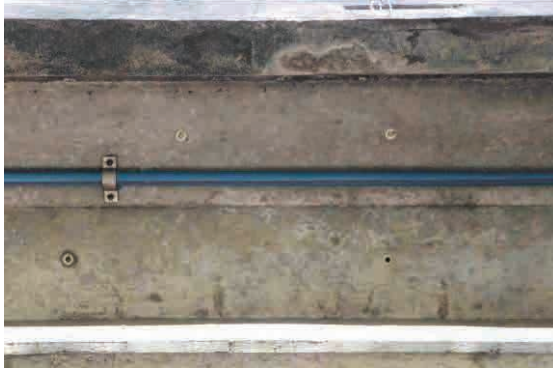
Slab P12-A2

No damage
