4.2 Meghna Bridge

4.2.1 Crack, water leakage, isolated lime

4.3 Gumti Bridge

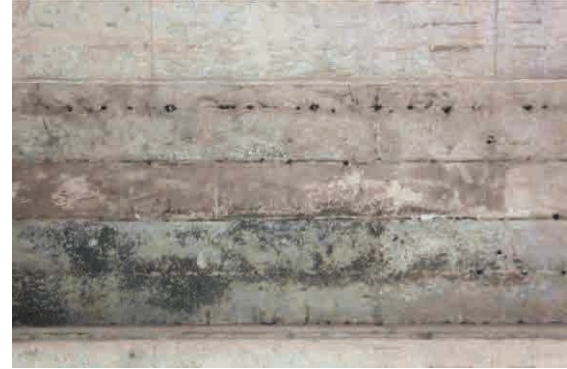
Slab P12-A2

No crack

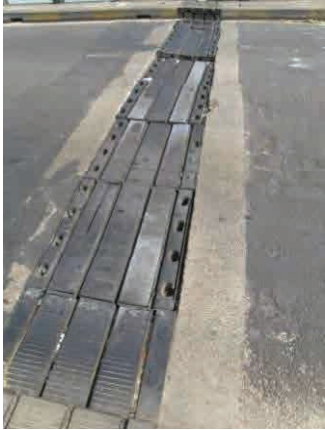
Surface	
Damage: Exist	Damage: Exist

Uneven more than 20mm	Uneven more than 20mm

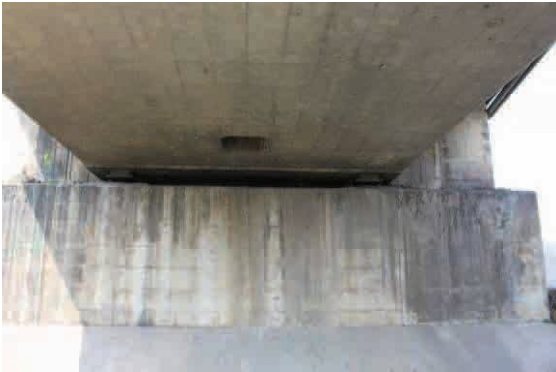
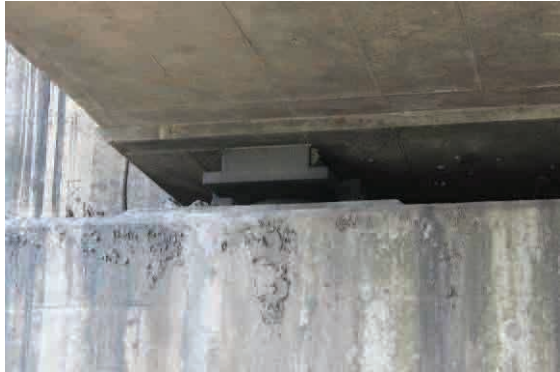
Abutment 01	
Damage: a	Damage: a

No crack	No crack

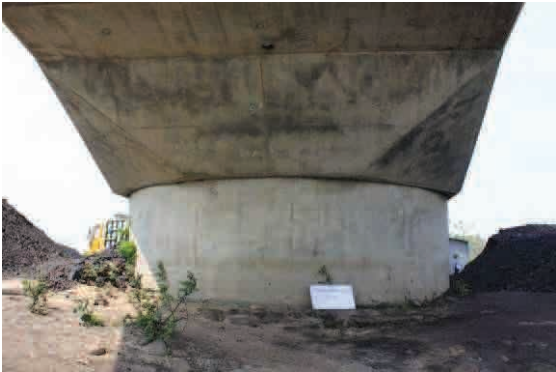
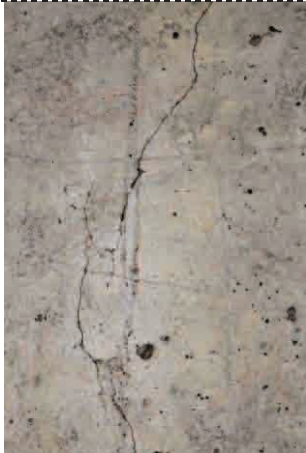
Pier 01	
Damage: a	Damage: b

No crack	Crack width less 0.2mm

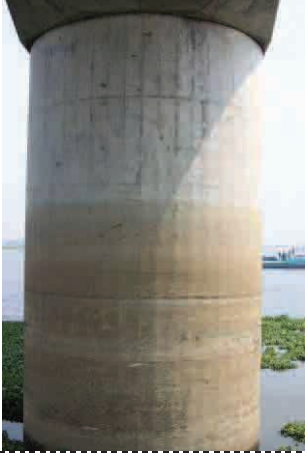
Pier 02	
Damage: a	Damage: c

No crack	Crack width over 0.2mm

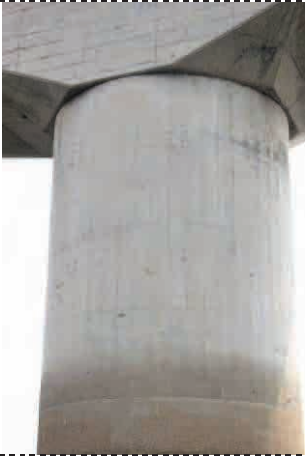
Pier 03	
Damage: a	Damage: c

No crack	Crack width over 0.2mm

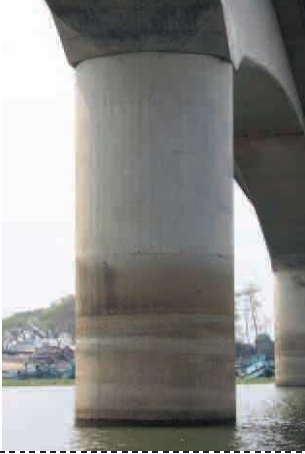
Pier 04	
Damage: a	Damage: c

No crack	Crack width over 0.2mm

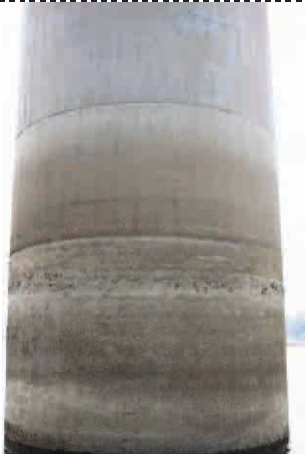
Pier 05	
Damage: a	Damage: c

No crack	Crack width over 0.2mm

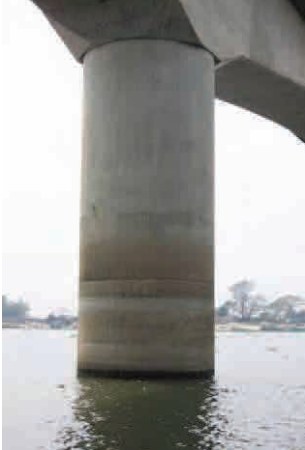
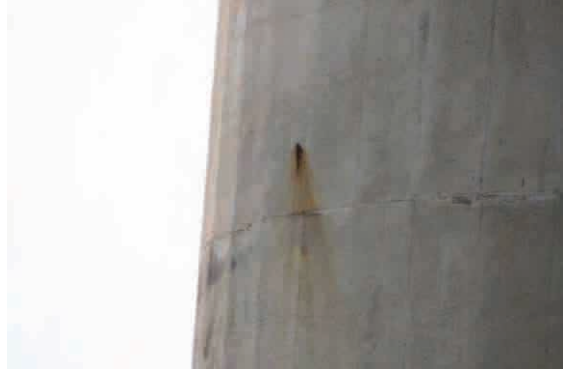
Pier 06	
Damage: a	Damage: c

No crack	Crack width over 0.2mm

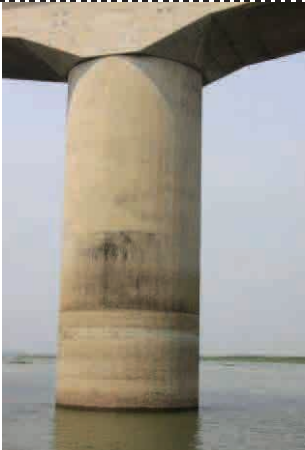
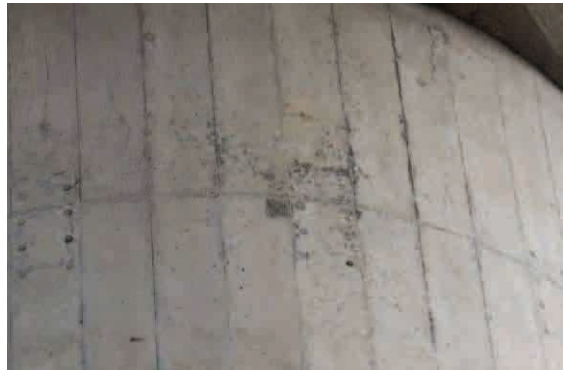
Pier 07	
Damage: a	Damage: c

No crack	Crack width over 0.2mm

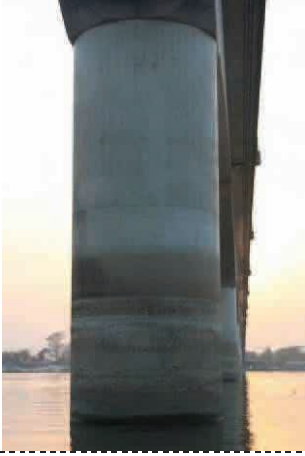
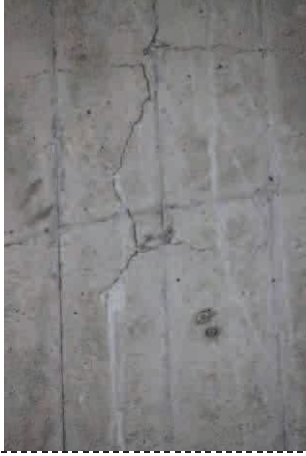
Pier 08	
Damage: a	Damage: c

No crack	Crack width over 0.2mm

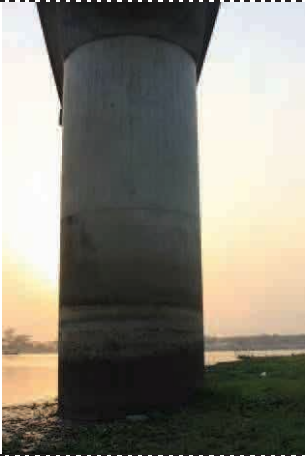
Pier 09	
Damage: a	Damage: c

No crack	Crack width over 0.2mm

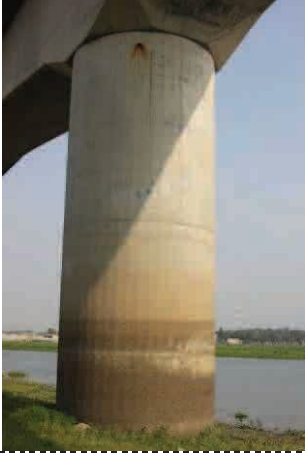
Pier 10	
Damage: a	Damage: c

No crack	Crack width over 0.2mm

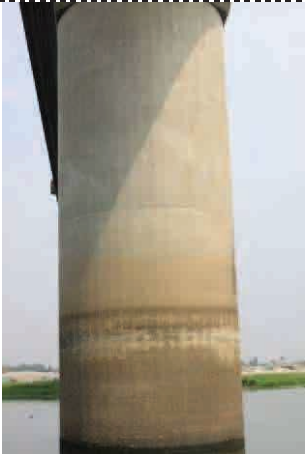
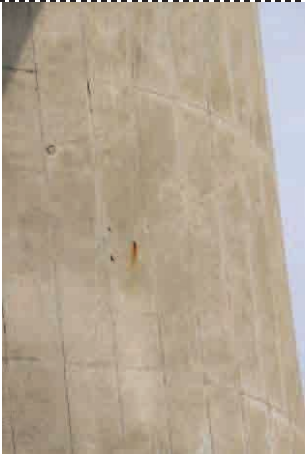
Pier 11	
Damage: a	Damage: a

No crack	No crack

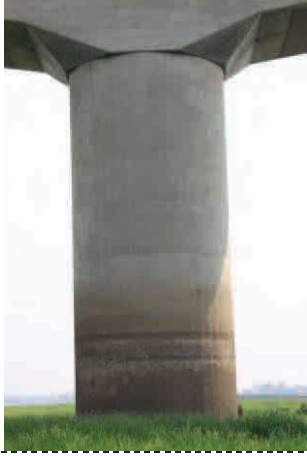
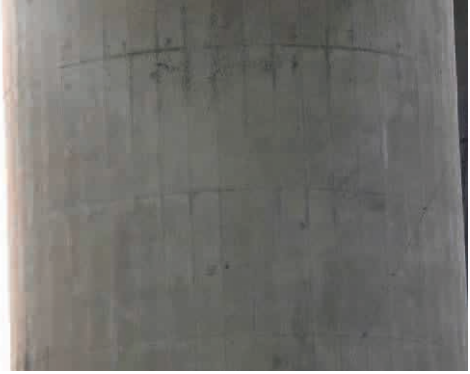
Pier 12	
Damage: a	Damage: a

No crack	No crack

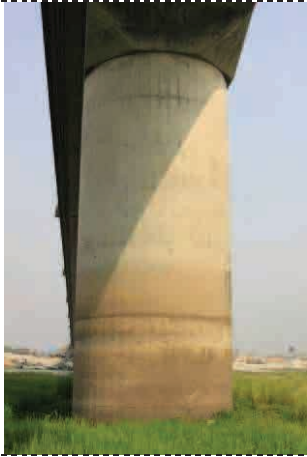
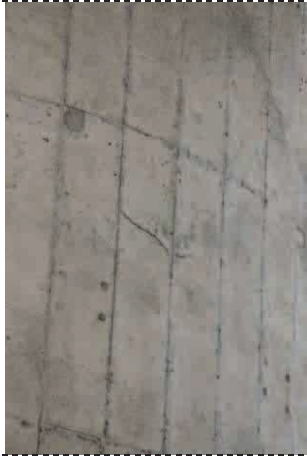
Pier 13	
Damage: a	Damage: c

No crack	Crack width over 0.2mm

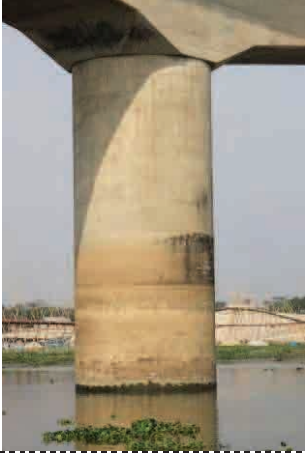
Pier 14	
Damage: a	Damage: d

No crack	Crack width over 0.2mm Water leakage only

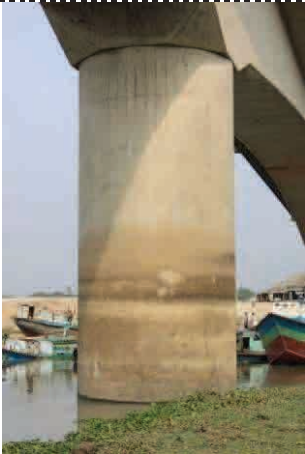
Pier 15	
Damage: a	Damage: c

No crack	Crack width over 0.2mm

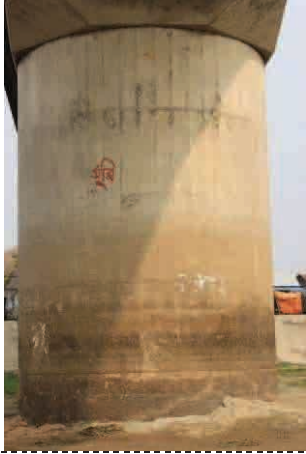
Pier 16	
Damage: a	Damage: d

No crack	Crack width over 0.2mm Water leakage only

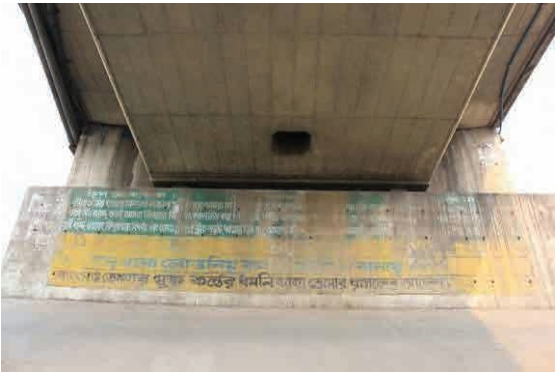
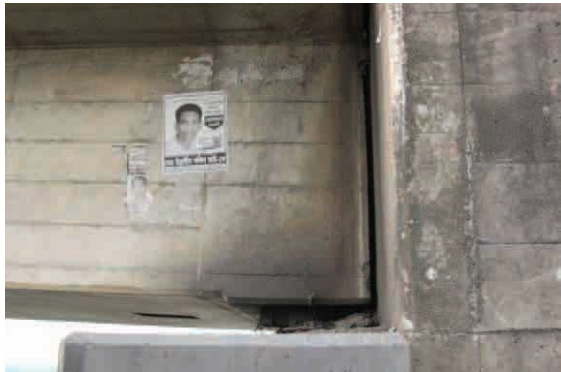
Abutment 02	
Damage: a	Damage: a

No crack	No crack

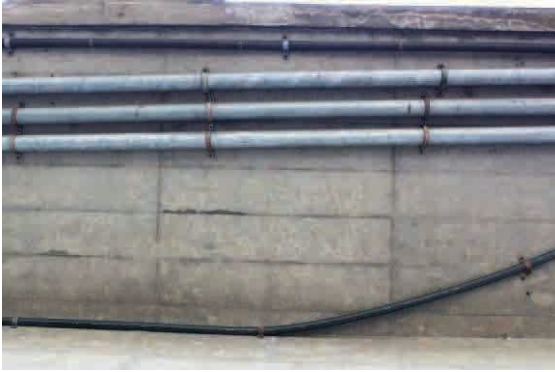
Superstructure P1	
Damage: a	Damage: c

No crack	Crack width over 0.2mm

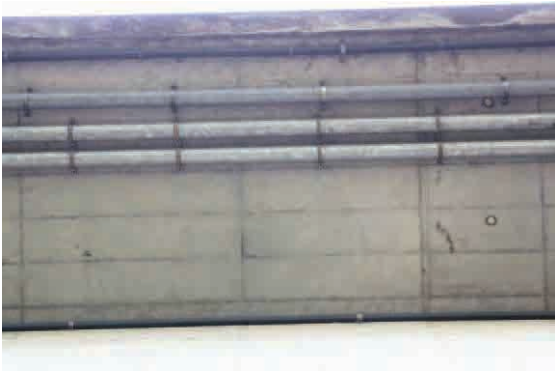
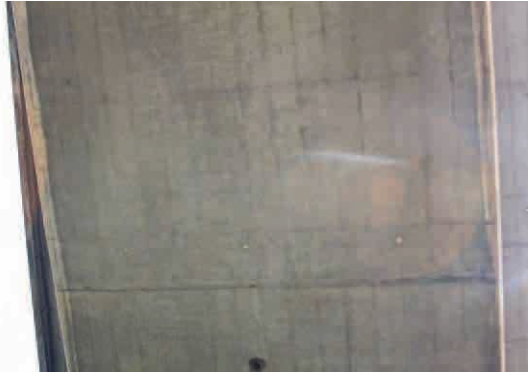
Superstructure P2	
Damage: a	Damage: a

No crack	No crack

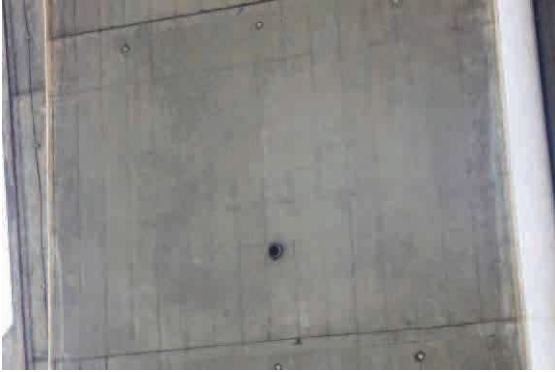
Superstructure P3	
Damage: a	Damage: a

No crack	No crack

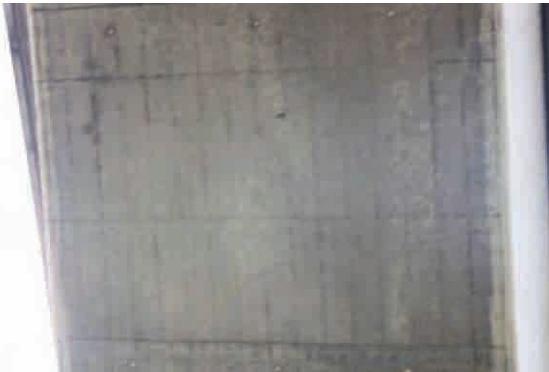
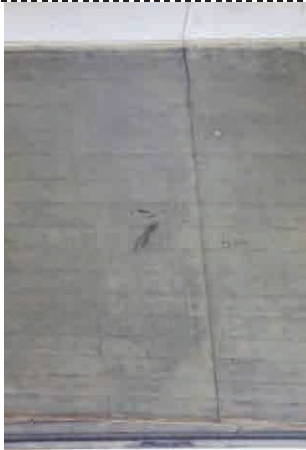
Superstructure P4	
Damage: a	Damage: a

No crack	No crack

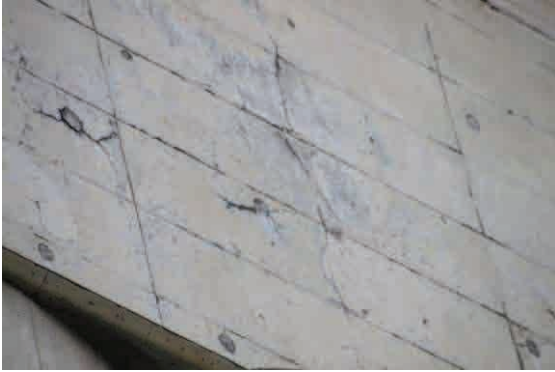
Superstructure P7	
Damage: c	Damage: d

Crack width over 0.2mm	Crack width over 0.2mm Water leakage only

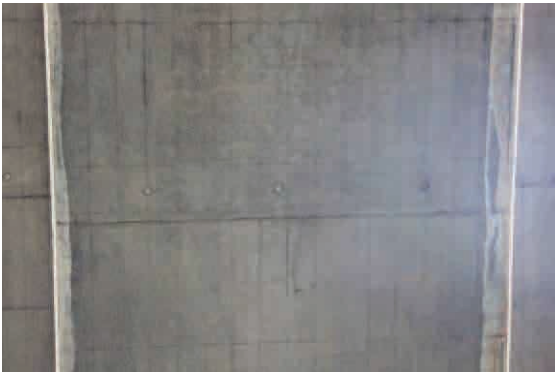
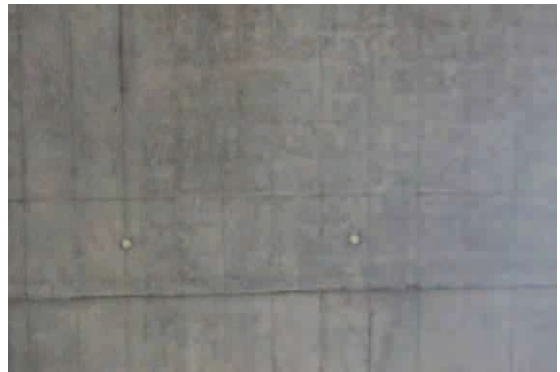
Superstructure P8	
Damage: a	Damage: a

No crack	No crack

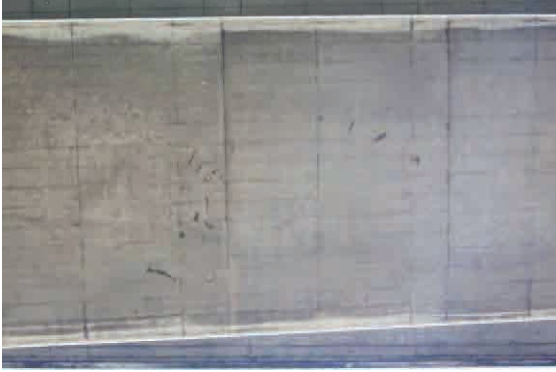
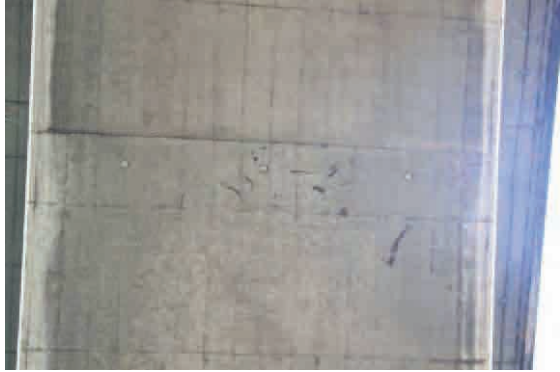
Superstructure P9	
Damage: a	Damage: a

No crack	No crack

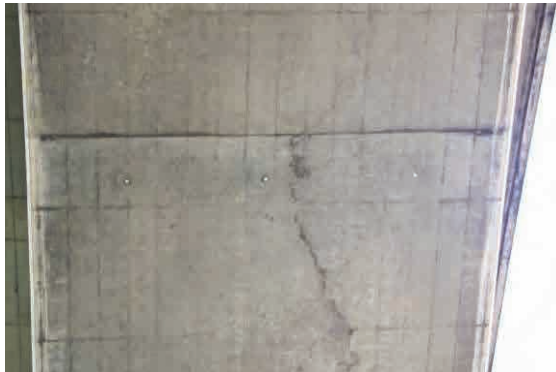
Superstructure P10	
Damage: a	Damage: d

No crack	Crack width over 0.2mm Water leakage only

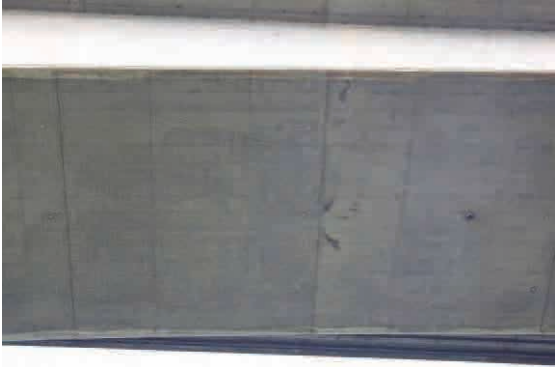
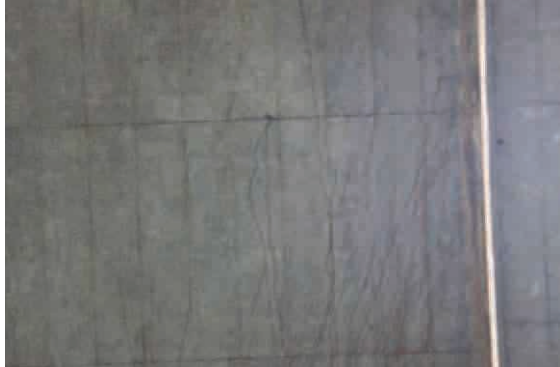
Superstructure P11	
Damage: a	Damage: a

No crack	No crack

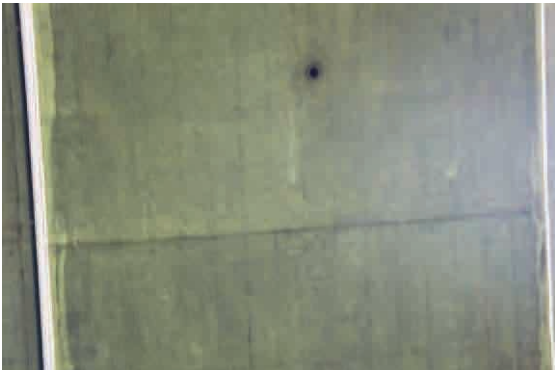
Superstructure P12	
Damage: a	Damage: a

No crack	No crack

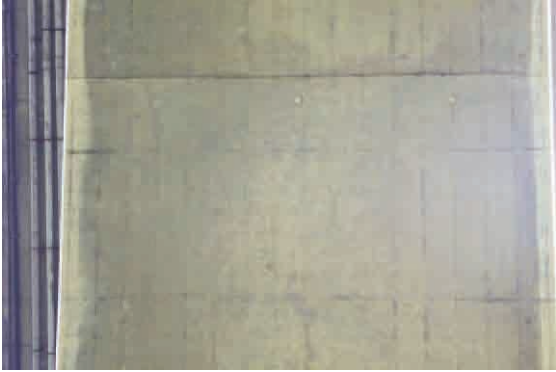
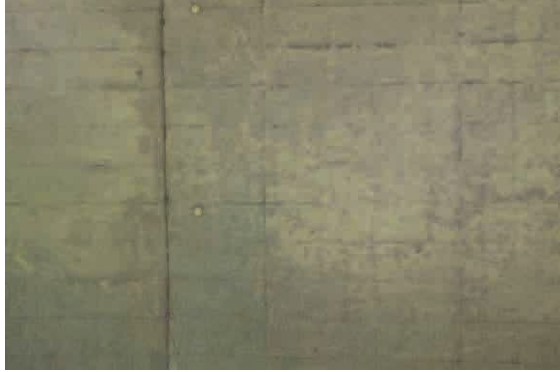
Superstructure P13	
Damage: a	Damage: a

No crack	No crack

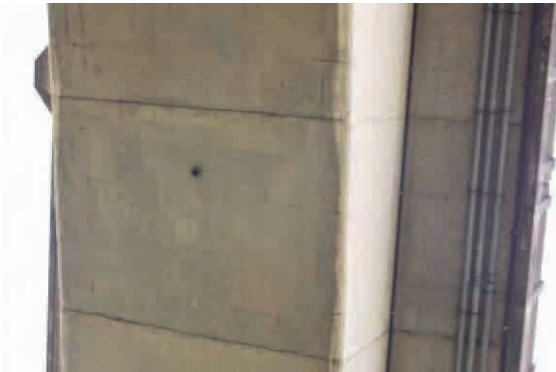
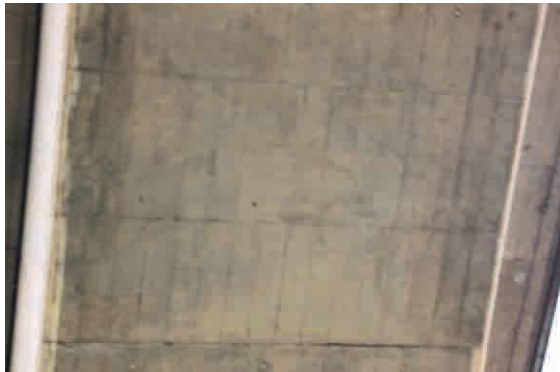
Superstructure P14	
Damage: a	Damage: a

No crack	No crack

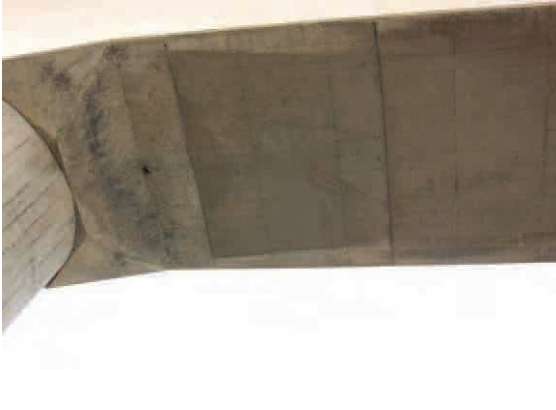
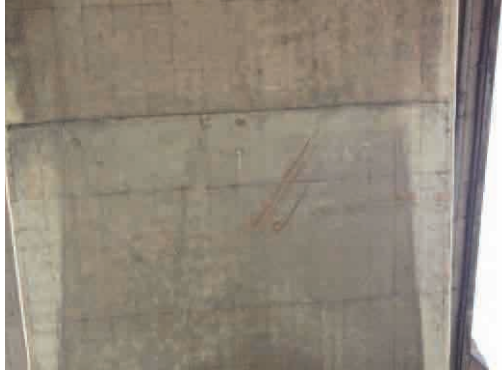
Superstructure P15	
Damage: a	Damage: a

No crack	No crack

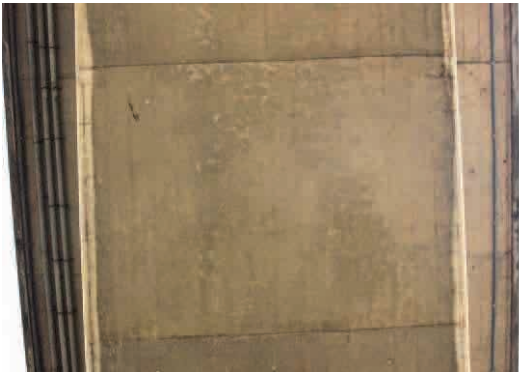
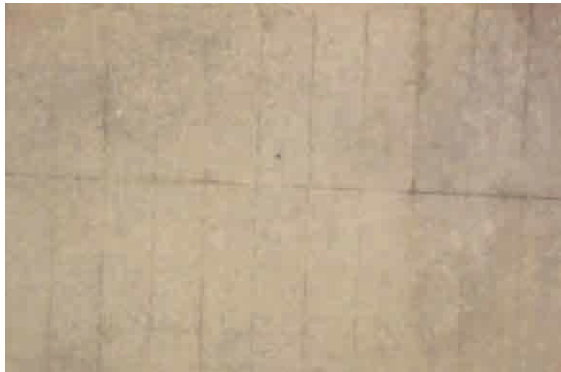
Superstructure P16	
Damage: a	Damage: a

No crack	No crack

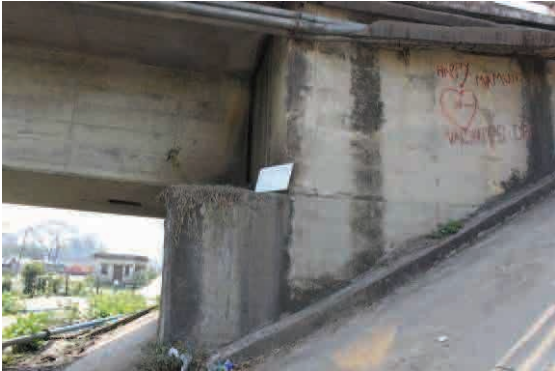
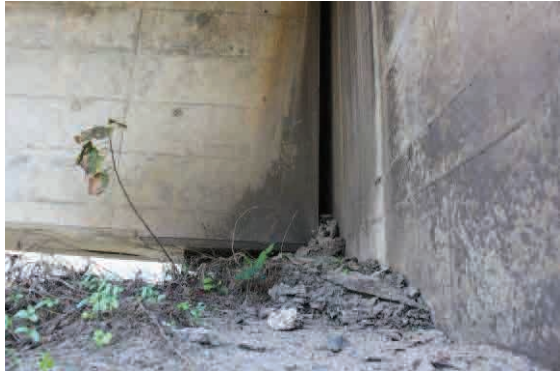
Abutment 01	
Damage: Not exist	Damage: Not exist

No damage	No damage

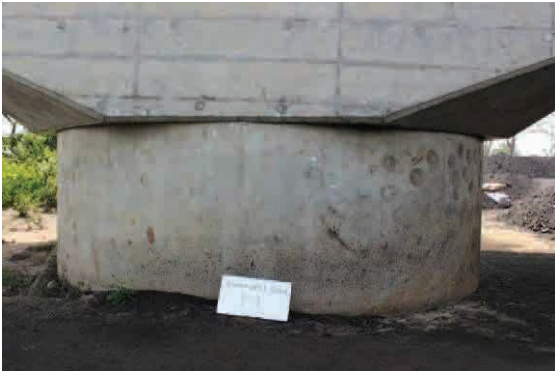
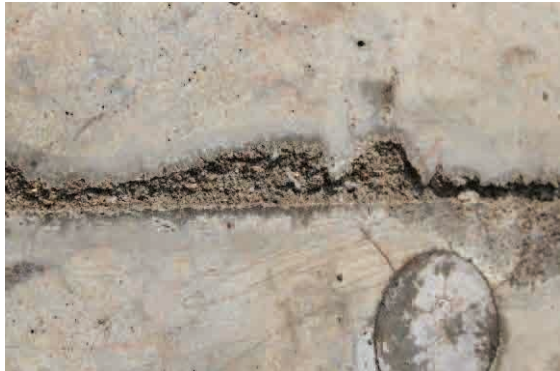
Pier 01	
Damage: Not exist	Damage: Not exist

No damage	No damage in reinforcement

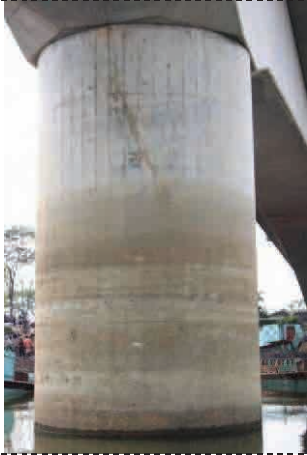
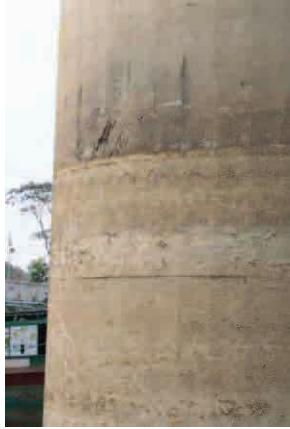
Pier 02	
Damage: Not exist	Damage: Not exist

No damage	No damage in reinforcement

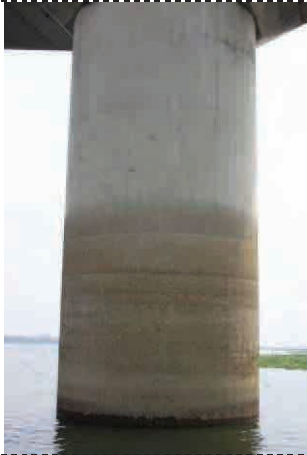
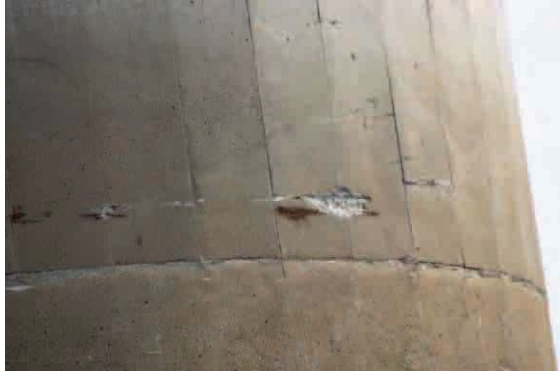
Pier 03	
Damage: Not exist	Damage: Not exist

No damage	No damage in reinforcement

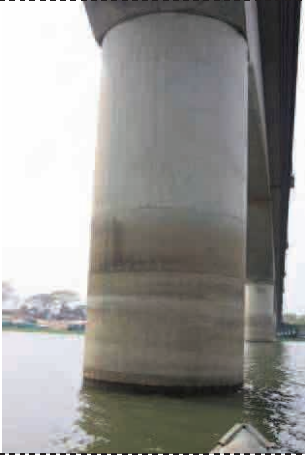
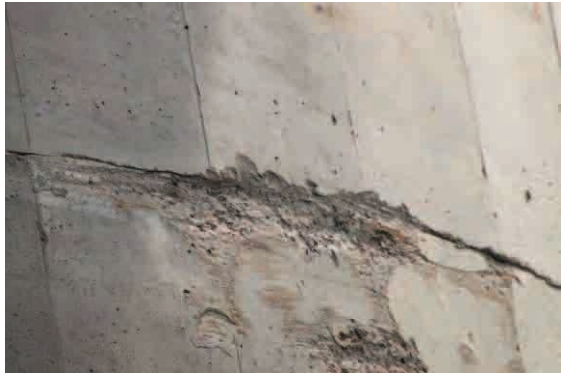
Pier 04	
Damage: Not exist	Damage: Not exist

No damage	No damage in reinforcement

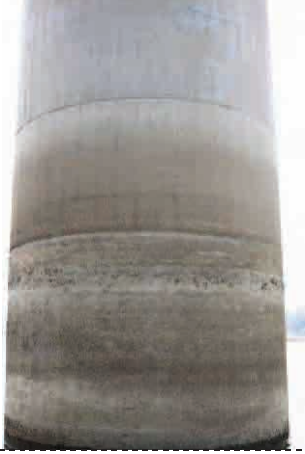
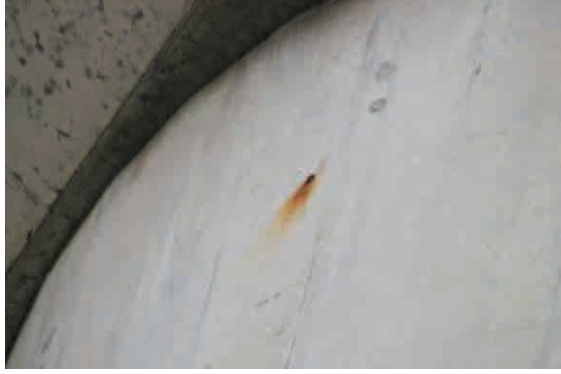
Pier 05	
Damage: Not exist	Damage: Not exist

No damage in reinforcement	No damage

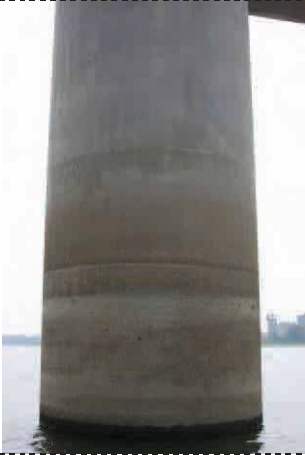
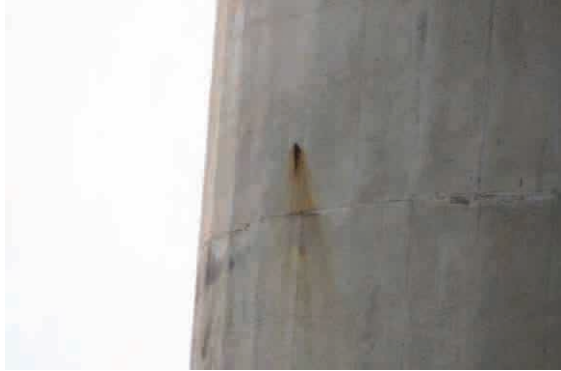
Pier 06	
Damage: Not exist	Damage: Not exist

No damage in reinforcement	No damage in reinforcement

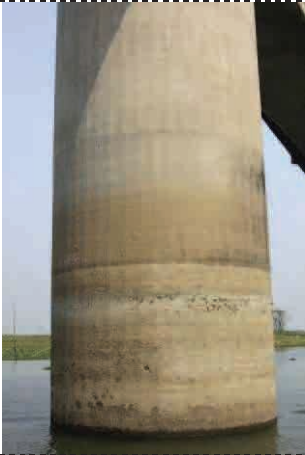
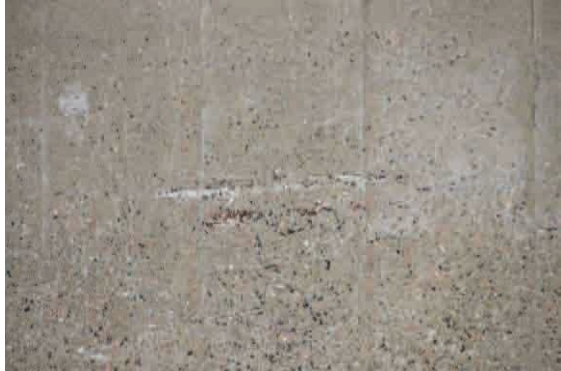
Pier 07	
Damage: Not exist	Damage: Not exist

No damage in reinforcement	No damage in reinforcement

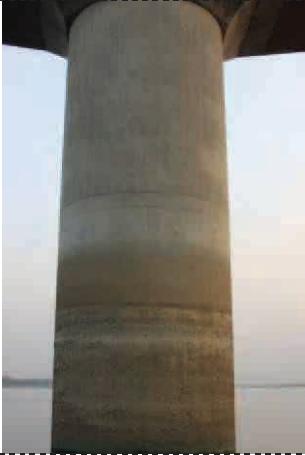
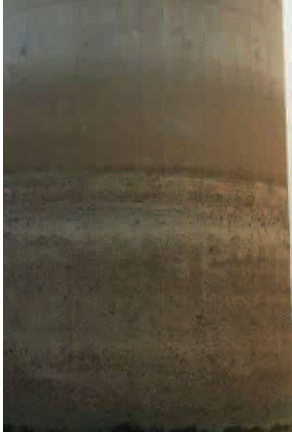
Pier 08	
Damage: Not exist	Damage: Not exist

No damage in reinforcement	No damage in reinforcement

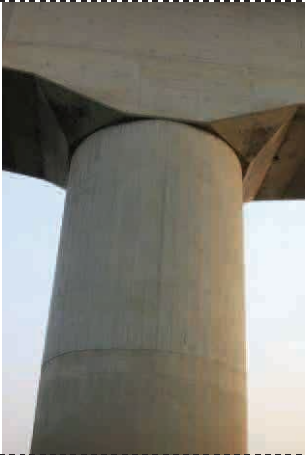
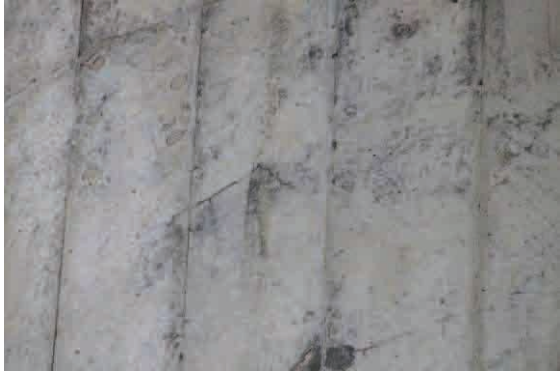
Pier 09	
Damage: Not exist	Damage: Not exist

No damage	No damage in reinforcement

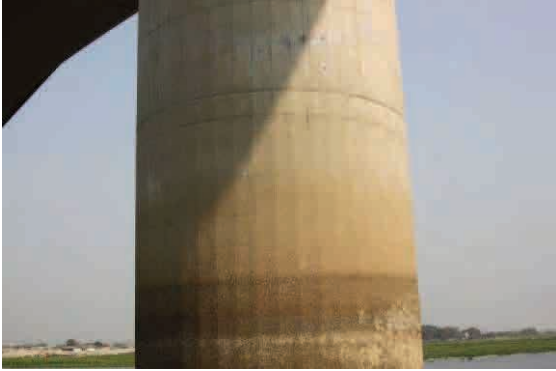
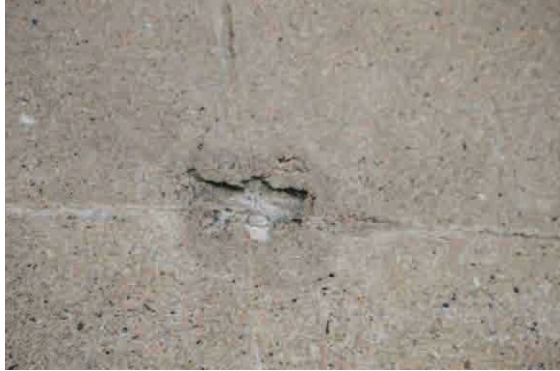
Pier 10	
Damage: Not exist	Damage: Not exist

No damage	No damage in reinforcement

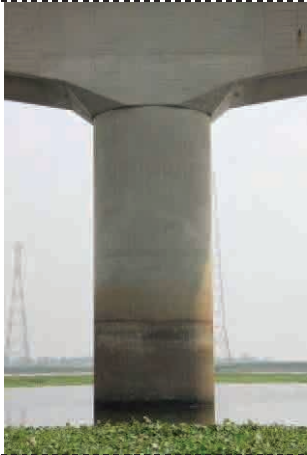
Pier 11	
Damage: Not exist	Damage: Not exist

No damage	No damage

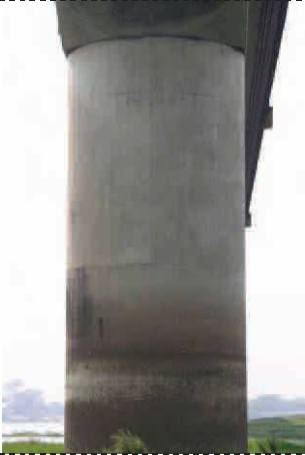
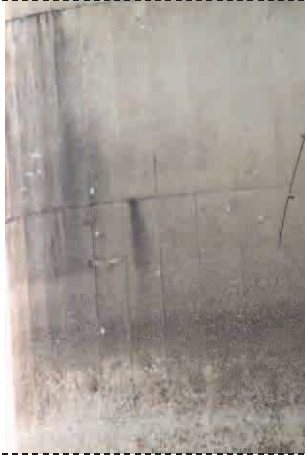
Pier 12	
Damage: Not exist	Damage: Not exist

No damage	No damage in reinforcement

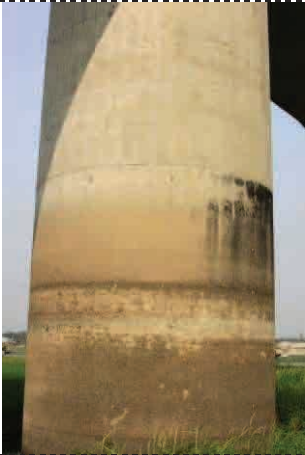
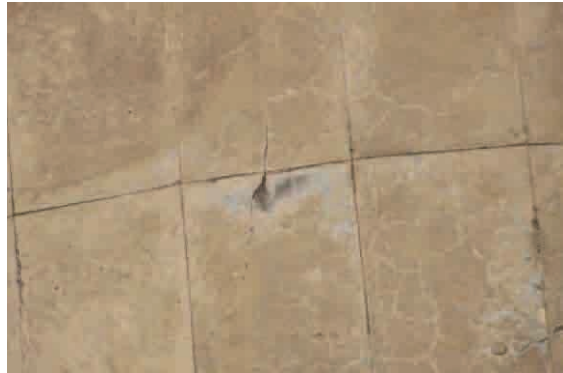
Pier 13	
Damage: Not exist	Damage: Not exist

No damage in reinforcement	No damage in reinforcement

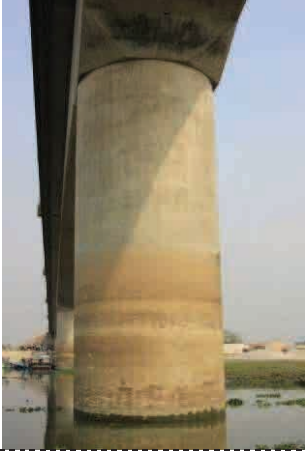
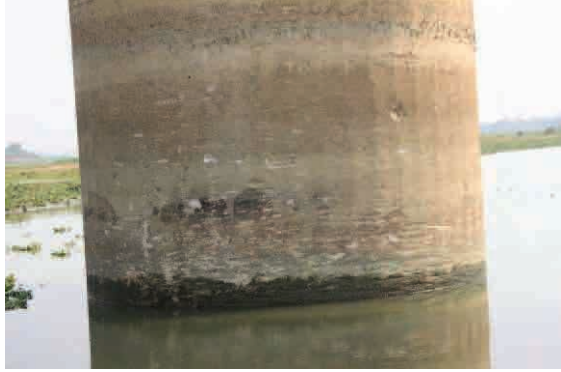
Pier 14	
Damage: Not exist	Damage: Not exist

No damage in reinforcement	No damage in reinforcement

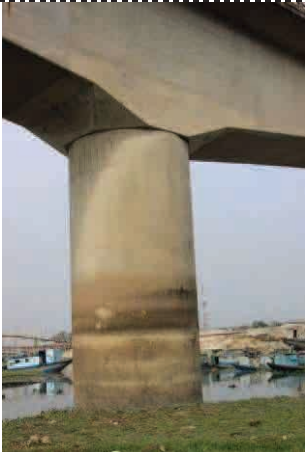
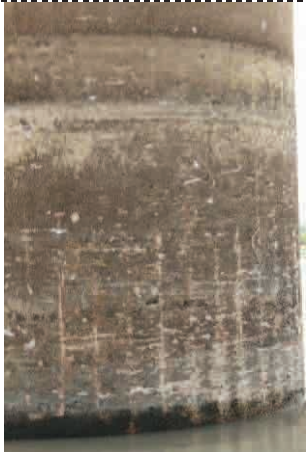
Pier 15	
Damage: Not exist	Damage: Not exist

No damage in reinforcement	No damage in reinforcement

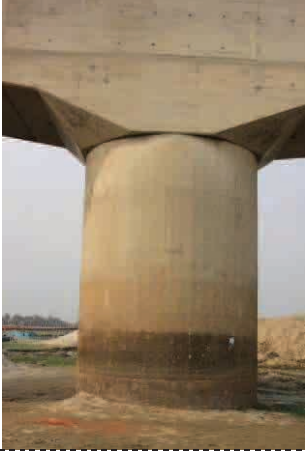
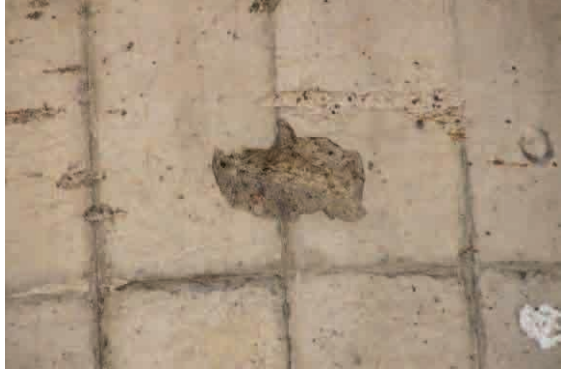
Pier 16	
Damage: Not exist	Damage: Not exist

No damage	No damage in reinforcement

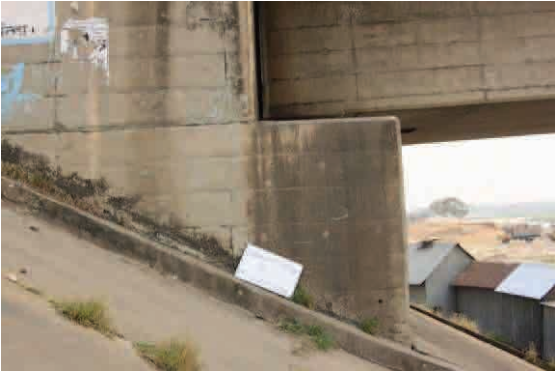
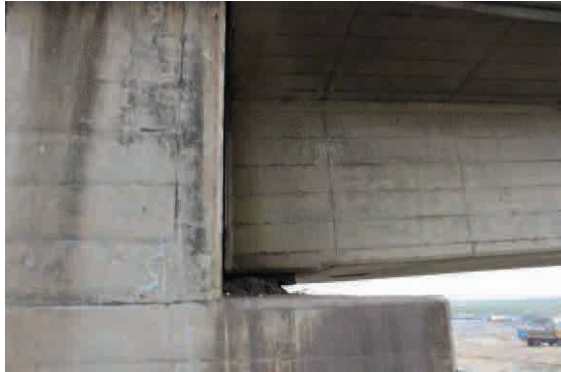
Abutment 02	
Damage: Not exist	Damage: Not exist

No damage	No damage

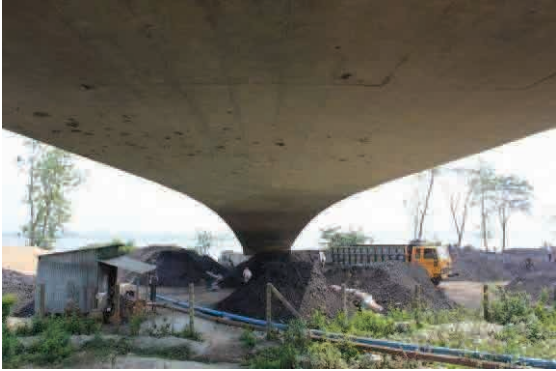
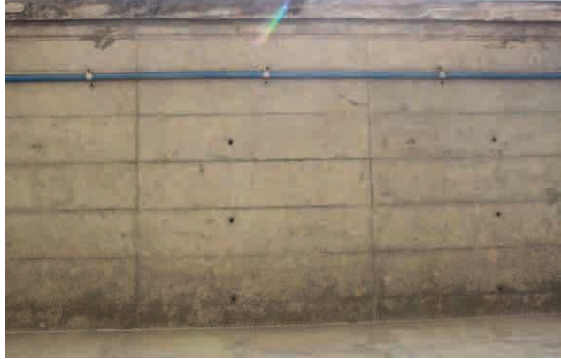
Superstructure P1	
Damage: Not exist	Damage: Not exist

No damage	No damage

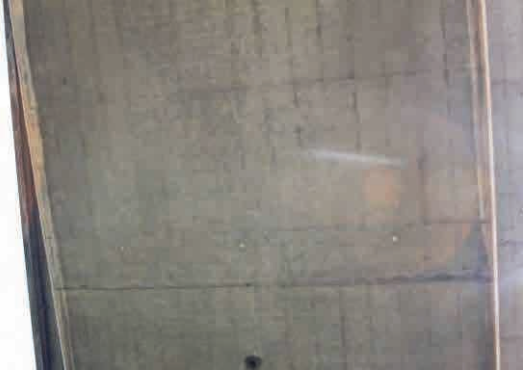
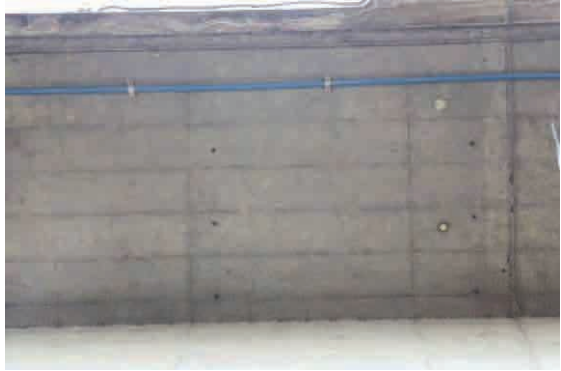
Superstructure P2	
Damage: Not exist	Damage: Not exist

No damage	No damage

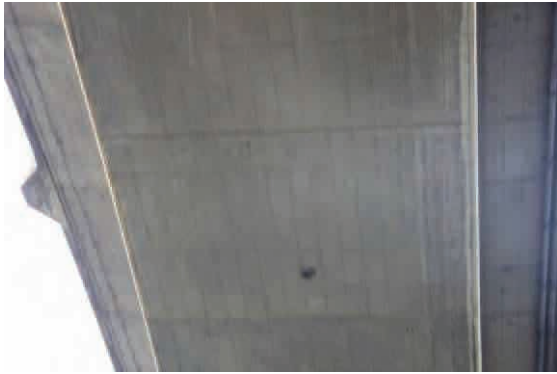
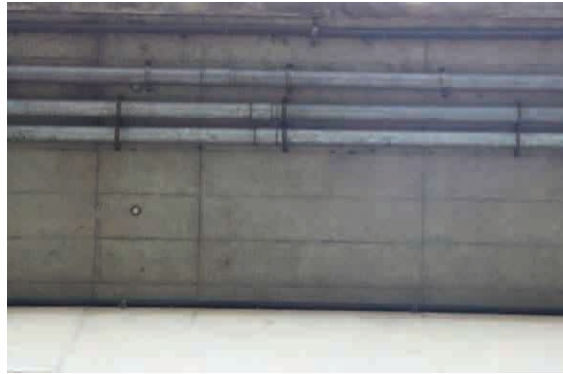
Superstructure P3	
Damage: Not exist	Damage: Not exist

No damage	No damage

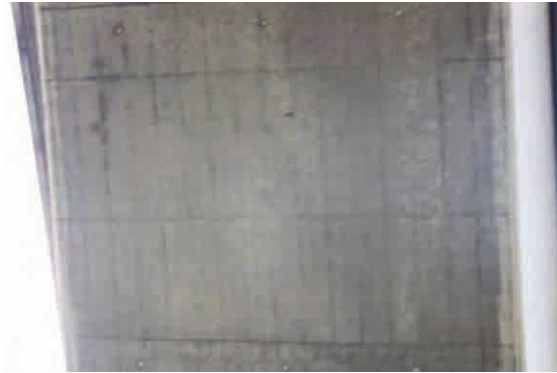
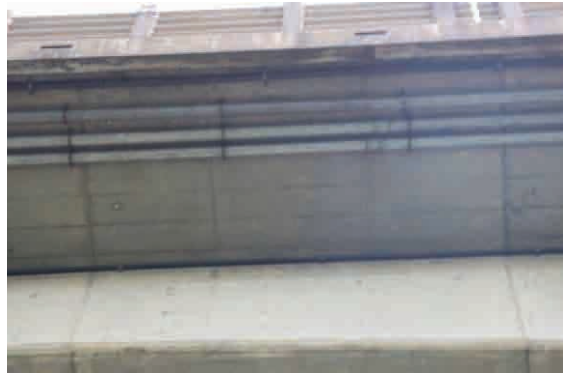
Superstructure P4	
Damage: Not exist	Damage: Not exist

No damage	No damage

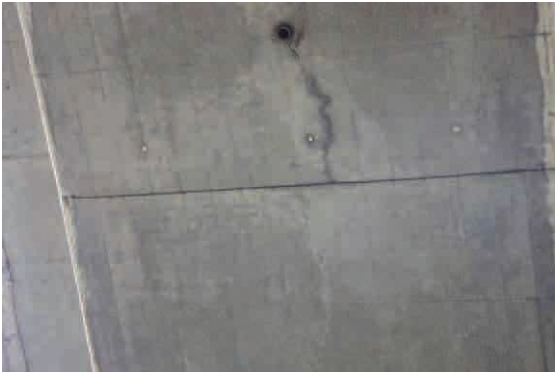
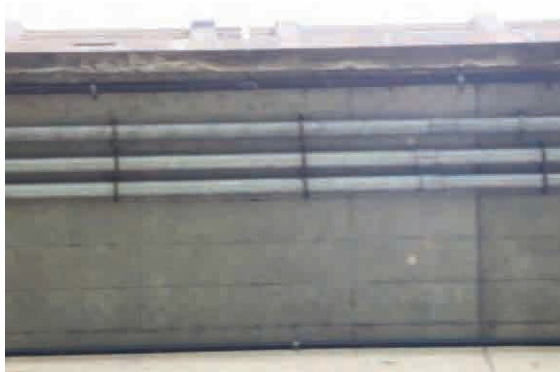
Superstructure P5	
Damage: Not exist	Damage: Not exist

No damage	No damage

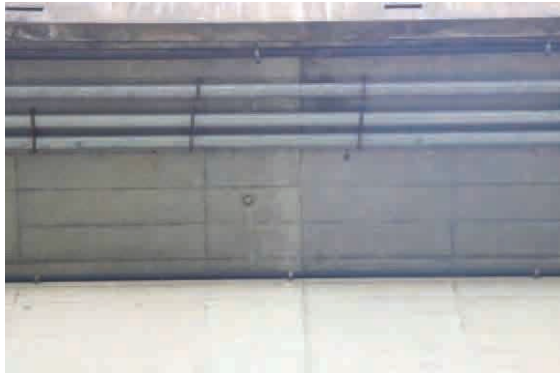
Superstructure P6	
Damage: Not exist	Damage: Not exist

No damage	No damage

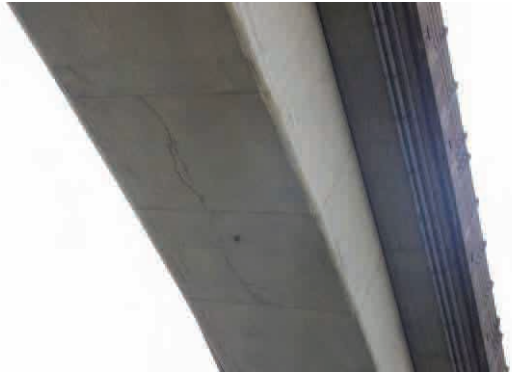
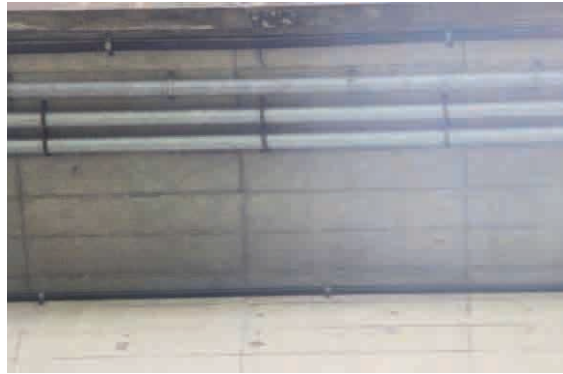
Superstructure P7	
Damage: Not exist	Damage: Not exist

No damage	No damage

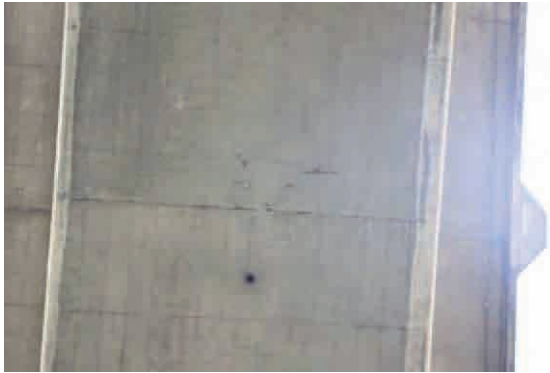
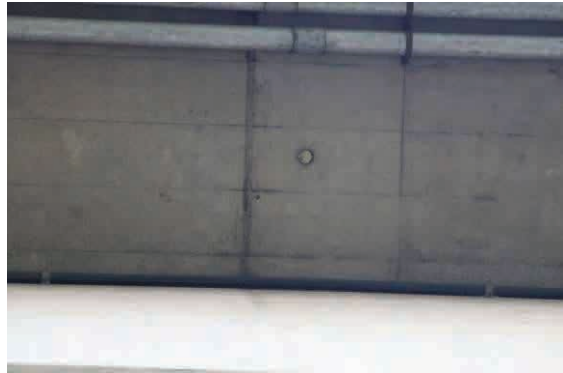
Superstructure P8	
Damage: Not exist	Damage: Not exist

No damage	No damage

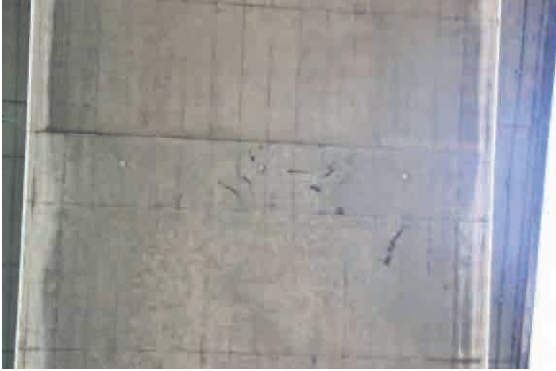
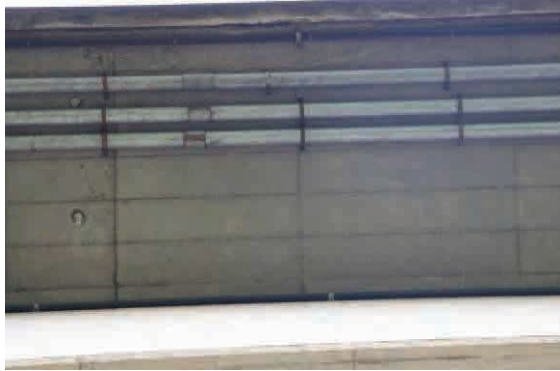
Superstructure P9	
Damage: Not exist	Damage: Not exist

No damage	No damage

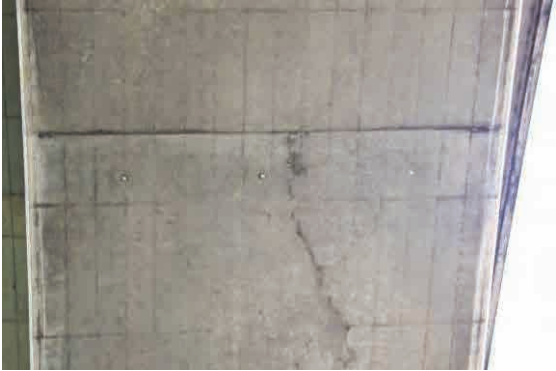
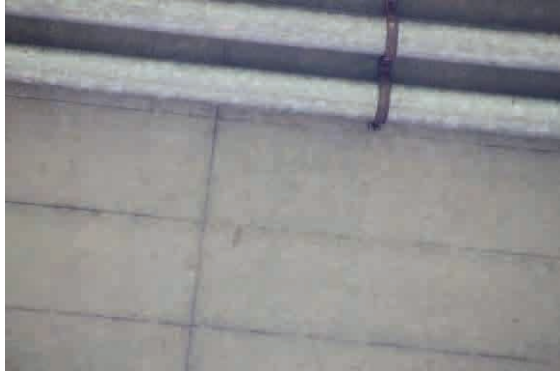
Superstructure P10	
Damage: Not exist	Damage: Not exist

No damage	No damage

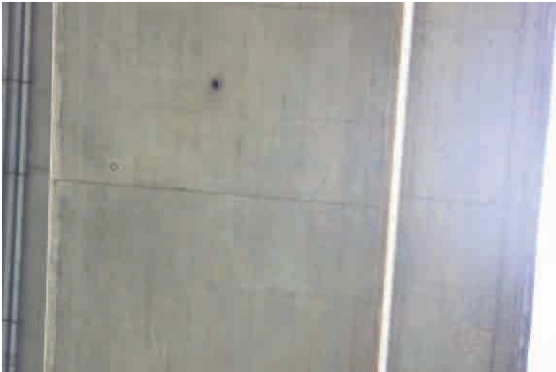
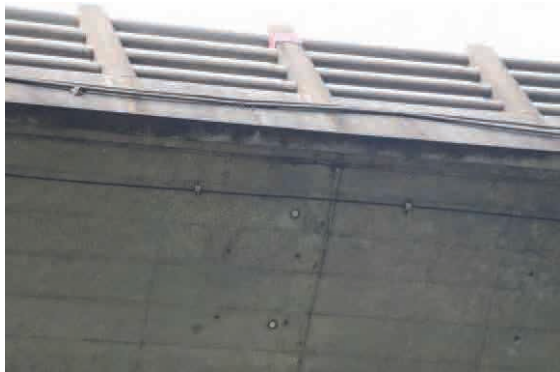
Superstructure P11	
Damage: Not exist	Damage: Not exist

No damage	No damage

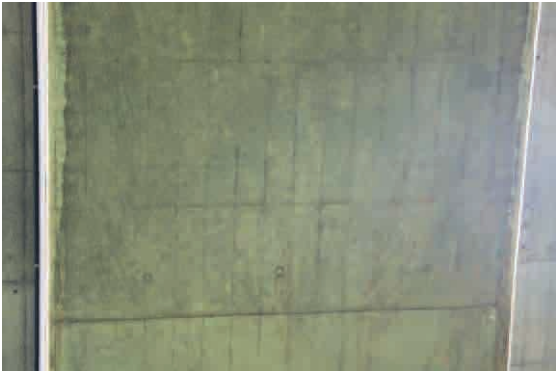
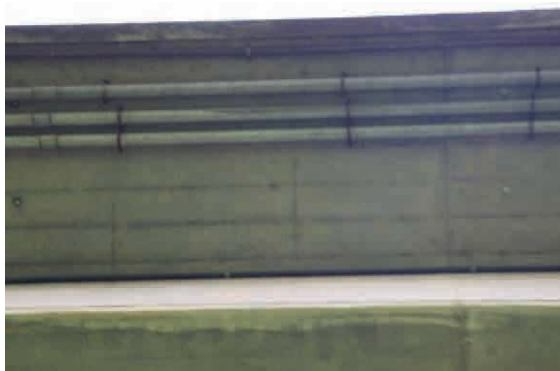
Superstructure P12	
Damage: Not exist	Damage: Not exist

No damage	No damage

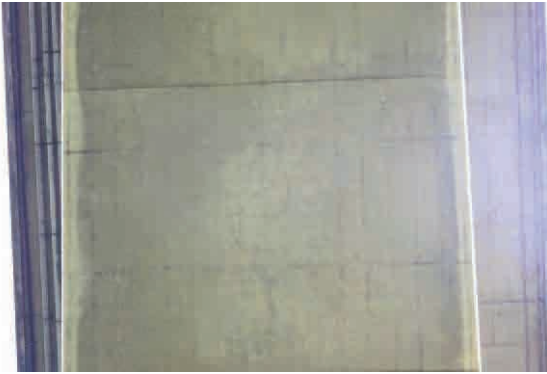
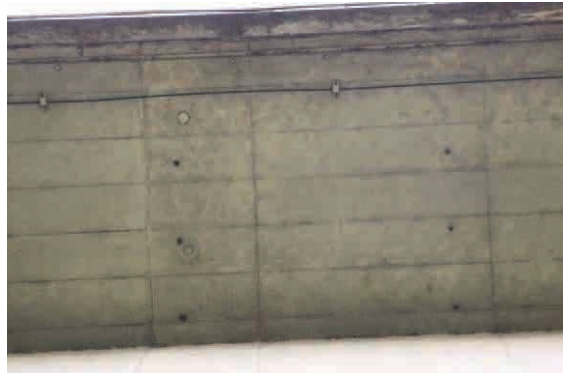
Superstructure P13	
Damage: Not exist	Damage: Not exist

No damage	No damage

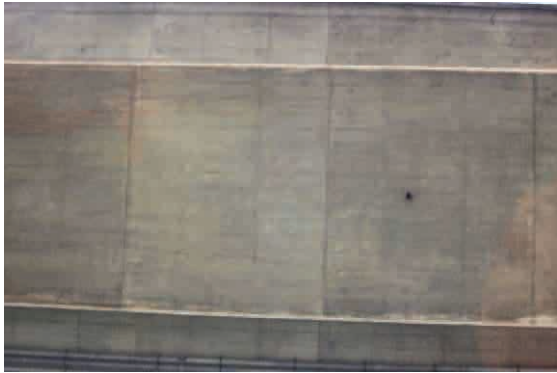
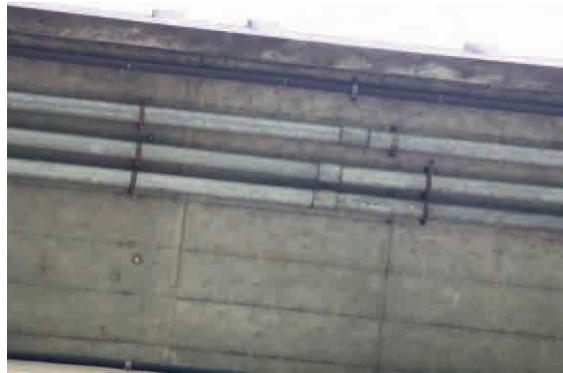
Superstructure P14	
Damage: Not exist	Damage: Not exist

No damage	No damage

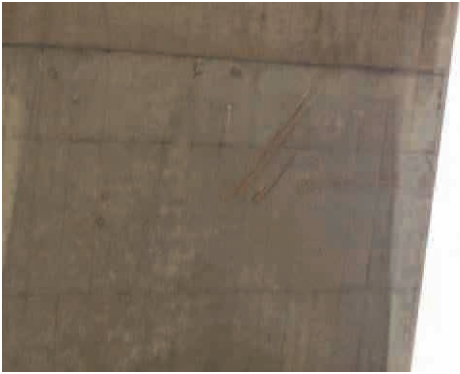
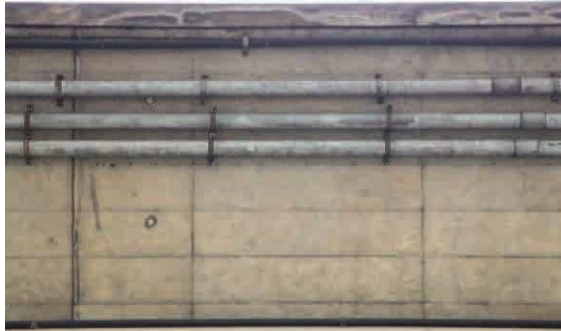
Superstructure P15	
Damage: Not exist	Damage: Not exist

No damage	No damage

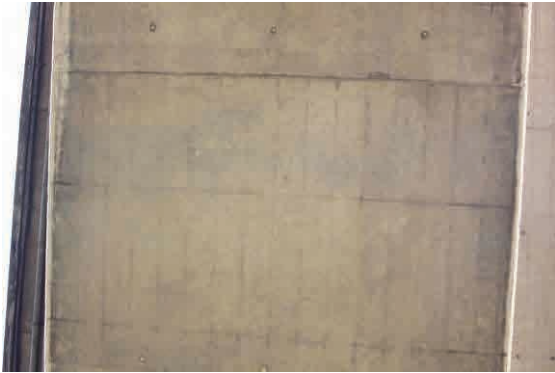
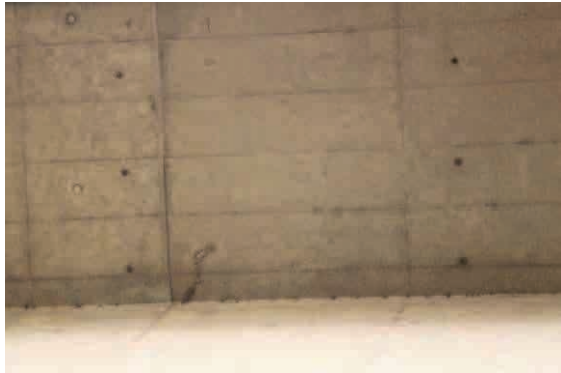
Superstructure P16	
Damage: Not exist	Damage: Not exist

No damage	No damage

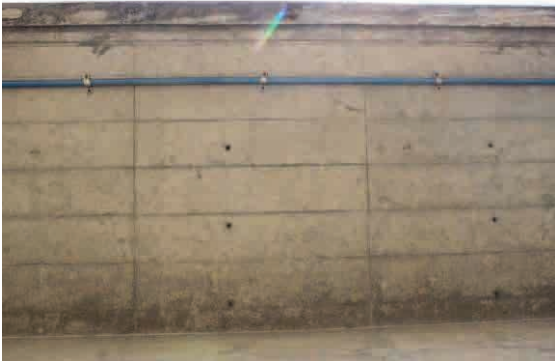
Slab P1	
Damage: Not exist	Damage: a

No damage	No crack
