4.2 Meghna Bridge

4.2.1 Crack, water leakage, isolated lime

4.3 Gumti Bridge

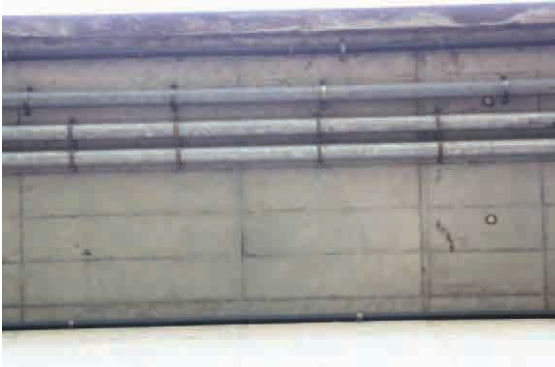
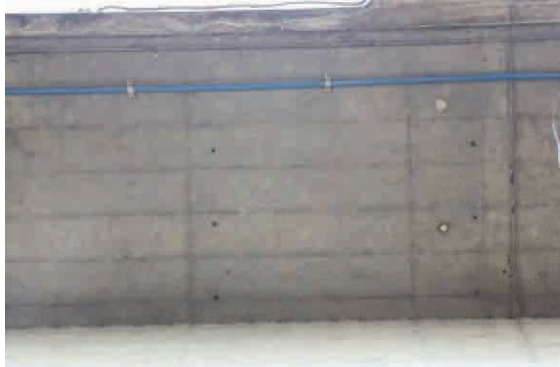
Slab P2	
Damage: Not exist	Damage: a

No damage	No crack

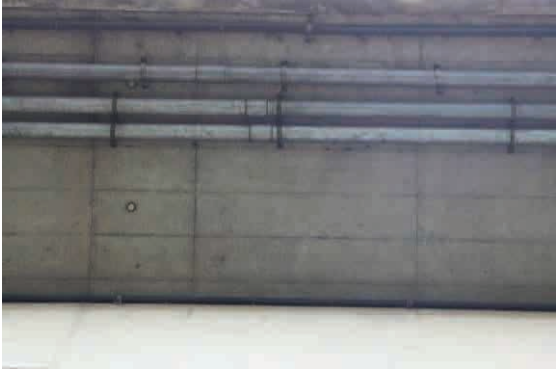
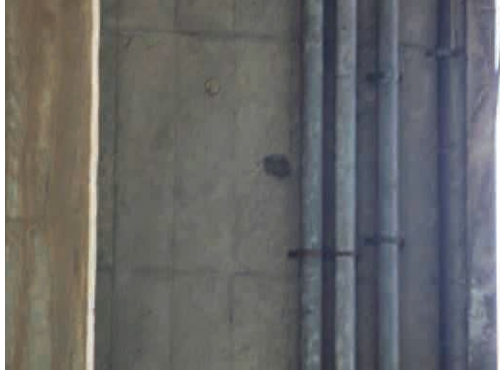
Slab P3	
Damage: Not exist	Damage: a

No damage	No crack

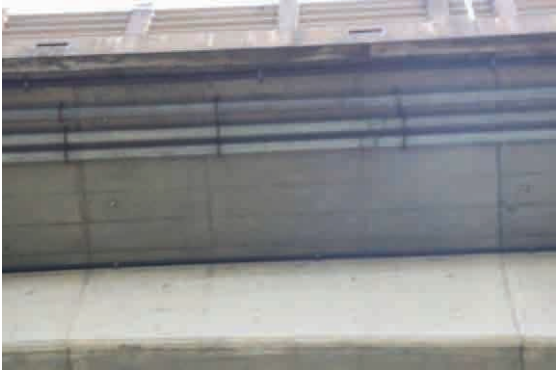
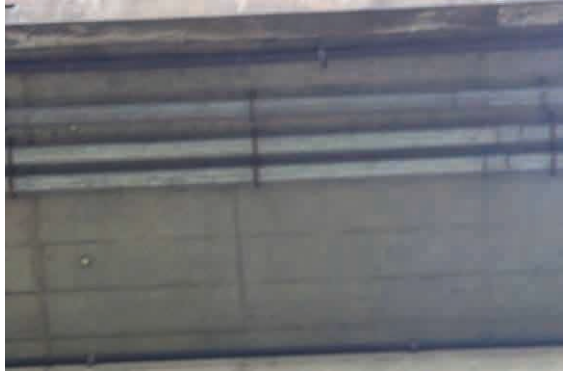
Slab P4	
Damage: Not exist	Damage: a

No damage	No crack

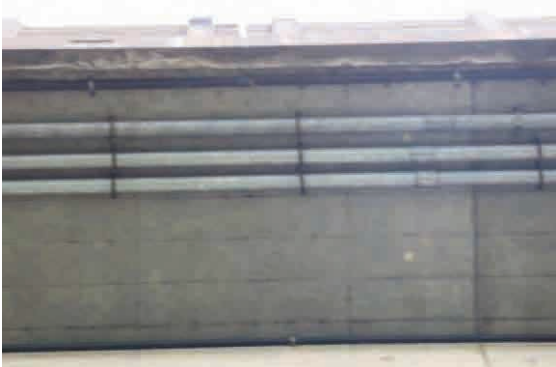
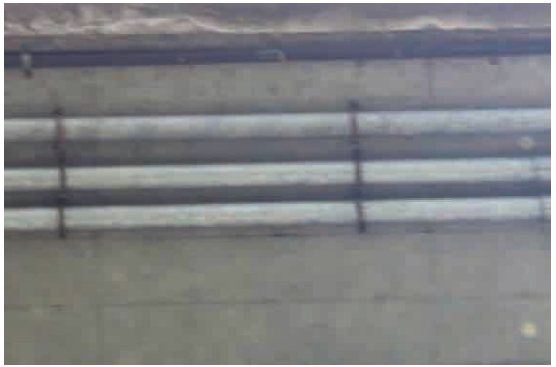
Slab P5	
Damage: Not exist	Damage: a

No damage	No crack

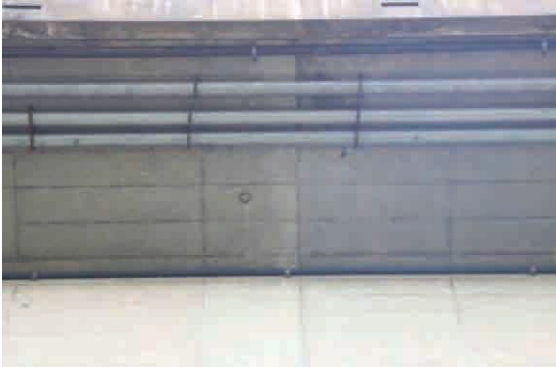
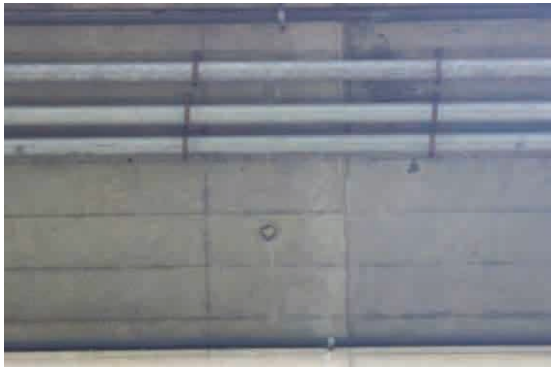
Slab P6	
Damage: Not exist	Damage: a

No damage	No crack

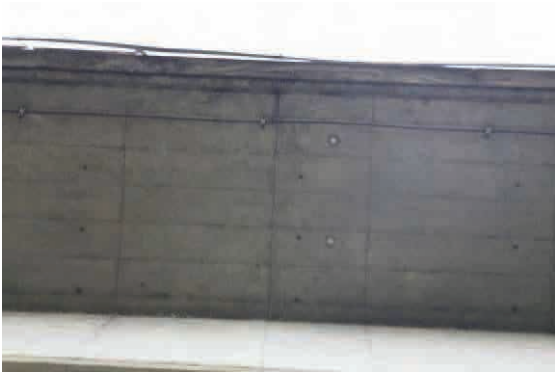
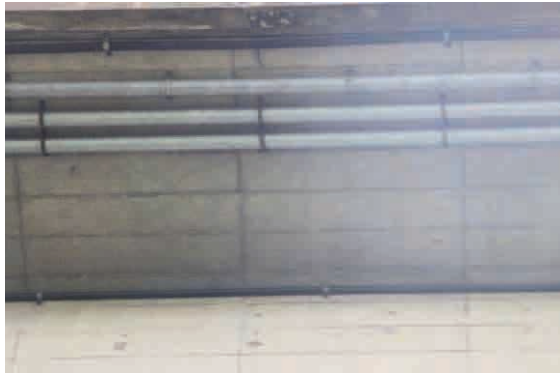
Slab P7	
Damage: Not exist	Damage: a

No damage	No crack

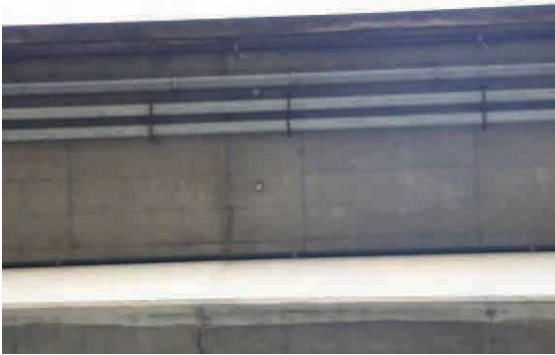
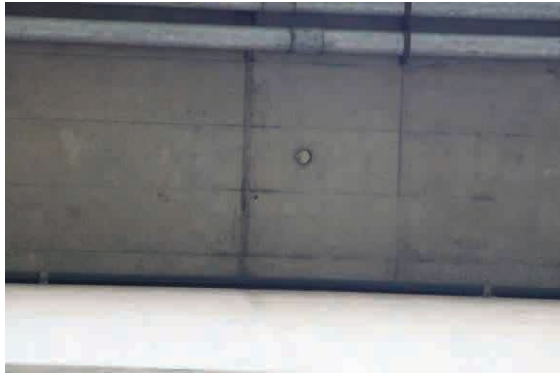
Slab P8	
Damage: Not exist	Damage: a

No damage	No crack

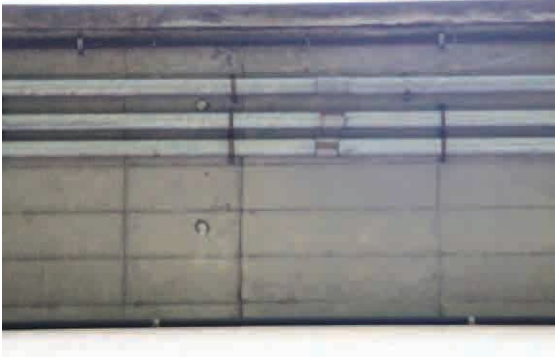
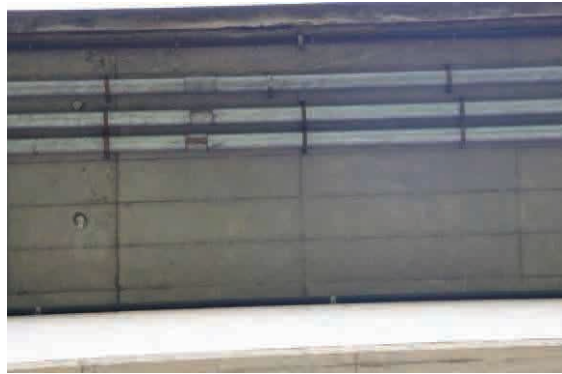
Slab P9	
Damage: Not exist	Damage: a

No damage	No crack

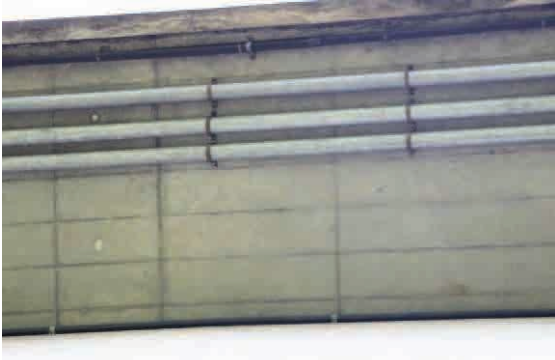
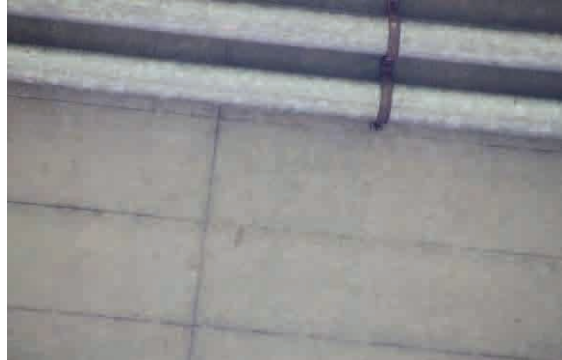
Slab P10	
Damage: Not exist	Damage: a

No damage	No crack

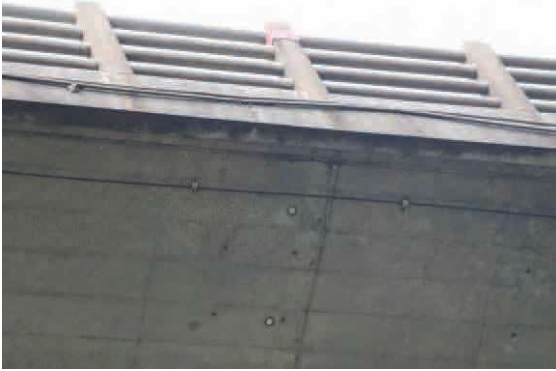
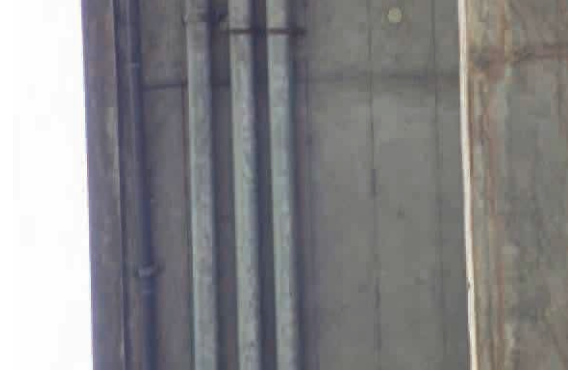
Slab P11	
Damage: Not exist	Damage: a

No damage	No crack

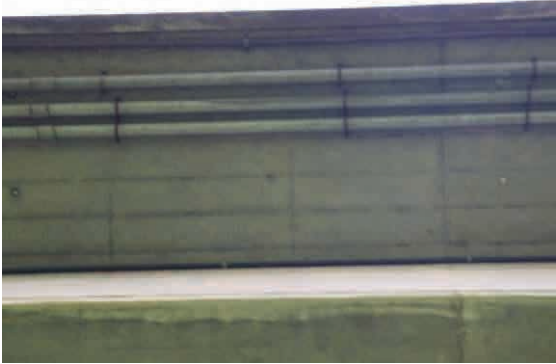
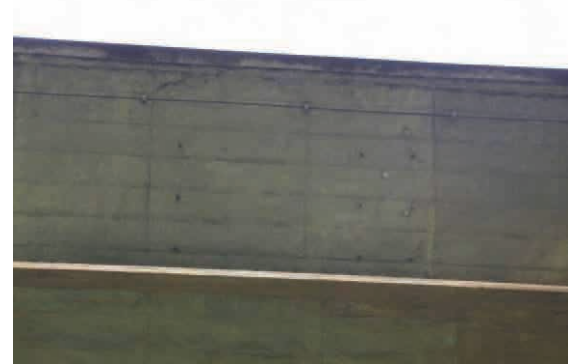
Slab P12	
Damage: Not exist	Damage: a

No damage	No crack

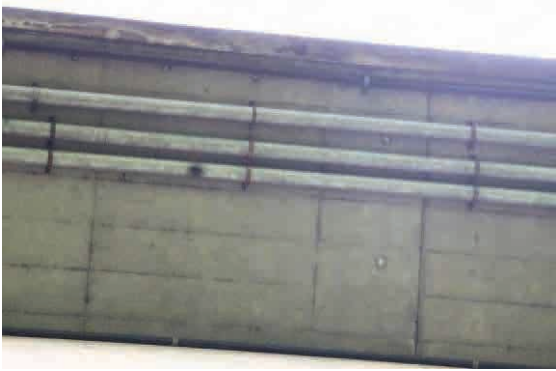
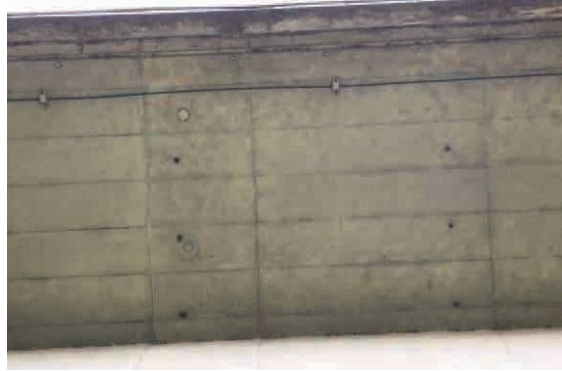
Slab P13	
Damage: Not exist	Damage: a

No damage	No crack

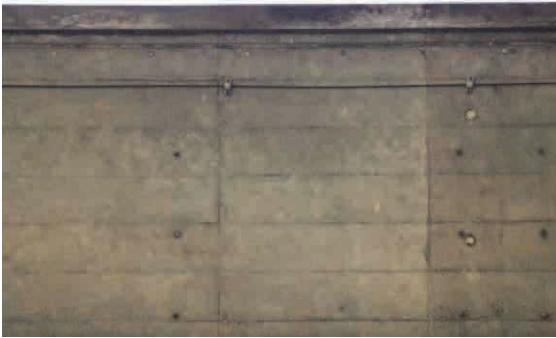
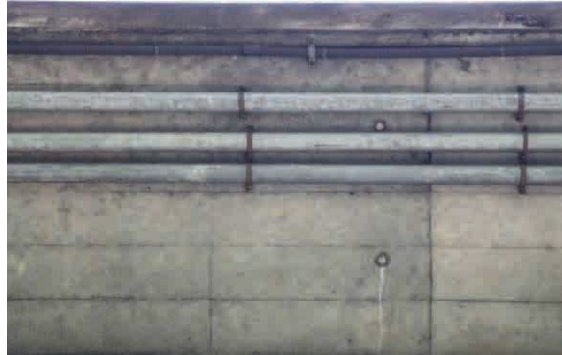
Slab P14	
Damage: Not exist	Damage: a

No damage	No crack

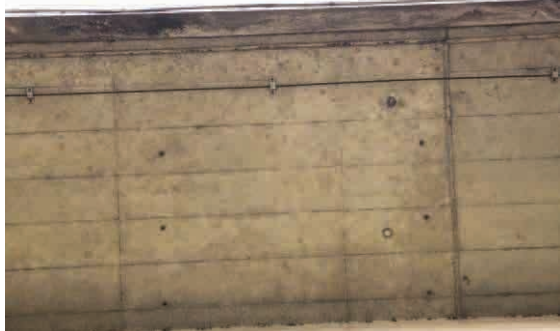
Slab P15	
Damage: Not exist	Damage: a

No damage	No crack

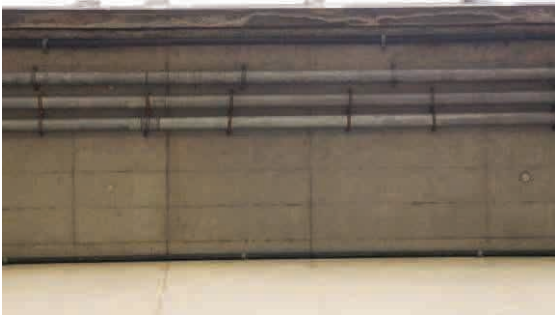
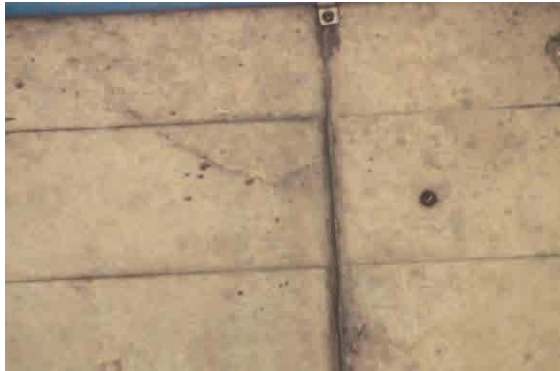
Slab P16	
Damage: Not exist	Damage: a

No damage	No damage
