APPENDIX 5.
RECORDS OF BRIDGE SURVEY

1. Visual inspection survey

4.1 Kanchpur Bridge

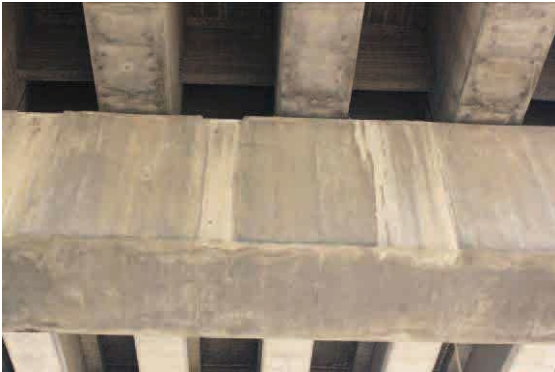
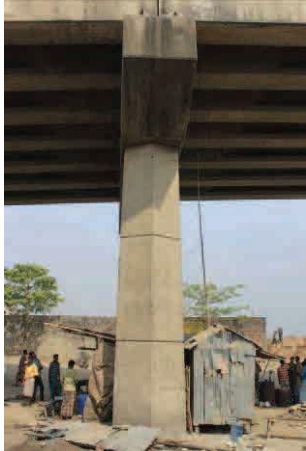
Pier 01	
Damage: a	Damage: a

No crack	No crack

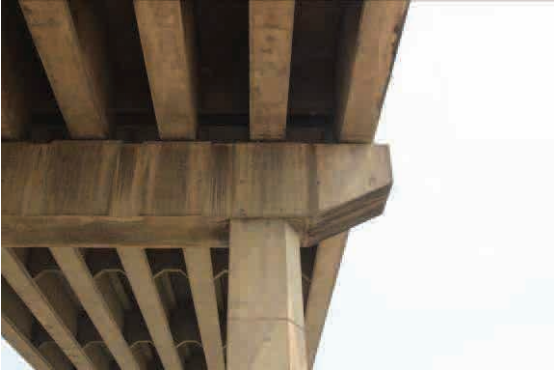
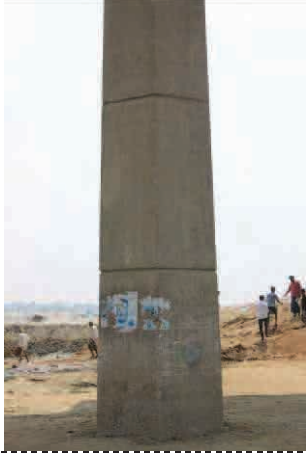
Pier 02	
Damage: a	Damage: a

No crack	No crack

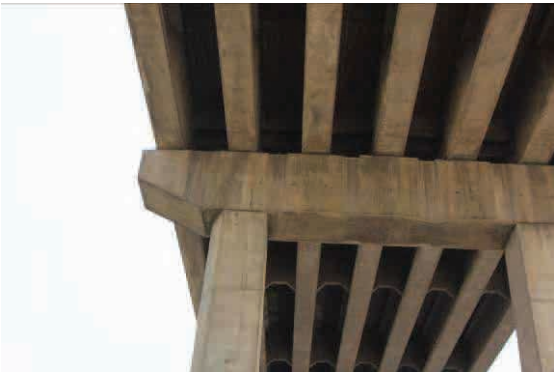
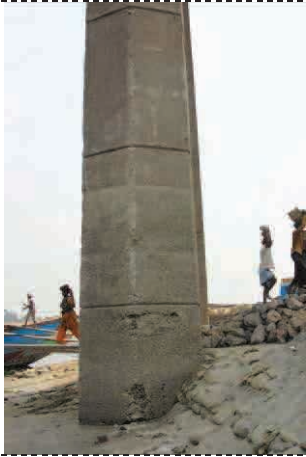
Pier 03	
Damage: a	Damage: a

No crack	No crack

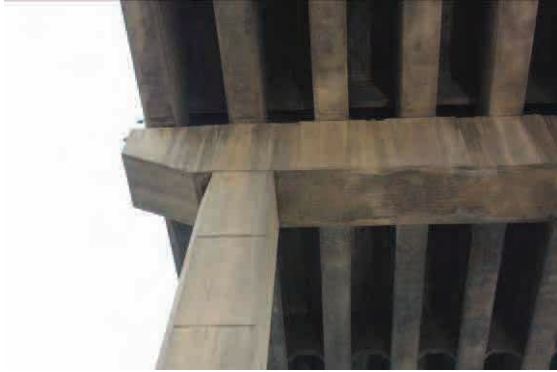
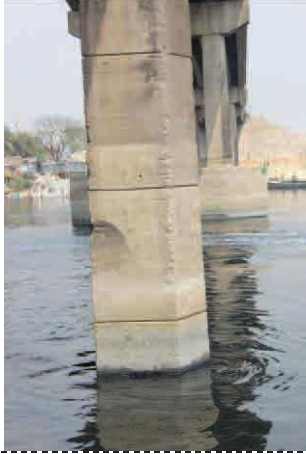
Pier 04	
Damage: a	Damage: a

No crack	No crack

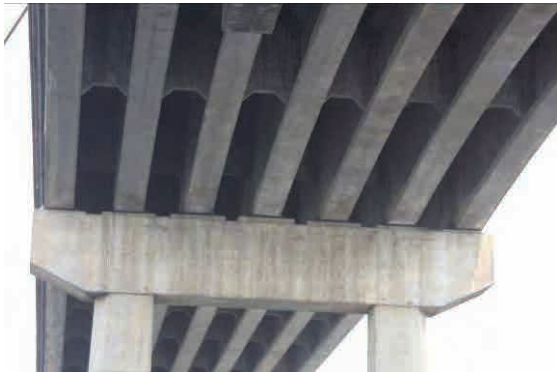
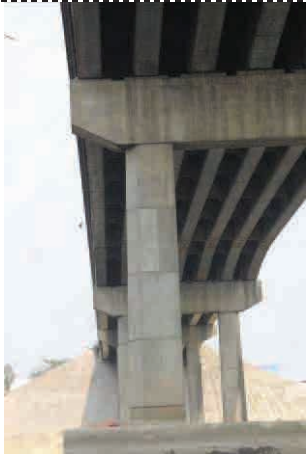
Pier 05	
Damage: a	Damage: a

No crack	No crack

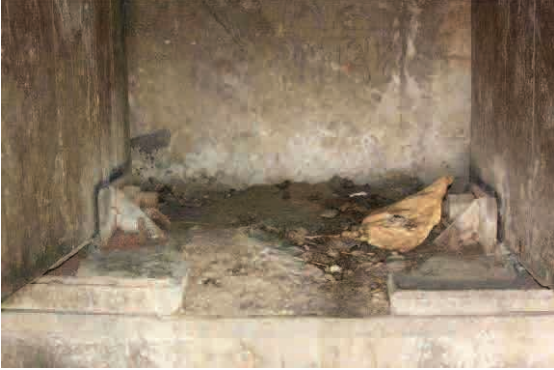
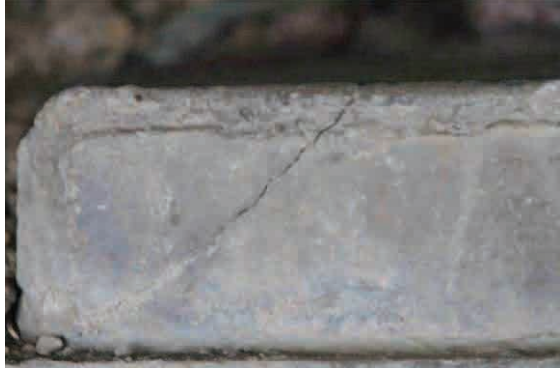
Abutment 02	
Damage: a	Damage: c

No crack	Crack width over 0.2mm Crack only

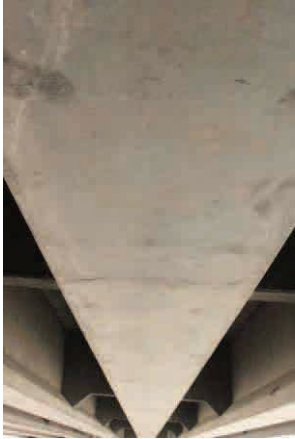
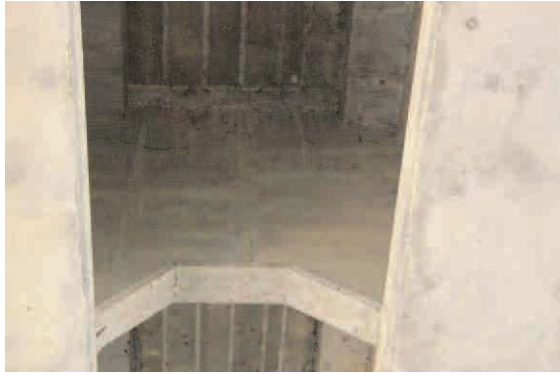
Superstructure A1-P1	
Damage: a	Damage: a

No crack	No crack

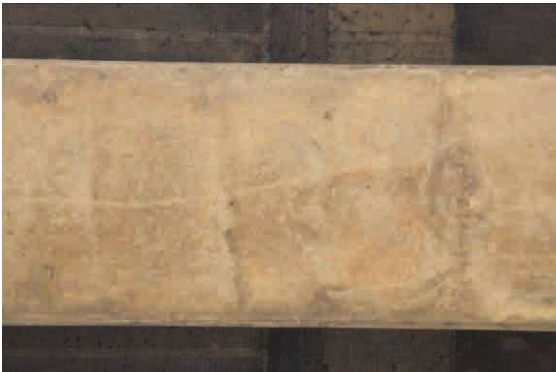
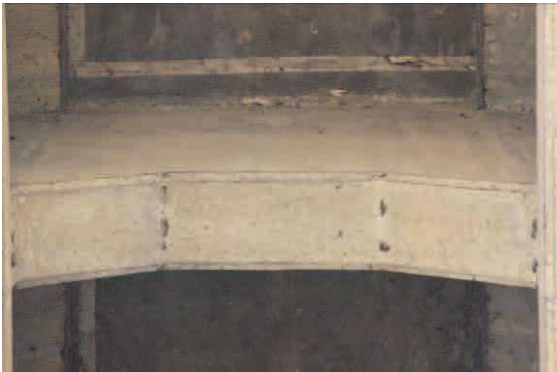
Superstructure P1-P2	
Damage: a	Damage: a

No crack	No crack

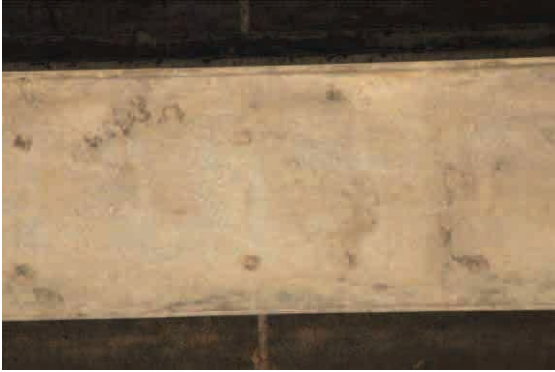
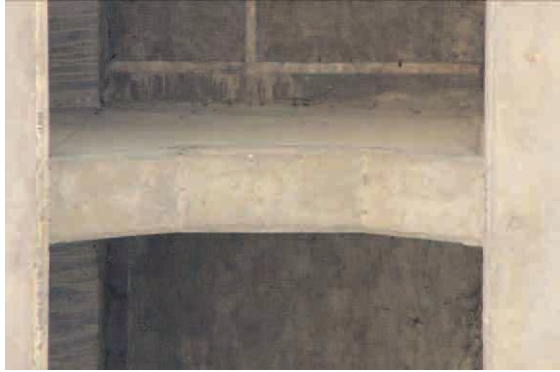
Superstructure P2-P3	
Damage: a	Damage: a

No crack	No crack

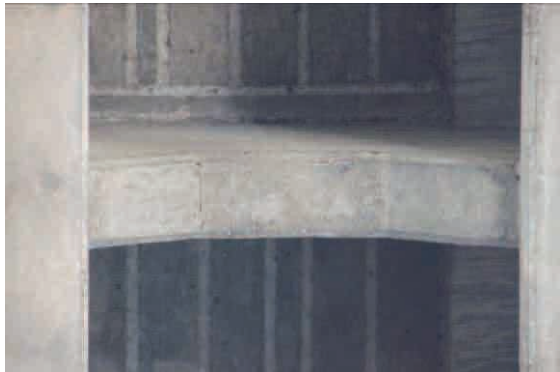
Superstructure P3-P4	
Damage: a	Damage: a

No crack	No crack

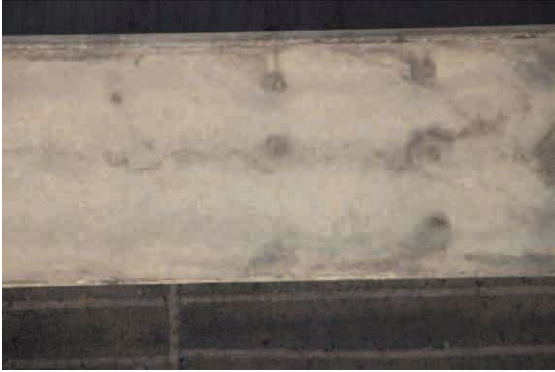
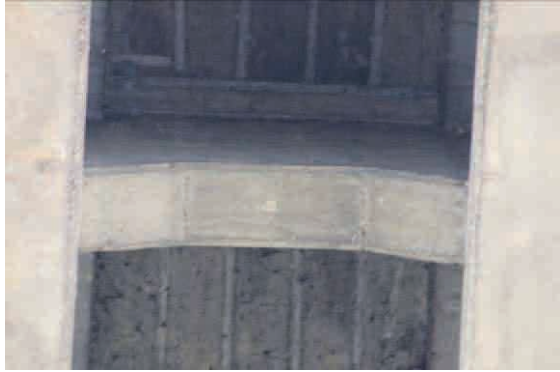
Superstructure P6-P7	
Damage: a	Damage: a

No crack	No crack

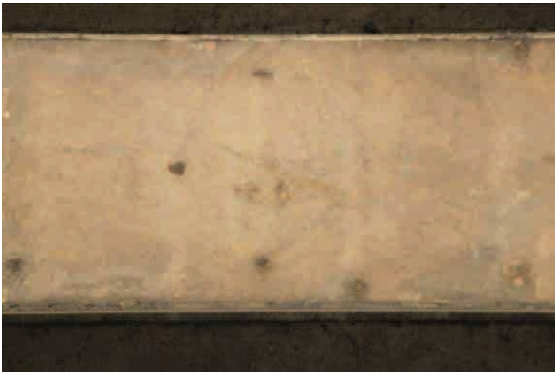
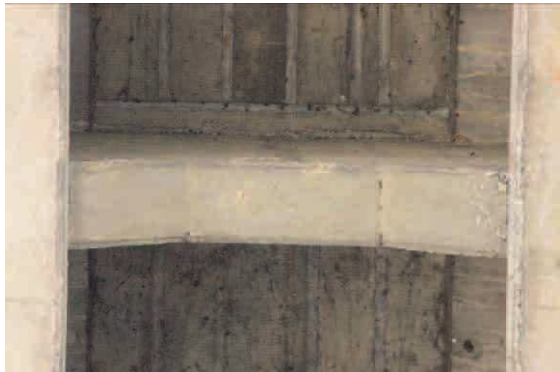
Superstructure P7-A2	
Damage: a	Damage: a

No crack	No crack

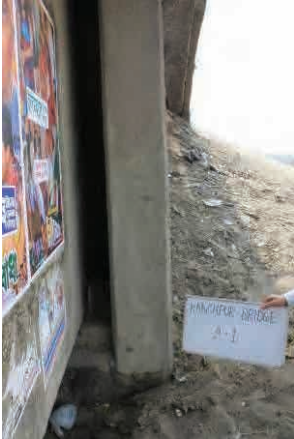
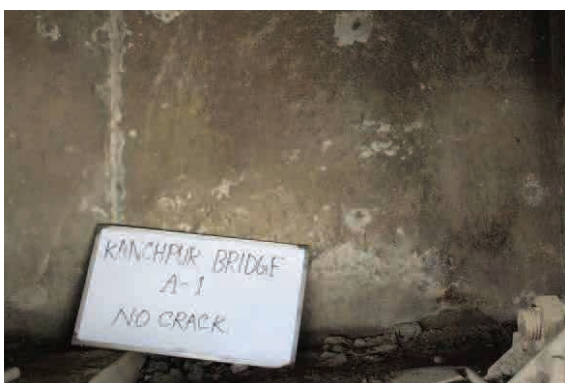
Abutment 01	
Damage: Not exist	Damage: Not exist

No damage	No damage

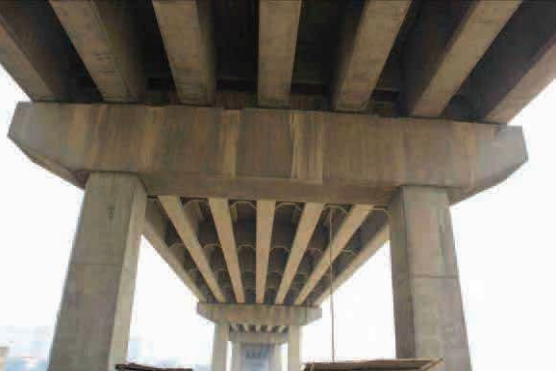
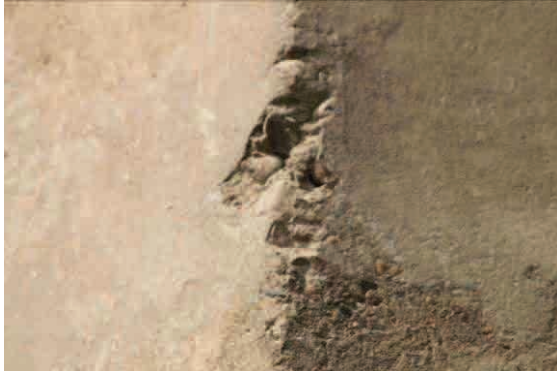
Pier 01	
Damage: Not exist	Damage: Not exist

No damage	No damage in reinforcement

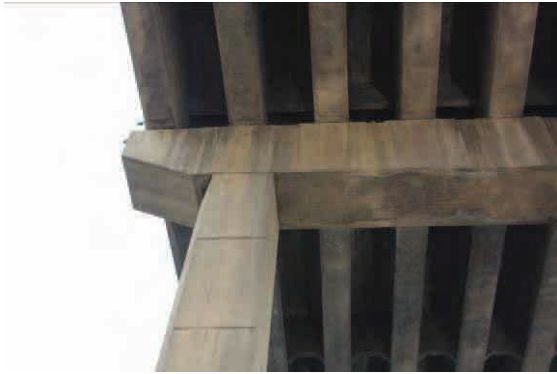
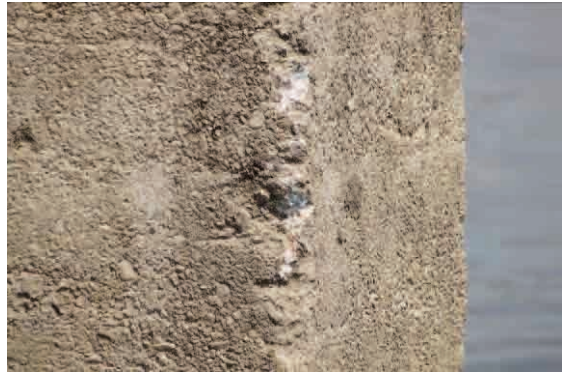
Pier 04	
Damage: Not exist	Damage: Not exist

No damage	No damage in reinforcement

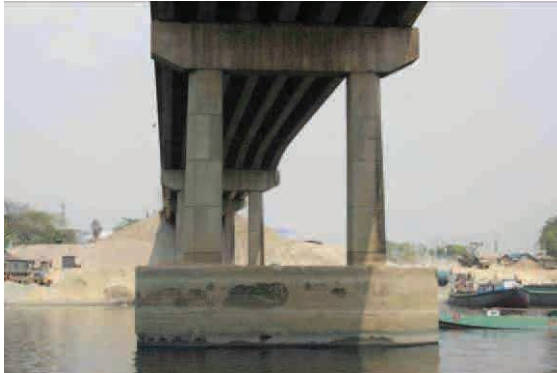
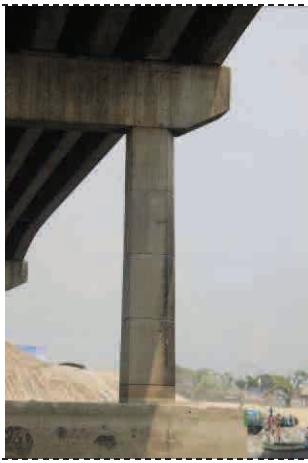
Pier 05	
Damage: Not exist	Damage: Not exist

No damage	No damage

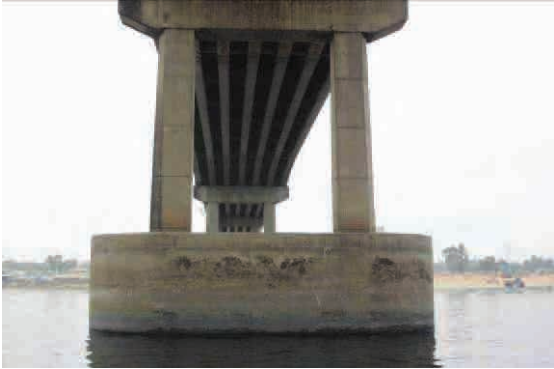
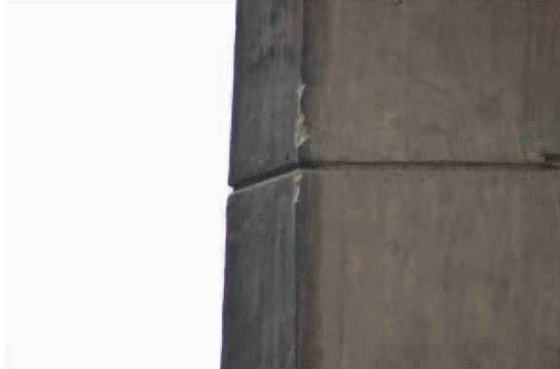
Pier 06	
Damage: Not exist	Damage: Not exist

No damage	No damage in reinforcement

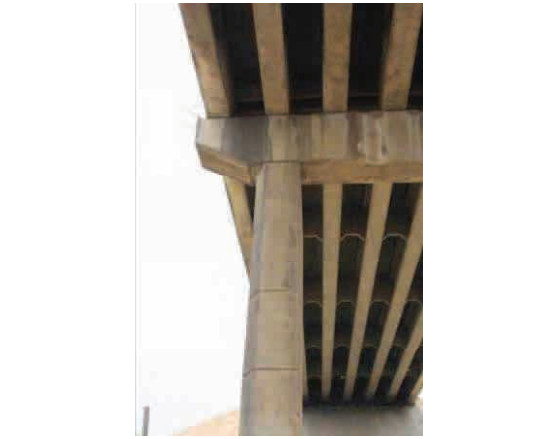
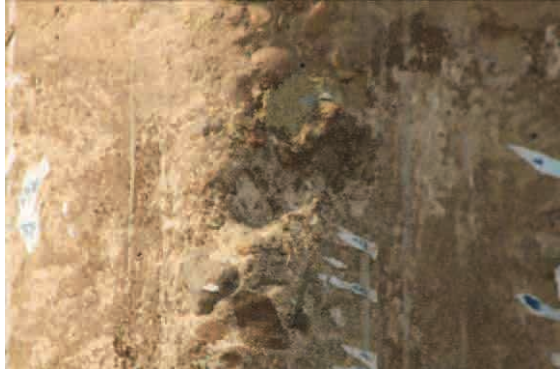
Pier 07	
Damage: Not exist	Damage: Not exist

No damage	No damage in reinforcement

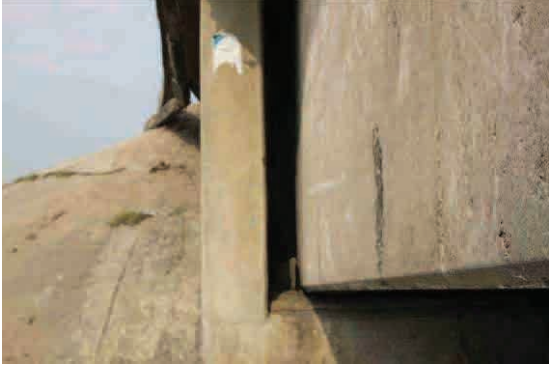
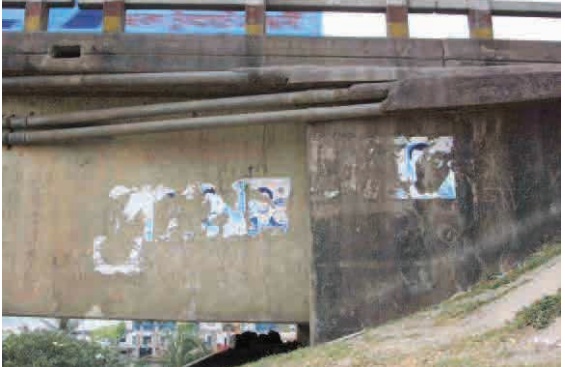
Abutment 02	
Damage: Not exist	Damage: Not exist

No damage	No damage

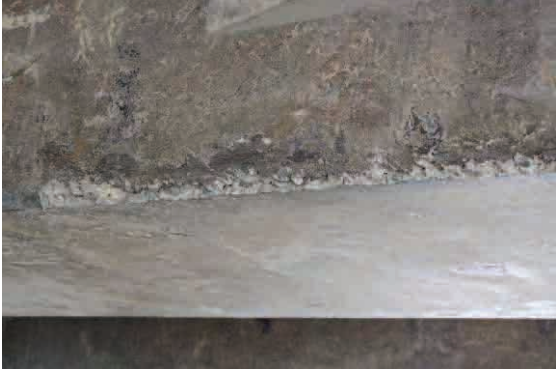
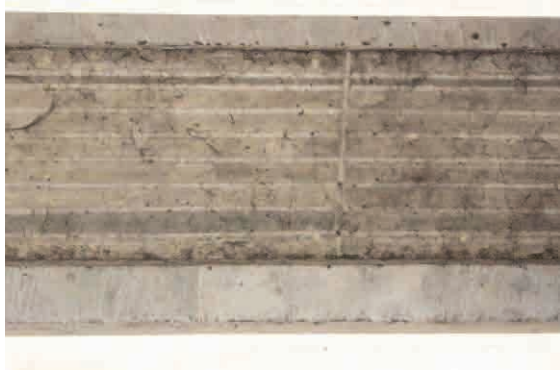
Superstructure A1-P1	
Damage: Not exist	Damage: Not exist

No damage in reinforcement	No damage in reinforcement

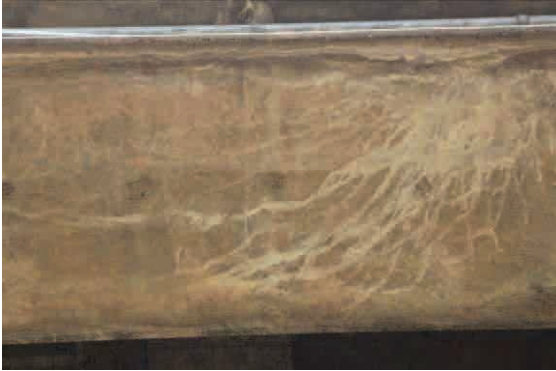
Superstructure P1-P2	
Damage: Not exist	Damage: Not exist

No damage in reinforcement	No damage in reinforcement

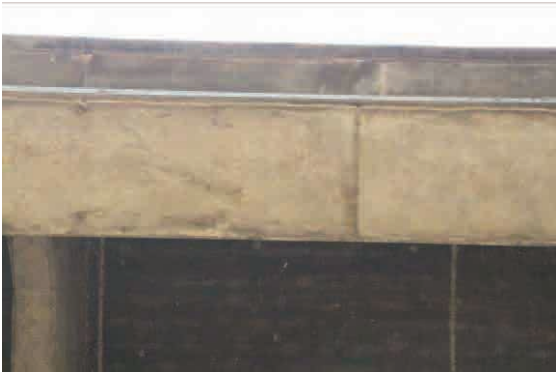
Superstructure P2-P3	
Damage: Not exist	Damage: Not exist

No damage	No damage in reinforcement

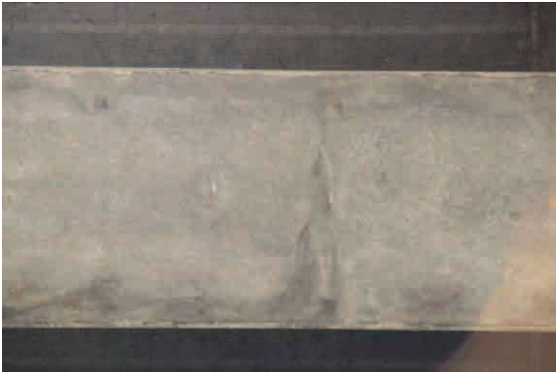
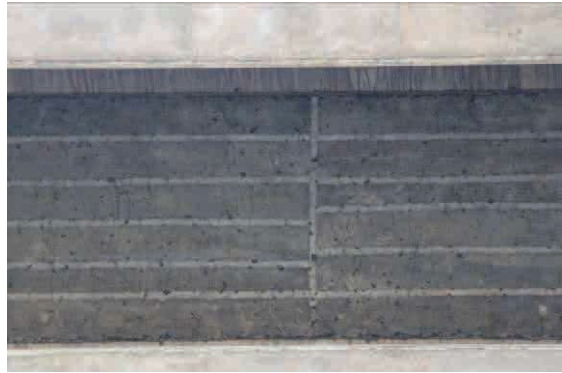
Superstructure P3-P4	
Damage: Not exist	Damage: Not exist

No damage in reinforcement	No damage in reinforcement

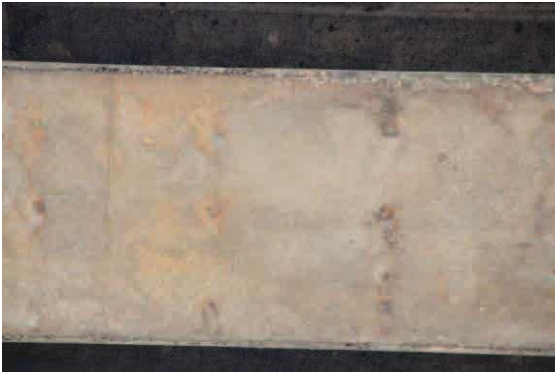
Superstructure P6-P7	
Damage: Not exist	Damage: Not exist

No damage in reinforcement	No damage in reinforcement

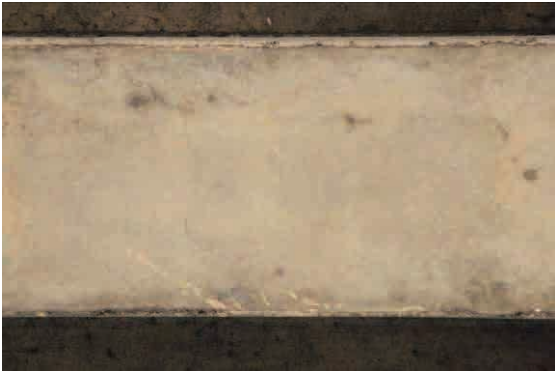
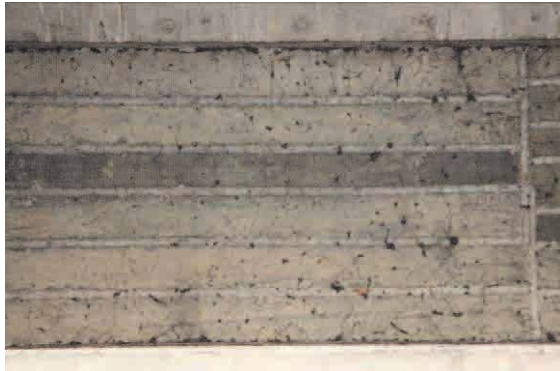
Superstructure P7-A2	
Damage: Not exist	Damage: Not exist

No damage in reinforcement	No damage in reinforcement

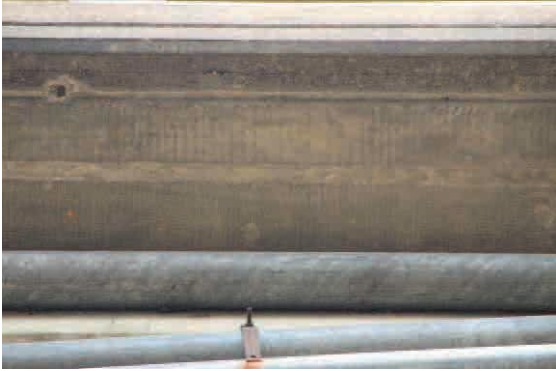
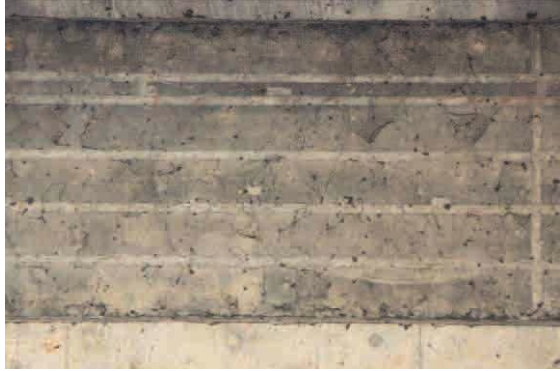
Slab A1-P1	
Damage: Not exist	Damage: Not exist

No damage	No damage

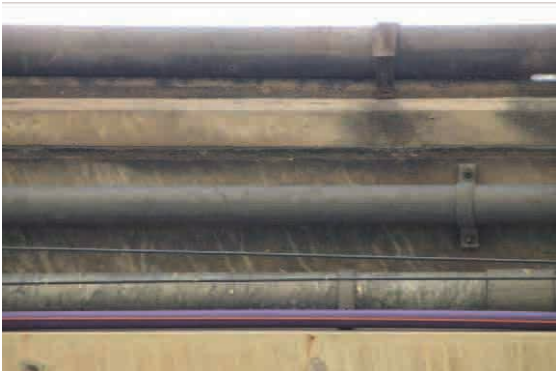
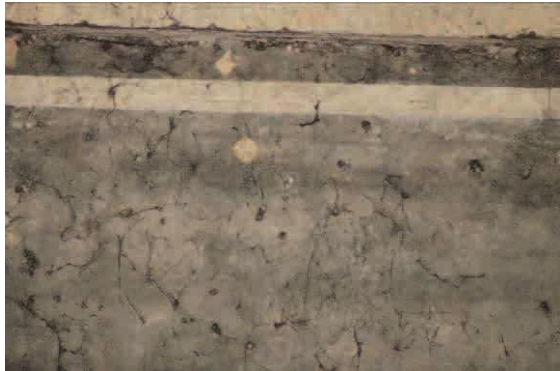
Slab P1-P2	
Damage: Not exist	Damage: Not exist

No damage	No damage

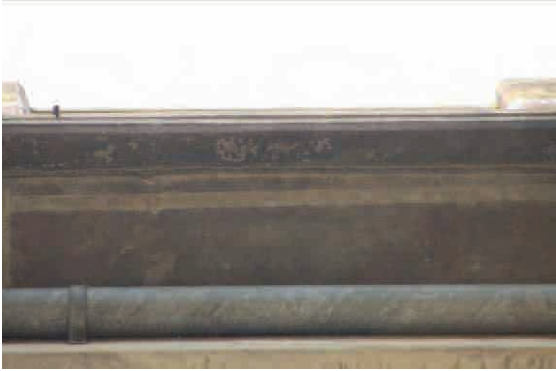
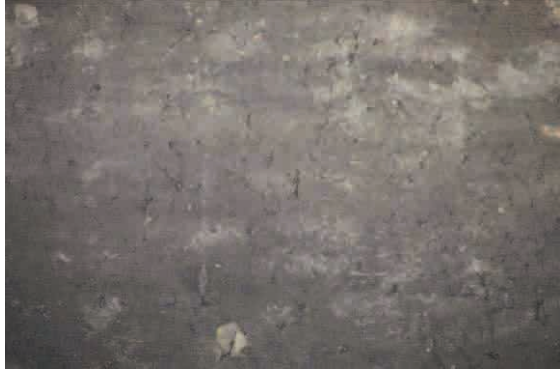
Slab P2-P3	
Damage: Not exist	Damage: Not exist

No damage	No damage

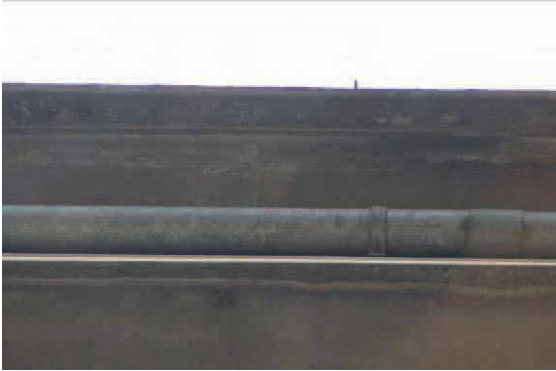
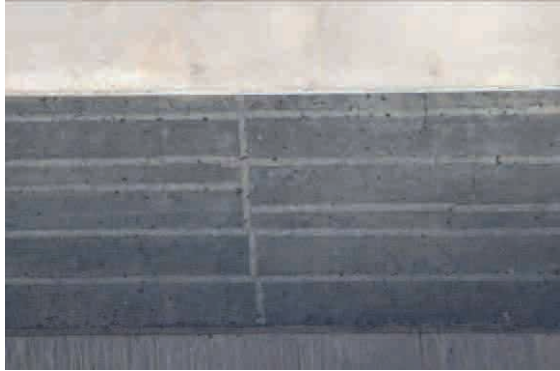
Slab P3-P4	
Damage: Not exist	Damage: Not exist

No damage	No damage

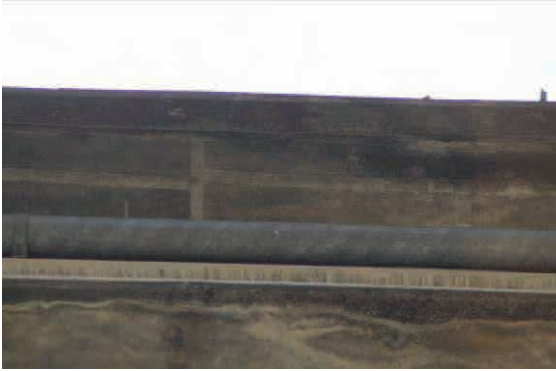
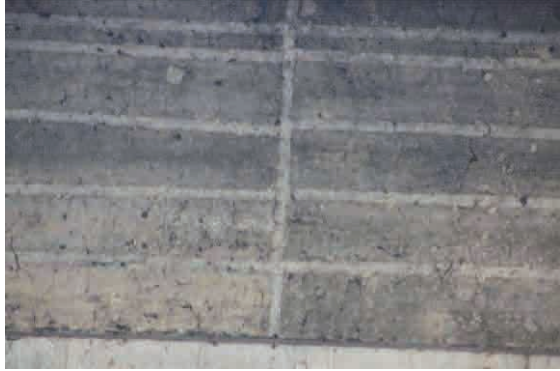
Slab P6-P7	
Damage: Not exist	Damage: Not exist

No damage	No damage

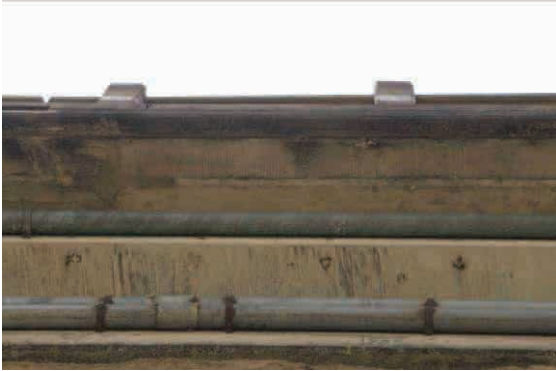
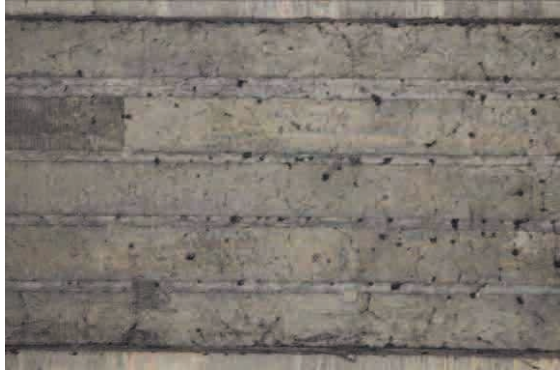
Slab P7-A2	
Damage: Not exist	Damage: Not exist

No damage	No damage

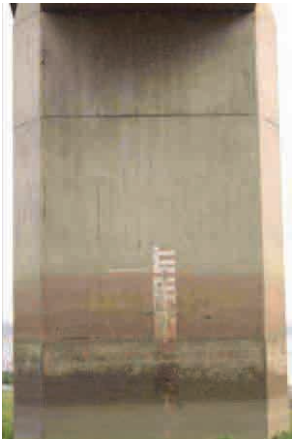
Pier 01	
Damage: a	Damage: c

No crack	Crack width over 0.2mm

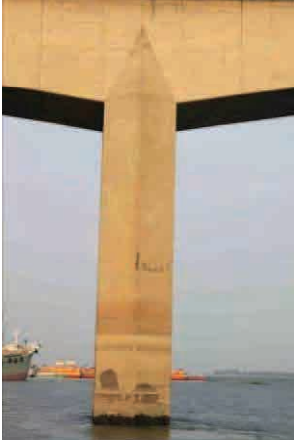
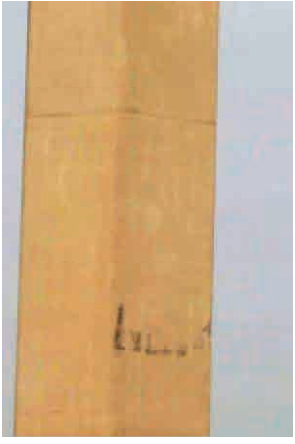
Pier 02	
Damage: a	Damage: a

No crack	No crack

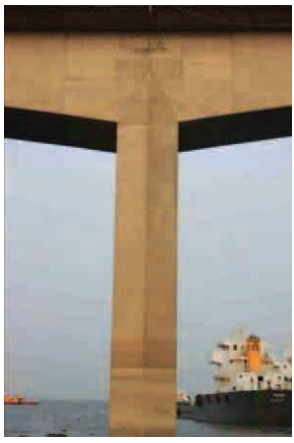
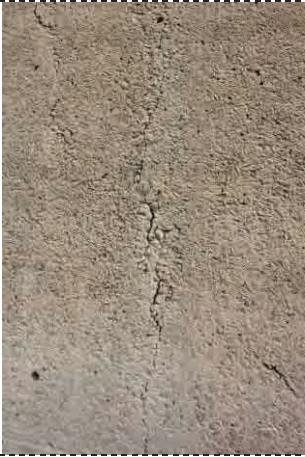
Pier 03	
Damage: a	Damage: c

No crack	Crack width over 0.2mm

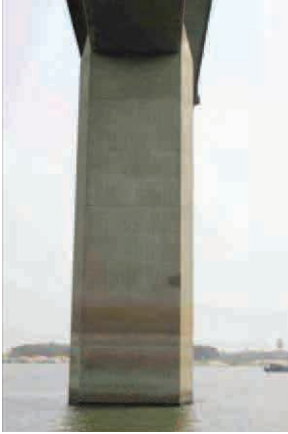
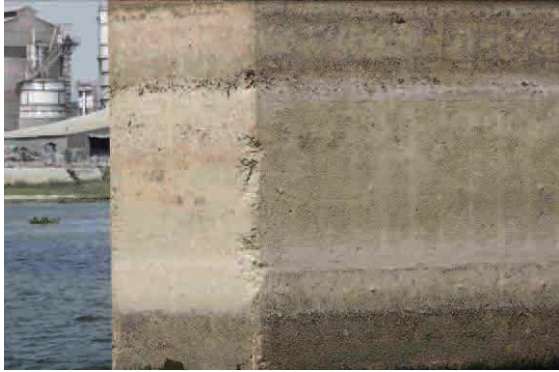
Pier 04	
Damage: a	Damage: a

No crack	No crack

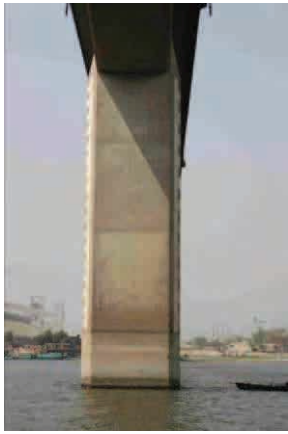
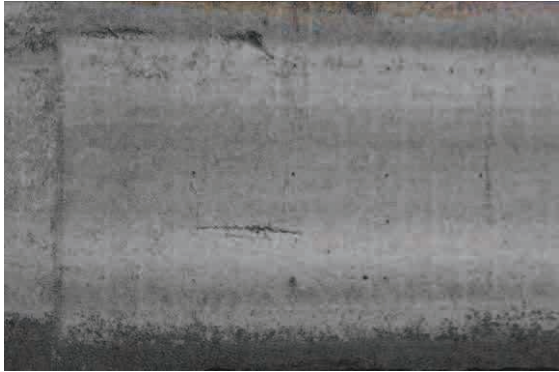
Pier 05	
Damage: a	Damage: a

No crack	No crack

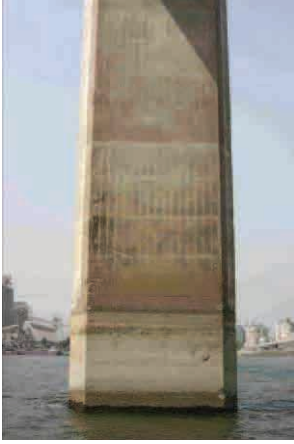
Pier 06	
Damage: a	Damage: c

No crack	Crack width over 0.2mm

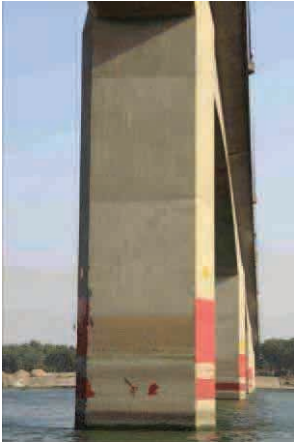
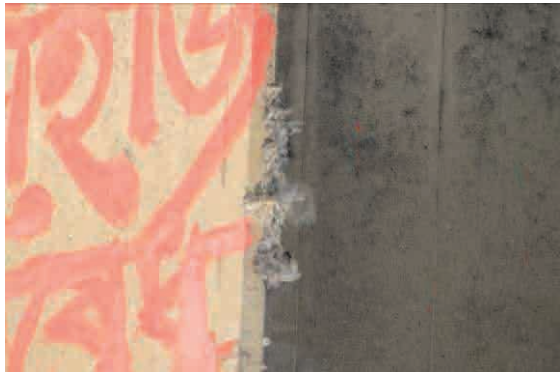
Pier 07	
Damage: a	Damage: a

No crack	No crack

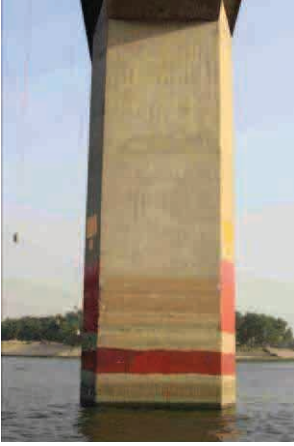
Pier 08	
Damage: a	Damage: c

No crack	Crack width over 0.2mm

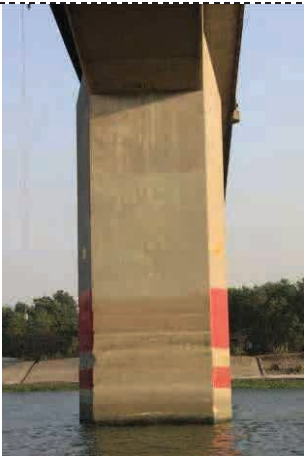
Pier 09	
Damage: a	Damage: c

No crack	Crack width over 0.2mm

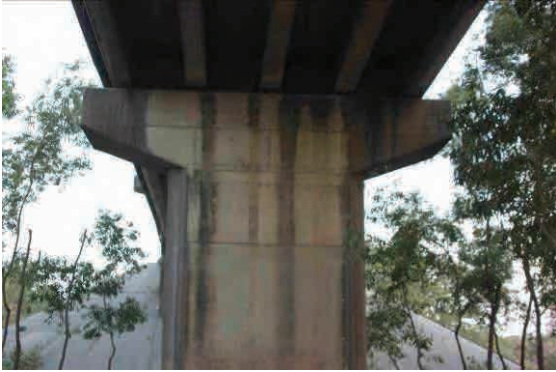
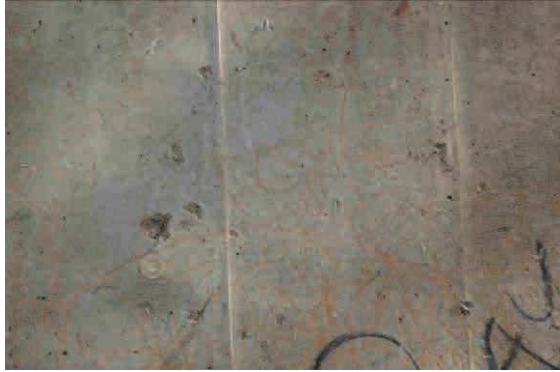
Pier 12	
Damage: a	Damage: a

No crack	No crack

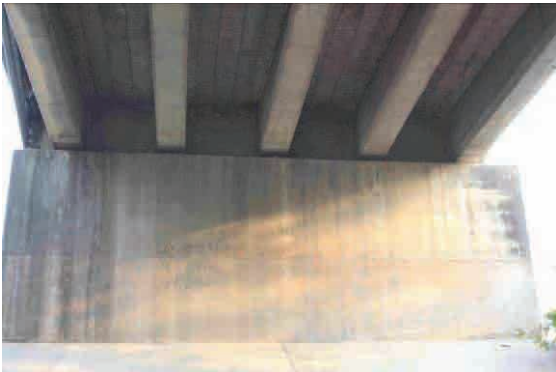
Abutment 02	
Damage: a	Damage: c

No crack	Crack width over 0.2mm

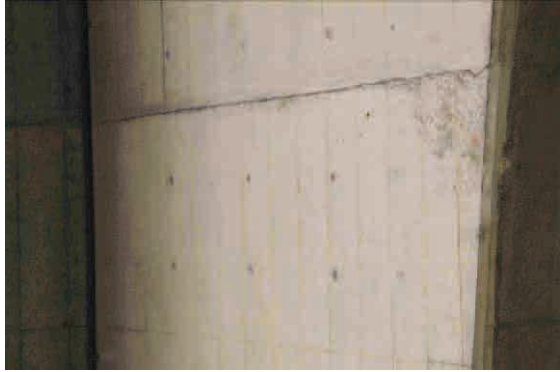
Superstructure P1	
Damage: a	Damage: a

No crack	No crack

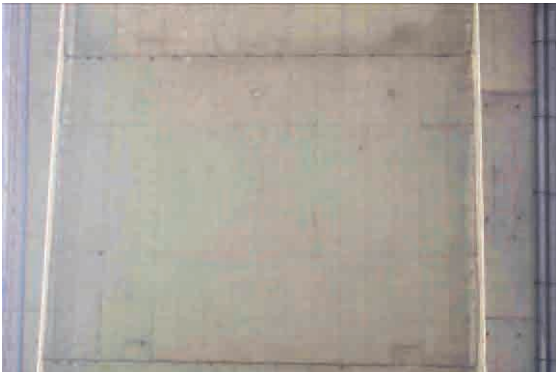
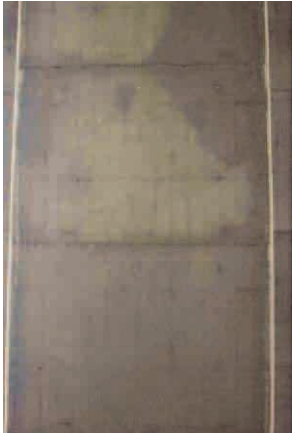
Superstructure P2	
Damage: a	Damage: a

No crack	No crack

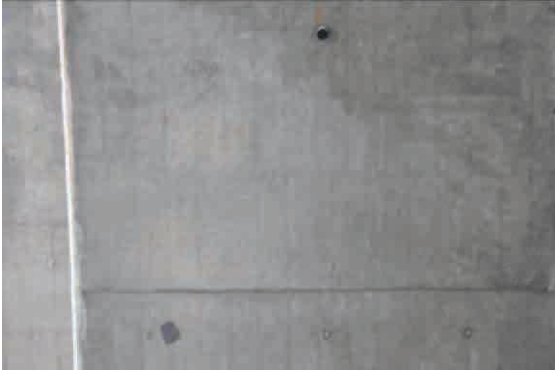
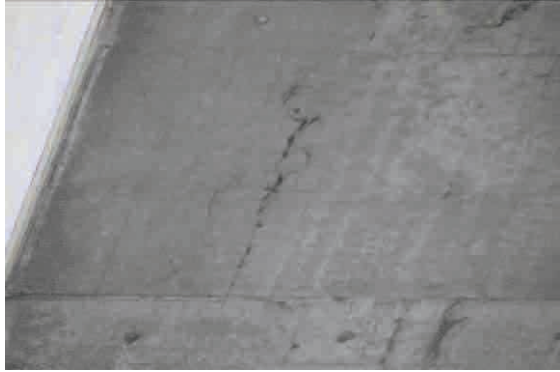
Superstructure P3	
Damage: a	Damage: a

No crack	No crack

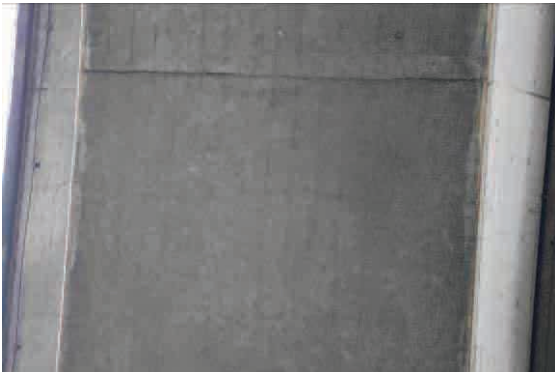
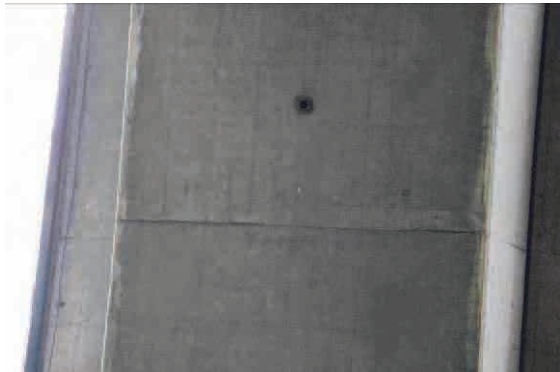
Superstructure P4	
Damage: a	Damage: a

No crack	No crack

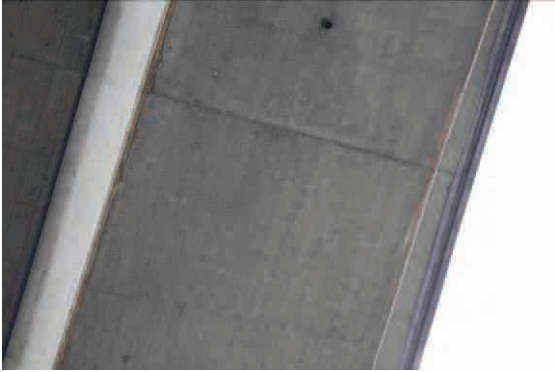
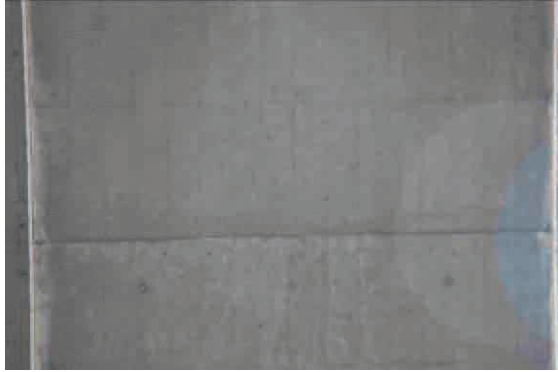
Superstructure P5	
Damage: a	Damage: a

No crack	No crack

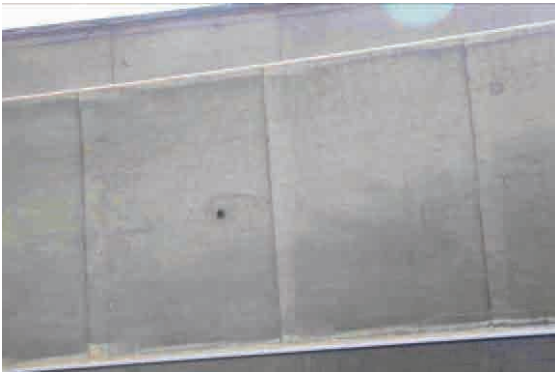
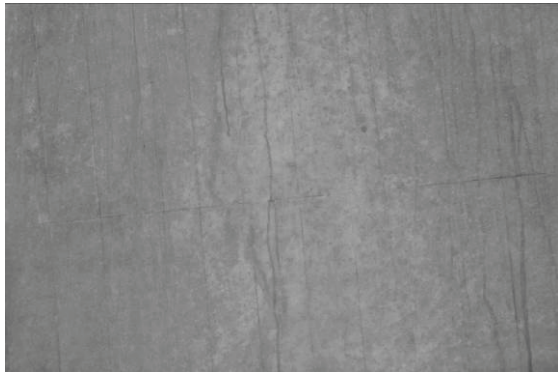
Superstructure P6	
Damage: a	Damage: a

No crack	No crack

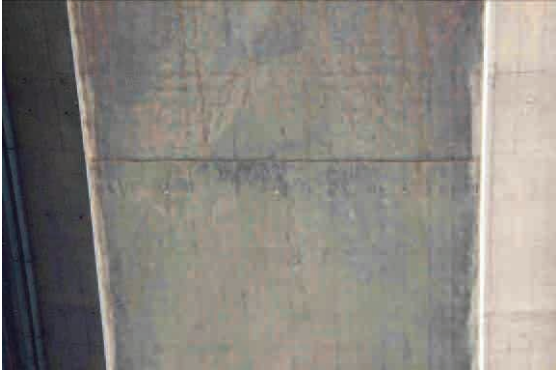
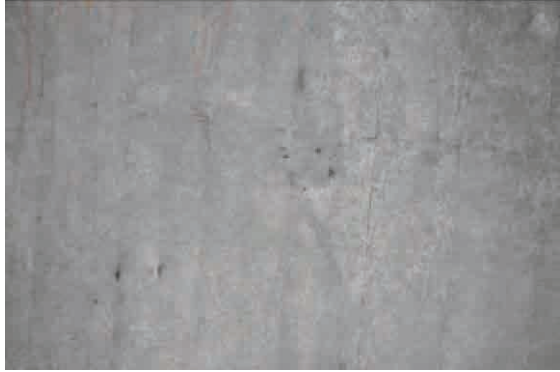
Superstructure P7	
Damage: a	Damage: a

No crack	No crack

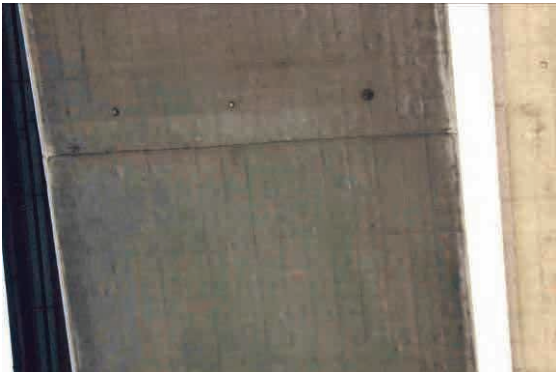
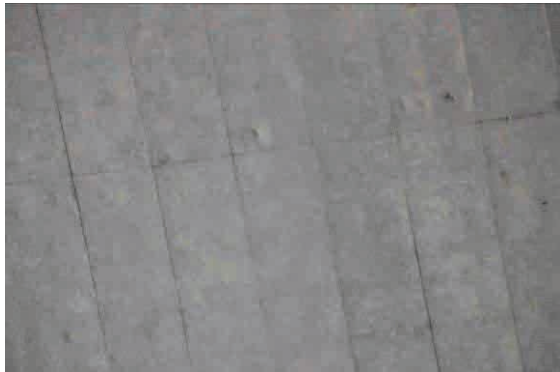
Superstructure P8	
Damage: a	Damage: a

No crack	No crack

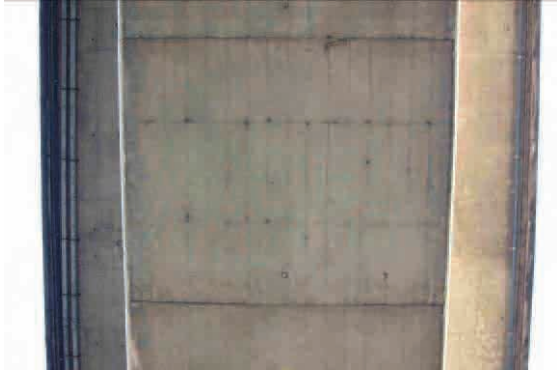
Superstructure P10	
Damage: a	Damage: a

No crack	No crack

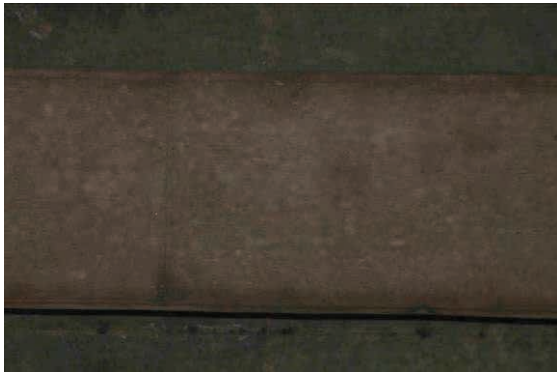
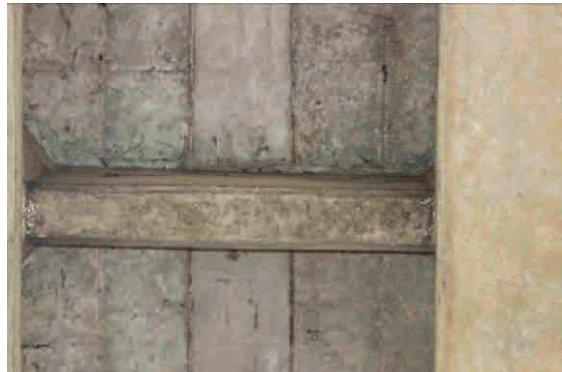
Superstructure P11-P12	
Damage: a	Damage: a

No crack	No crack

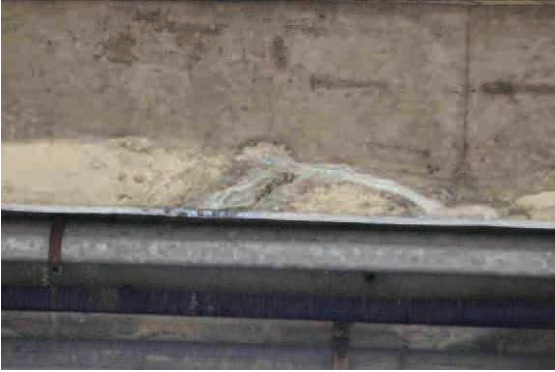
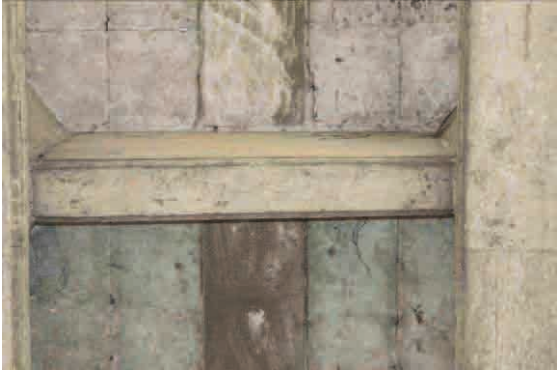
Superstructure P12-A2	
Damage: d	Damage: a

<p>Crack width over 0.2mm Small isolated lime</p>	<p>No crack</p>

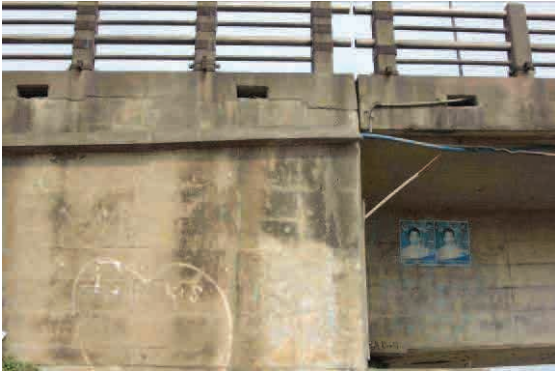
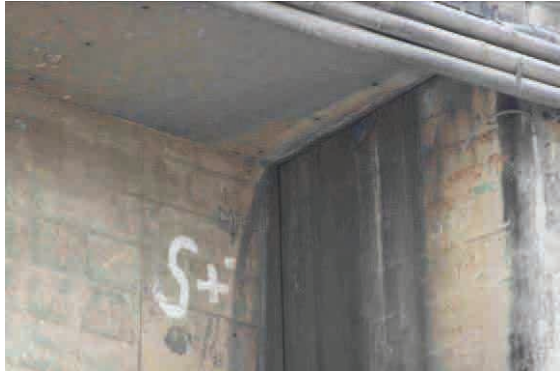
Abutment 01	
Damage: Not exist	Damage: Not exist

No damage	No damage

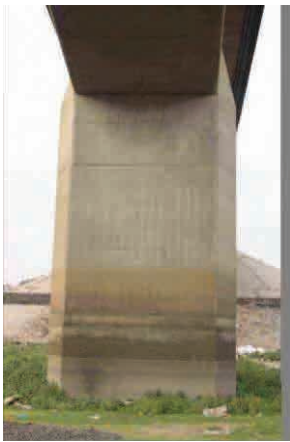
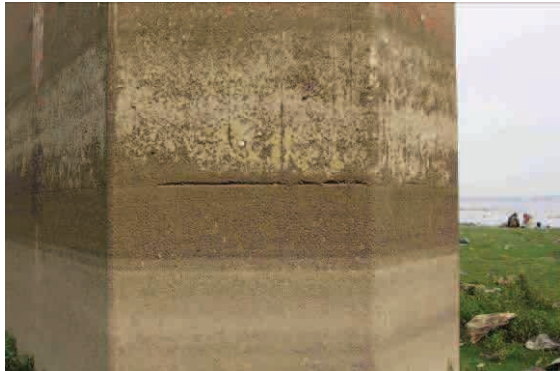
Pier 01	
Damage: Not exist	Damage: Not exist

No damage	No damage in reinforcement

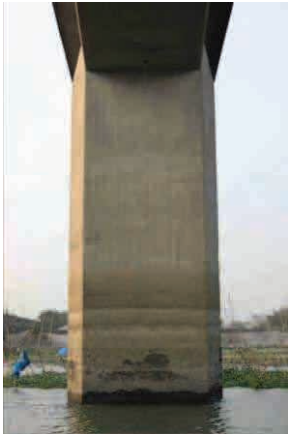
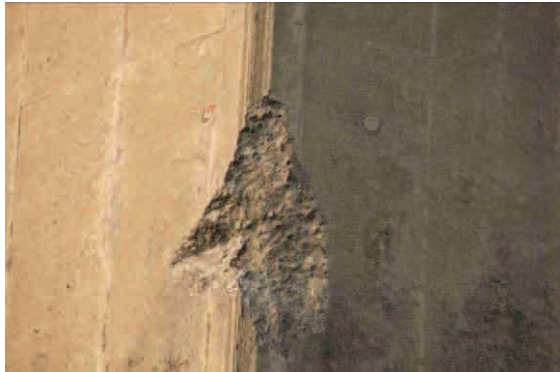
Pier 02	
Damage: Not exist	Damage: Not exist

No damage	No damage in reinforcement

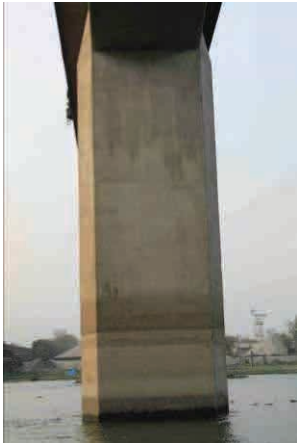
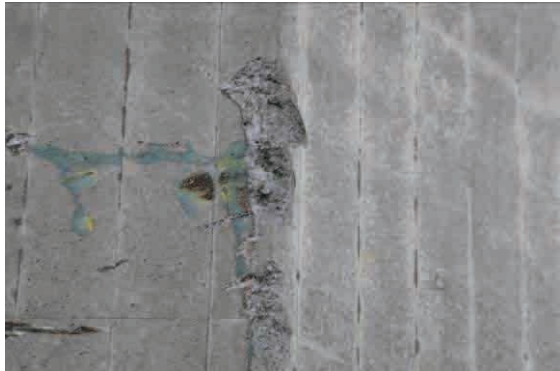
Pier 03	
Damage: Not exist	Damage: Not exist

No damage	No damage in reinforcement

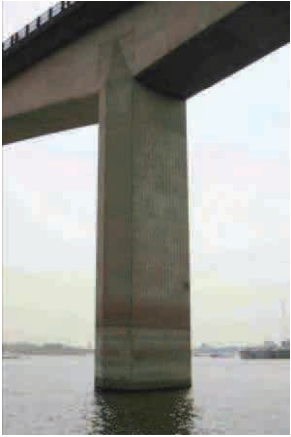
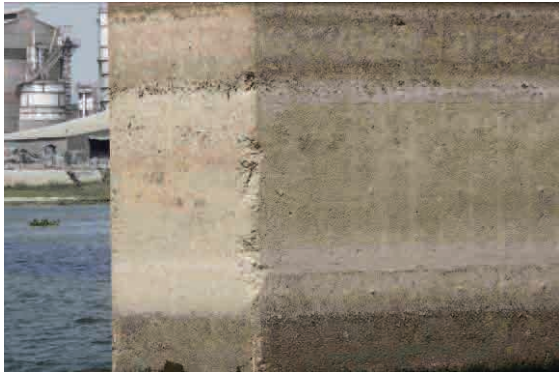
Pier 04	
Damage: Not exist	Damage: Not exist

A close-up photograph of the concrete surface of the pier column, showing some texture and minor discoloration but no significant damage.
No damage	No damage in reinforcement

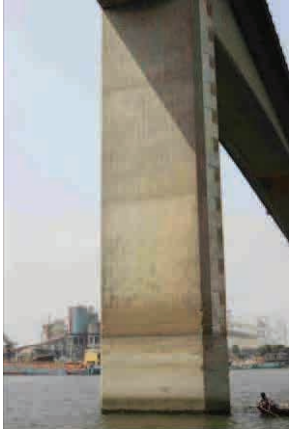
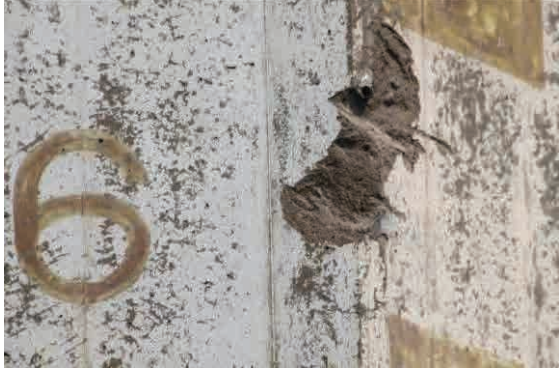
Pier 05	
Damage: Not exist	Damage: Not exist

A close-up photograph of the concrete surface of the pier column, showing some texture and minor discoloration but no significant damage.
No damage	No damage in reinforcement

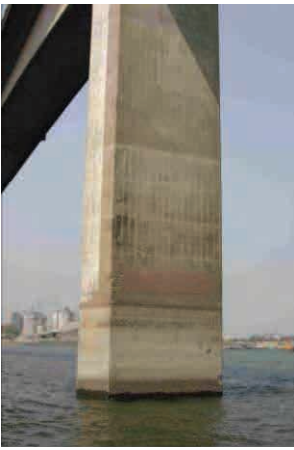
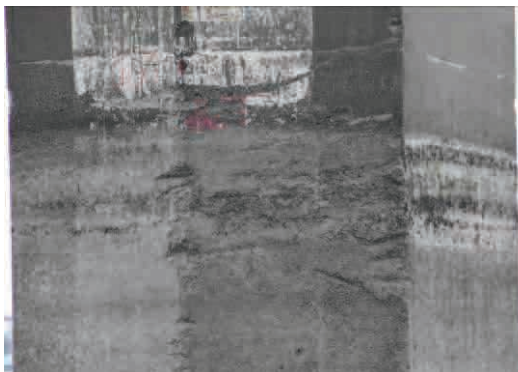
Pier 06	
Damage: Not exist	Damage: Not exist

No damage	No damage in reinforcement

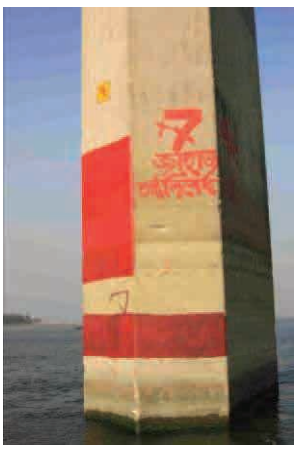
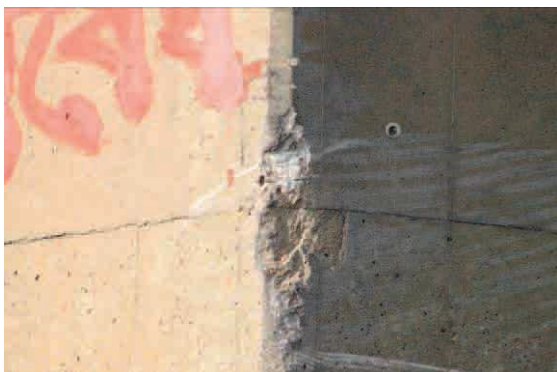
Pier 07	
Damage: Not exist	Damage: Not exist

No damage	No damage in reinforcement

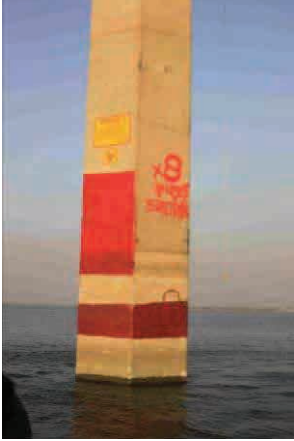
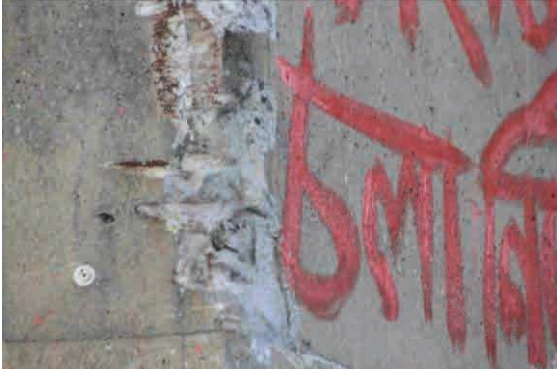
Pier 08	
Damage: Not exist	Damage: Not exist

No damage	No damage in reinforcement

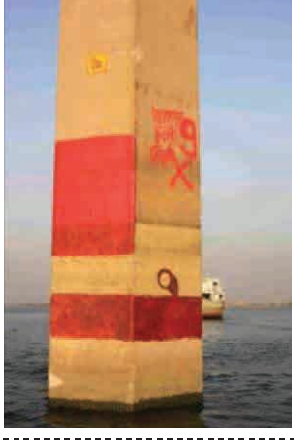
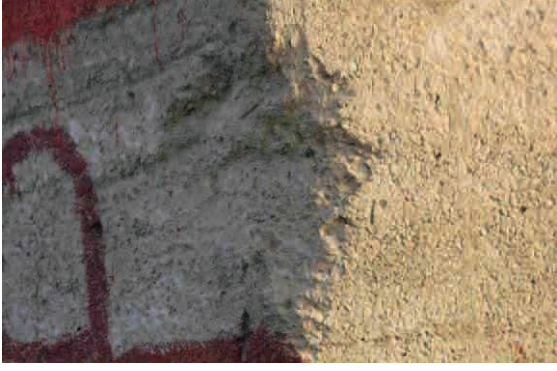
Pier 09	
Damage: Not exist	Damage: Not exist

No damage	No damage in reinforcement
